Validation Completion Report  
Plots 1-54  
Bowes Street, Manchester

Reference:11-813-R5-1  
Date: March 2022

Plots 1-54  
Former Stagecoach Bus Depot  
Land off Bowes Street  
Manchester

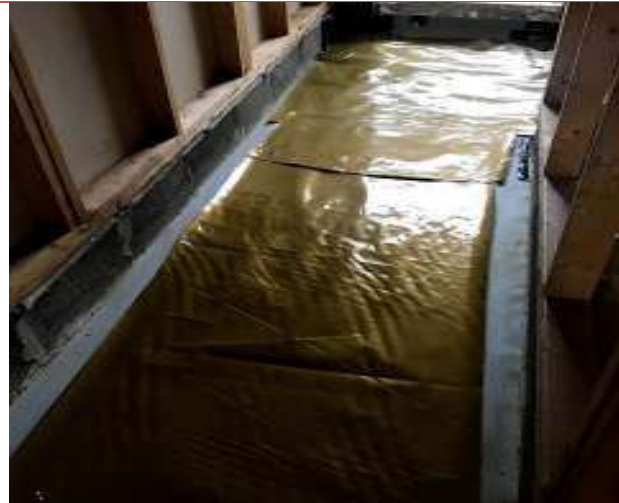
**Verification of Joints and Seals-Good Condition**

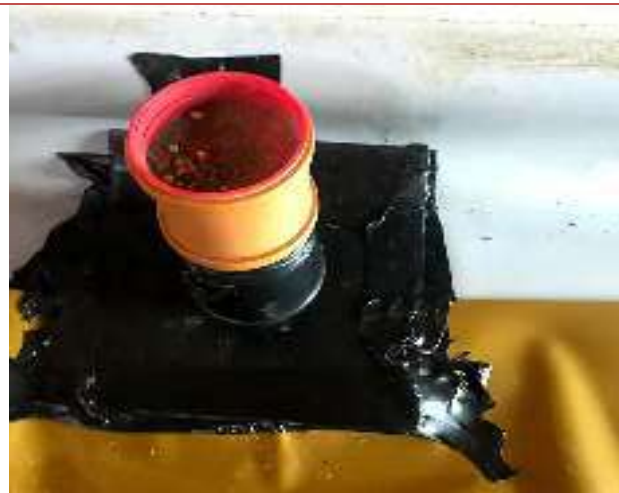
**Verification of Service Penetrations-Good Condition**

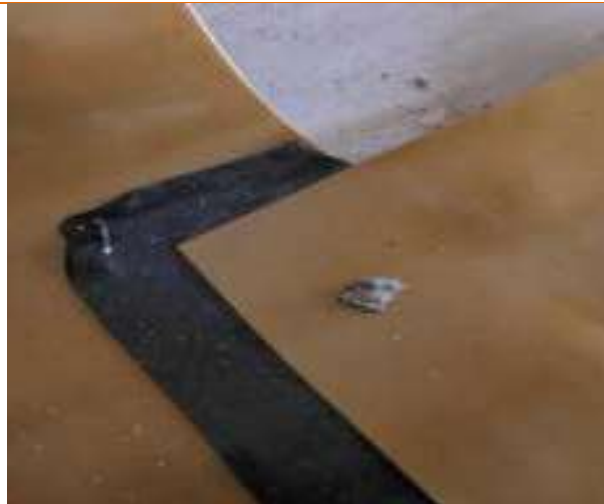
**Verification of Joints and Seals-Good Condition**

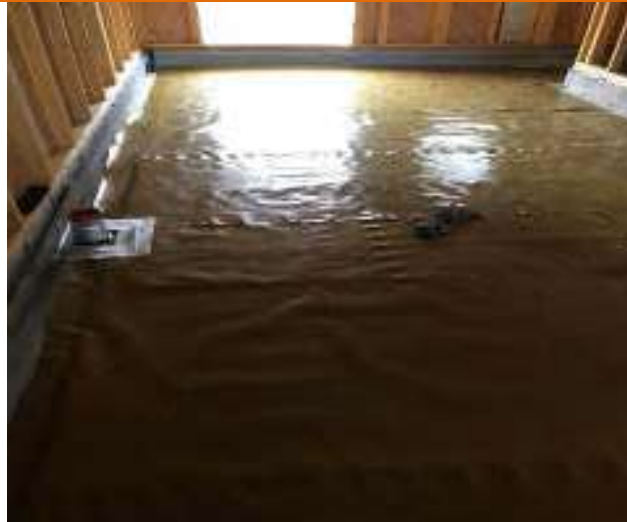
**Plot – 26**

**General Condition of Membrane-Good Condition**

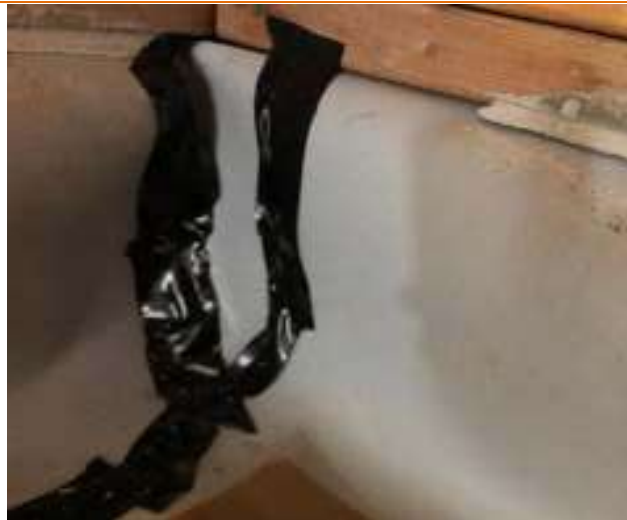
**Verification of Joints and Seals-Good Condition**

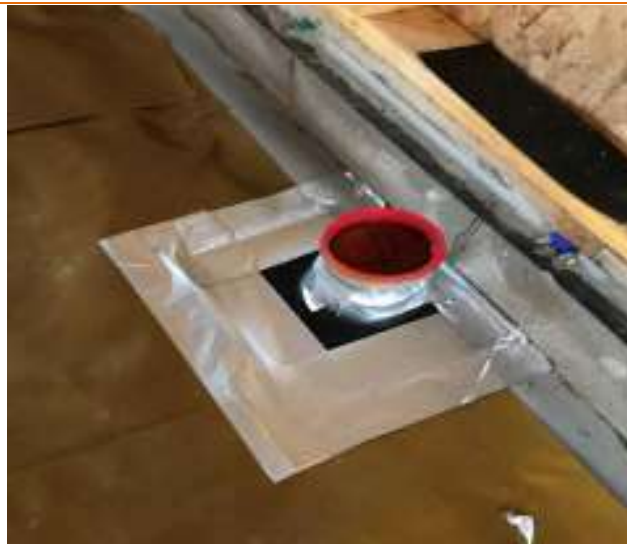
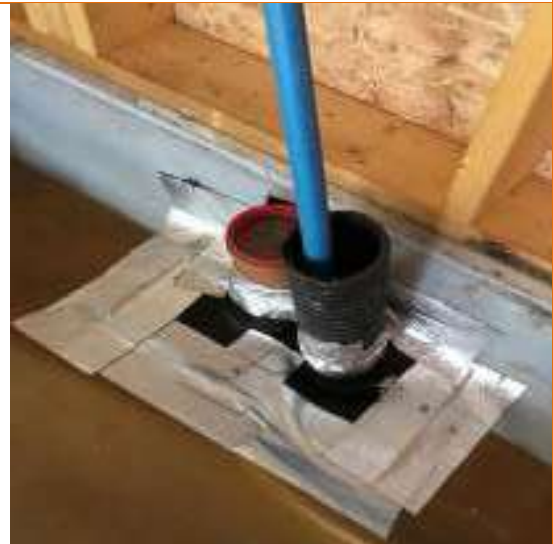
**Verification of Service Penetrations-Good Condition**

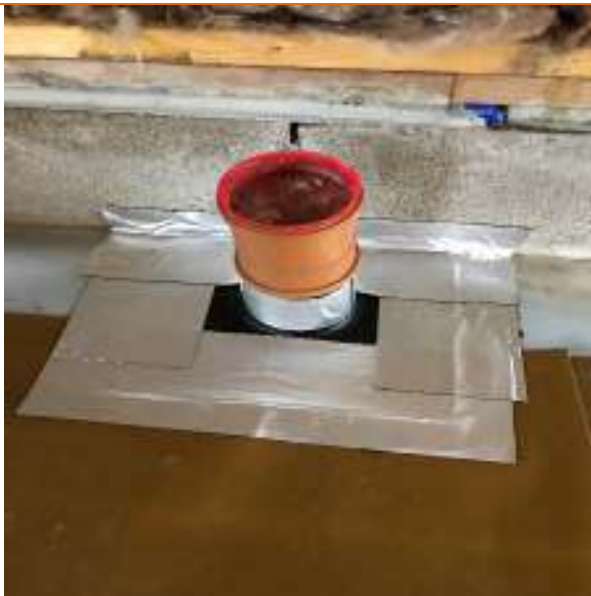
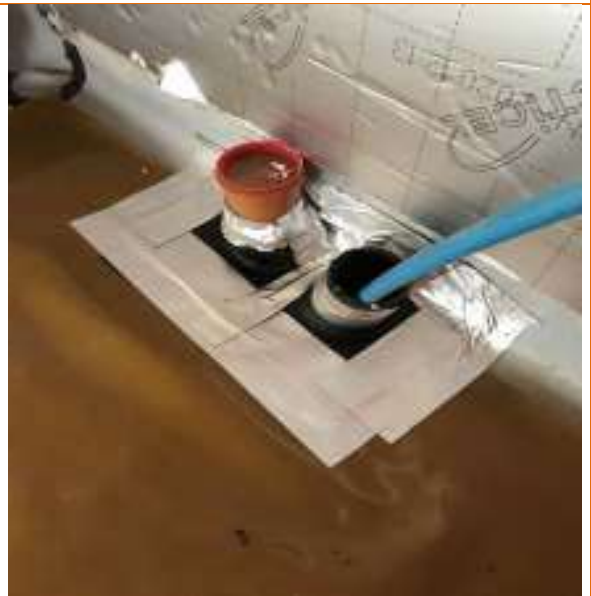
**Plot – 27**

**Verification of Service Penetrations-Good Condition**

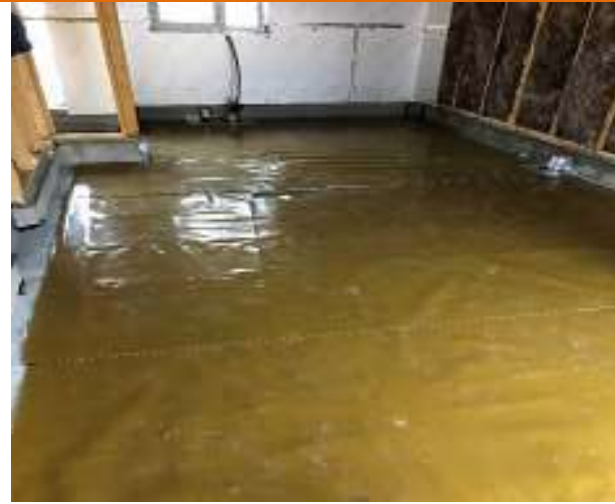
**Plot – 28**

**General Condition of Membrane-Good Condition**

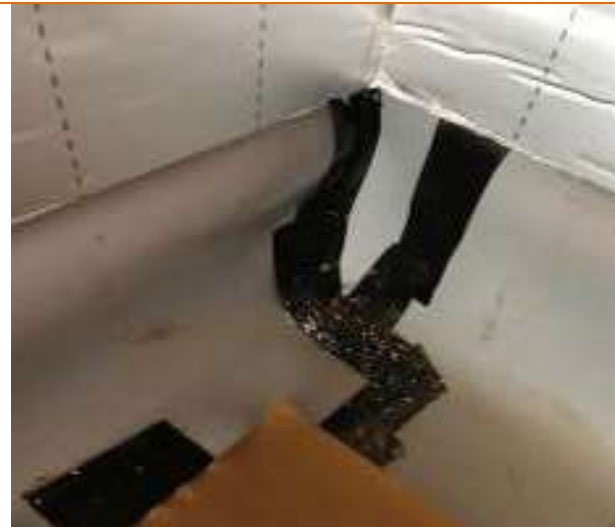
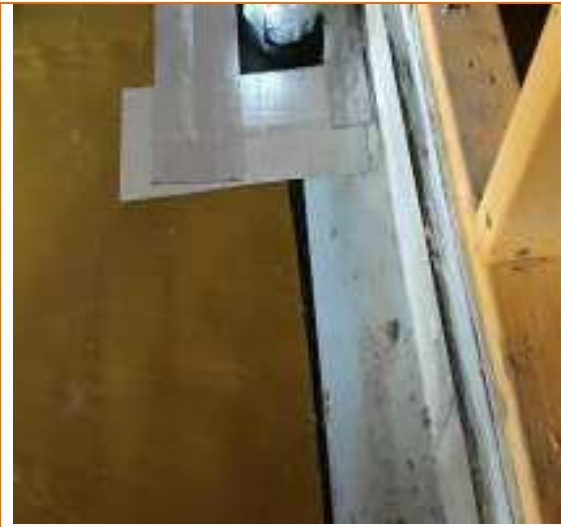
**Verification of Joints and Seals-Good Condition**

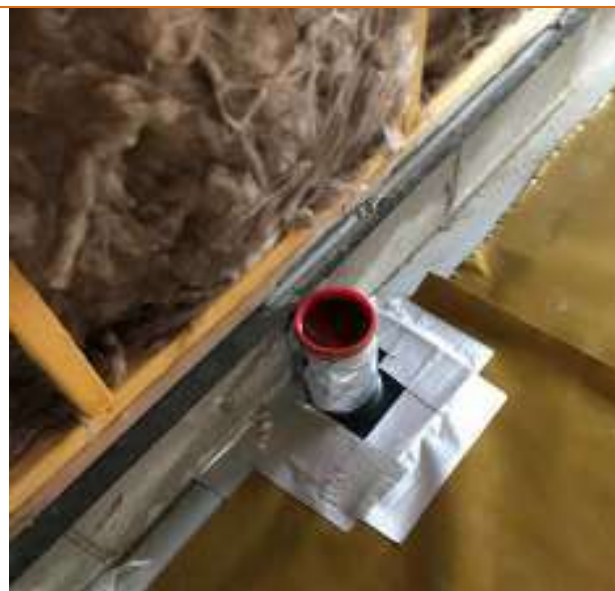
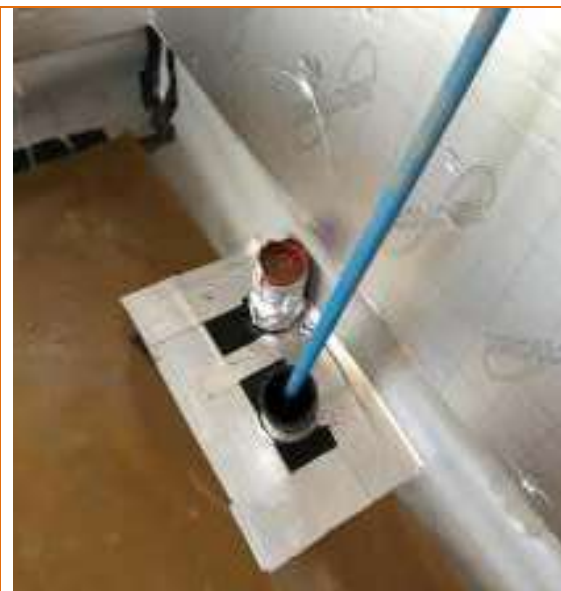
**Verification of Service Penetrations-Good Condition**

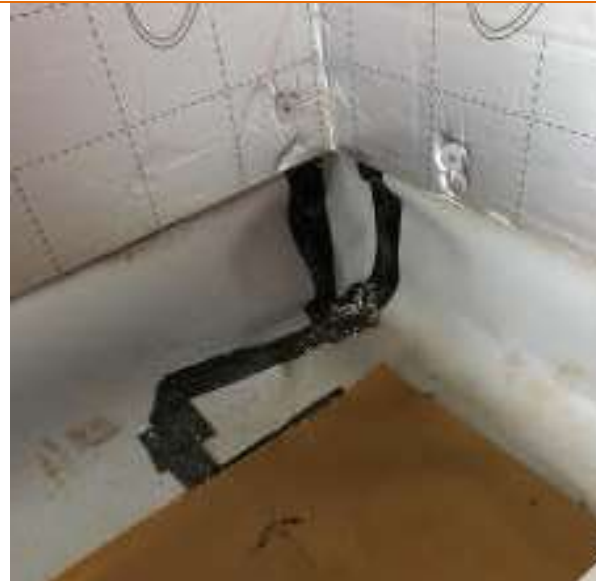
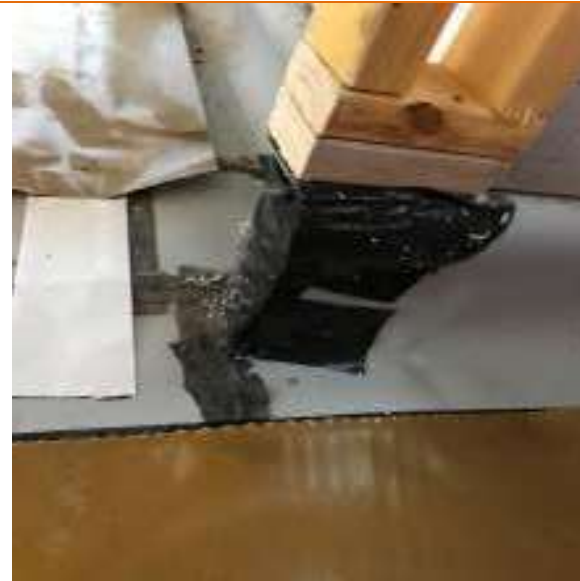
**Plot – 29**

**Verification of Joints and Seals-Good Condition**

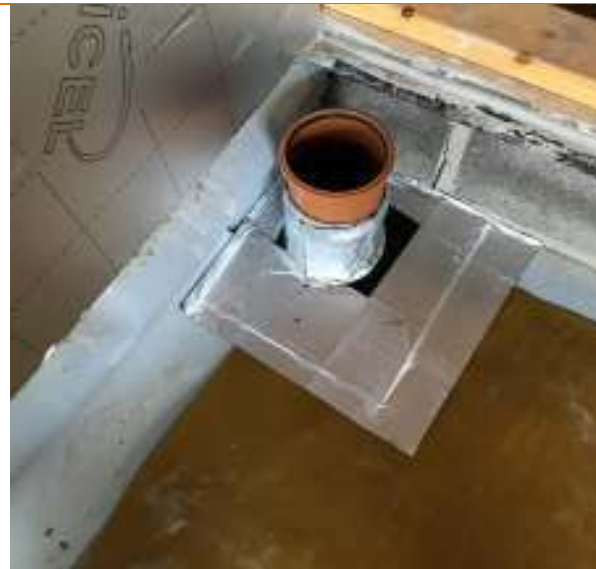
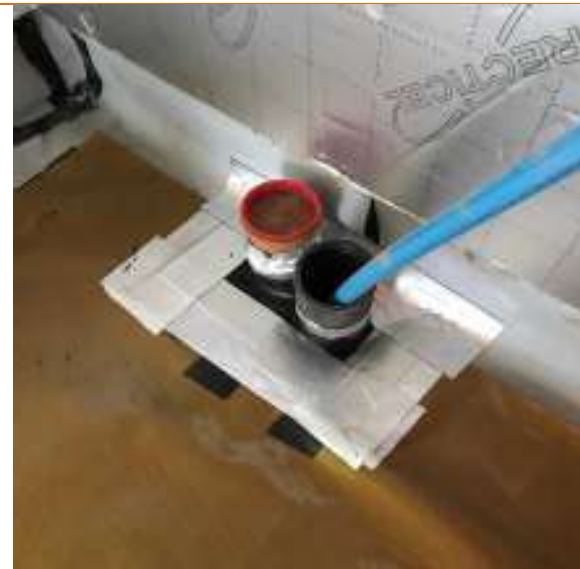
**Verification of Service Penetrations-Good Condition**

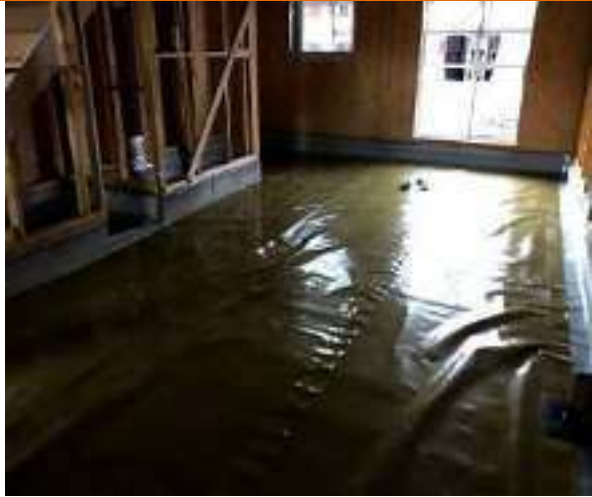
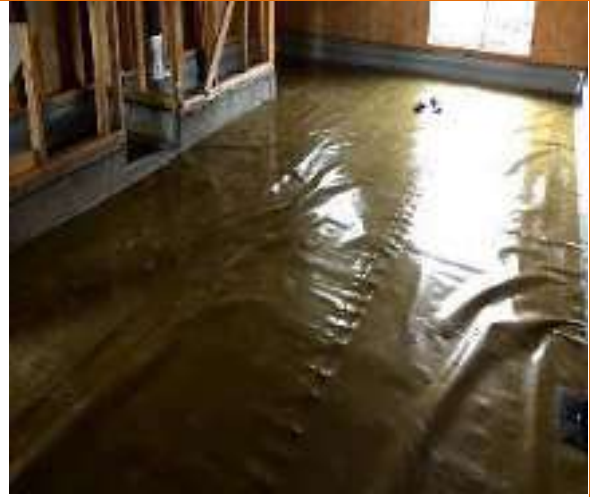
**Plot - 30**

**General Condition of Membrane-Good Condition**

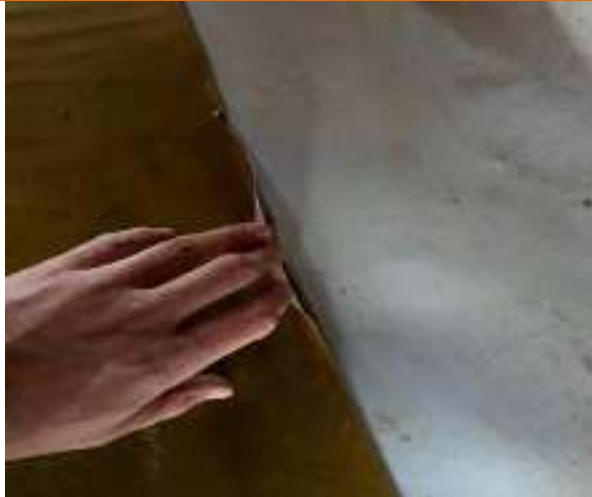
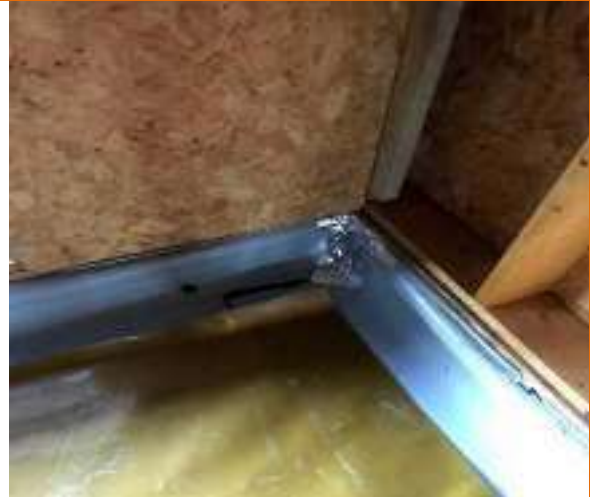
**Verification of Joints and Seals-Good Condition**

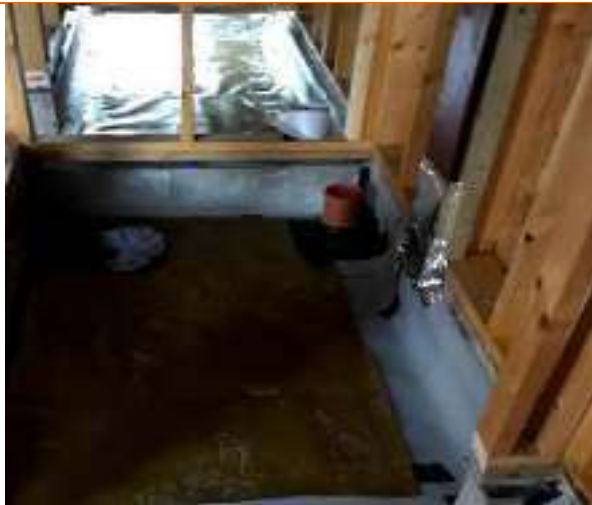
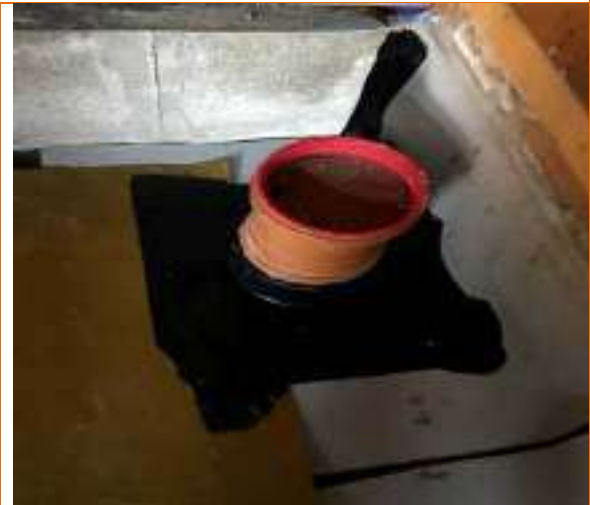
**Verification of Service Penetrations-Good Condition**

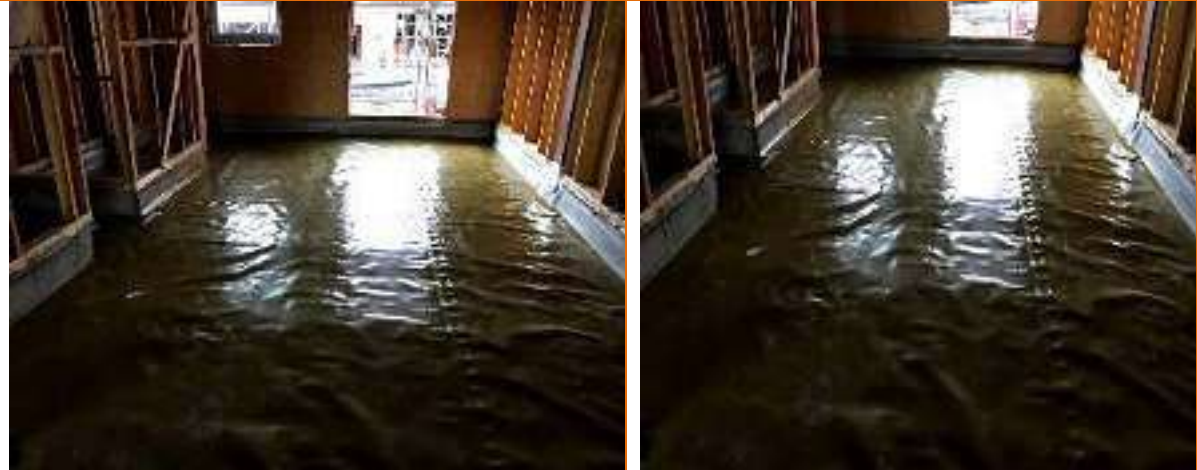
**Plot - 31**

**General Condition of Membrane-Good Condition**

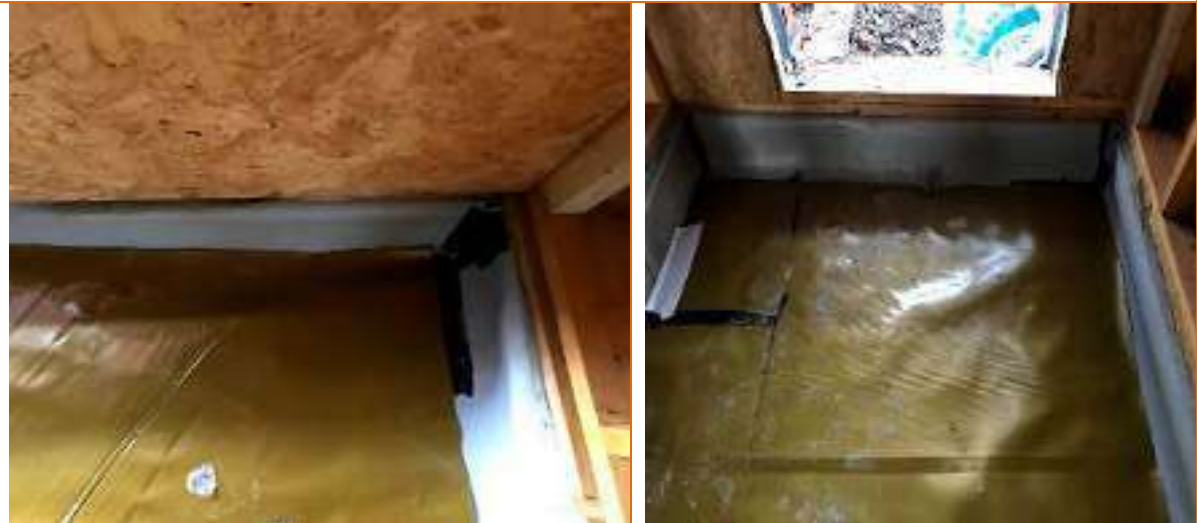
**Verification of Joints and Seals-Good Condition**

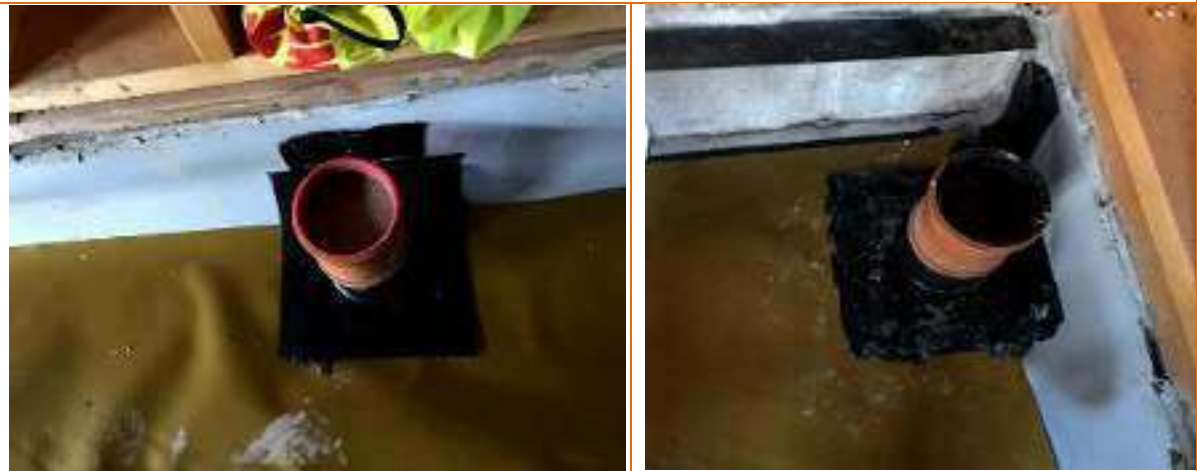
**Verification of Service Penetrations-Good Condition**

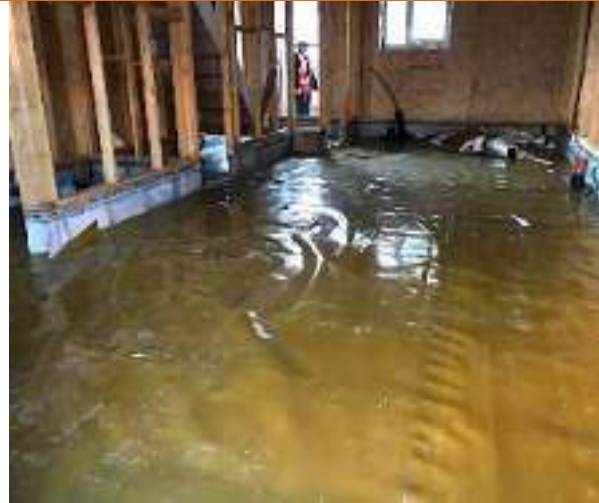
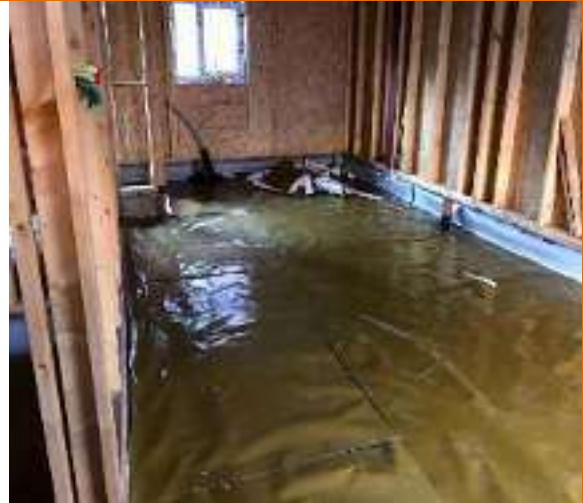
**Plot - 48**

**General Condition of Membrane-Good Condition**

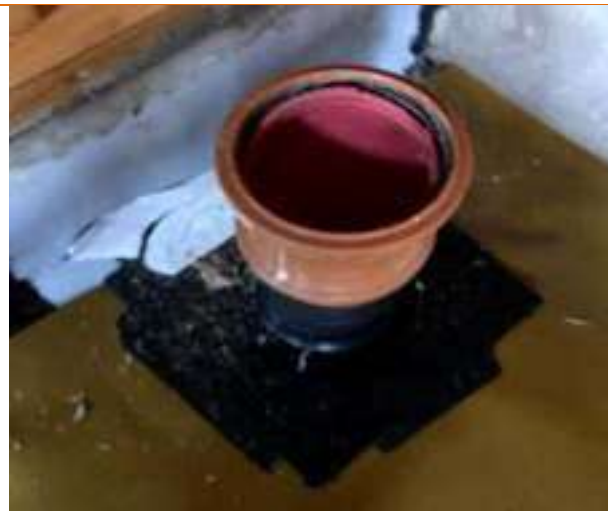
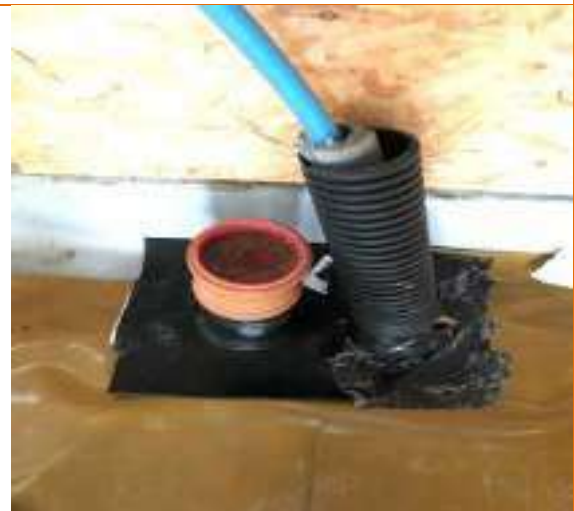
**Verification of Service Penetrations-Good Condition**

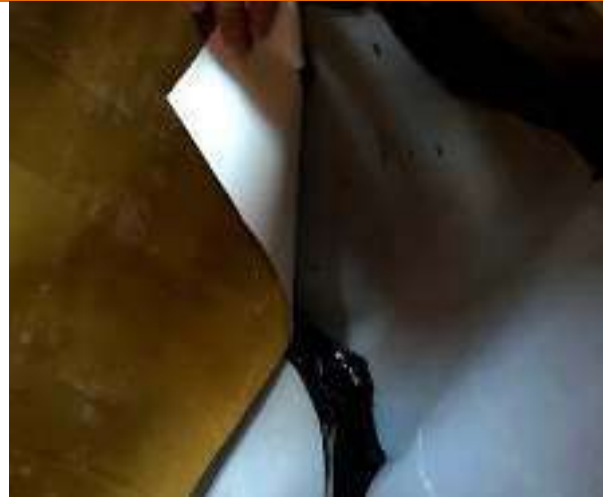
**Plot - 49**

**Verification of Joints and Seals-Good Condition**

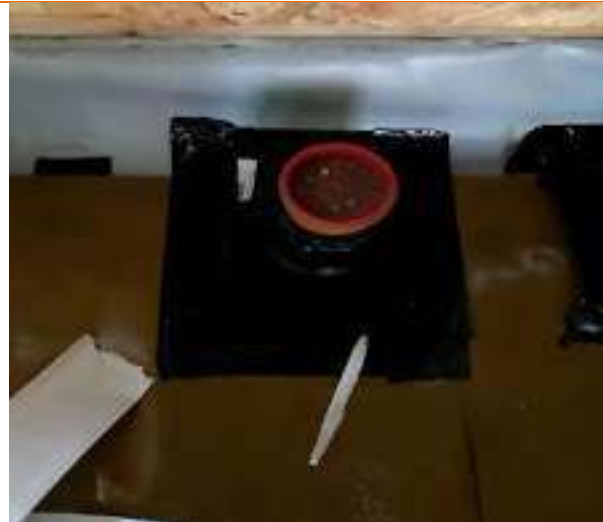
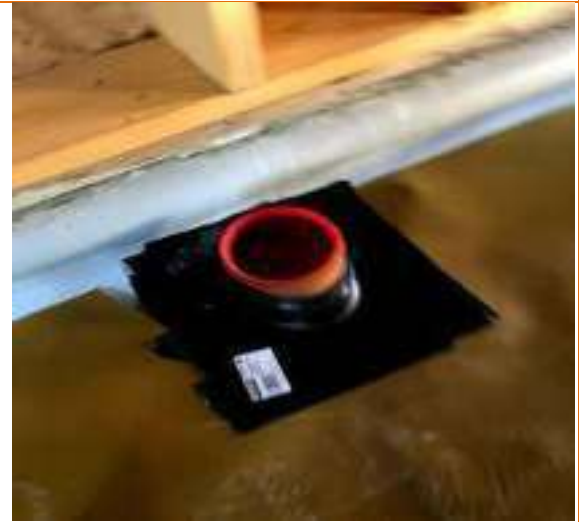
**Verification of Service Penetrations-Good Condition**

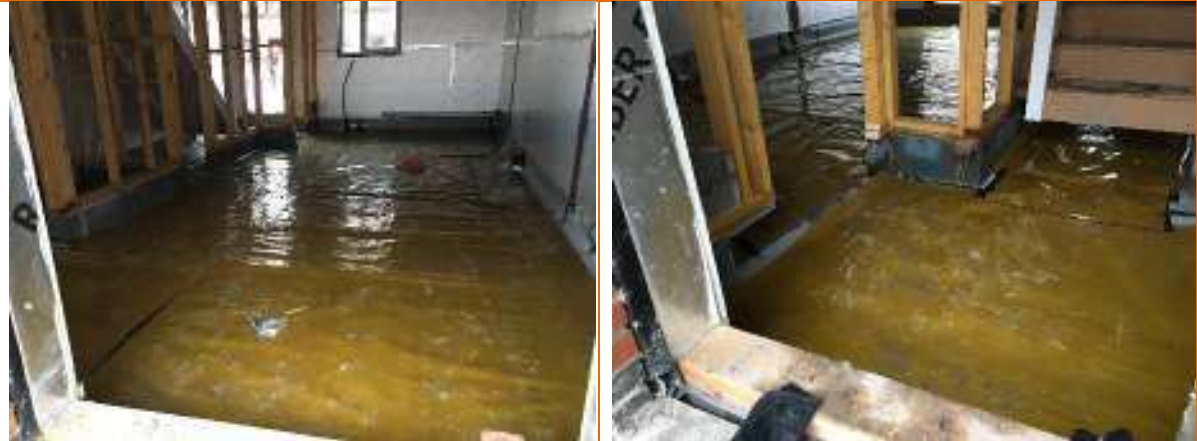
**Plot – 34**

**General Condition of Membrane-Good Condition**

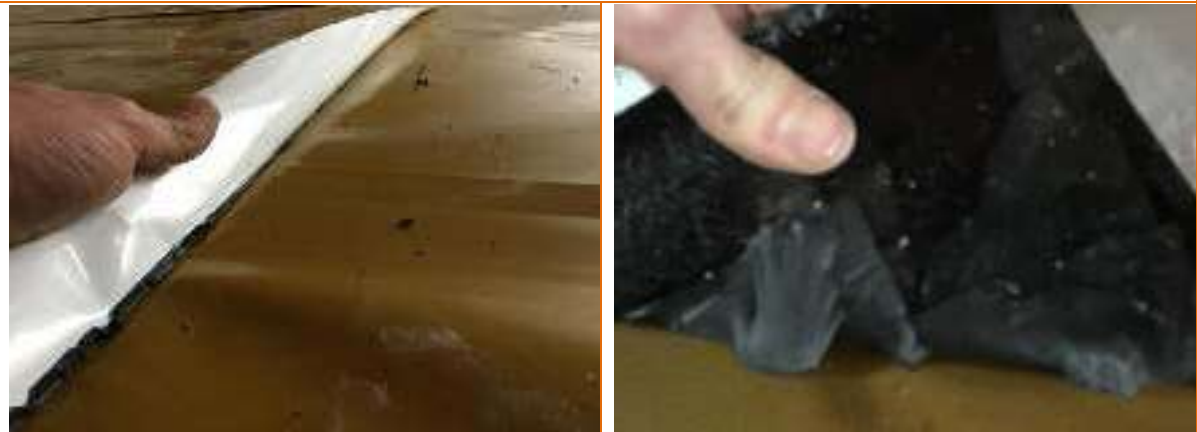
**Verification of Joints and Seals-Good Condition**

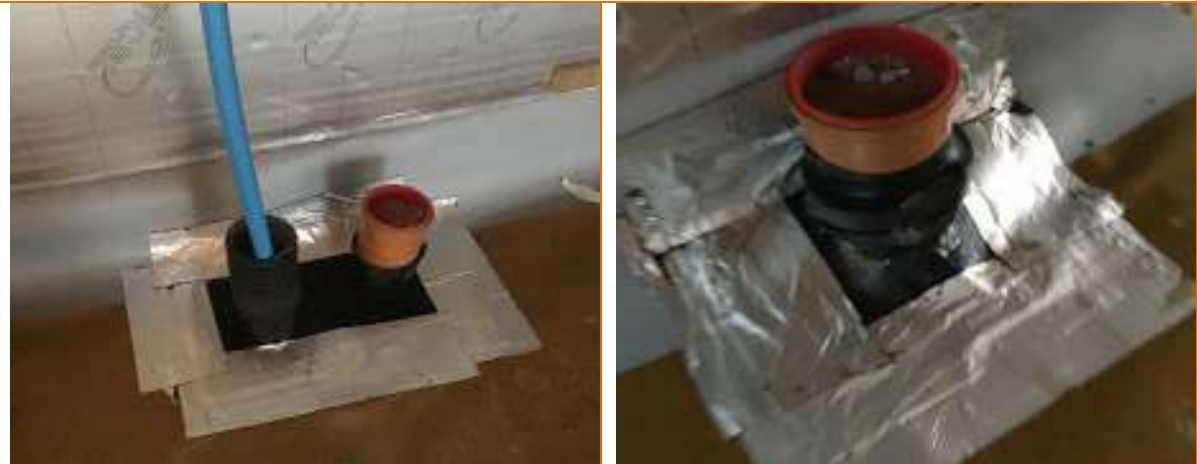
**Verification of Service Penetrations-Good Condition**

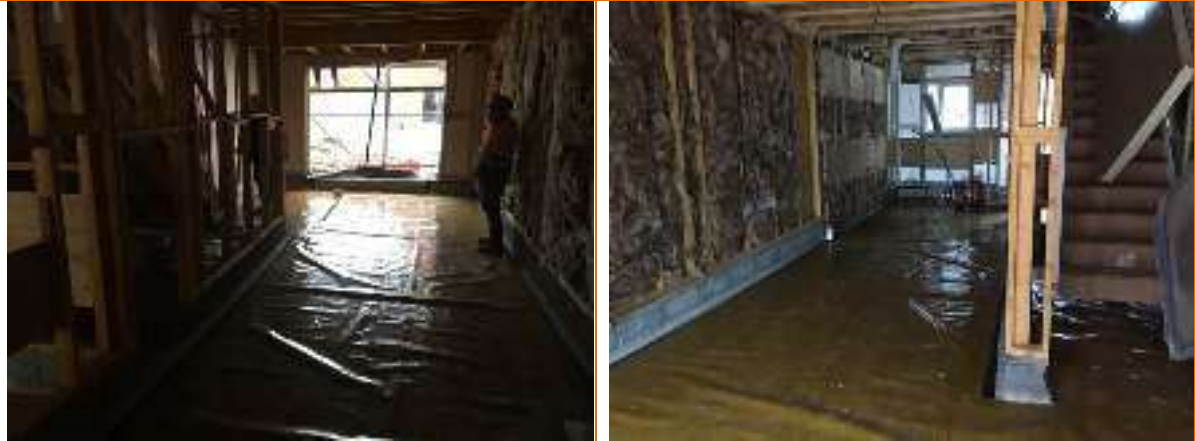
**Plot – 38**

**General Condition of Membrane-Good Condition**

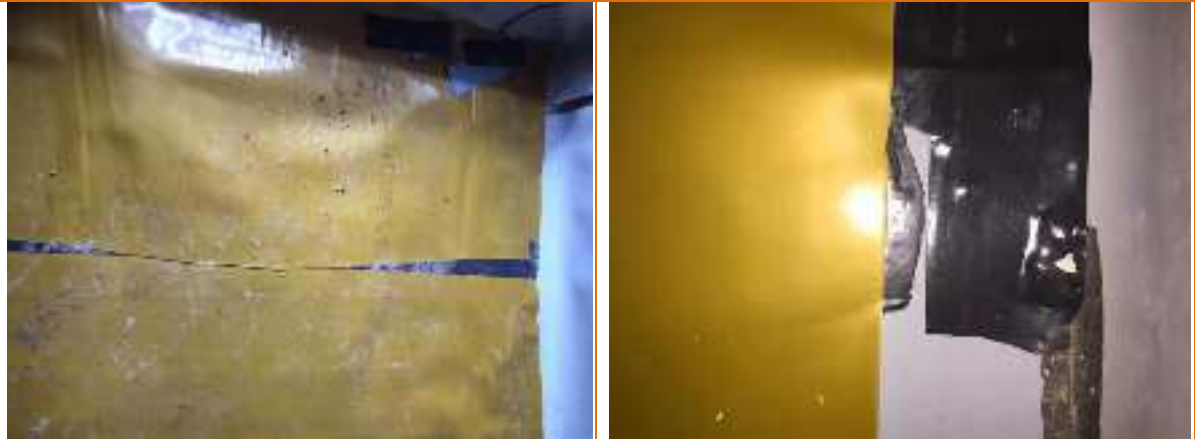
**Verification of Joints and Seals-Good Condition**

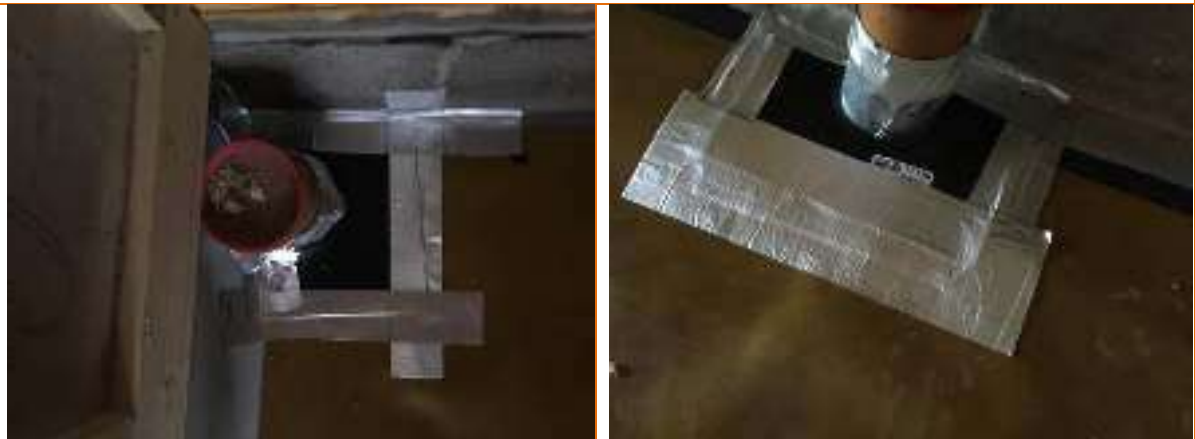
**Verification of Service Penetrations-Good Condition**

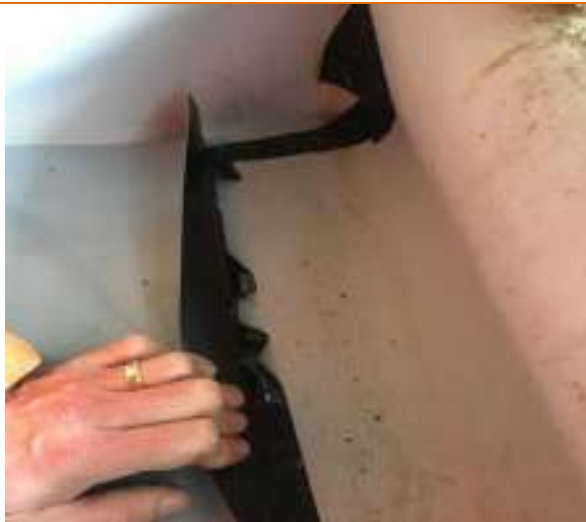
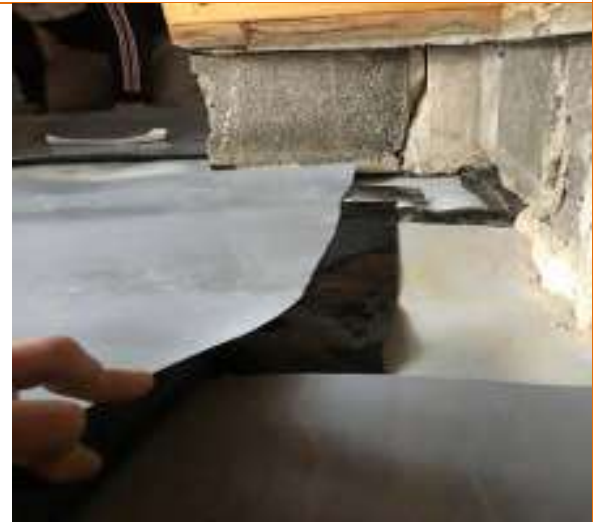
**Verification of Joints and Seals-Good Condition**

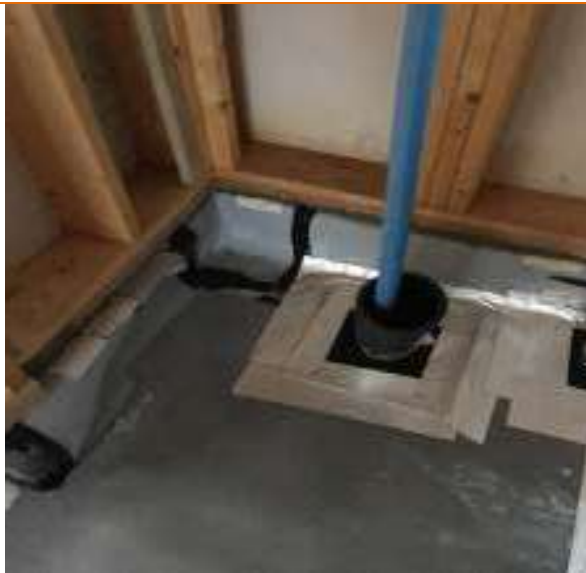
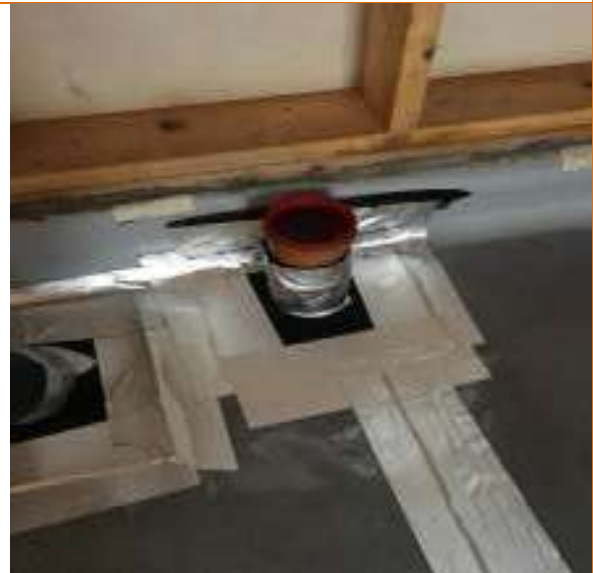
**Verification of Service Penetrations-Good Condition**

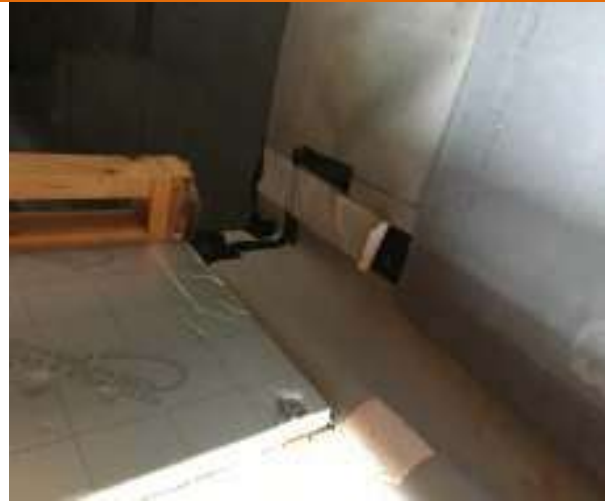
**Plot – 40**

**Verification of Joints and Seals-Good Condition**

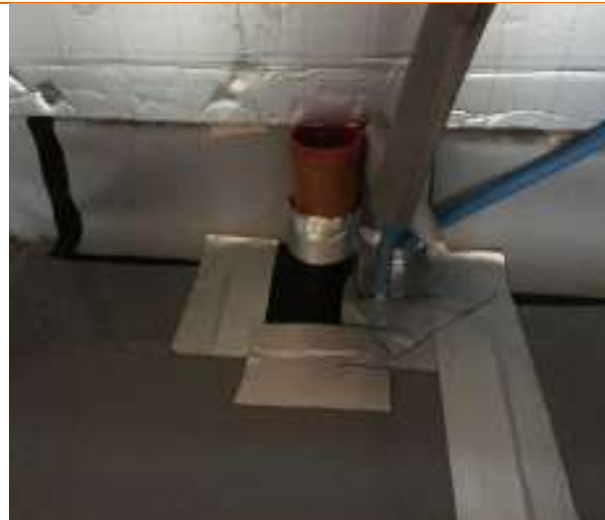
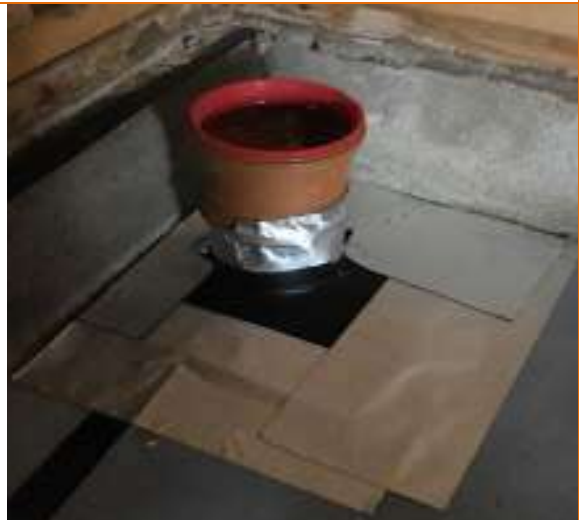
**Verification of Service Penetrations-Good Condition**

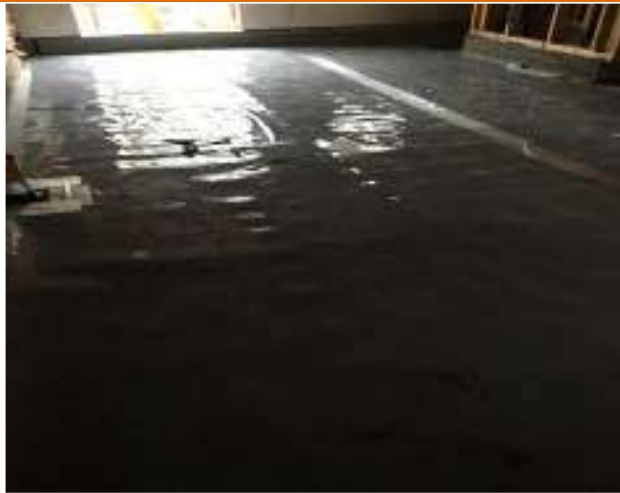
**Plot – 41**

**General Condition of Membrane-Good Condition**

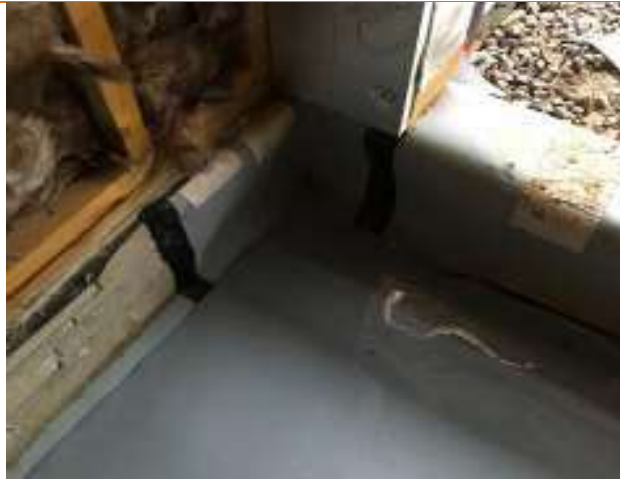
**Verification of Joints and Seals-Good Condition**

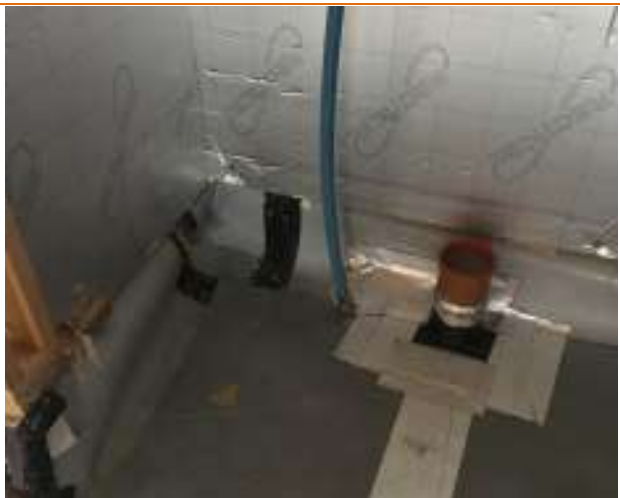
**Verification of Service Penetrations-Good Condition**

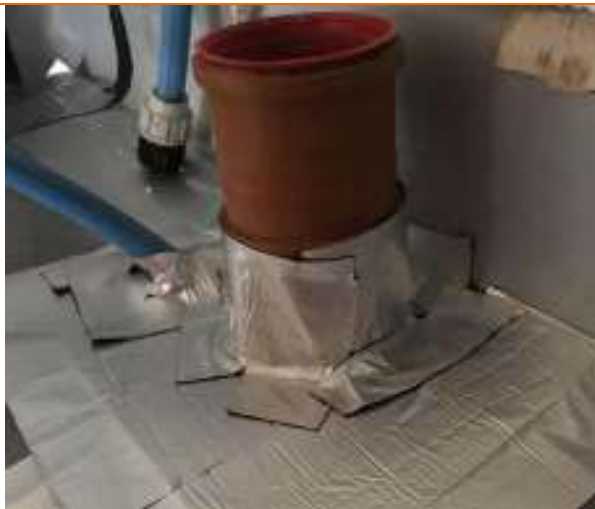
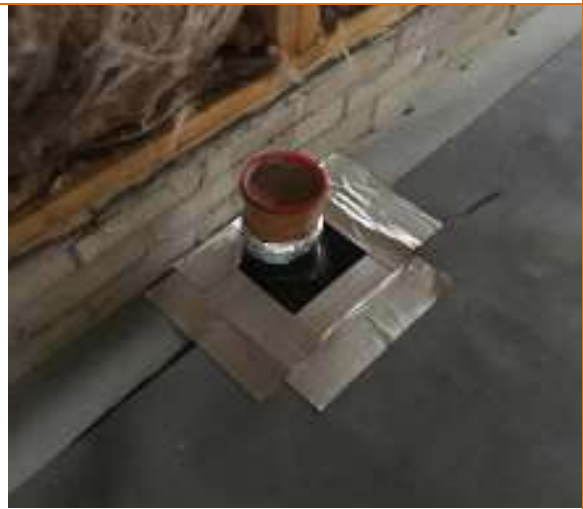
**Plot – 42**

**Verification of Service Penetrations-Good Condition**

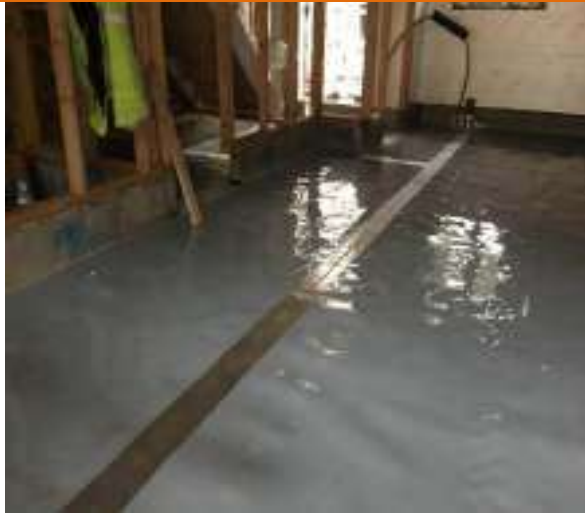
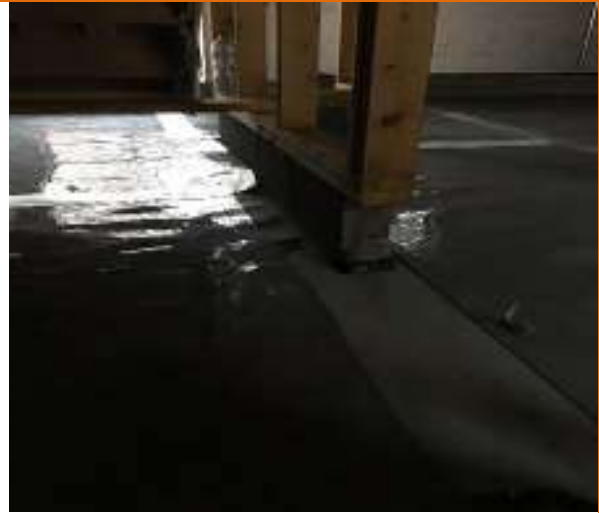
**Plot – 43**

**General Condition of Membrane-Good Condition**

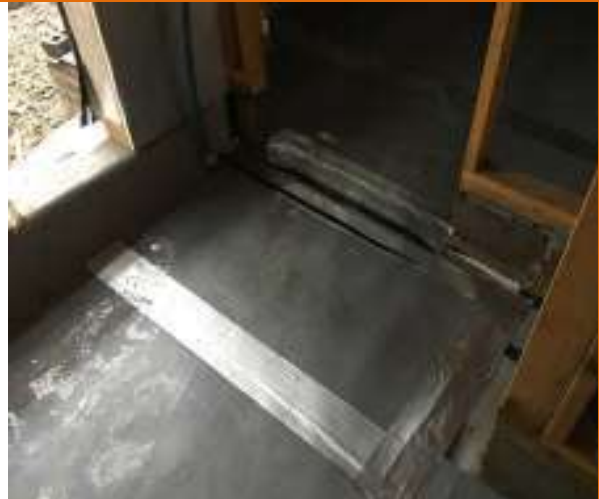
**Verification of Joints and Seals-Good Condition**

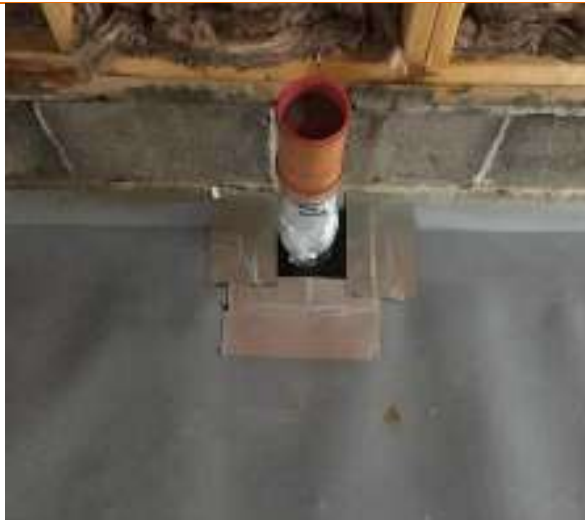
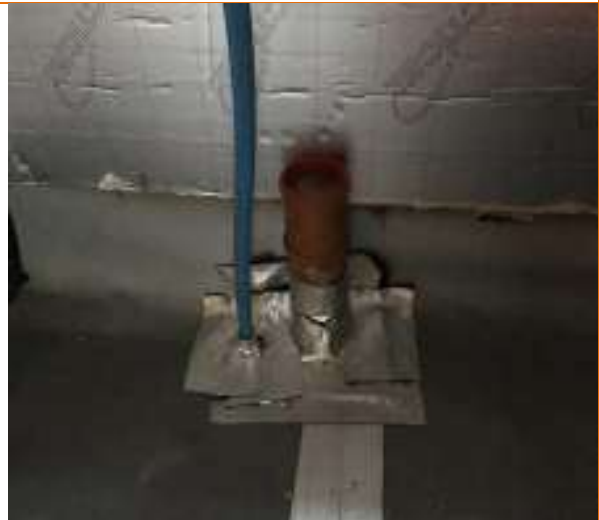
**Verification of Service Penetrations-Good Condition**

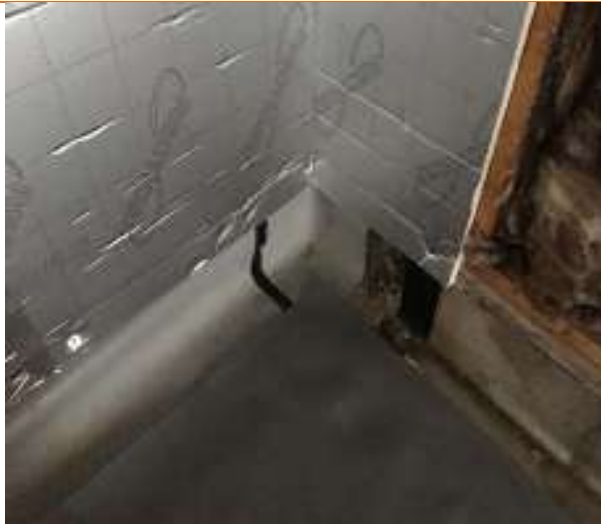
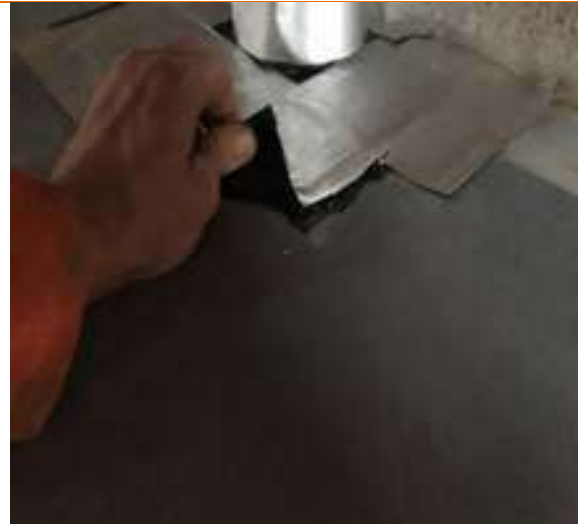
**Plot – 44**

**Verification of Joints and Seals-Good Condition**

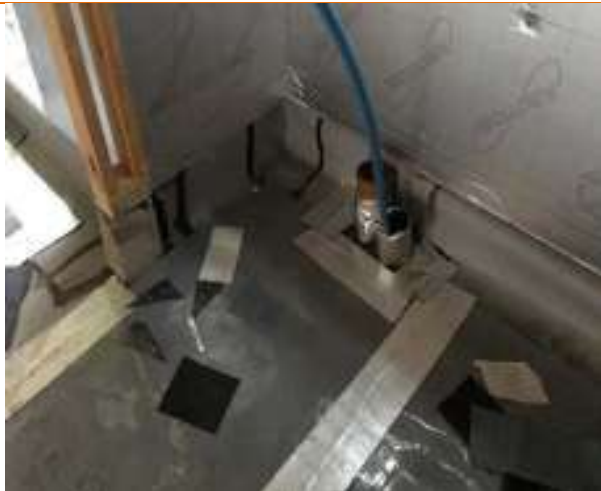
**Verification of Service Penetrations-Good Condition**

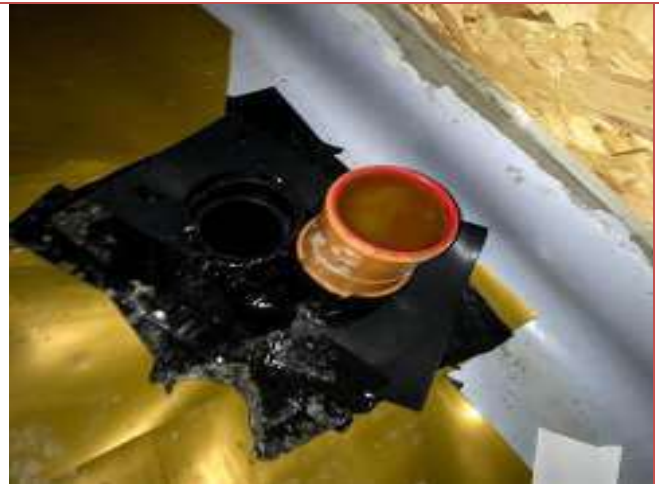
**Verification of Service Penetrations-Good Condition**

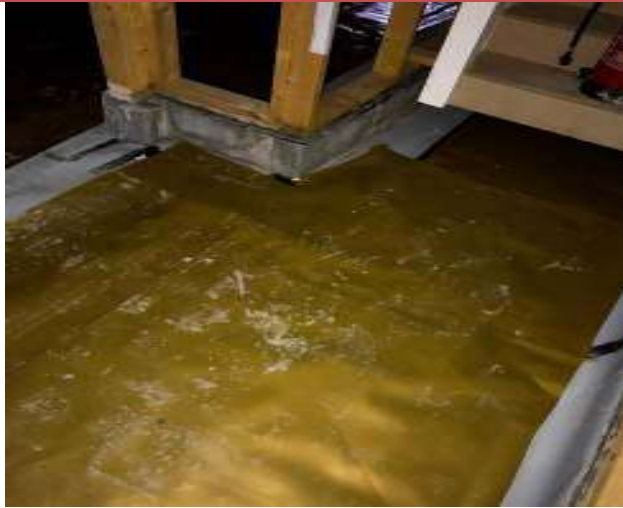
**Plot - 50**

**General Condition of Membrane-Good Condition**

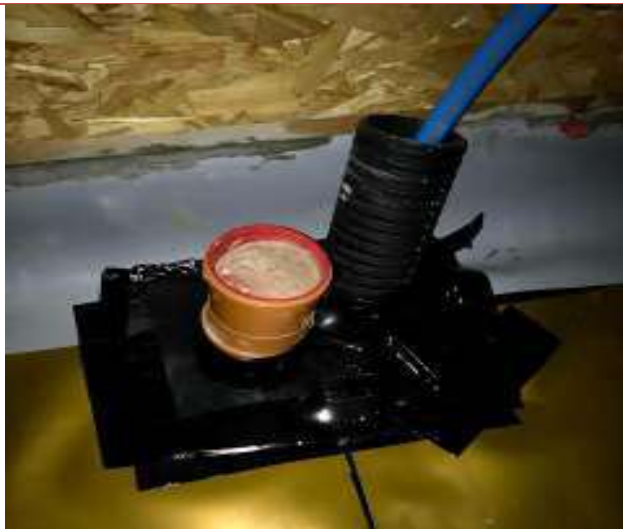
**Verification of Service Penetrations-Good Condition**

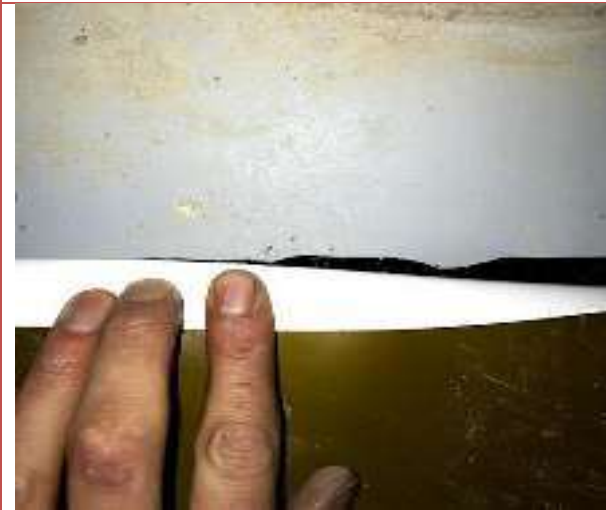
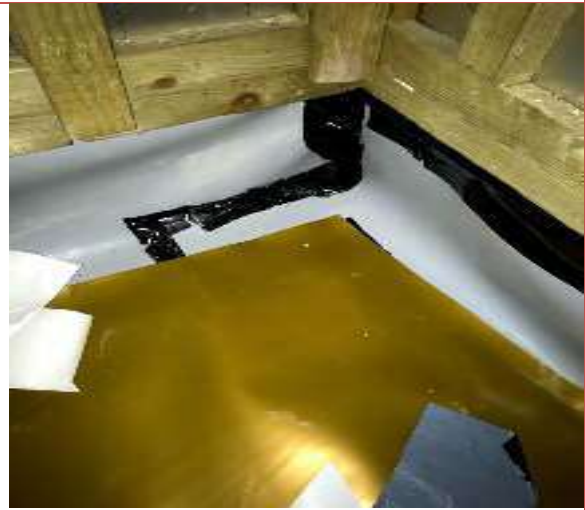
**Plot - 51**

**Verification of Joints and Seals-Good Condition**
