Validation Completion Report  
Plots 1-54  
Bowes Street, Manchester

Reference:11-813-R5-1  
Date: March 2022

Plots 1-54  
Former Stagecoach Bus Depot  
Land off Bowes Street  
Manchester

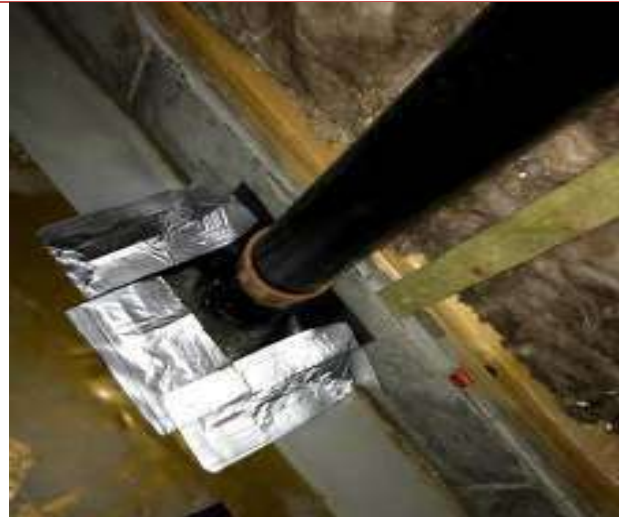
**Verification of Service Penetrations-Good Condition**
