## Tree Condition Survey

Luther King House

1 November 2021

### **Northern Baptist College, Luther King House, M14 5JP**

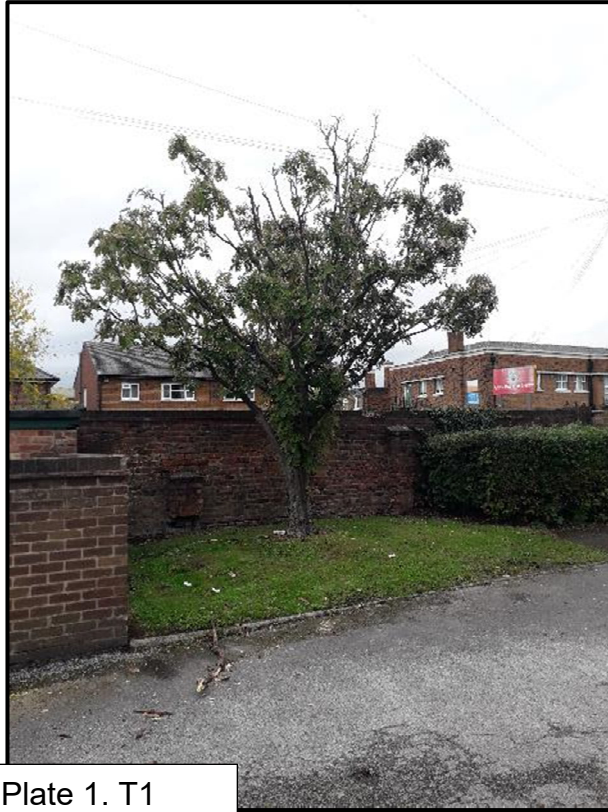
Plate 1. T1

| Tree ID | Common Name | Comments & work recommendations |
|---|---|---|
| T1 | Mountain ash<br>See plate 1 | Over mature tree appears to be entering decline with 20% dieback observed in crown. <b>Recommend removal of deadwood from tree's crown within six months.</b> |

| | | | | | | <b>Survey Comment:</b> | Over mature tree appears to be entering decline with 20% dieback observed in crown. Recommend removal of deadwood from tree's crown within six months. | | | | |

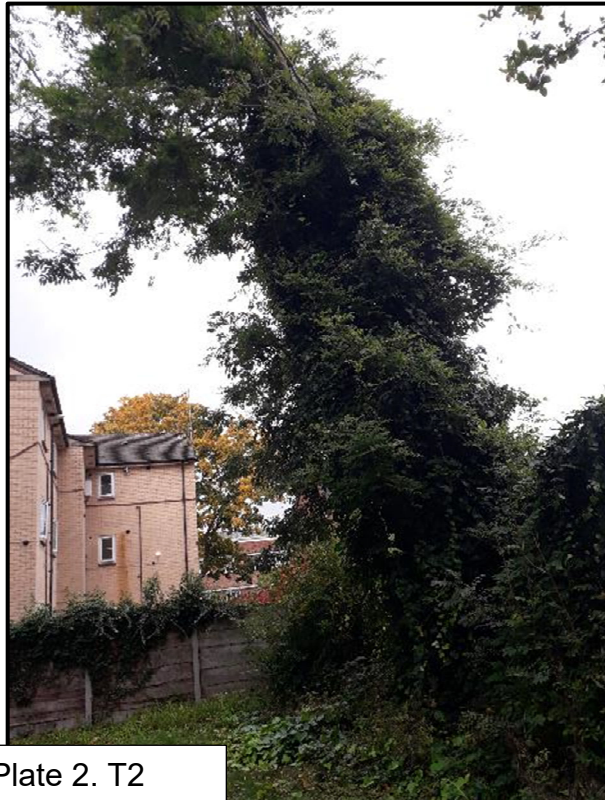
Plate 2. T2

| Tree ID | Common Name | Works/Remedial Action Required |
|---|---|---|
| T2 | Ash<br>See plate 2 | Early mature tree. Early symptoms of ash dieback pathogen were observed in tree's crown. <b>Recommend to reinspect tree within 24 months to assess level of advancement of pathogen.</b> Thick ivy is spreading throughout tree's stem precluding a full stem inspection, <b>recommend to sever ivy within 12 months to aid future tree inspections.</b> |

| | | | | | | <b>Survey Comment:</b> | Early mature tree. Early symptoms of ash dieback pathogen were observed in tree's crown. Recommend to reinspect tree within 24 months. Thick ivy is spreading throughout tree's stem precluding a full stem inspection, recommend to sever ivy within 12 months to aid future tree inspections. | | | | |

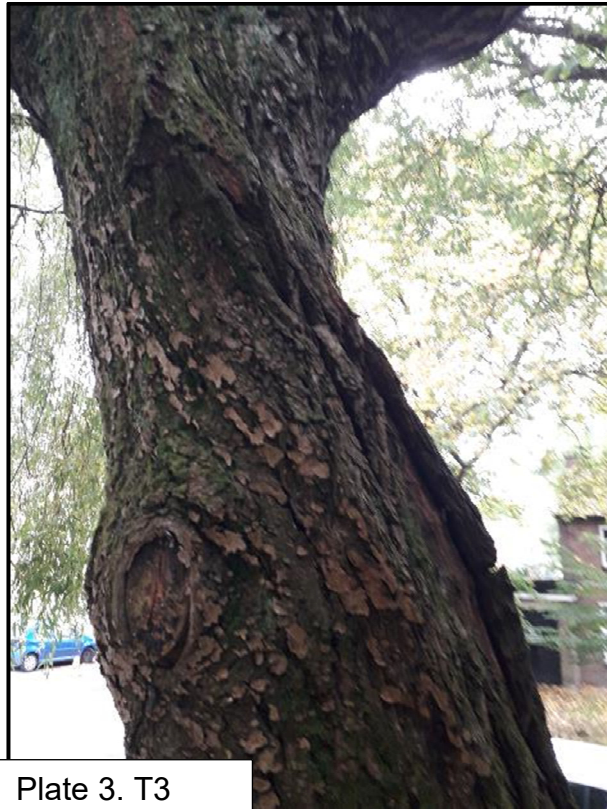
Plate 3. T3

| Tree ID | Common Name | Comments & work recommendations |
|---|---|---|
| T3 | Weeping willow<br>See plate 3 | Area of necrotic cambium was observed in tree's northern stem at 3m. Symptoms of an internal crack are developing adjacent to the area of cambium necrosis. <b>Recommend to reduce tree's height to 4m within six months.</b> |

**Tree Comment:**  
**Survey Comment:** Area of necrotic cambium was observed in tree's northern stem at 3m. Symptoms of an internal crack are developing adjacent to the area of cambium necrosis. Recommend to reduce tree's height to 4m within six months.

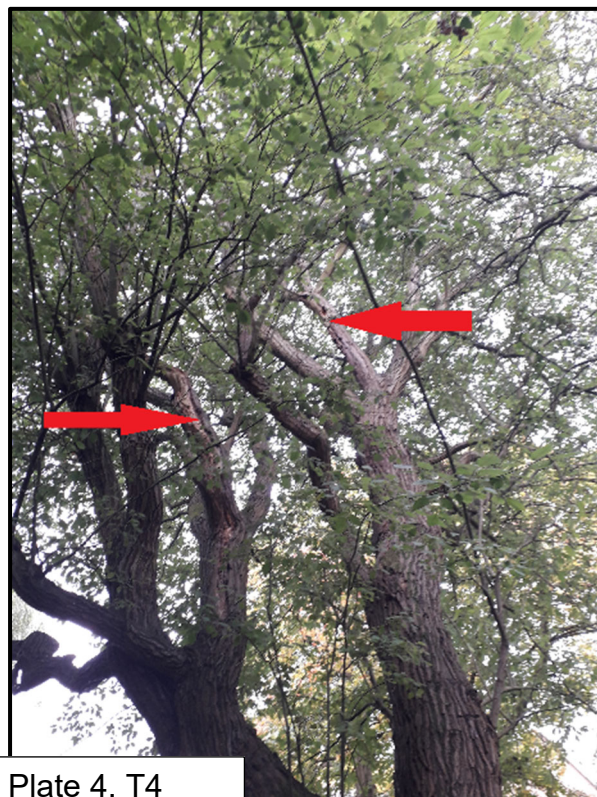
Plate 4. T4

| Tree ID | Common Name | Comments & work recommendations |
|---|---|---|
| T4 | Goat willow<br>See plate 4 | Area of necrotic cambium was observed in tree's northern stem at 3m. Symptoms of an internal crack are developing adjacent to the area of cambium necrosis. <b>Recommend to reduce tree's height to 4m within six months.</b> |

**Tree Comment:**  
**Survey Comment:** 2 x Major deadwood limbs were observed in the centre of tree's crown at 4 and 5m. Remove deadwood limbs within six months.

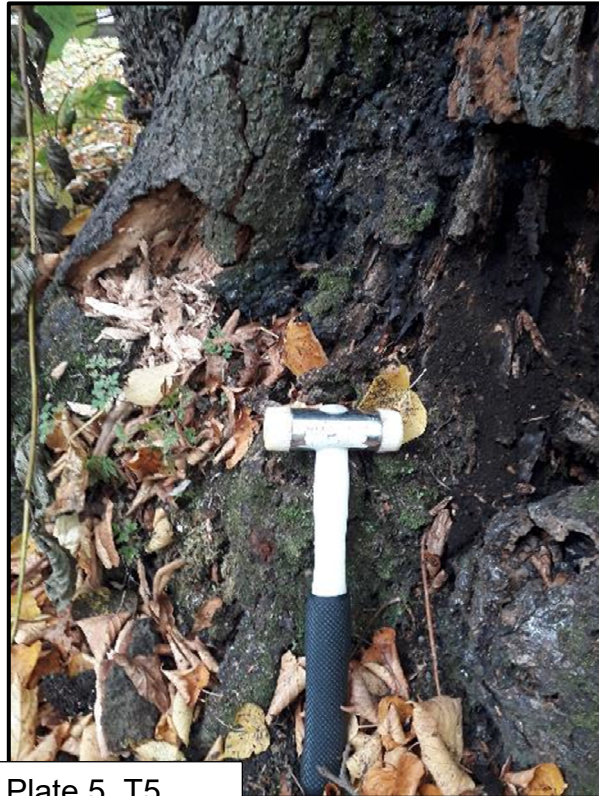
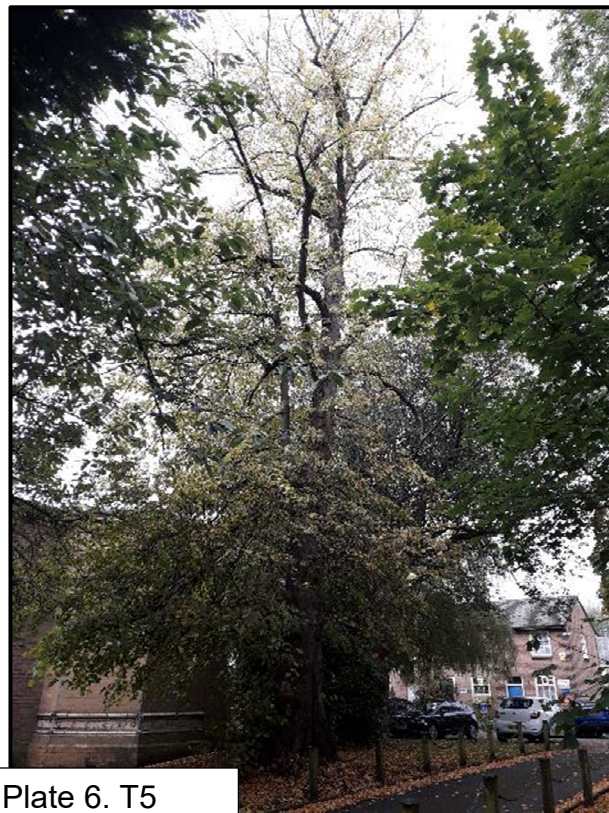
Plate 5. T5

| Tree ID | Common Name | Notes & Remedial Action Required |
|---|---|---|
| T5 | Lime<br>See plates 5 & 6 | Advanced kretschmaria adusta fungal infection observed at tree's base. Decay has degraded major buttresses. Tree's rootplate is expected to be heavily decayed and compromised. Tree should be regarded as unstable. <b>Tree is recommended to be felled as a matter of urgency.</b> |

**Tree Comment:**  
**Survey Comment:** Advanced kretschmaria adusta fungal infection observed at tree's base. Decay has degraded major buttresses. Tree's rootplate is expected to be heavily decayed and comprised. Tree should be regarded as unstable. Tree is recommended to be felled as a matter of urgency.

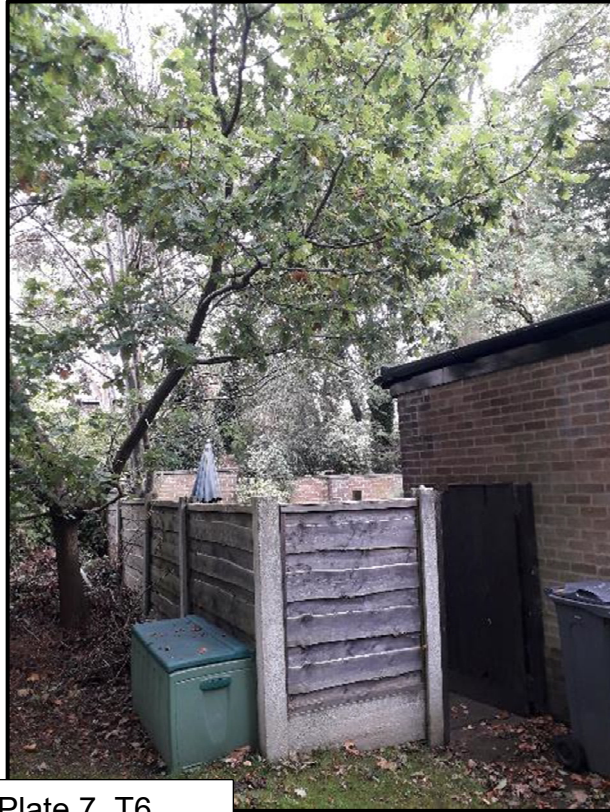
Plate 7. T6

| Tree ID | Common Name | Comments & work recommendations |
|---|---|---|
| T6 | Oak<br>See plate 7 | Tree's canopy is coming into contact with adjacent residential property. <b>Recommended to prune (within 6 months) to give 1.5m clearance from property to avoid potential damage to roofing, guttering, fascias etc. from whipping branches in strong winds.</b> |

| <b>Tree ID: T6</b> | Common Oak<br><i>Quercus robur</i> | <b>Tag:</b><br><b>TPO:</b><br><b>Tree Comment:</b><br><b>Survey Comment:</b> Tree's canopy is coming into contact with adjacent residential property. Recommended to prune (within 6 months) to give 1.5m clearance from property to avoid potential damage to roofing, guttering, fascias etc. from whipping branches in strong winds. | <b>Assessor:</b> Alan Thompson<br><b>Date:</b> 14-Oct-21 |

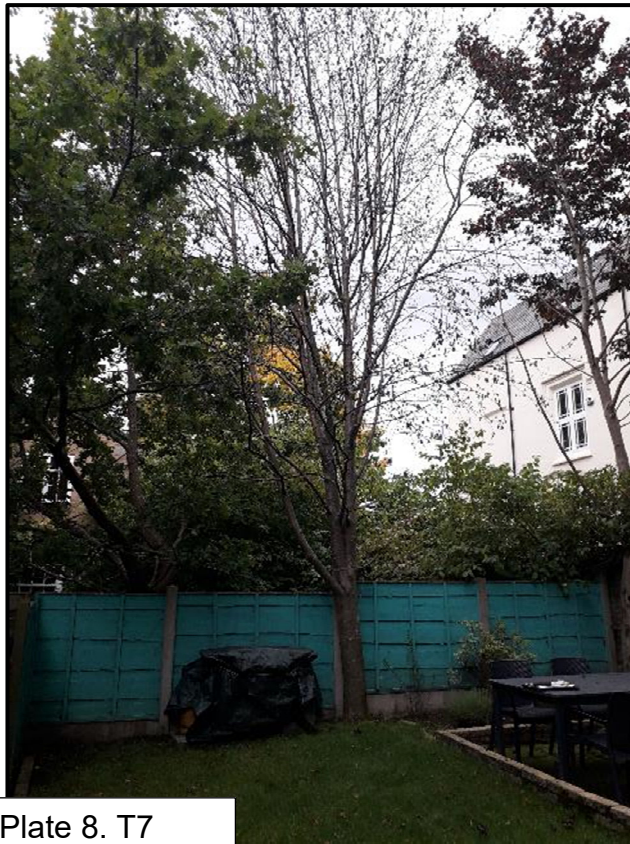
Plate 8. T7

| Tree ID | Common Name | Notes & Remedial Action Required |
|---|---|---|
| T7 | Whitebeam<br>See plate 8 | Standing dead tree. <b>Recommend tree to be felled within three months.</b> |

| <b>Tree ID: T7</b> | Whitebeam<br><i>Sorbus aria</i> | <b>Tag:</b><br><b>TPO:</b><br><b>Tree Comment:</b><br><b>Survey Comment:</b> Standing dead tree. Recommend tree to be felled within three months. | <b>Assessor:</b> Alan Thompson<br><b>Date:</b> 14-Oct-21 |

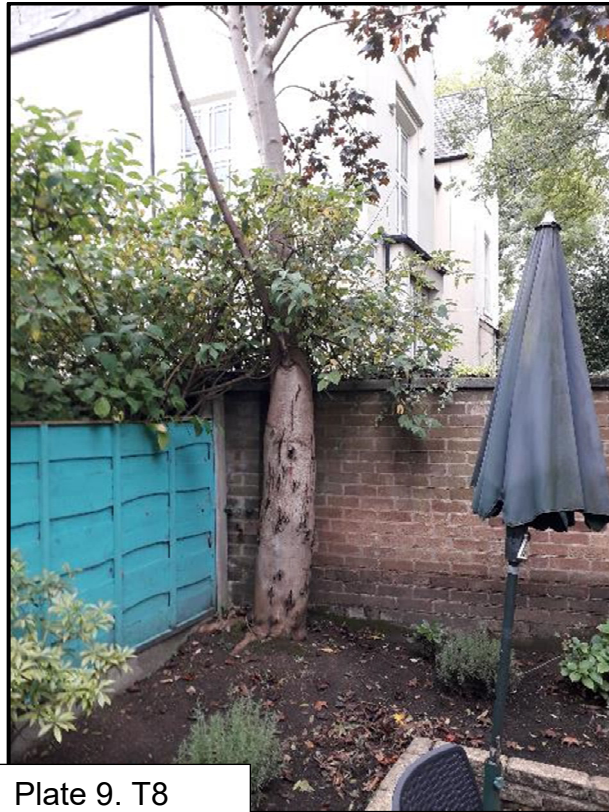
Plate 9. T8

| Tree ID | Common Name | Works/Remedial Action Required |
|---|---|---|
| T8 | Sugar maple<br>See plate 4 | Bacterial infection was observed throughout tree's stem. <b>Recommend to reinspect tree within 24 months to assess level of advancement of pathogen.</b> |

| <b>Tree ID: T8</b> | Sugar Maple<br><i>Acer saccharum</i> | <b>Tag:</b><br><b>TPO:</b><br><b>Tree Comment:</b><br><b>Survey Comment:</b> Bacterial infection was observed throughout tree's stem. Recommend to reinspect tree within 24 months. | <b>Assessor:</b> Alan Thompson<br><b>Date:</b> 14-Oct-21 |

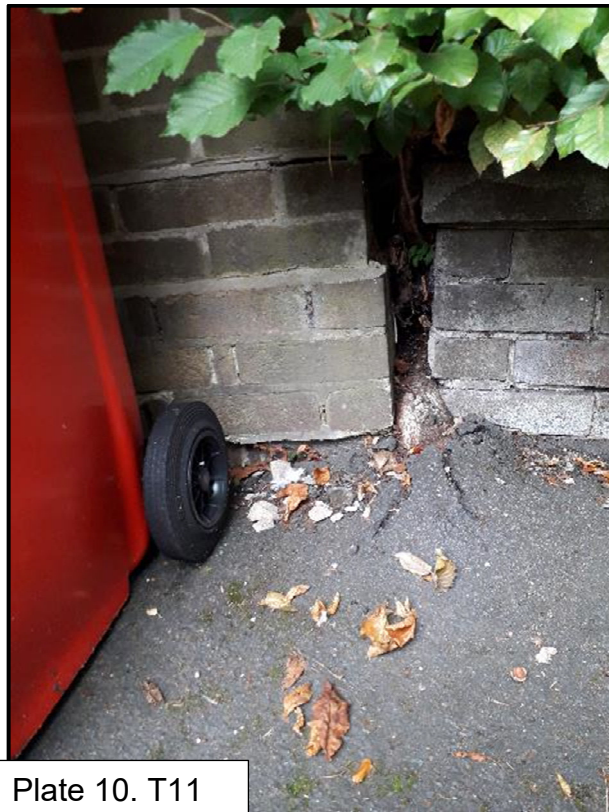
Plate 10. T11

| | | <b>Survey Comment:</b> Tree's surface root has displaced adjacent gatepost. Rebuilding the gatepost would require to removal of significant surface root of 90mm diameter. | | | | | | | | | |

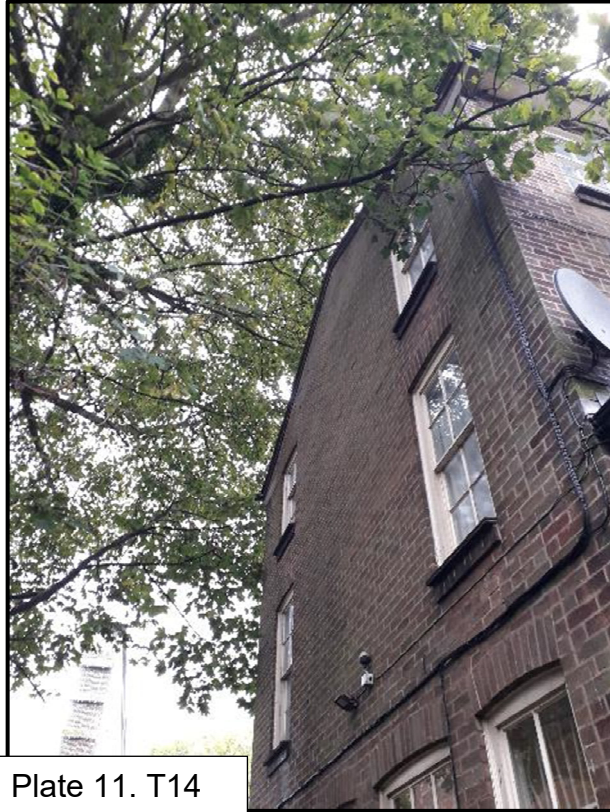
Plate 11. T14

| Tree ID | Common Name | Comments & work recommendations |
|---|---|---|
| T14 | Sycamore<br>See plate 11 | Tree's canopy is coming into contact with the roof of the adjacent building, <b>recommend to prune tree's crown (within 6 months)</b> to give 1.5m clearance from roof to avoid damage being caused to roofing, guttering, fascias etc from whipping branches in strong winds. |

| Tree ID | Common Name | Works/Remedial Action Required |
|---|---|---|
| T14 | Sycamore<br>See plate 11 | Thick ivy is spreading throughout tree's stem precluding a full stem inspection, <b>recommend to sever ivy within 12 months to aid future tree inspections.</b> |

| <b>Tree ID: T14</b> | Sycamore<br><i>Acer pseudoplatanus</i> | <b>Tag:</b><br><b>TPO:</b><br><b>Tree Comment:</b><br><b>Survey Comment:</b> Tree's canopy is coming into contact with the roof of the adjacent building, recommend to prune tree's crown (within 6 months) to give 1.5m clearance from roof to avoid damage being caused to roofing, guttering, fascias etc from whipping branches in strong winds. Thick ivy is spreading throughout tree's stem precluding a full stem inspection, recommend to sever ivy within 12 months to aid future tree inspections. | <b>Assessor:</b> Alan Thompson<br><b>Date:</b> 14-Oct-21 |
