## Appendix 9.5 Walkover Survey

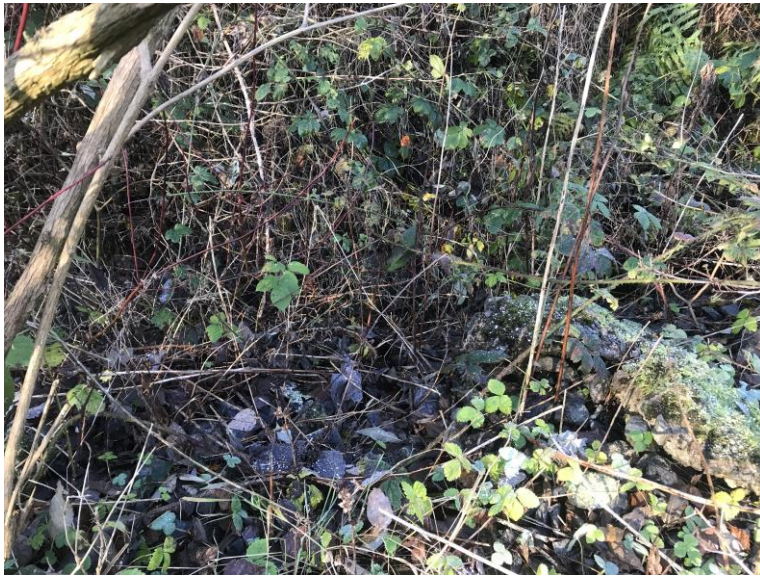
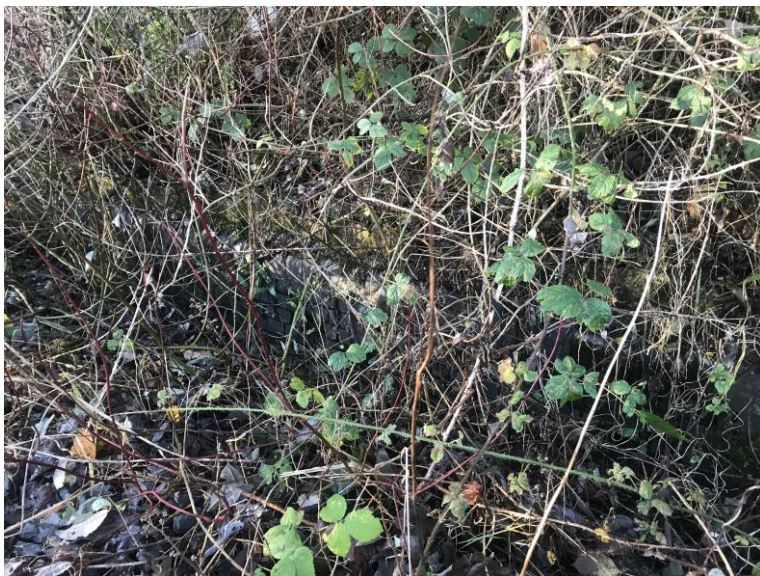
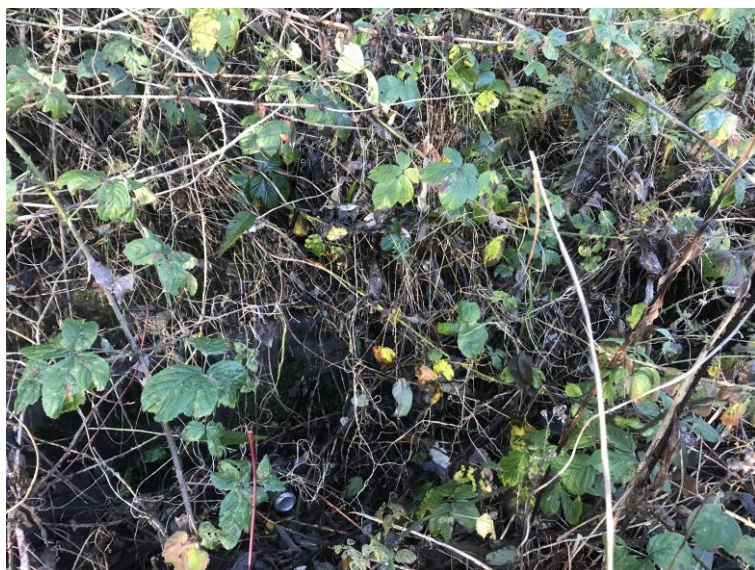
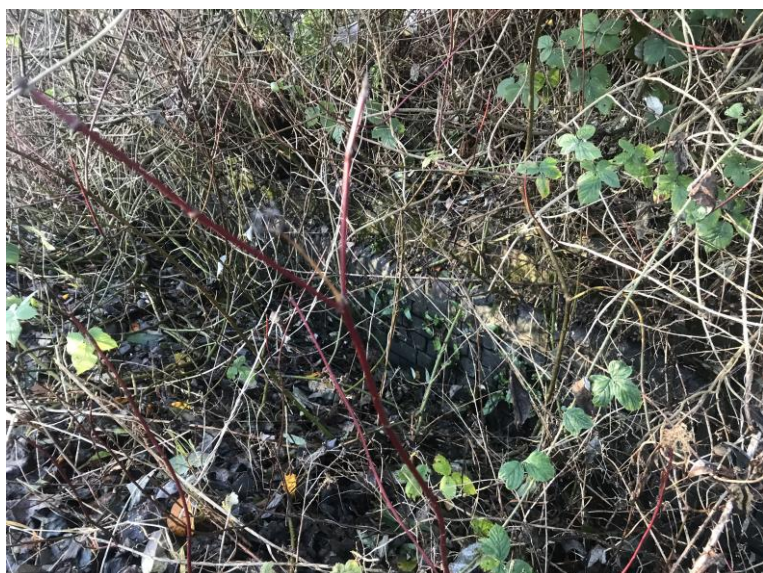
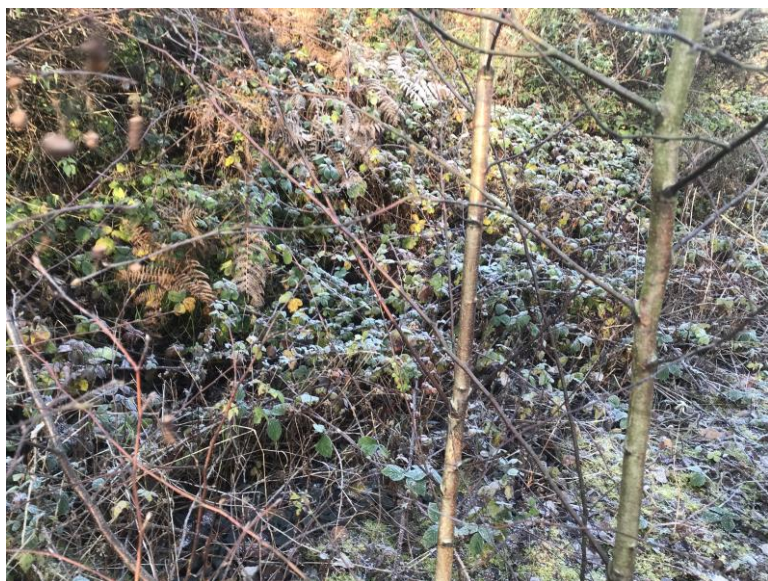
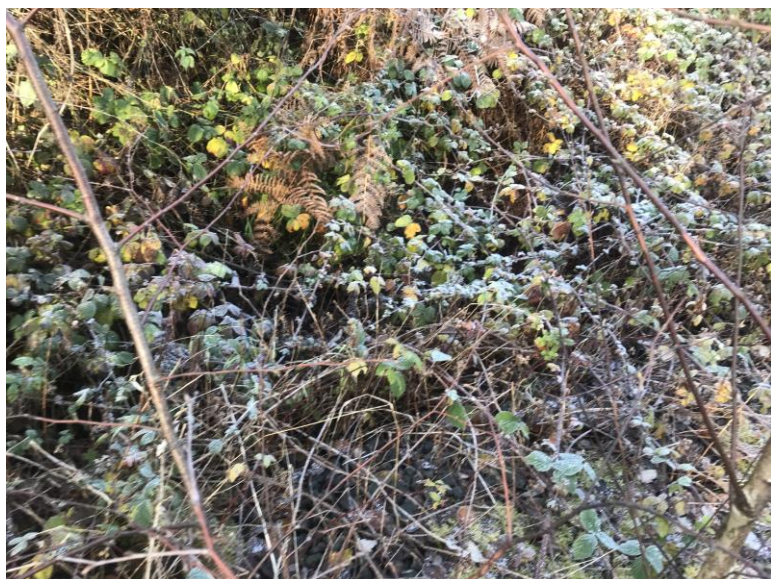
A drain was depicted on the infrastructure plans. On a site visit, it appeared to be old surface water channel which could be from when the area was a railway. It was a dry brick structure, that was overgrown and covered by leaves. The start of the drain was difficult to locate but becomes barely visible moving 'upstream'. Photos featured below:
