HAMMERSTONE ROAD DEPO

### PERMANENT REPAIR WORKS

## SOUTHERN BOUNDARY WAL

- CUR - 00 - XX - DR - S - 27-000

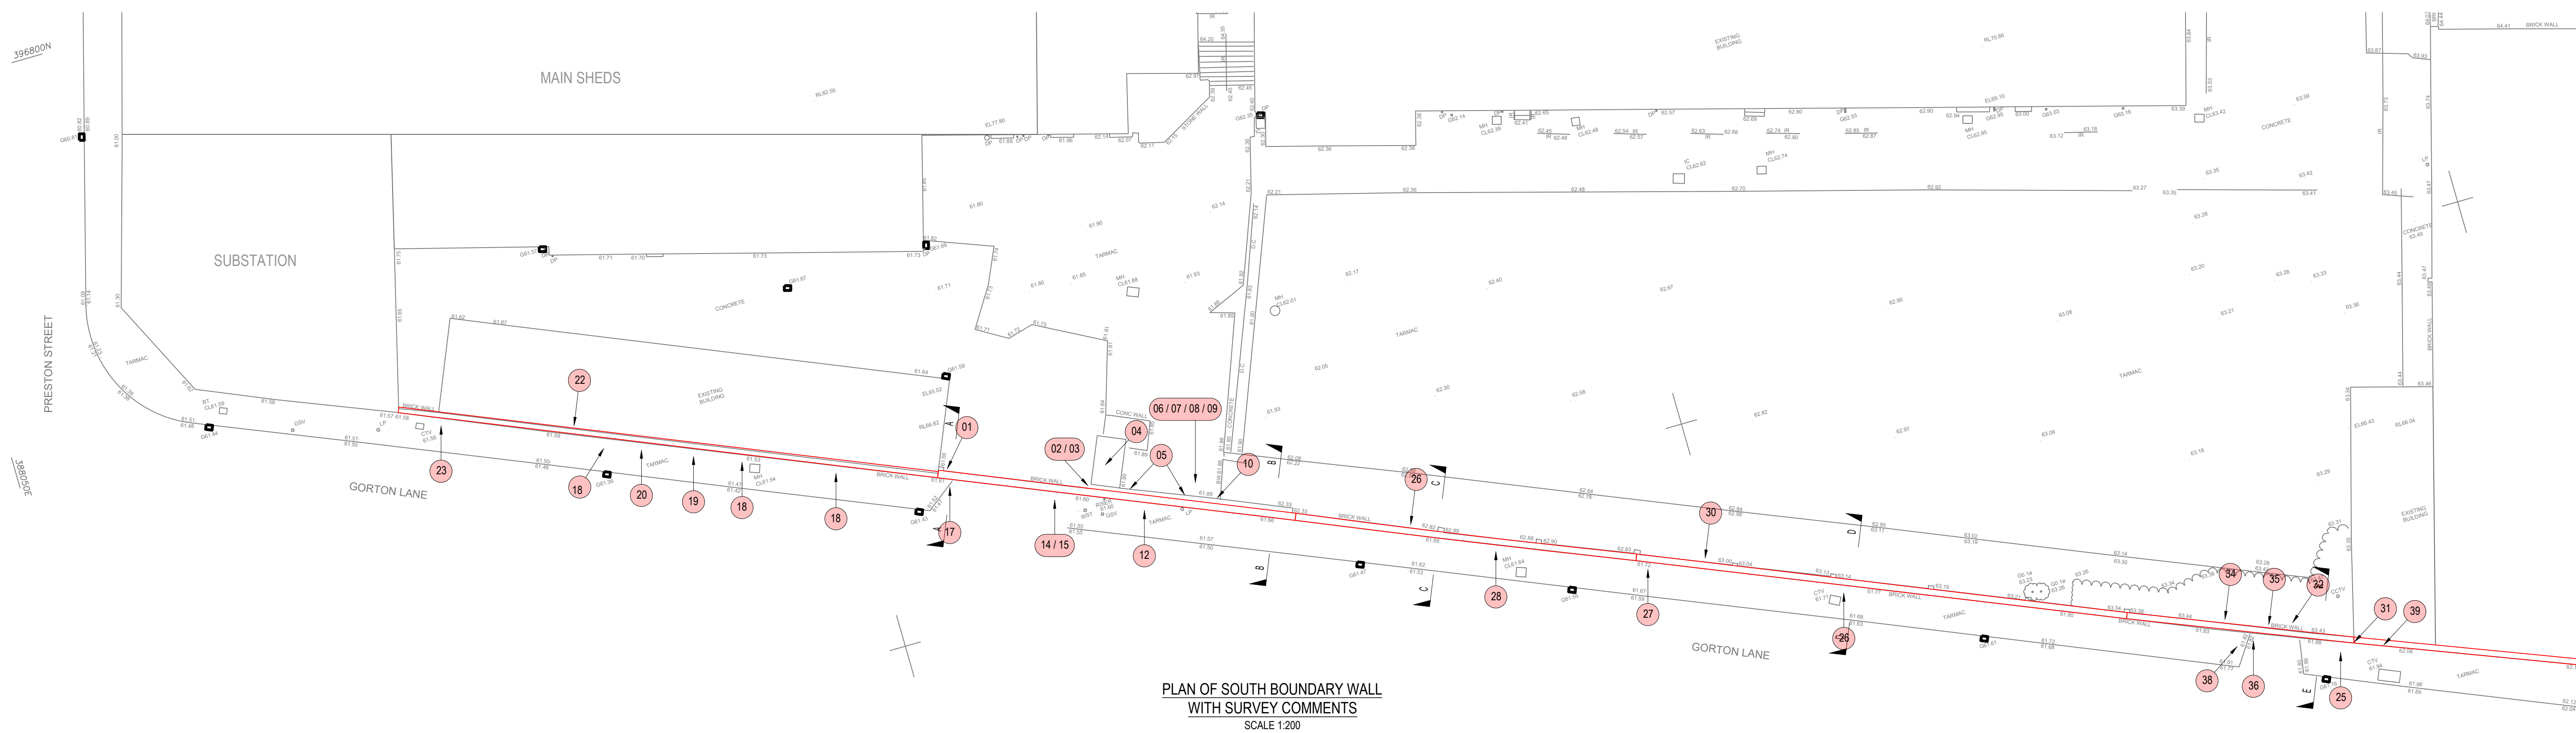
| EXTERNAL SOUTH BOUNDARY WALL | |

| EXTERNAL SOUTH BOUNDARY WALL | |
|---|---|
| 01 | INFILLED OPENING PARTLY BONDED ON WEST SIDE. |
| 02 | SMALLER INFILLED DOW OPENING WITH REINFORCED CONCRETE LINTEL ABOVE. |
| 03 | CONCRETE SPALLED FIN WEST FACE. REINFORCEMENT HEAVILY CORRODED. |
| 04 | DIAGONAL CRACKING STARTING AT MID HEIGHT CIRCA 5mm DEEP DOWN TO HURLING UP TO ASK (1 METRE LONG). |
| 05 | EMBEDDED STEEL REMAINS OF I BEAM BEARING, JACKING UP SURROUNDING MASONRY. |
| 06 | LOOSE MASONRY UNITS AT TOP OF LEDGE BELOW WALL HEAD. |
| 07 | VEGETATION GROWTH. |
| 08 | SIGN SEPARATION BETWEEN LEDGE AND PRINCIPAL WALL HEAD. STRETCHER COURSE, LAST 4 COURSES, NOT BONDED. |
| 09 | LOSS OF MORTAR TO WALL HEAD. HEAVILY DECAYED. |
| 10 | MISSING AND LOOSE MASONRY UNITS, RAMSHACKLE REPAIRS, SEVERED CROSS BONDS AT HEADER COURSE. TAKE DOWN, REMOVE STEELWORK AND RE-BUILD. |
| 11 | WALL BULGES OUT ON PLAN AND RETURNS AT WALL HEAD. MAXIMUM DISPLACEMENT CIRCA 25mm AT CIRCA 500mm FROM CORNER. CONSTANT ALONG THE BULGE. |
| 12 | WALL HEAD BULGES IN ON PLAN CIRCA 20mm. COPES DISPLACED. |
| 13 | MASONRY INFILL PARTLY BONDED UP TO EXISTING AT INTERFACE. DIFFERENCE OF VERTICALLY AT WALL HEAD DECREASING TOWARDS ROOF LEVEL. |
| 14 | INFILL IN DOOR OPENING IN MASONRY WALL, BUT JOINT UNBONDED TO SURROUNDING STRUCTURE. |
| 15 | REINFORCED CONCRETE LINTEL, CORRODED AND SPALLING. |
| 16 | HEAVILY DECAYED MASONRY FABRIC TOP 1m. |
| 17 | MASONRY WALL BULGES OUTWARDS CIRCA 30 - 40mm. MAXIMUM DISPLACEMENT AT MID HEIGHT. BULGE STARTS AT INTERFACE AND COMES BACK INTO LINE WHERE INDICATED INTERNALLY. |
| 18 | VEGETATION GROWTH CIRCA PRINCIPAL TRUSS BEARING INTERNALLY. |
| 19 | MASONRY ARCH APPEARS DECAYED ALTHOUGH BED JOINT MASONRY ARCHES ABOVE CROWN. |
| 20 | CRACKING CIRCA 5 - 10mm DISPLACEMENT UP FROM PRINCIPAL POINT TO WALL HEAD. |

| EXTERNAL SOUTH BOUNDARY WALL | |
|---|---|
| 21 | SIGNIFICANTLY DETEIORATED MASONRY (LOCALISED). |
| 22 | MATURE VEGETATION JACKING UP WALL HEAD MASONRY CIRCA 30mm AT VALLEY GUTTER LOCATION (CIRCA 500mm DOWN FROM WALL HEAD, PRINCIPAL TRUSS LOCATION INTERNAL). PARAPET ABOVE UNSTABLE. TAKE DOWN AND REMEDIATE. |
| 23 | EMBEDDED STEELWORK. |
| 24 | AT BUTT JOINT WITH SUBSTATION, DIFFERENCE IN VERTICALITY OF CIRCA 10mm AT MID HEIGHT RETURNING TO GROUND AND WALL HEAD |
| 25 | OUTWARD LEAN CIRCA 30mm. RE-BUILD OPENINGS AND ABOVE NEW OPENING EMBEDDED STEEL AT ALL OPENING LINTELS. |
| 26 | VEGETATION GROWTH. |
| 27 | INFILL PANEL PARTLY BONDED. LACK OF MORTAR BEDDING. |
| 28 | POORLY RE-POINTED SECTION OF WALL. GROUND LEVEL UP TO 1.5m. |
| 29 | MISSED MASONRY UNITS. |
| 30 | OUTWARD LEAN CIRCA 20mm. |
| 31 | MATURE VEGETATION JACKING UP MASONRY AT WALL HEAD CIRCA 40mm. |
| 32 | DIAGONAL CRACKING FROM BEAM BEARING TO WALL HEAD BOTH SIDES CIRCA 15 - 20mm. BEAM SAGGING AT MID POINT. MASONRY AND BED JOINTS ABOVE BEAM SAGGING. CHECK T BEAM FOR ROT. |
| 33 | OUTWARD LEAN OF WHOLE WALL SECTION CIRCA 40mm OVER HEIGHT REDUCING TO NIL AT GROUND LEVEL. |
| 34 | WALL HEAD AND FREE STANDING WALL RE-BUILD. |
| 35 | EMBEDDED METAL SAGGING OVER T LINTEL. |
| 36 | SECTION OF OPENING OUTWARD LEAN 20mm AT WALL INTERFACE. |
| 37 | WALL HEAD LEANING OUT. |
| 38 | OPEN PERPEND. SECTION BETWEEN COPES NO COPES AT END OF FREE-STANDING WALL. |
| 39 | SERIOUSLY MASONRY FABRIC DETERIORATION. DEEP PACK POINTING AND INDENT REPAIR REQUIRED ALL EMBEDDED STEEL. |

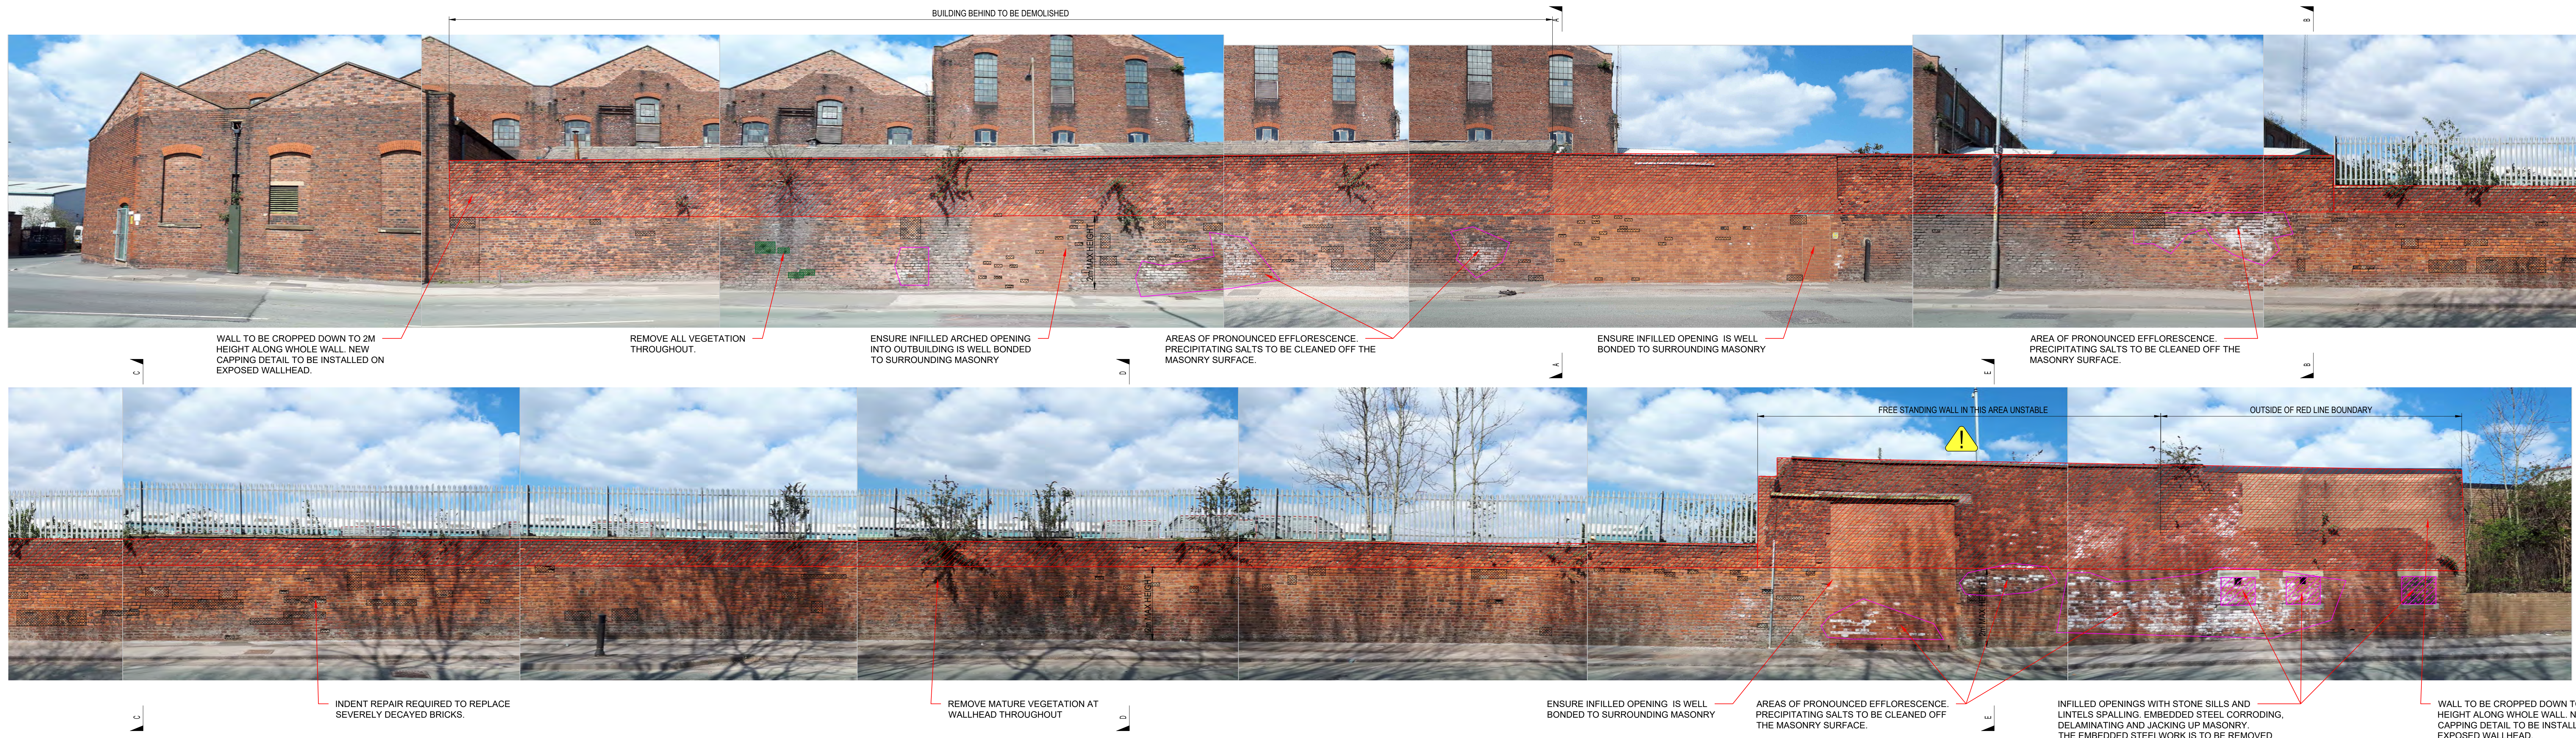
PHOTOGRAPHIC ELEVATION OF SOUTH  
BOUNDARY WALL  
NOT TO SCALE

1. THE BOUNDARY WALL HAS BEEN IDENTIFIED AS UNSTABLE IN PLACES. IT HAS BEEN DETERMINED THAT IF THE WALL IS EXPOSED TO A MAXIMUM HEIGHT OF 2M ABOVE FINISH FLOOR FINISHNESS OF 50MM, IT WILL BE ABLE TO ACT AS A FREESTANDING MASONRY WALL WITHOUT THE NEED FOR FURTHER STRENGTHENING VOLUME OF MASONRY TO BE REMOVED AS 4m3

2. THE MASONRY FABRIC OF THE WALL IS IN POOR CONDITION IN PLACES. BRICK INDENT PATTERN (AS 353) LOCATIONS ACCORDING TO ELEVATION ABOVE AS WELL AS DEEP PACK REPAIRING WITH COMPATIBLE MORTAR ALONG ITS LENGTH WILL BE REQUIRED THROUGHOUT.

WALL HEIGHT TO BE CAREFULLY REDUCED AND ALL SOUND BRICKS TO BE CLEANED, RECLAIMED AND USED AS PART OF REPAIR WORKS.

ENTIRE LENGTH OF REMAINING WALL TO BE CLEANED OF POLLUTION AND SALTS, AND DEEP PACK REPOINTED ON BOTH SIDES. WHERE EXISTING CEMENT MORTAR REMAINS, RAKE OUT TO A DEPTH 3x THICKNESS OF JOINT OR 30mm, AND CLEAN BEFORE NEW APPROVED MORTAR IS APPLIED ACCORDING TO CURTINS MORTAR SPEC.
