## Roof Inspection

New Maldren Hotel Report 4

| Title: | New Maldren Hotel Report 4 |

This report is prepared for SPS Flat Roof Systems Ltd, and its purpose is to report on the non-destructive electronic integrity test of the exposed waterproofing membrane of level 12, 7 and 2 of the New Maldren Hotel, Charles Street, Manchester.

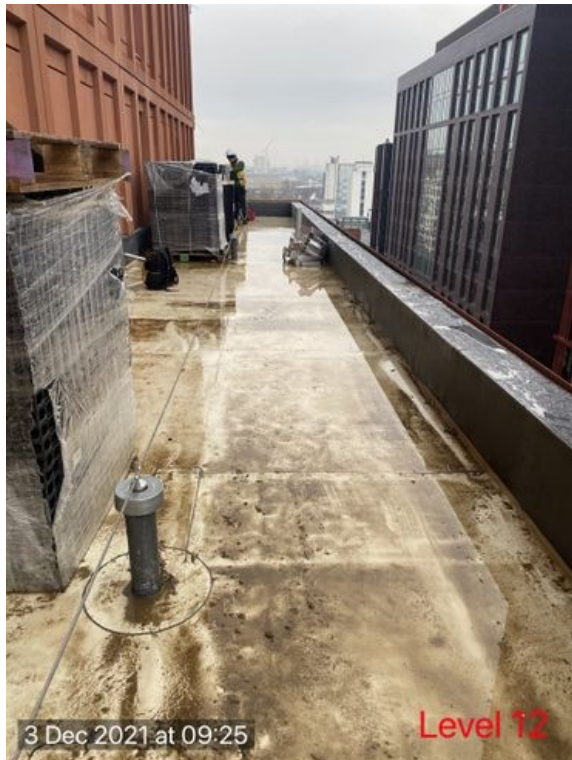
## Sketch of roof plan

The testing identified two (2) breaches (shown in red on the roof plan sketch) where water may penetrate into the construction.

Level 12: 2 mechanical damage
