# GEOSHIELD Verification Report

GEO101021

003

McAlear & Rushe

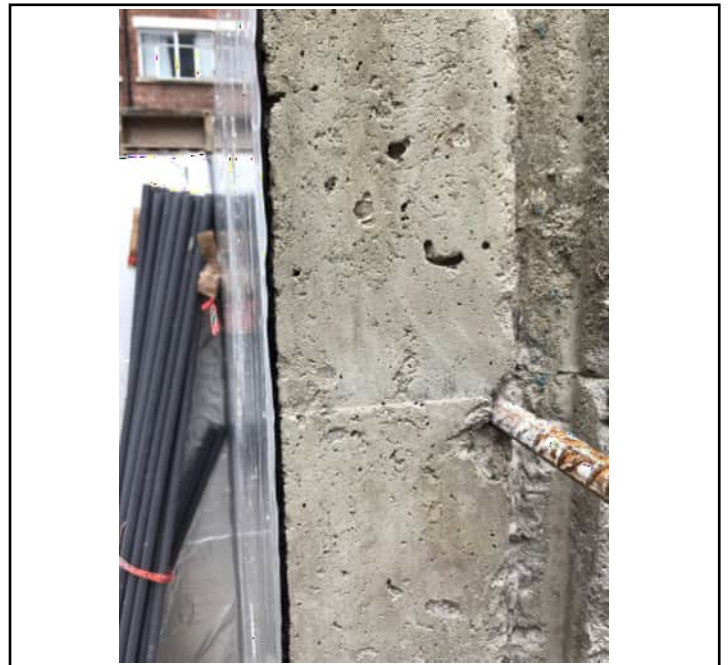
Right photo) GR SAM sealed to concrete wall

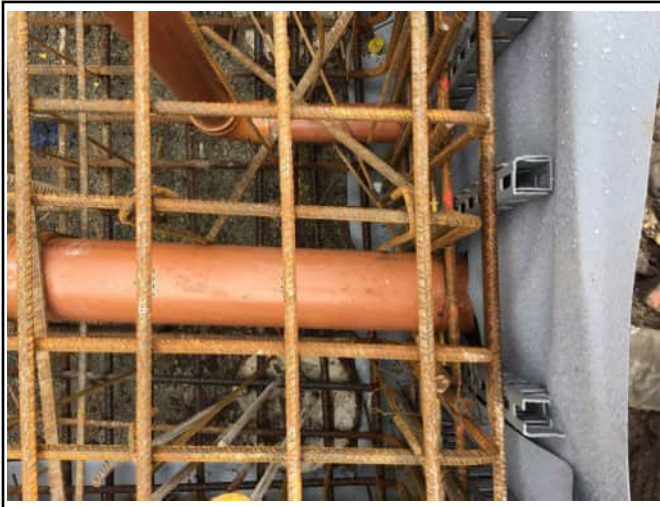
NOTES: Whilst inspecting the pile caps I noticed a piping had been

Fitted within PC04-A. Due to the steel rebar cage already being fitted, visual inspection

Left photo) section of pipe work within the pile cap

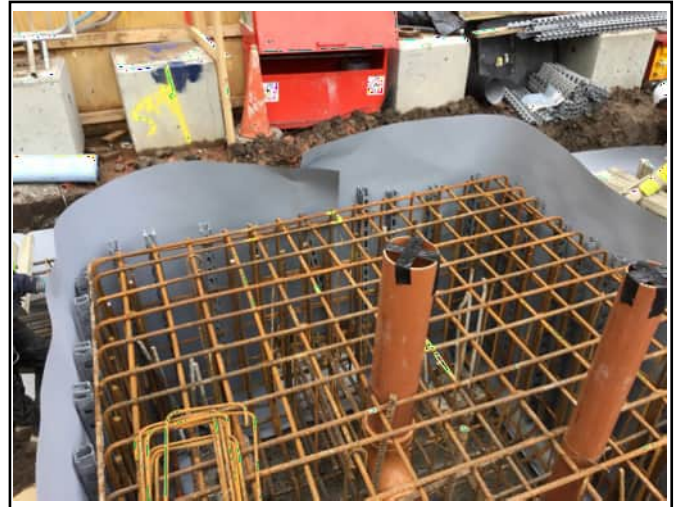
Right photo) overview of pile cap 04-A, showing 150mm overlap under the rebar cage

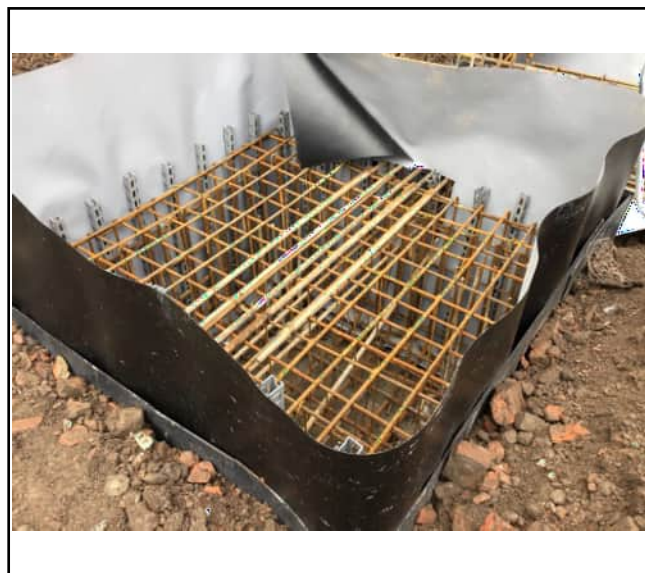
Carried out on the seal. 150mm overlap of Visqueen Geoseal Ultimate was also

Installed under the bear cage.

Right photo) closer photo showing the lap under the rebar

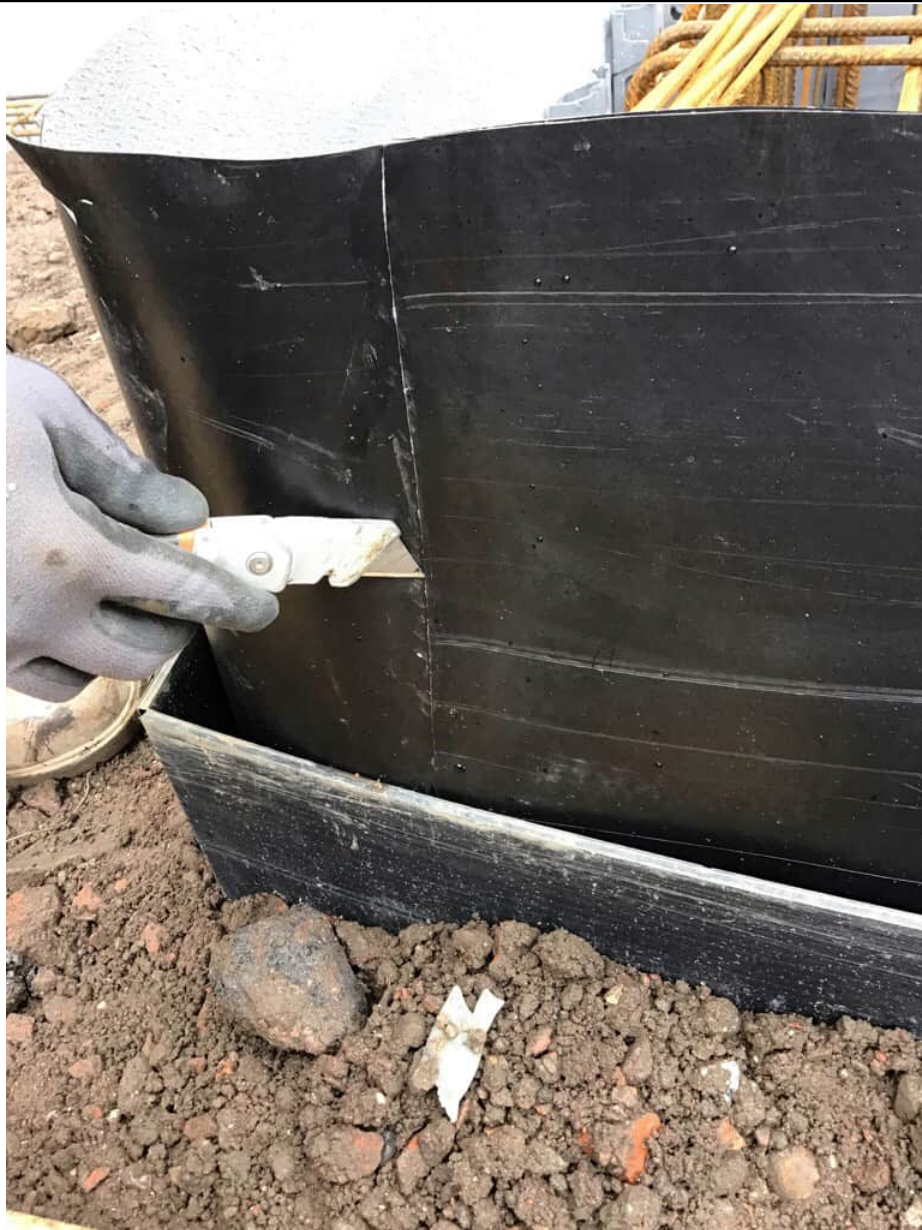
Above photo) pick and prob carried out on the hot welded joint, also

Showing the protection board, to protect against backfill

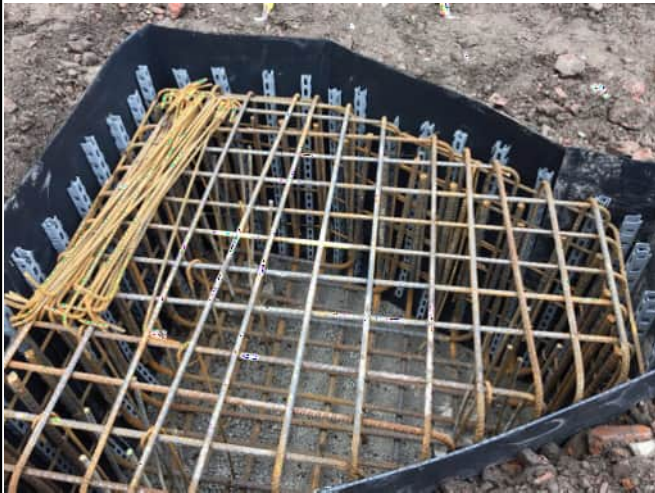
One of the pile caps did not need

Membrane as per design
