# GEOSHIELD Verification Report

GEO101021

McAlear & Rushe

101 Charles Street

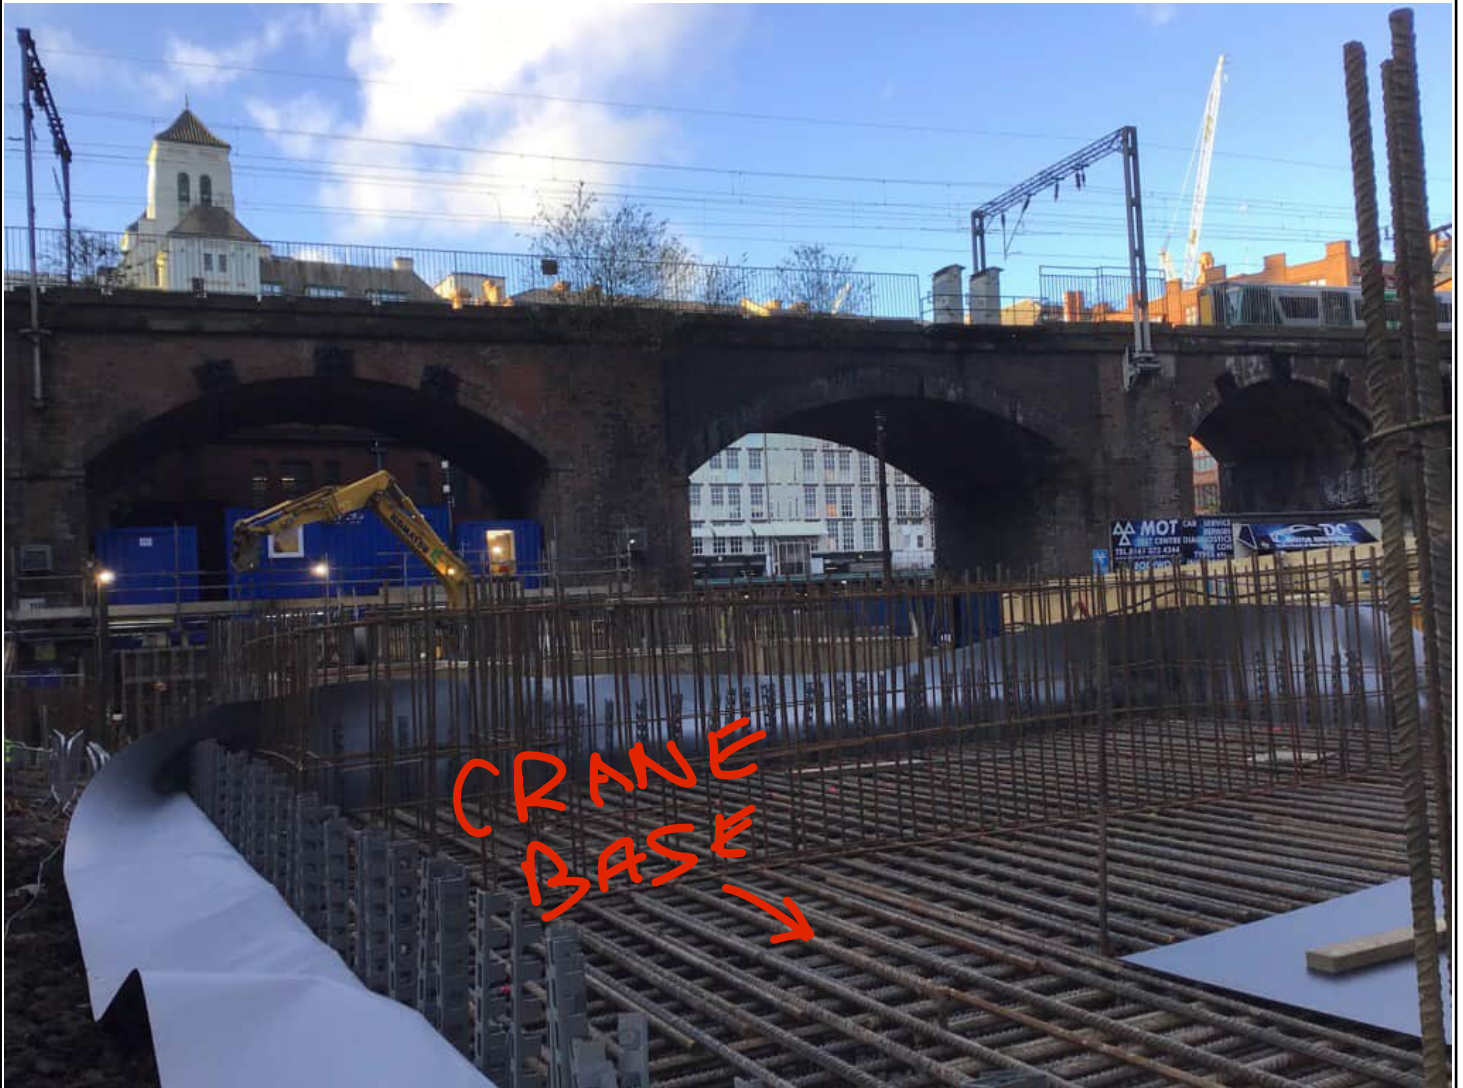
Overview of site. Crane Base steel rebar already installed on arrival.

Visqueen Geoseal Ultimate wrapped around the edges and sealed

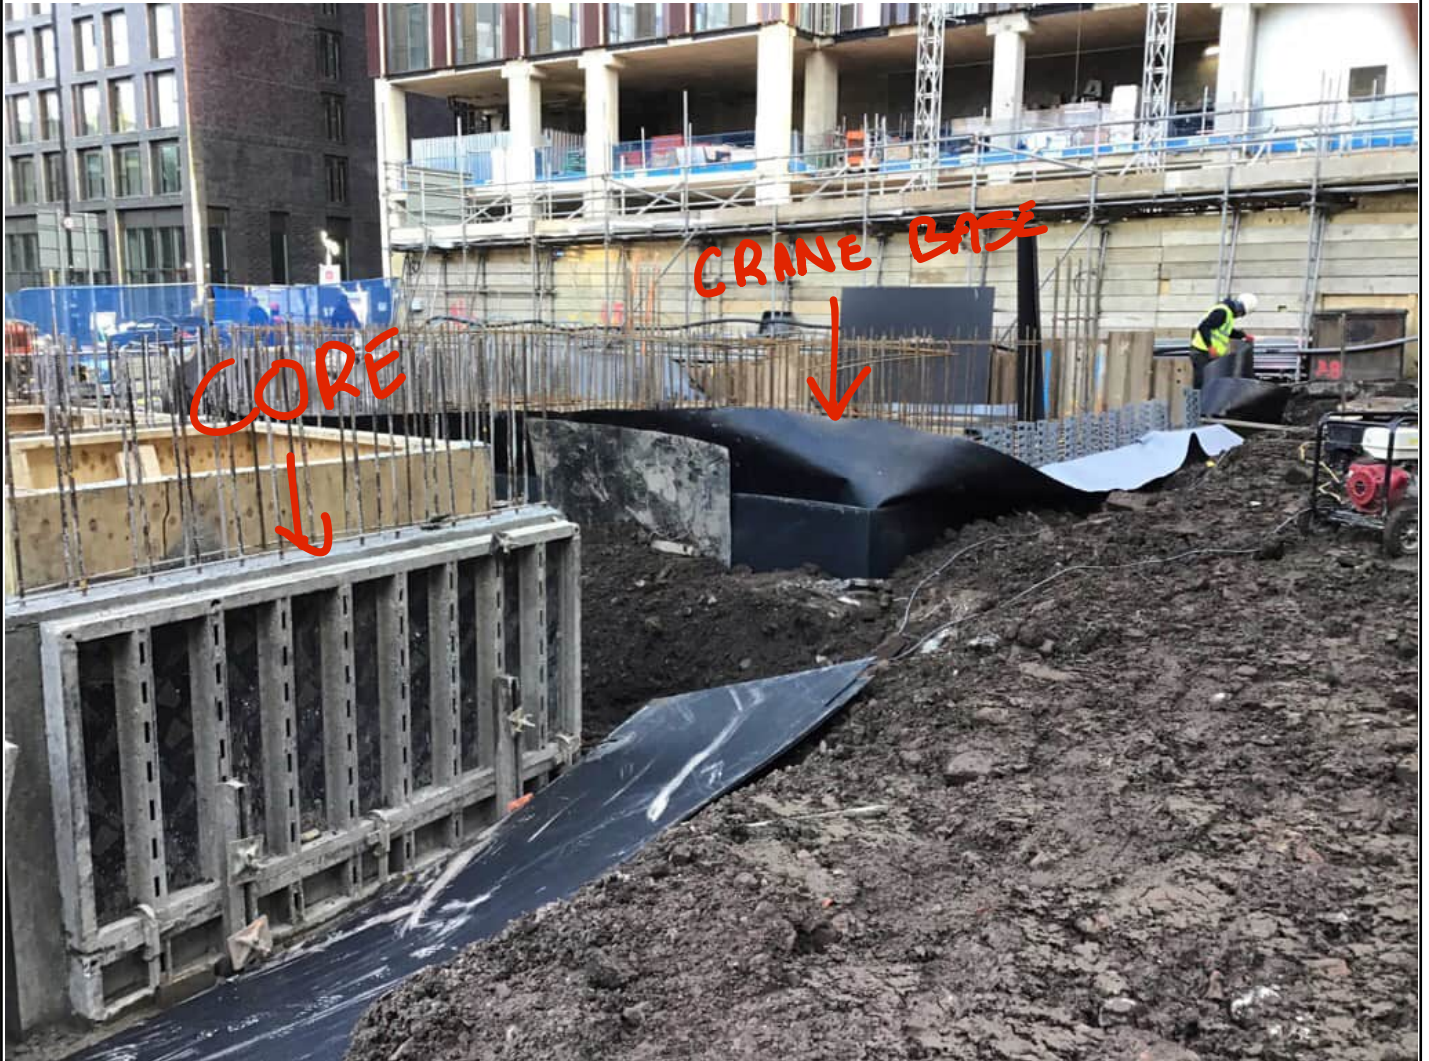
Overview of Core and a Crane Base

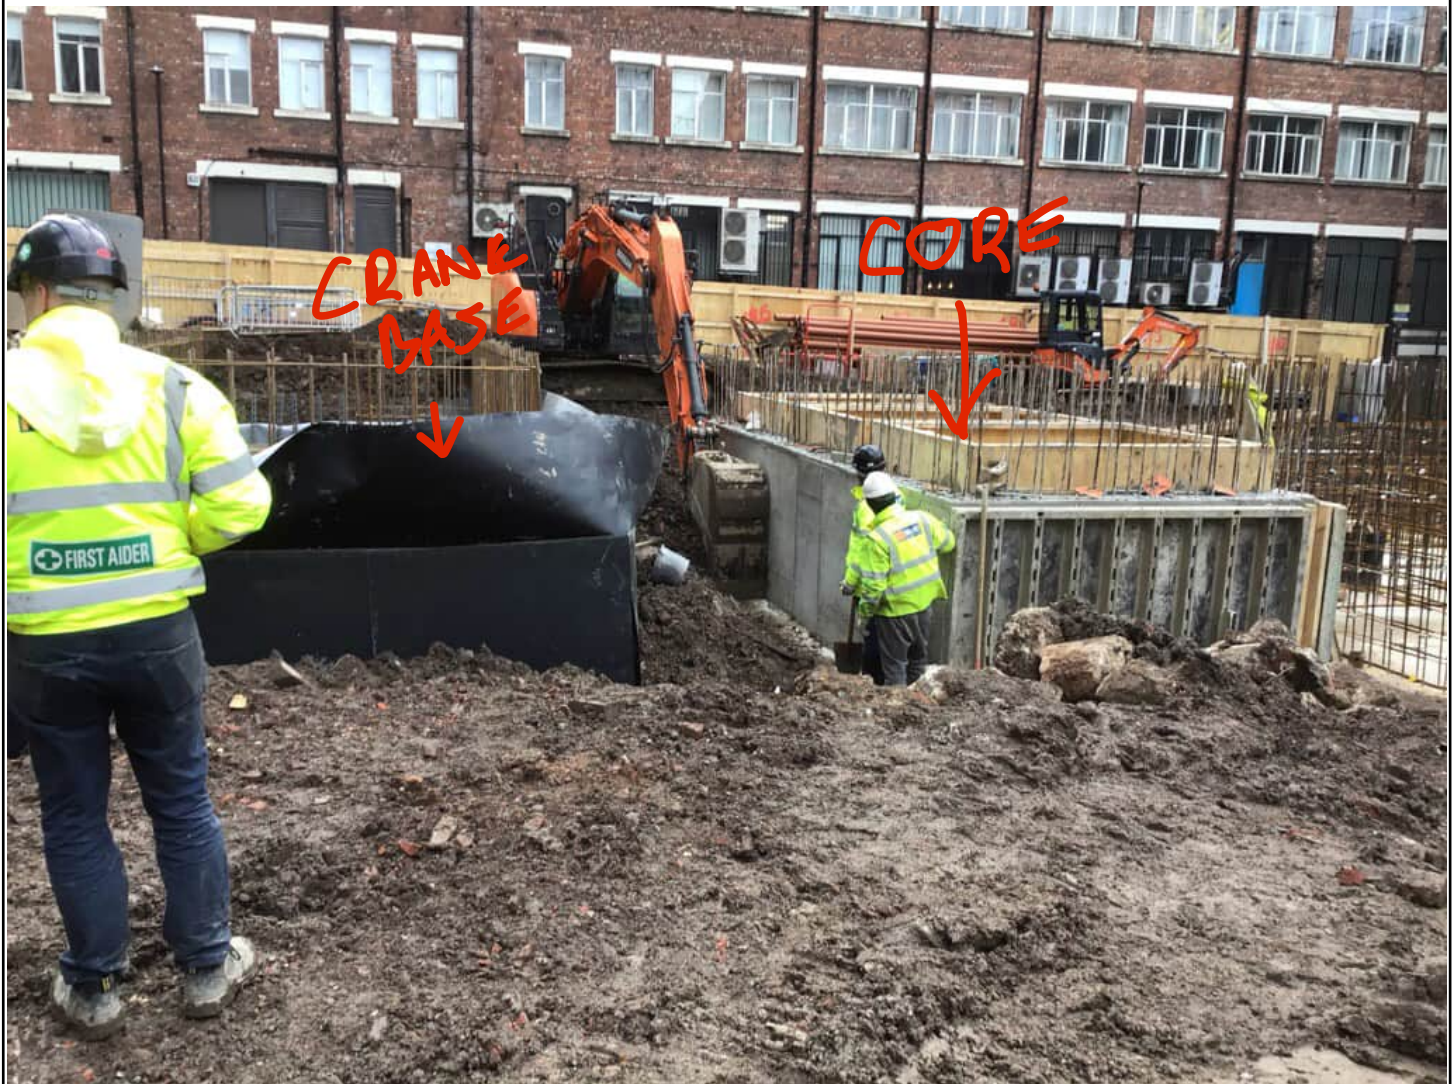
Overview of Core and a Crane Base

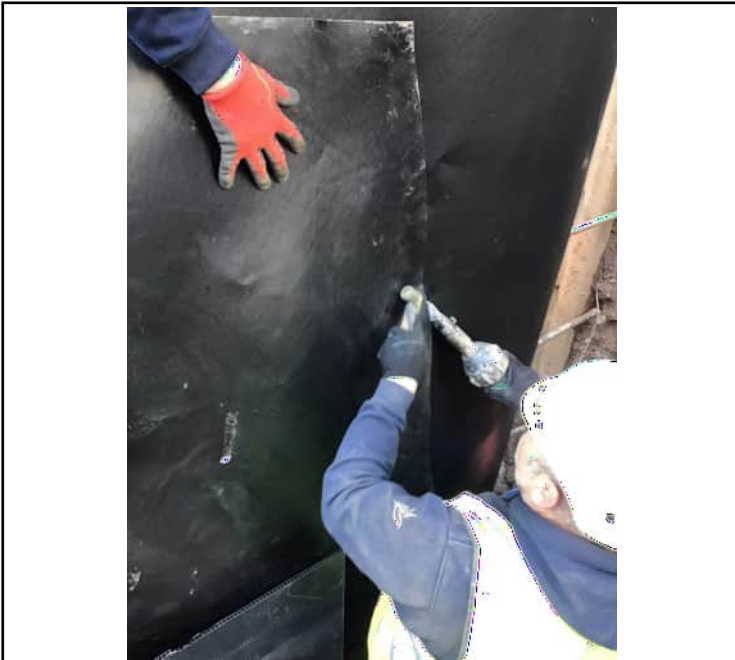
NOTES: Visqueen Geoseal Ultimate installed with minimum 150mm

return beneath the rebar. Long rolls used to minimise the number of joints required.

Joints sealed with hot weld before being extrusion welded. Visual inspection and

pick and probe test carried out.

1. Joints hot welded shut.

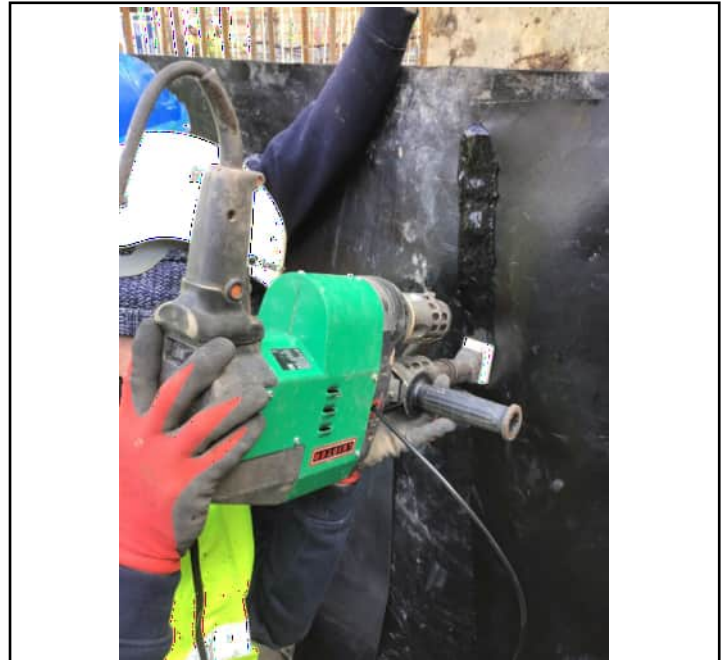
2. Joints reinforced and sealed with extrusion weld.

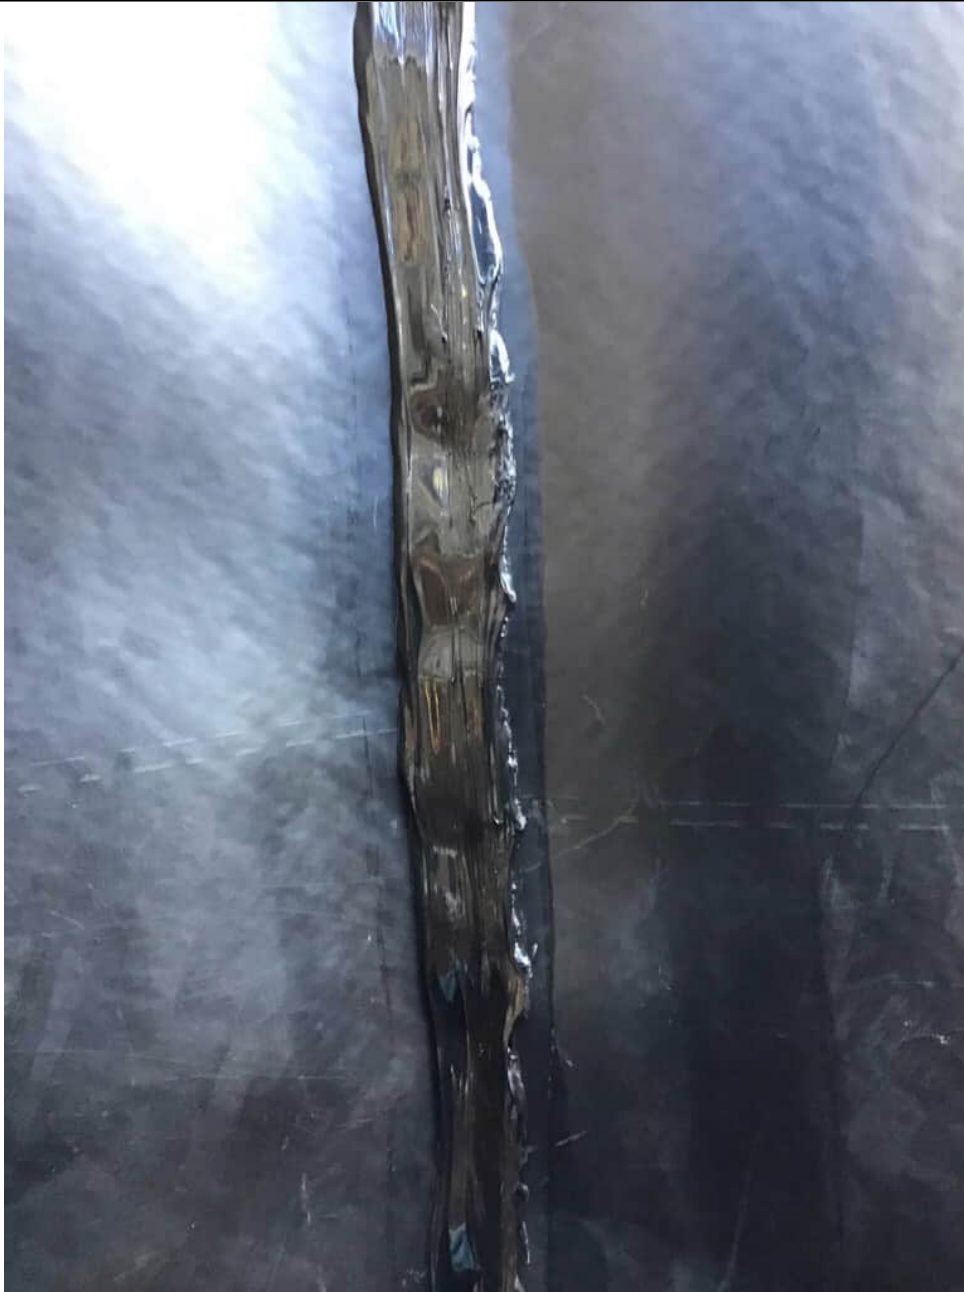
3. Joint sealed with hot weld and extrusion weld.

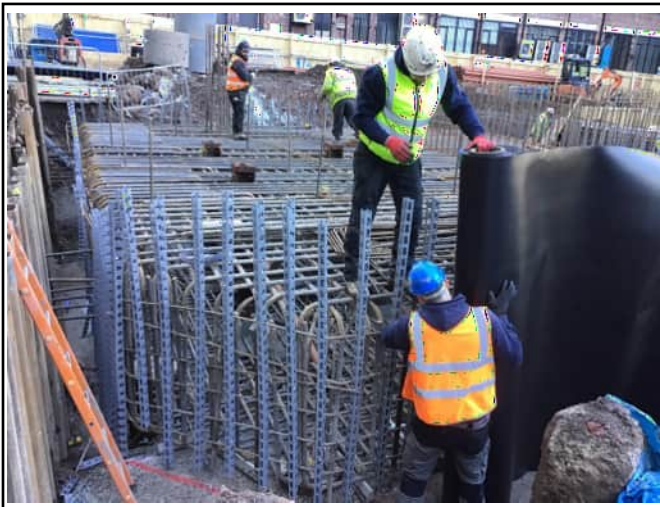
NOTES: Visqueen Ultimate Geoseal installed around the edges

of the crane base. Installation method and verified. Good number of spacers attached to rebar and pegs installed through Visqueen to embed in concrete sealed with

GR SAM.

1. Good number of spacers attached to rebar.

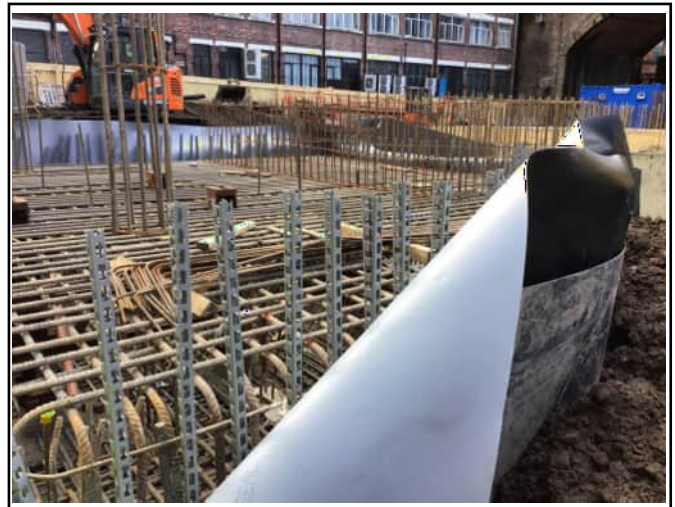
2. Membrane kept minimum 50mm from rebar.

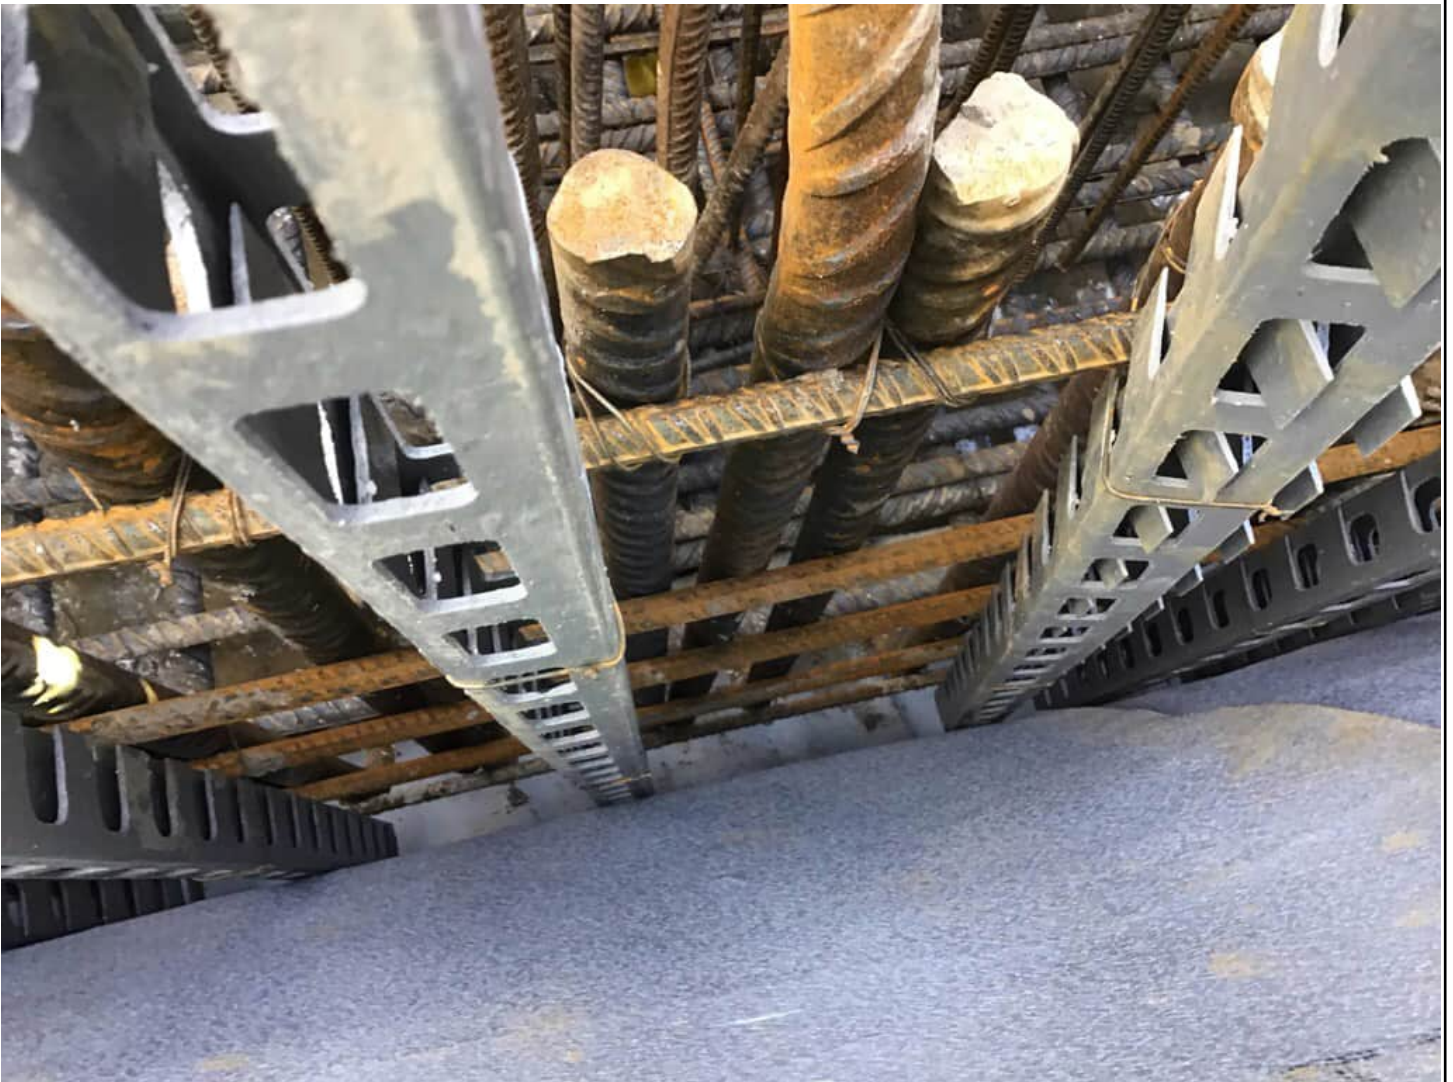
3. Minimum 150mm lap beneath steel rebar.

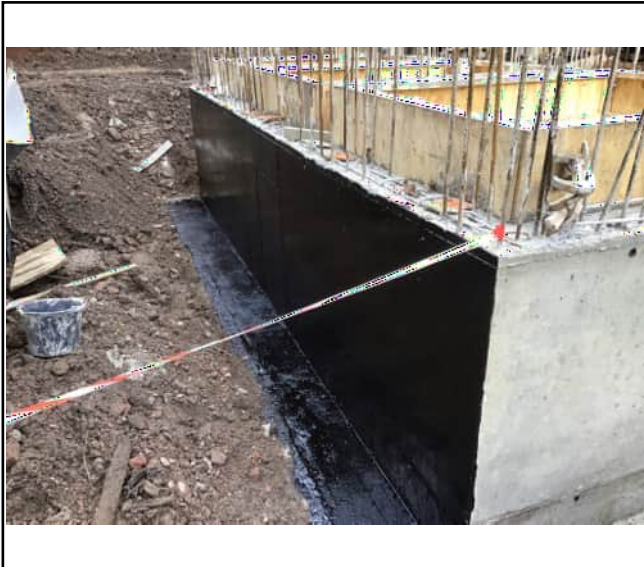
NOTES: Core wall primed with HP Tanking Primer and left

overnight to go off. Visqueen GR SAM installed the following day once primer

ready. GR SAM then protected with Visqueen Protective Board before being backfilled.

1. HP Tanking Primer applied to face of core

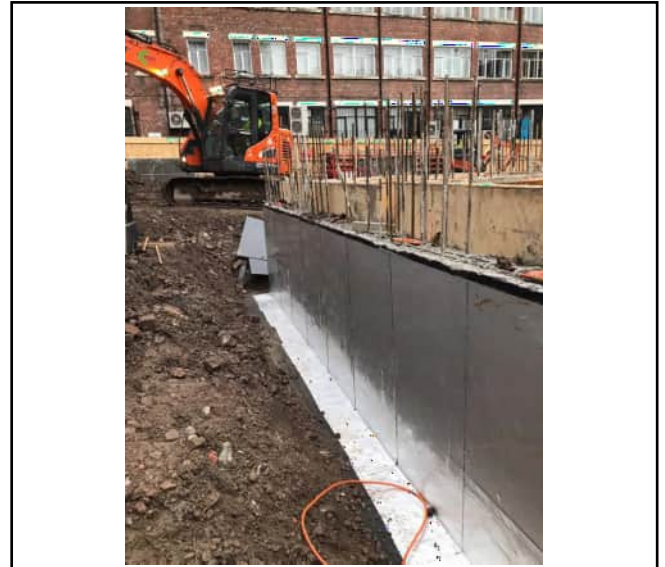
2. GR SAM applied to face of Core

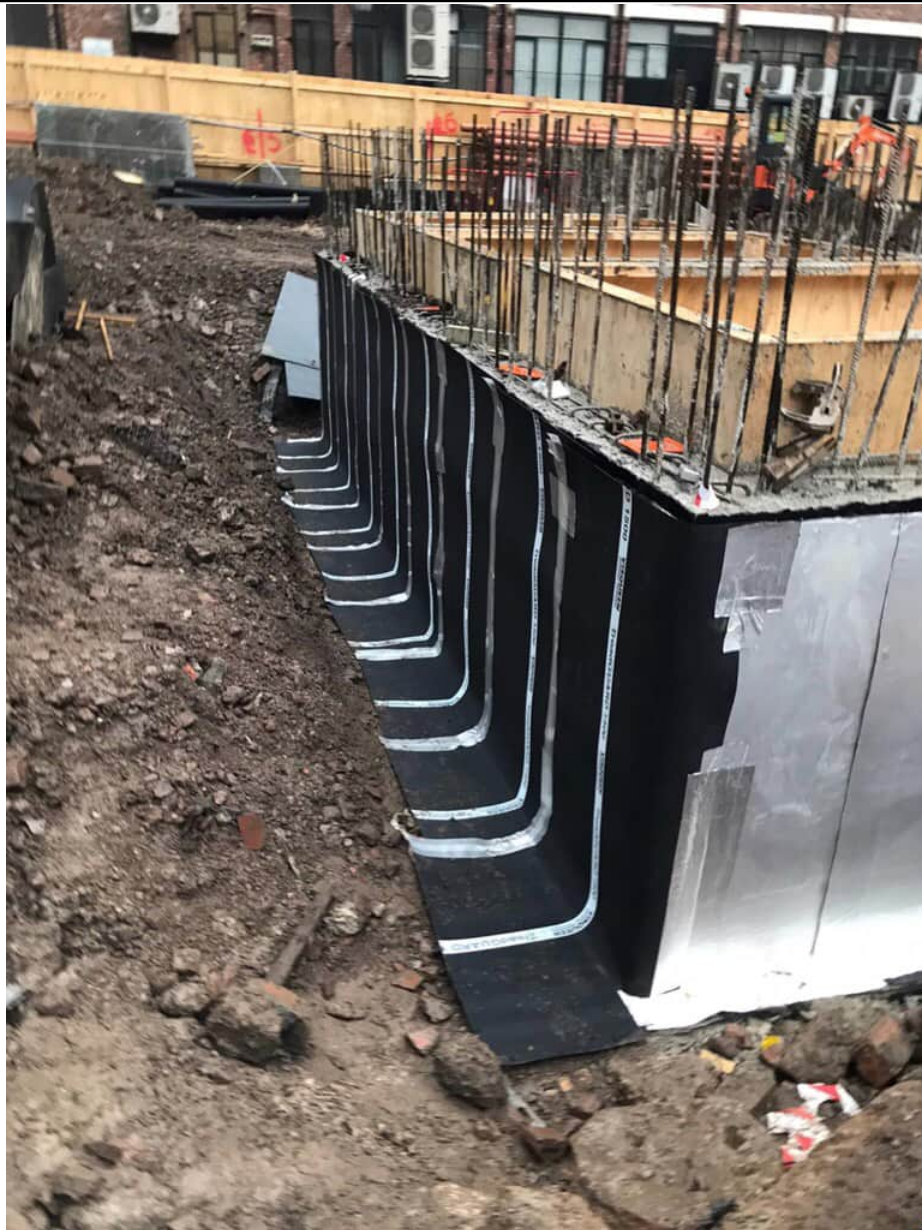
3. GR SAM protected with Protective Boarding before being backfilled.

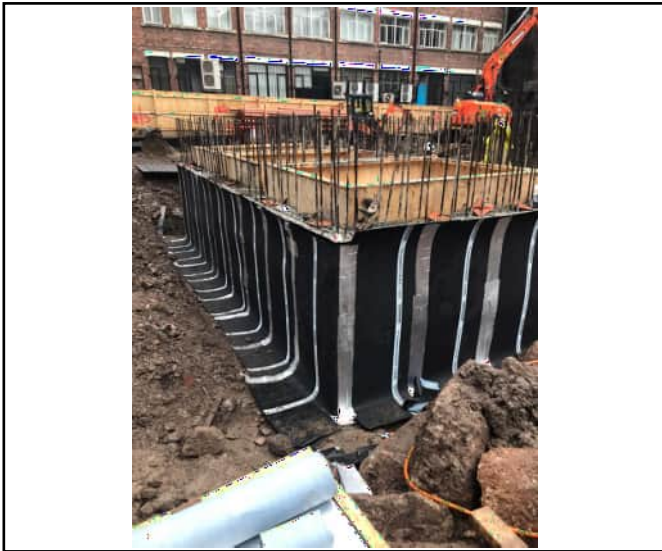
Core protected with protective boarding

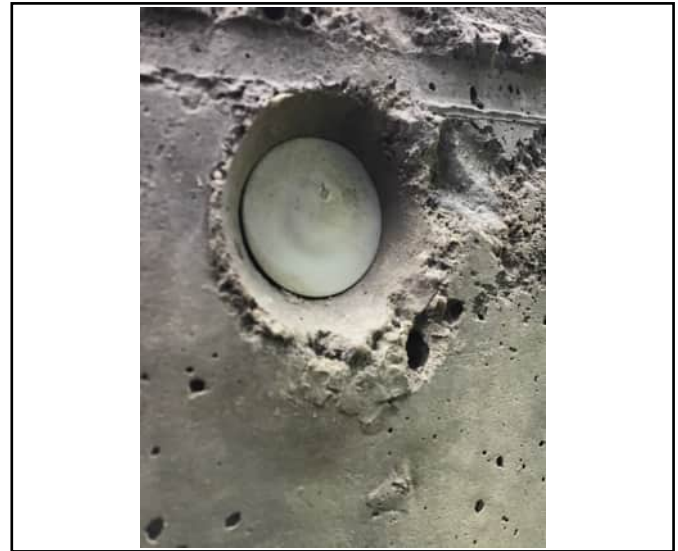
Dividag holes plugged with rubber

plugs before being primed

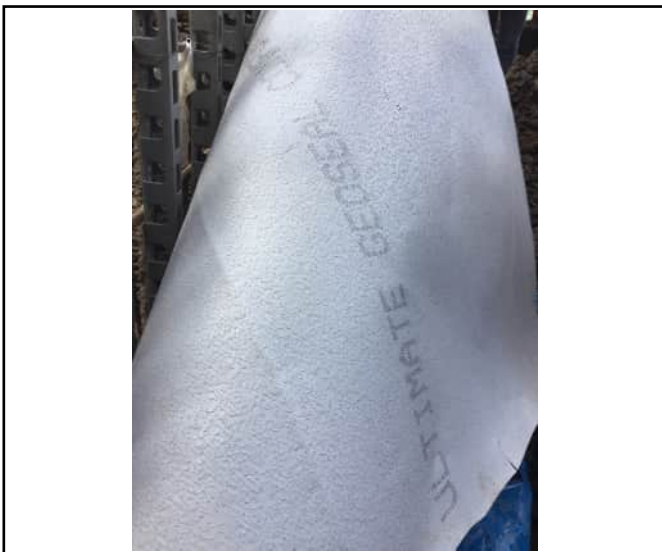
Visqueen Geoseal Ultimate used

around crane base

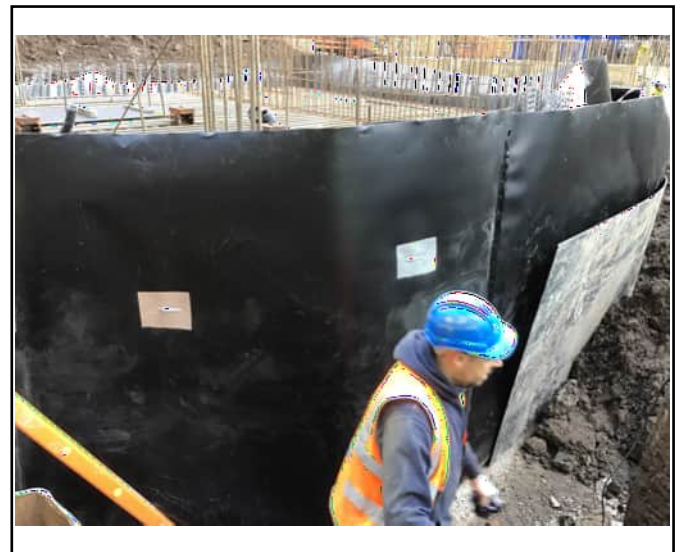
Pegs to bed in concrete sealed

with GR SAM

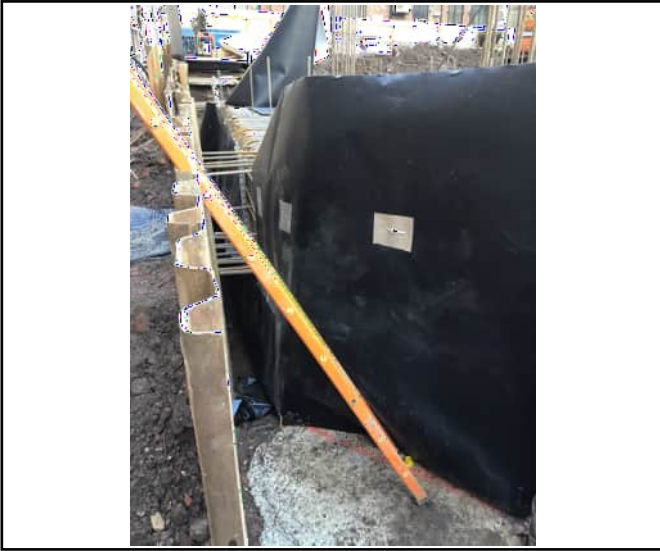
Peg sealed

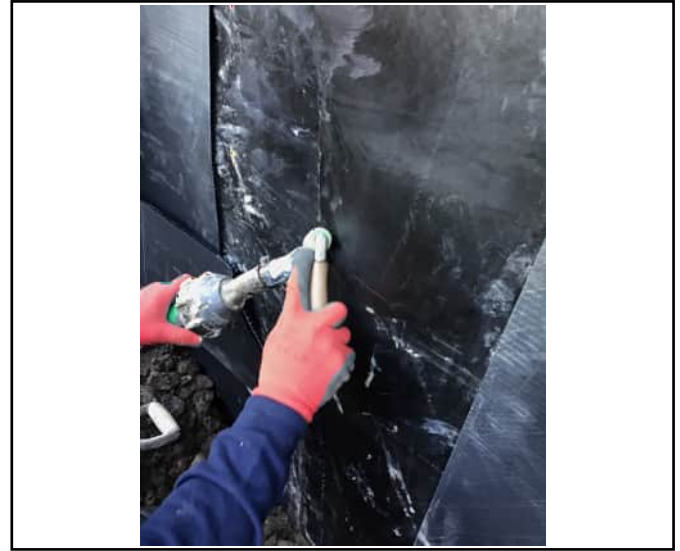
Hot weld in before extrusion

weld witnessed

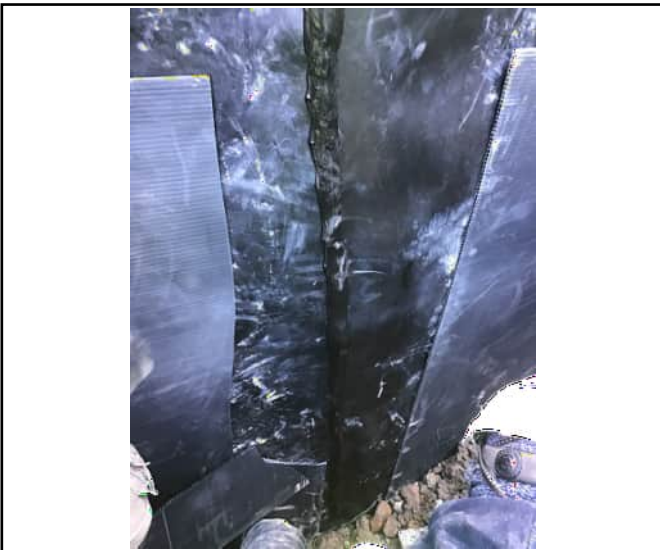
Extrusion weld on complete

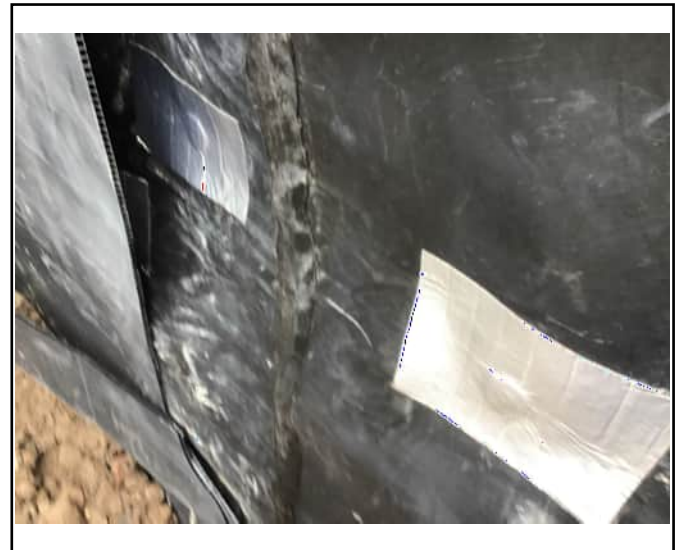
Pegs installed either side of

extrusion weld and sealed

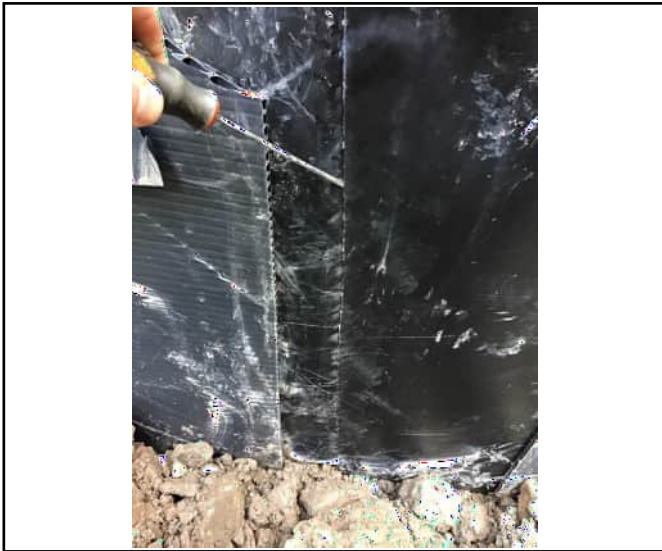
Pick and probe on hot weld before

extrusion welded

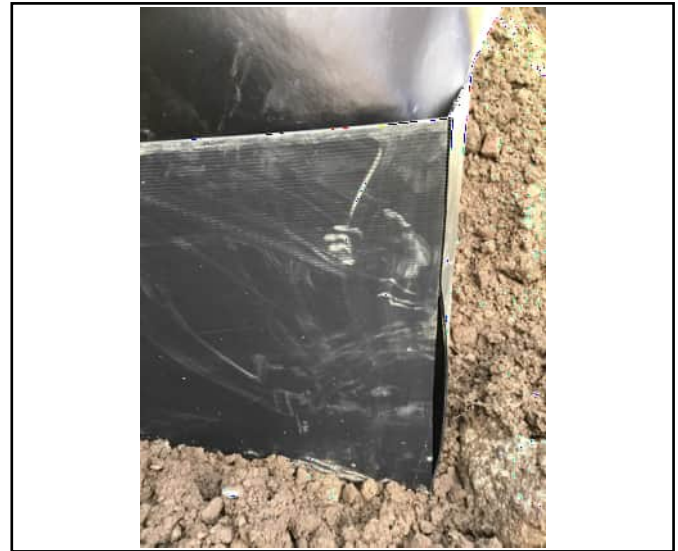
Protection board applied to

base of crane

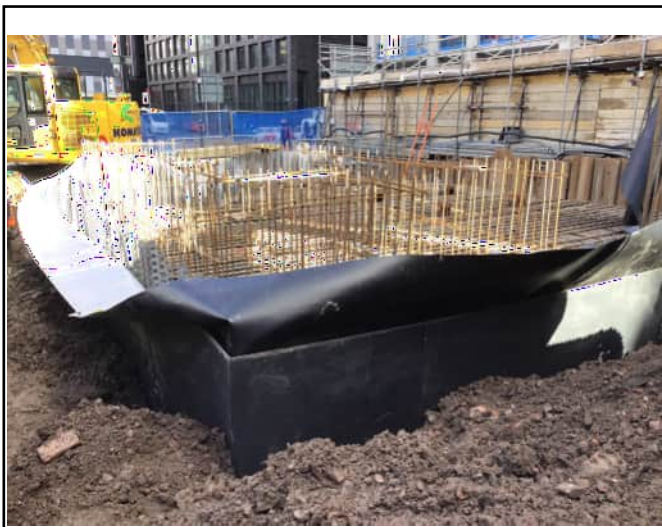
Protection board to base of crane

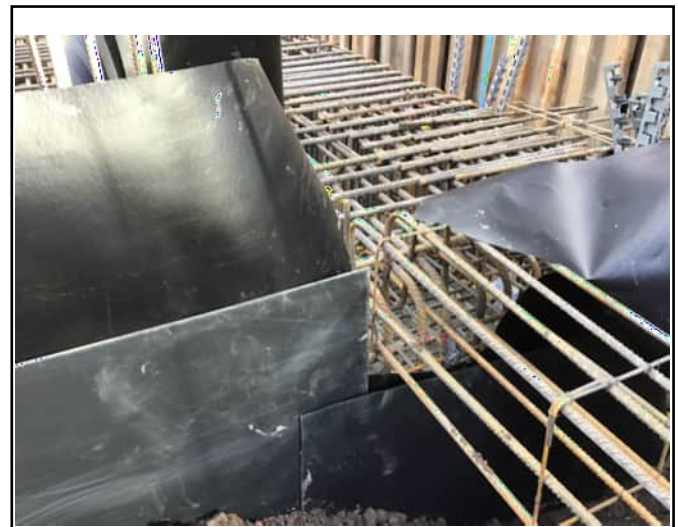
Membrane cut around ring beam

to be connected to base
