## BS5837:2012 TREE SURVEY / Arboricultural Impact Assessment

Customer No: MBHDE05  
Document No: 800722  
09/10/2021

Site Address:  
Ardwick Service Station  
Chancellor Lane  
Manchester M12 6JZ

Site: FS664 Ardwick Service Station, Chancellor Lane, Manchester M12 6JZ

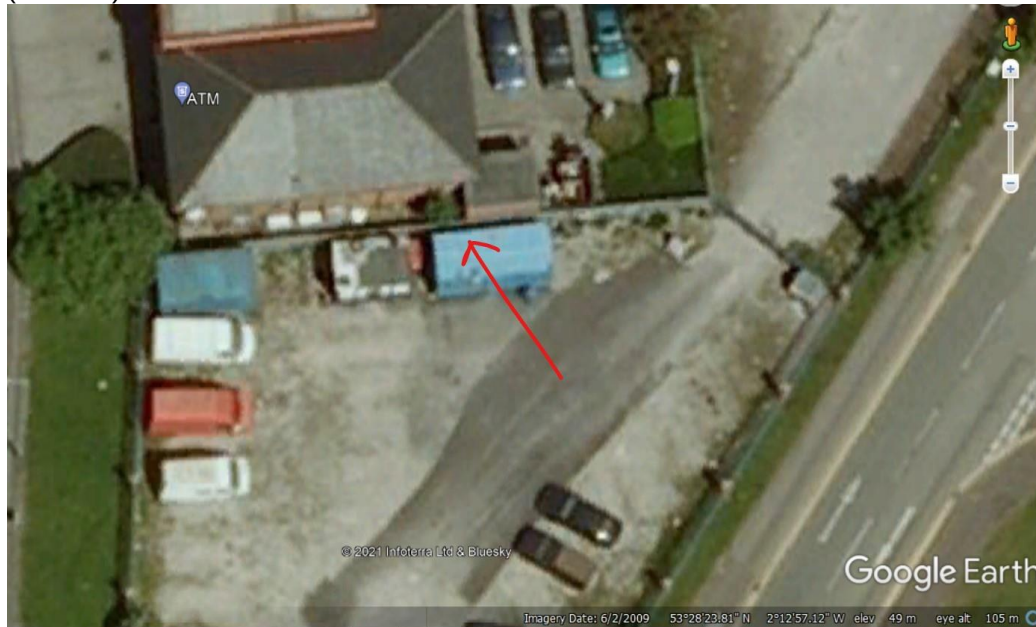
**A Google Earth map** screenshot with the image date of 2<sup>nd</sup> June 2009 shows a very small tree (arrowed) in situ.

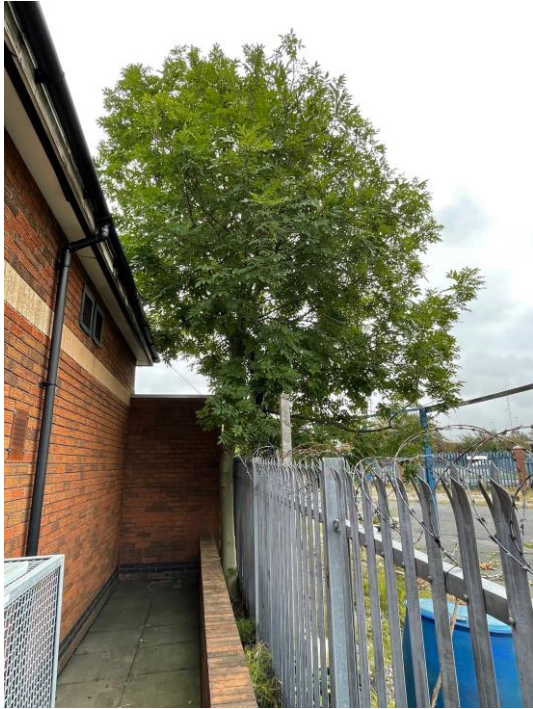
Crown height differs around the tree, with a low crown over the neighbouring (apparently) disused land that has been used to park cars. Against the rear guttering of the Sales Building and roof, the crown overshadows and impacts the building at just under 4m.

**The Current impact** on the site is that the tree is about as big as it can get before damage occurs to the wall alongside the path and the boundary fence. The crown is already impacting directly on the roof and gutter of the Sales Building.

T1 Ash to the rear of the Sales Building impacting on the roof and gutter

Given the above assessment of the tree, its age, location and negative desirability for retention and Classification, the recommendation must be to Fell the tree and Poison the stump to prevent regrowth.

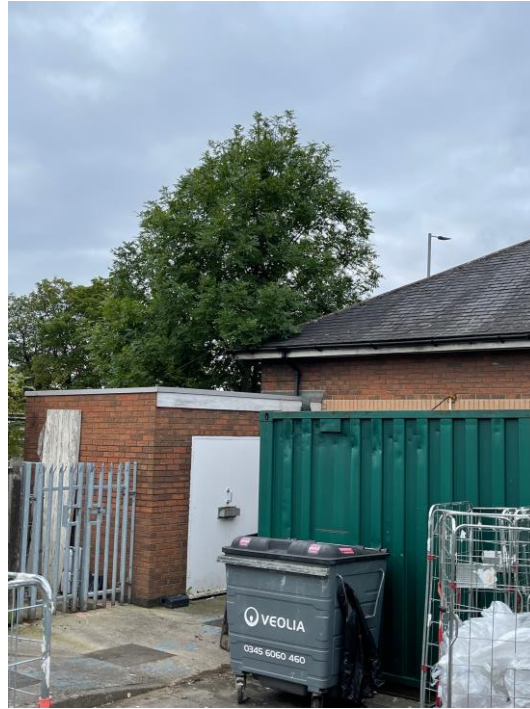
**Location of T1 Ash**, is on the south border of the site, the base pressed against the metal high security fence and also touching a low brick wall that separates the edge of the site from an approx 1m wide concrete slab path. The slab path is an access path for maintenance to the rear of the Sales Building and touches both the low brick wall and the rear wall of the Building.

**The future projected impact** is that as the continues to grow at the current fairly rapid rate, the wall and path will be damaged and likely uplifted. The boundary fence will also be damaged. The primary damage however, is likely to be to the rear wall of the sales building, either by uplift if roots penetrate below the foundations, or depending on the exact nature of the superficial deposits (reported to be Devensian Till by the iGeology iOS App) which may contain unsorted layers of Clay, mudstone and sand leaving it potentially shrinkable.

T1 Ash trunk already pressed against the wall and security fence
