# Drainage Report

**MMUIOS**  
**99 OXFORD ROAD**  
**MANCHESTER**  
**MANCHESTER**

**AQUASPEED DRAIN SERVICES**  
**Surveyor: RYAN HITCHCOCK**  
**INFO@AQUASPEED.CO.UK**  
**01942 886722**

**MMUIOS 99 OXFORD ROAD MANCHESTER - CCTV Survey Report : 01/10/21**

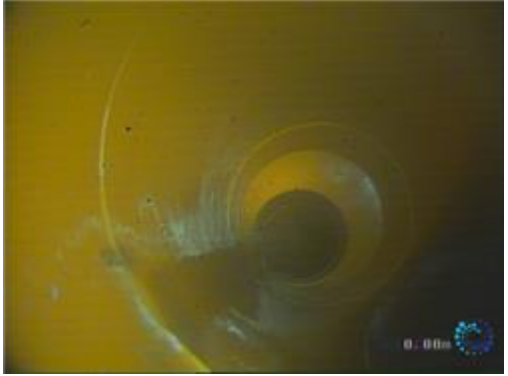
| Pos | Video Ref | Code | Description | Image |
|---|---|---|---|---|
| 01.60m | 0:00:40 | JN | Junction at 03 o'clock: 150mm Diameter | Image Provided - Ref: 0_2<br> |

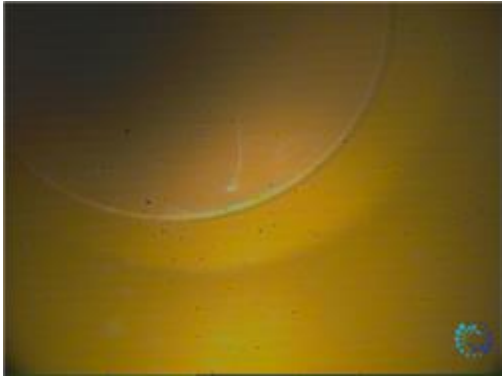
| Pos | Video Ref | Code | Description | Image |
|---|---|---|---|---|
| 00.40m | 0:00:26 | SC | Dimension of drain/sewer changes: 100mm Diameter | <p>Image Provided - Ref: 1_2</p> |

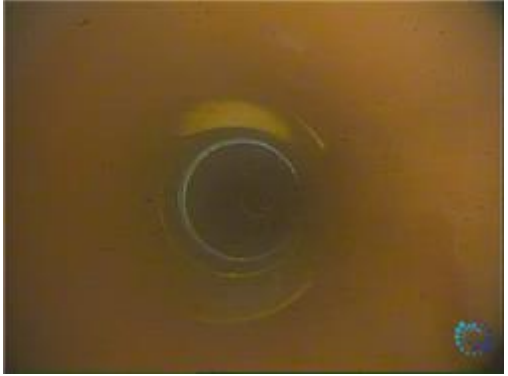
| Pos | Video Ref | Code | Description | Image |
|---|---|---|---|---|
| 06.10m | 0:00:34 | JN | Junction at 03 o'clock: 100mm Diameter | Image Provided - Ref: 2_2<br> |

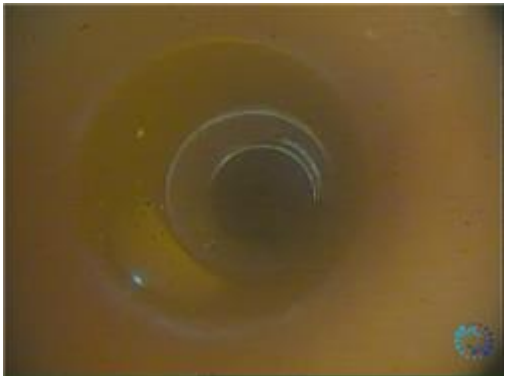
| Pos | Video Ref | Code | Description | Image |
|---|---|---|---|---|
| 11.89m | 0:00:48 | JN | Junction at 09 o'clock: 100mm Diameter | Image Provided - Ref: 2_3<br> |

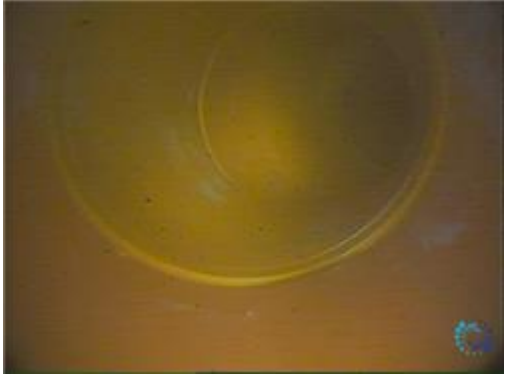
| Pos | Video Ref | Code | Description | Image |
|---|---|---|---|---|
| 00.02m | 0:00:05 | LRQ | Line of drain/sewer deviates right [quarter] | Image Provided - Ref: 6_2<br> |

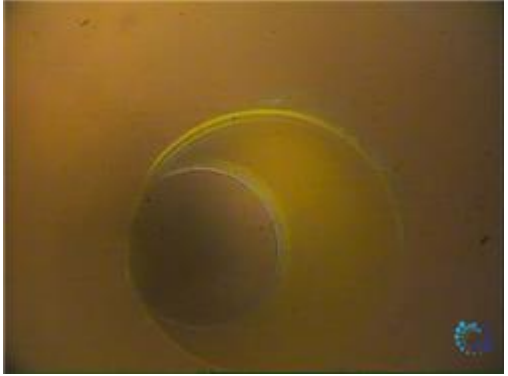
| Pos | Video Ref | Code | Description | Image |
|---|---|---|---|---|
| 01.01m | 0:00:20 | LLQ | Line of drain/sewer deviates left [quarter] | Image Provided - Ref: 9_2<br> |

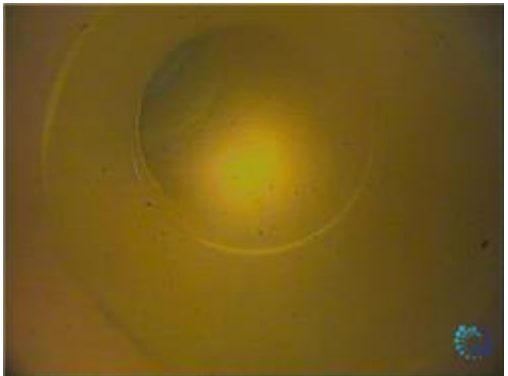
| Pos | Video Ref | Code | Description | Image |
|---|---|---|---|---|
| 03.23m | 0:00:50 | LLF | Line of drain/sewer deviates left [full] | Image Provided - Ref: 9_3<br> |

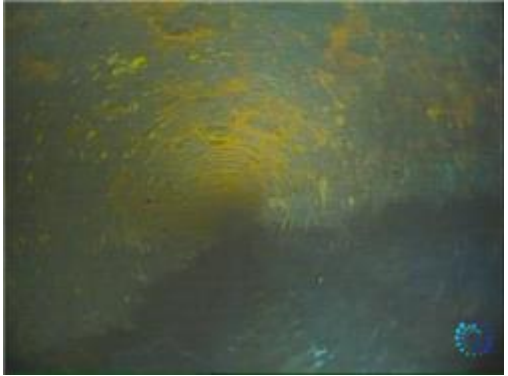
| Pos | Video Ref | Code | Description | Image |
|---|---|---|---|---|
| 01.00m | 0:00:37 | MCCI | Material of pipe changes to Cast Iron | Image Provided - Ref: 10_2<br> |

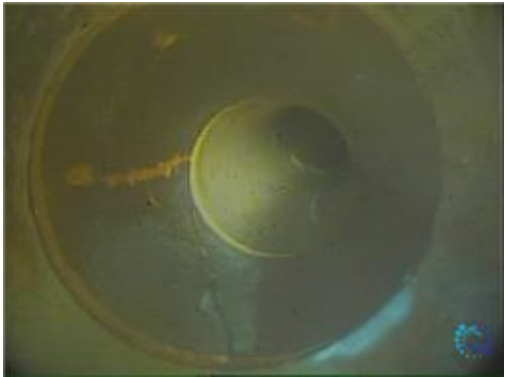
| Pos | Video Ref | Code | Description | Image |
|---|---|---|---|---|
| 03.50m | 0:00:49 | LRQ | Line of drain/sewer deviates right [quarter] | Image Provided - Ref: 10_3<br> |

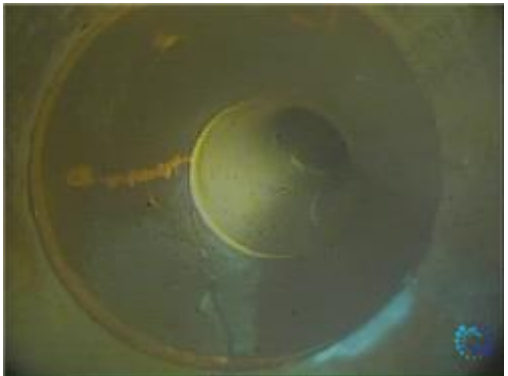
| Pos | Video Ref | Code | Description | Image |
|---|---|---|---|---|
| 03.50m | 0:00:49 | MCVC | Material of pipe changes to Vitrified Clay (i.e. all clayware) | Image Provided - Ref: 10_4<br> |

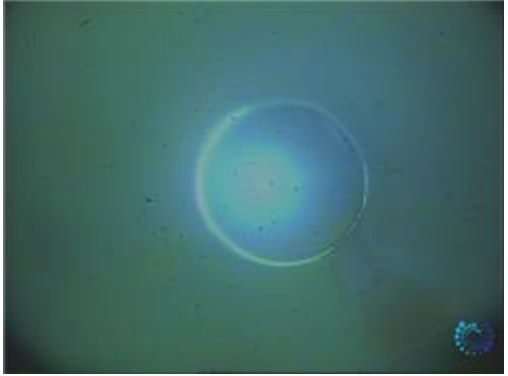
| Pos | Video Ref | Code | Description | Image |
|---|---|---|---|---|
| 04.50m | 0:01:09 | LUF | Line of drain/sewer deviates up [full] | <p>Image Provided - Ref: 11_2</p> |

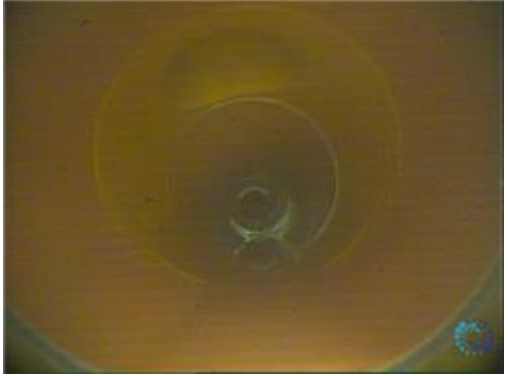
| Pos | Video Ref | Code | Description | Image |
|---|---|---|---|---|
| 11.00m | 0:00:50 | JN | Junction at 12 o'clock: 100mm Diameter | <p>Image Provided - Ref: 13_2</p> |

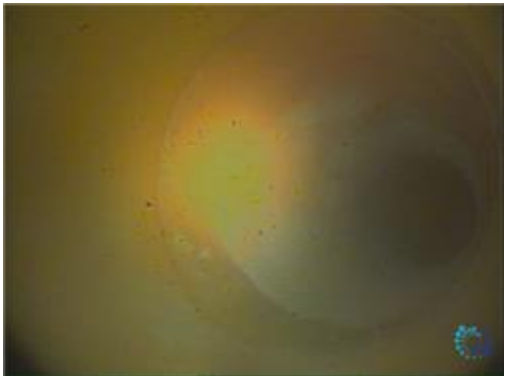
| Pos | Video Ref | Code | Description | Image |
|---|---|---|---|---|
| 02.10m | 0:00:24 | LRQ | Line of drain/sewer deviates right [quarter] | Image Provided - Ref: 14_3<br> |

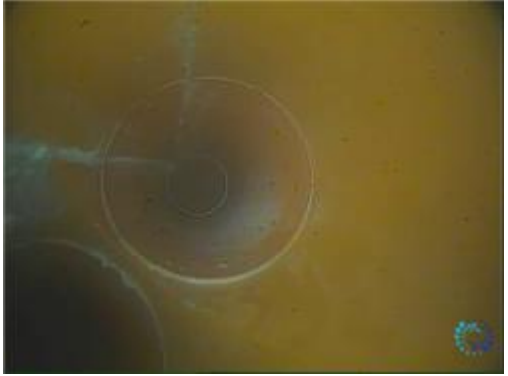
| Pos | Video Ref | Code | Description | Image |
|---|---|---|---|---|
| 00.00m | 0:00:05 | JN | Junction at 03 o'clock: 100mm Diameter | Image Provided - Ref: 15_2<br> |

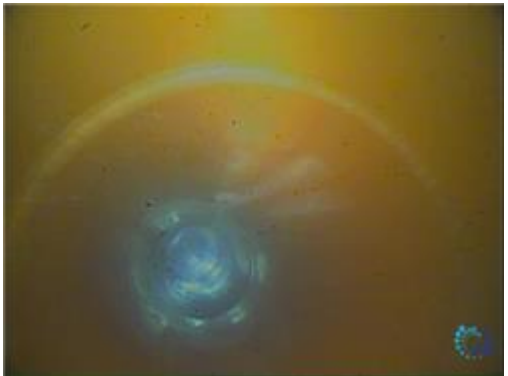
| Pos | Video Ref | Code | Description | Image |
|---|---|---|---|---|
| 02.56m | 0:00:21 | LLQ | Line of drain/sewer deviates left [quarter] | Image Provided - Ref: 15_3<br> |

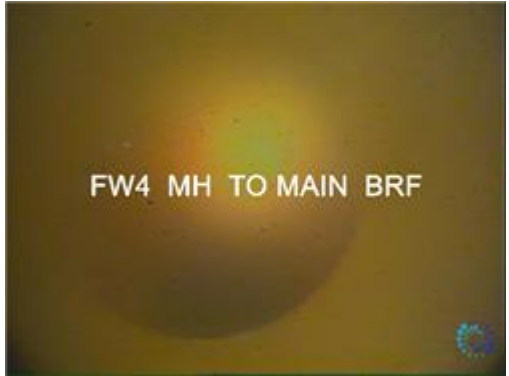
| Pos | Video Ref | Code | Description | Image |
|---|---|---|---|---|
| 00.49m | 0:00:04 | LDF | Line of drain/sewer deviates down [full] | <p>Image Provided - Ref: 16_2</p> |

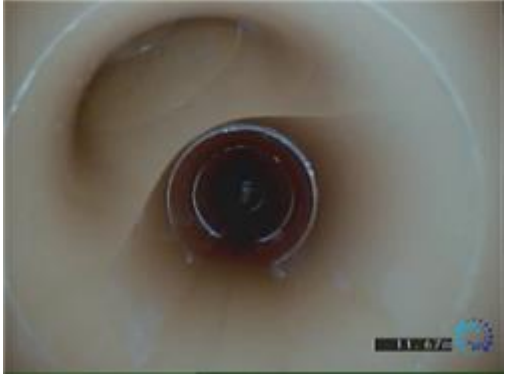
| Pos | Video Ref | Code | Description | Image |
|---|---|---|---|---|
| 11.67m | 0:01:15 | JN | Junction at 11 o'clock: 150mm Diameter | <p>Image Provided - Ref: 18_2</p> |

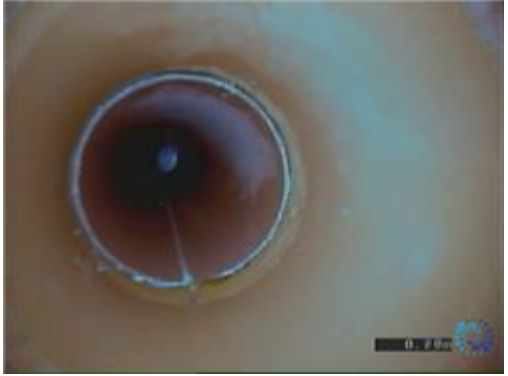
| Pos | Video Ref | Code | Description | Image |
|---|---|---|---|---|
| 00.70m | 0:00:13 | LLQ | Line of drain/sewer deviates left [quarter] | <p>Image Provided - Ref: 19_2</p> |

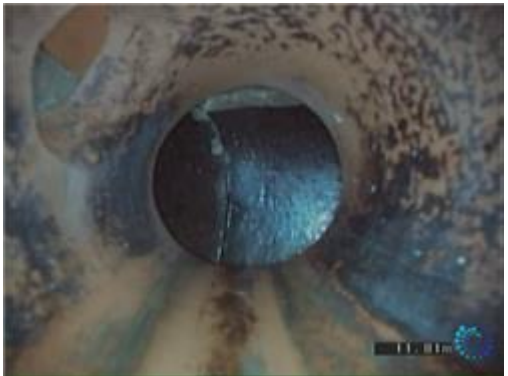
| Pos | Video Ref | Code | Description | Image |
|---|---|---|---|---|
| 11.81m | 0:00:52 | JN | Junction at 10 o'clock: 100mm Diameter | Image Provided - Ref: 22_3<br> |
