## CIS Tower Refurbishment.

Recording Strategy and Photographic Audit of internal & external features.

# APPENDIX 21.1 – LEVEL 15. INTERNAL.

**CIS Tower. Appendix 21.1 - Level 15. Recording Strategy and Photographic Audit of internal features – Post Strip Out, 2021.**

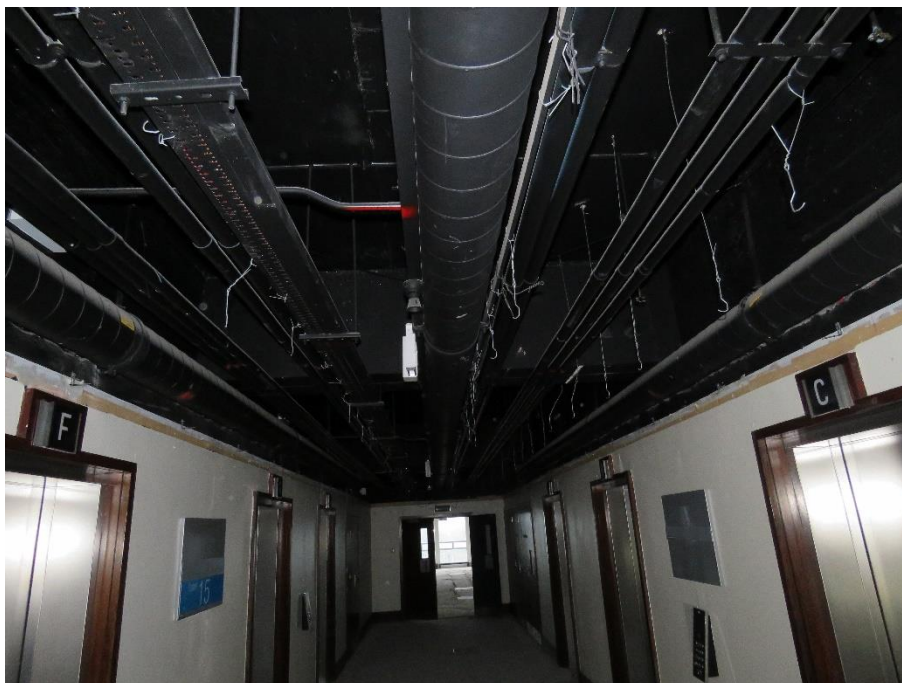
**15.01** Looking along the lift lobby with now exposed services, unusually, the services have all been painted out black as you would find in a modern office development but have never been known to have been exposed.

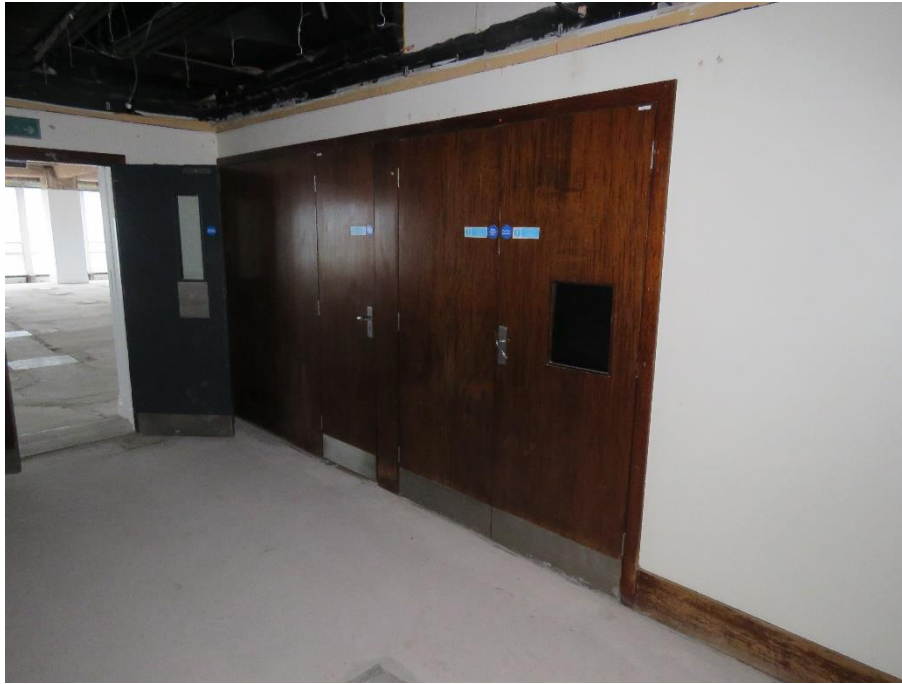
**15.02** View of the original riser cupboard doors.

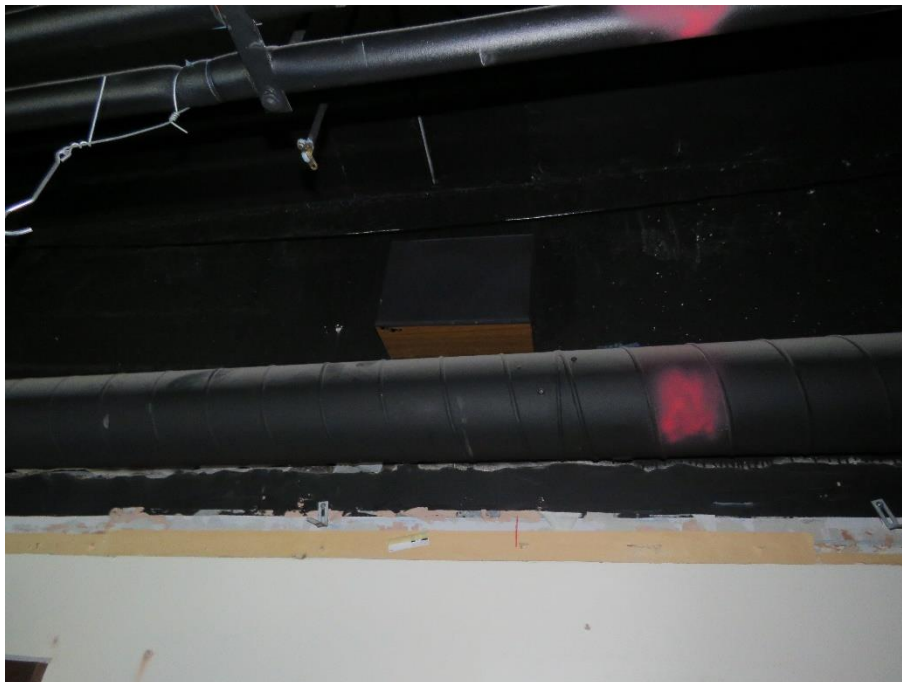
**15.03** A speaker within the ceiling void was most probably from an early tannoy system.

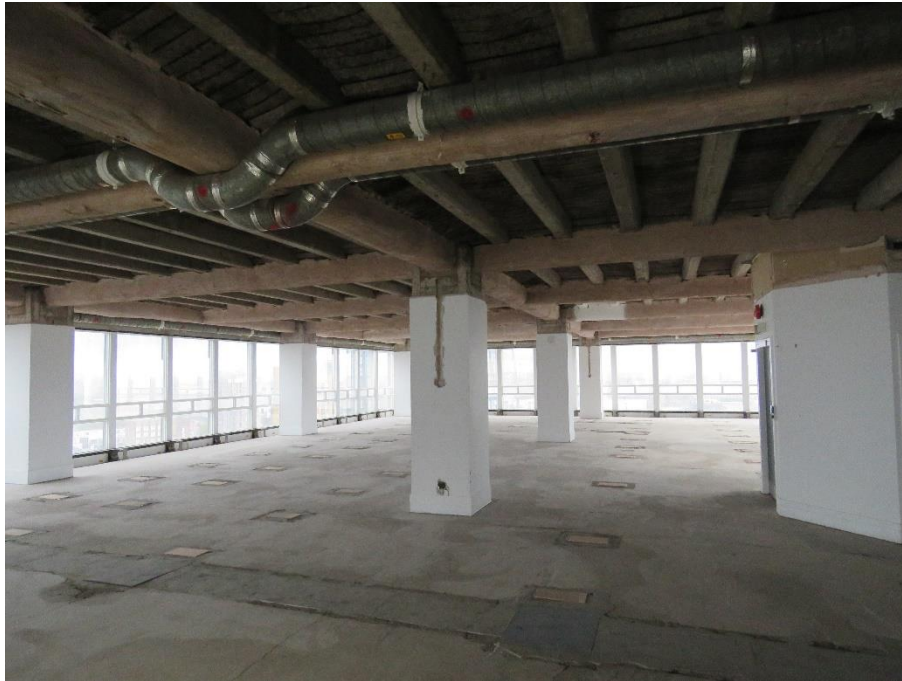
**15.04** Looking east across the tower floor plate.

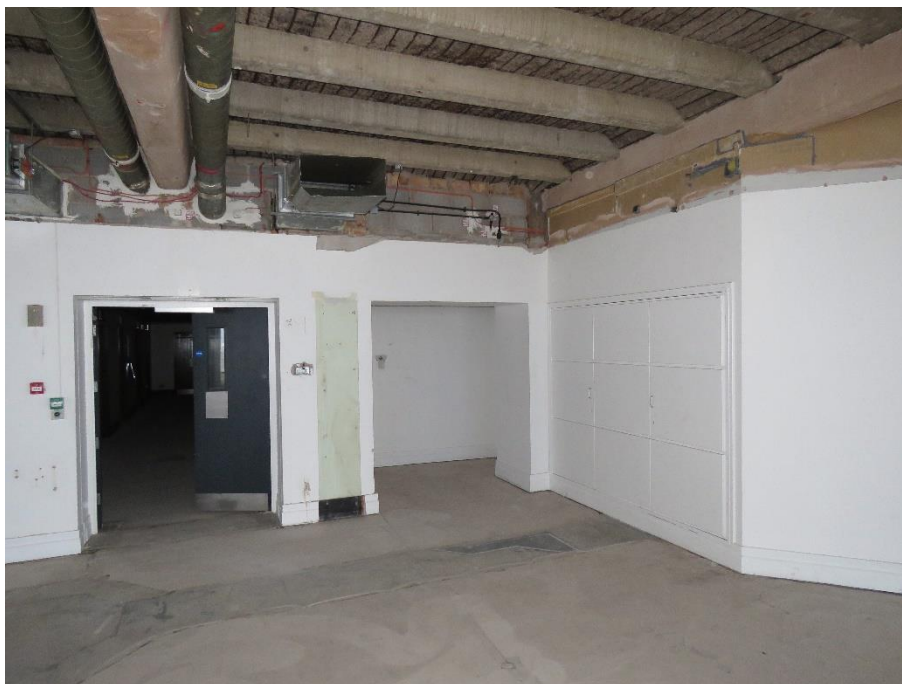
**15.05** View toward the Telelift area following strip out of the screen partition and track.

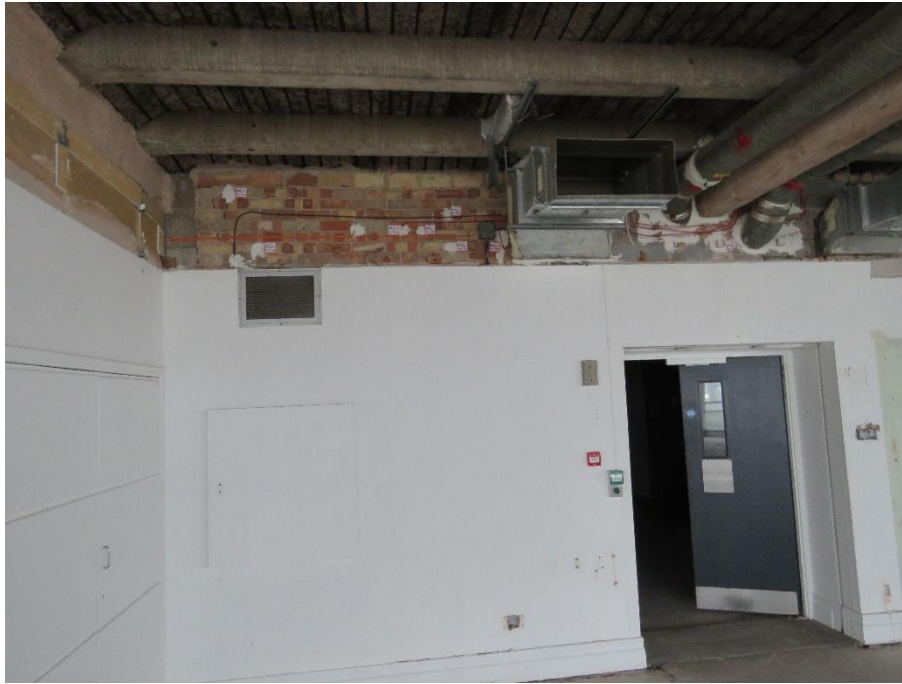
**15.06** View towards the lift lobby with services cut back and brick partition.

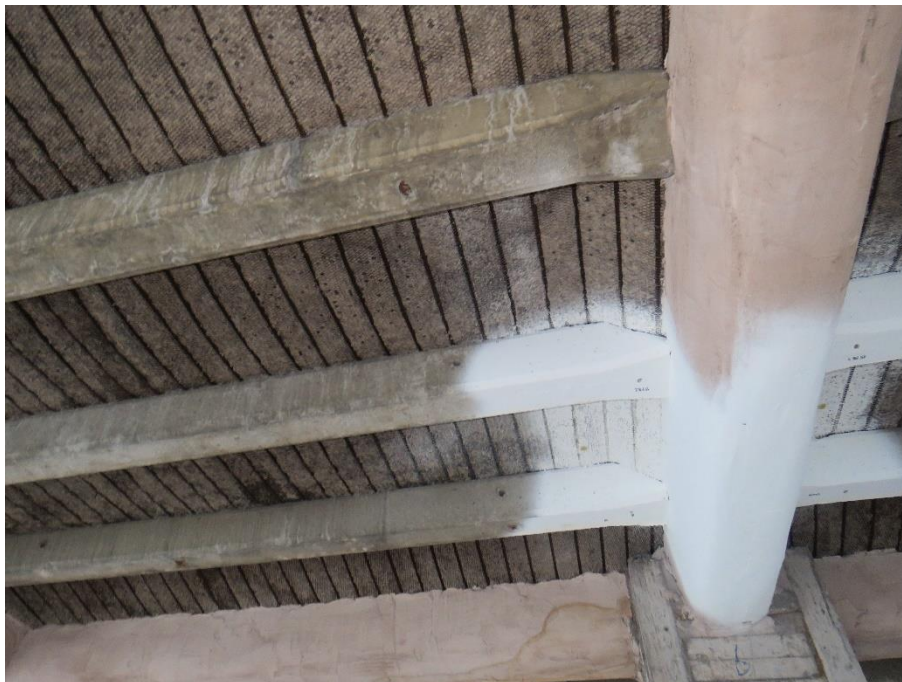
**15.07** View of the floor slab construction with retained wire mesh shuttering utilised to the tower floor slabs. Also note that the primary beam was plastered, and a sample intumescent paint application can be seen for the fire protection of the buildings structural concrete.

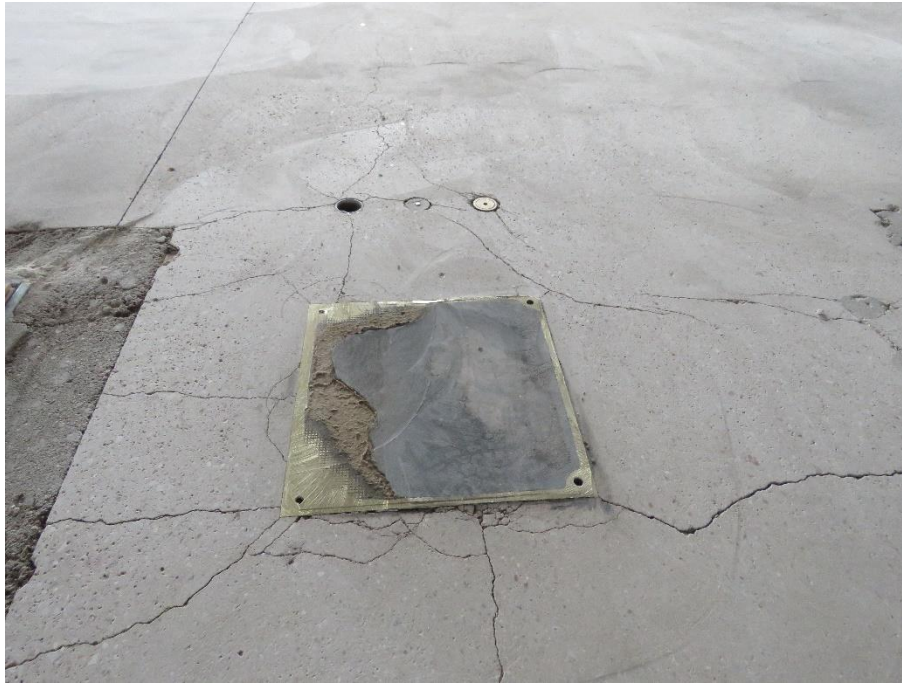
**15.08** Detail of a brass floor plate uncovered below the carpet.

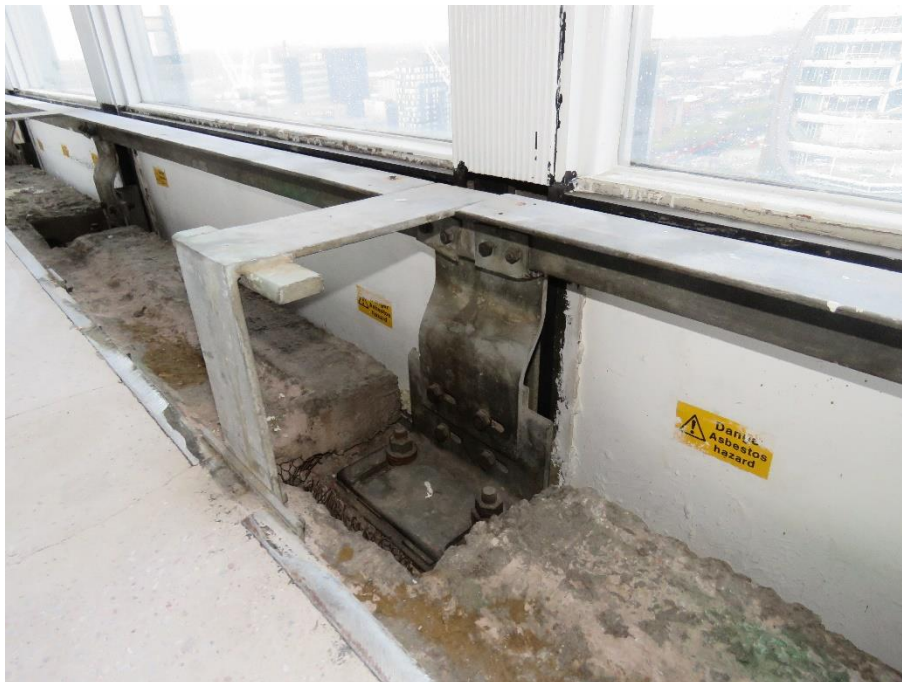
**15.09** Close up view of the connection detail of the curtain walling to floor slab, also note the frame of the Weathermaster housing was also integrated into this detail.

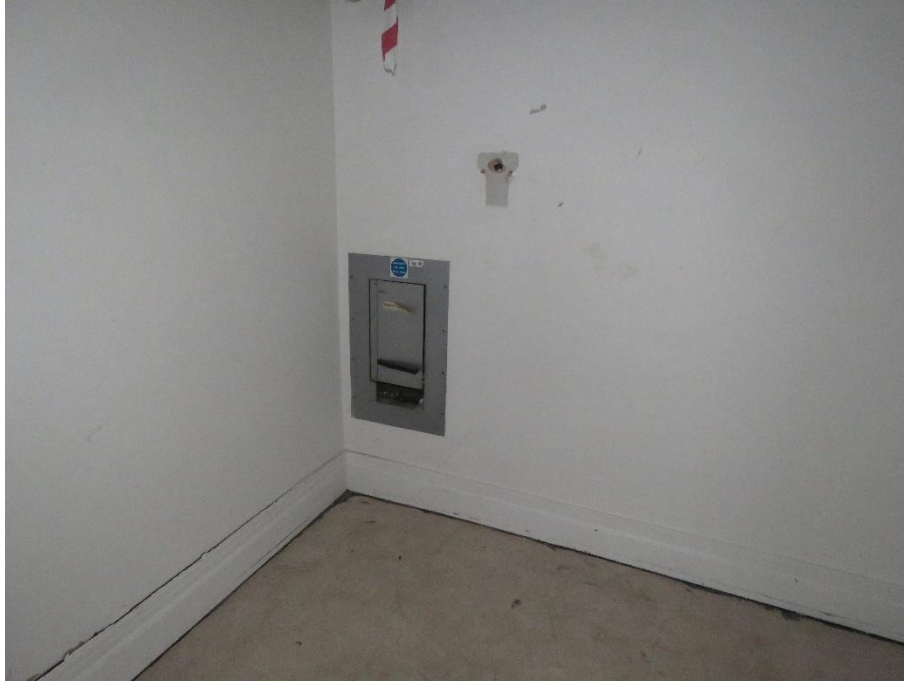
**15.10** View of the Telelift outlet.

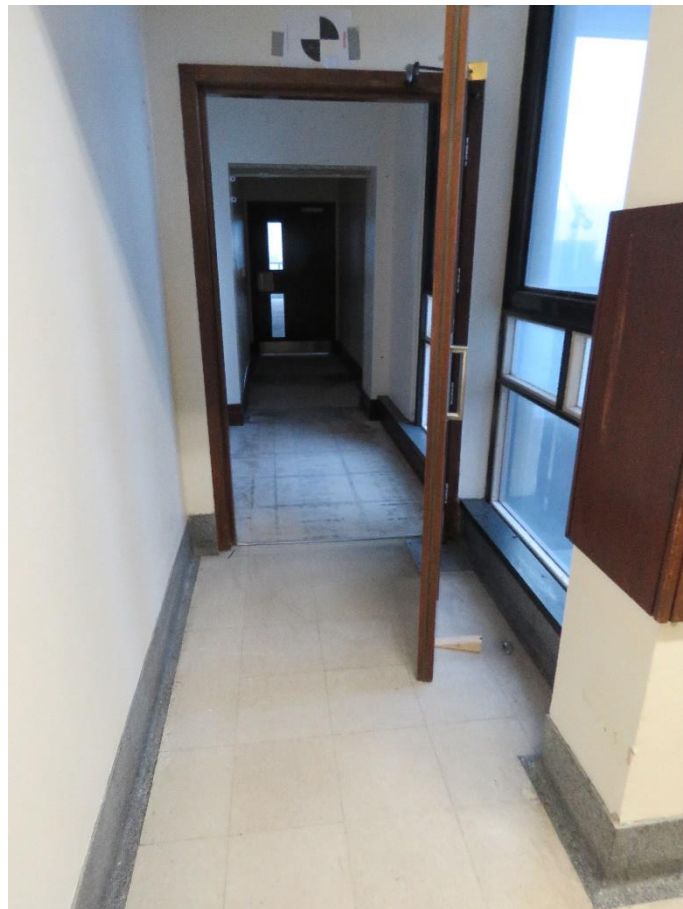
**15.11** View north from the eastern stair back through the separating fire lobbies.

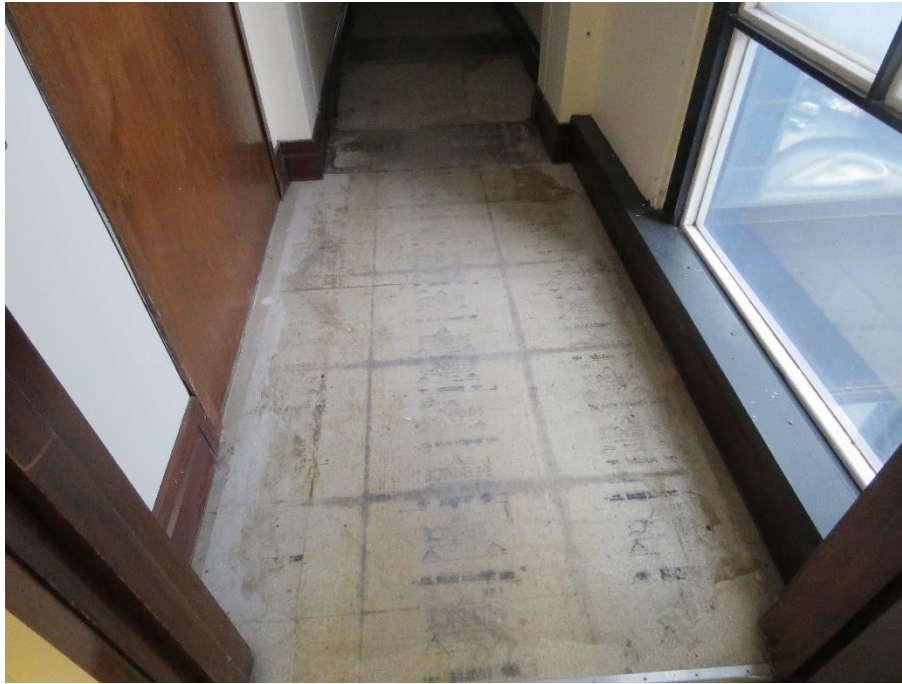
**15.12** The removal of later floor coverings has shown that the terrazzo tiles continue from the stair through towards the office space and stop in line with the fire shutter.

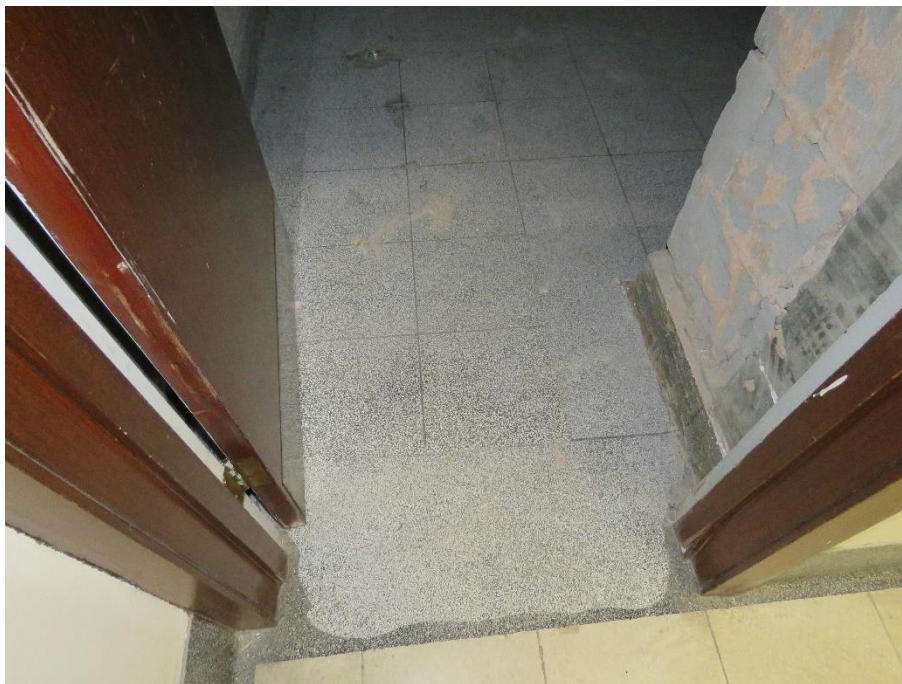
**15.13** Close up view of the terrazzo tiles to the WC.

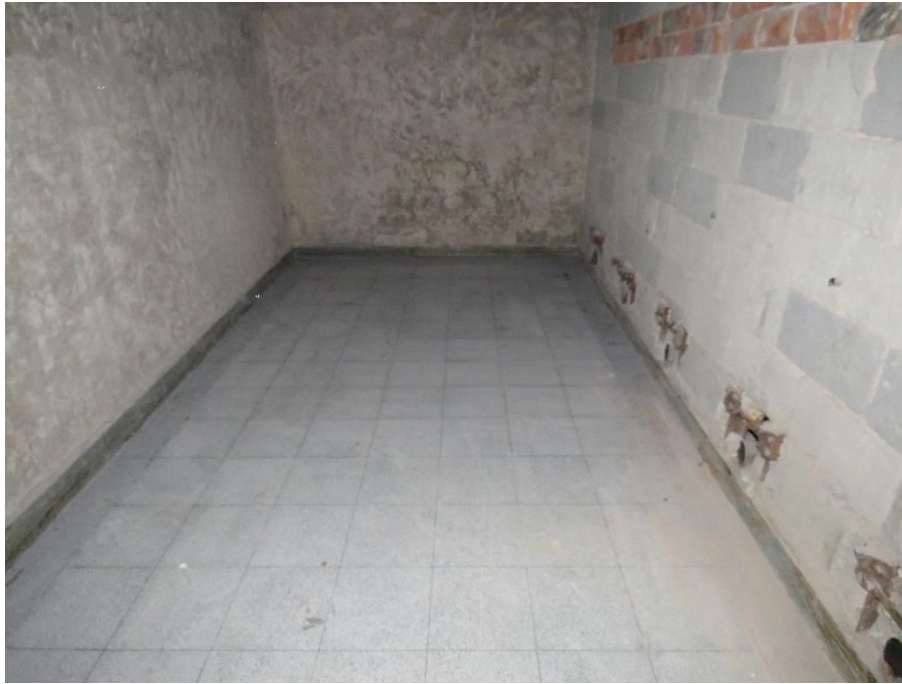
**15.14** View of the eastern WC with all cubicles and services removed, the western WC survives in the same condition.

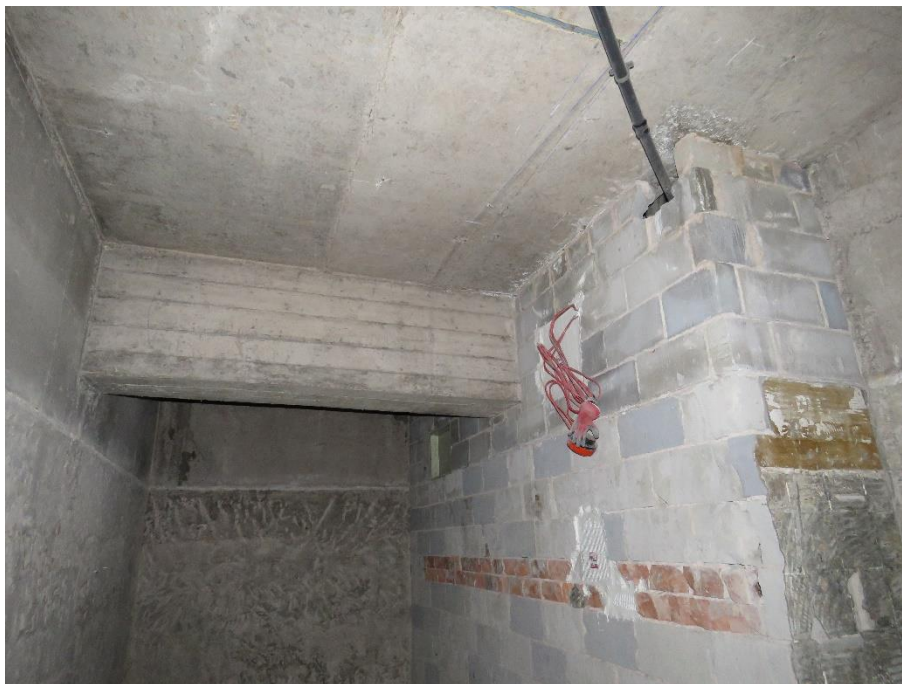
**15.15** View of the structural concrete slab of the service core utilising shuttered concrete.
