# Asbestos Refurbishment Survey

72 Errwood Road

Manchester

M19 2QH

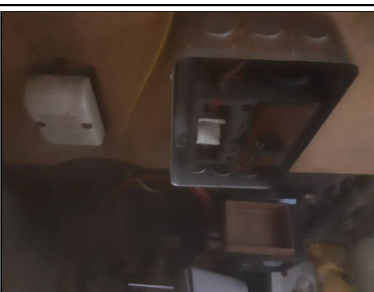
| | Survey Date: | Lead Surveyor | Survey Type | Floor | Analysis |
|---|---|---|---|---|---|
| | 8 Mar 2021 to 9 Mar 2021 | Richard Watson | Refurbishment Survey | Ground Floor | Chrysotile (1) |
| | AC001889 (S) | Asbestos Textiles/Paper (2) | Surface Sealed (1) | Low Damage (1) | Occasionally likely to be disturbed |

| | Survey Date: | Lead Surveyor | Survey Type | Floor | Analysis |
|---|---|---|---|---|---|
| Recommended action | A - Urgent Removal | | | | |

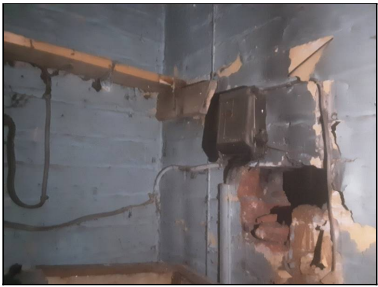
| | Survey Date: | Lead Surveyor | Survey Type | Floor | Analysis |
|---|---|---|---|---|---|
| | 8 Mar 2021 to 9 Mar 2021 | Richard Watson | Refurbishment Survey | Ground Floor | Chrysotile (1) |
| | As AC001889 (SP) | Asbestos Textiles/Paper (2) | Surface Sealed (1) | Low Damage (1) | Occasionally likely to be disturbed |
| Surveyor comments | | One to holder one to fuse | | | |

| | Survey Date: | Lead Surveyor | Survey Type | Floor | Analysis |
|---|---|---|---|---|---|
| Recommended action | | A - Urgent Removal | | | |
