**Burnage Road**

# **Gas Membrane Validation Report**

**Lainton Services Ltd**

**07 July 2021**

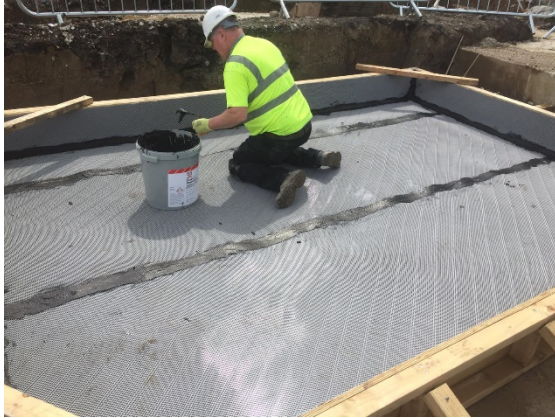
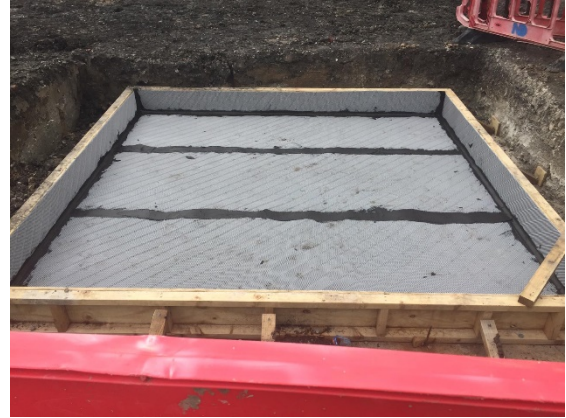
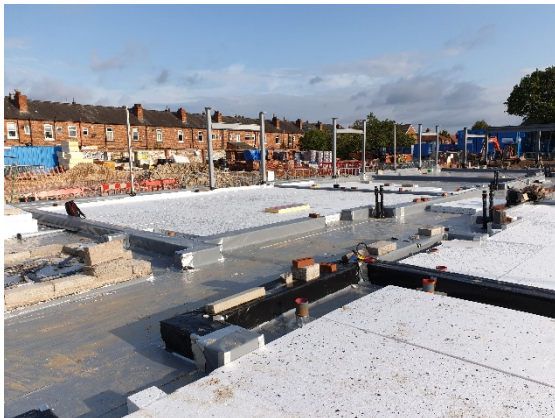
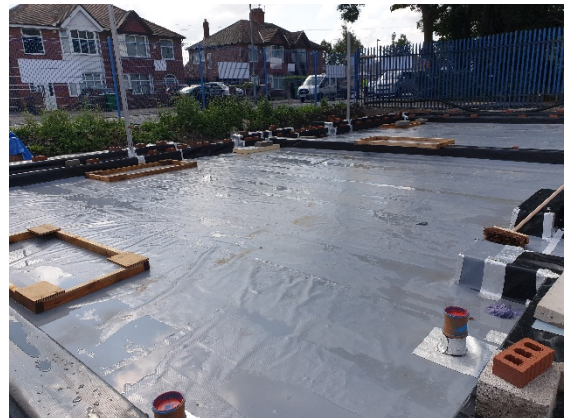
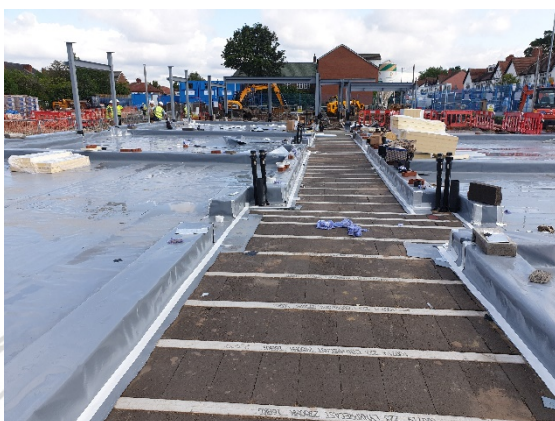
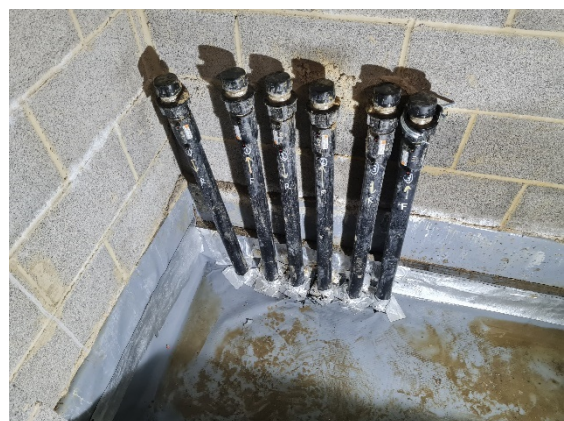
## Photos During Visual Membrane Inspections

Over the 7no. site visits there were 150 instances of damage located on the installed membrane. All damage located was repaired and rechecked.

The overall installation was in-line with manufacturers guidelines and good practice. 100% of the installation was visually inspected over the seven site visits including all penetrations.

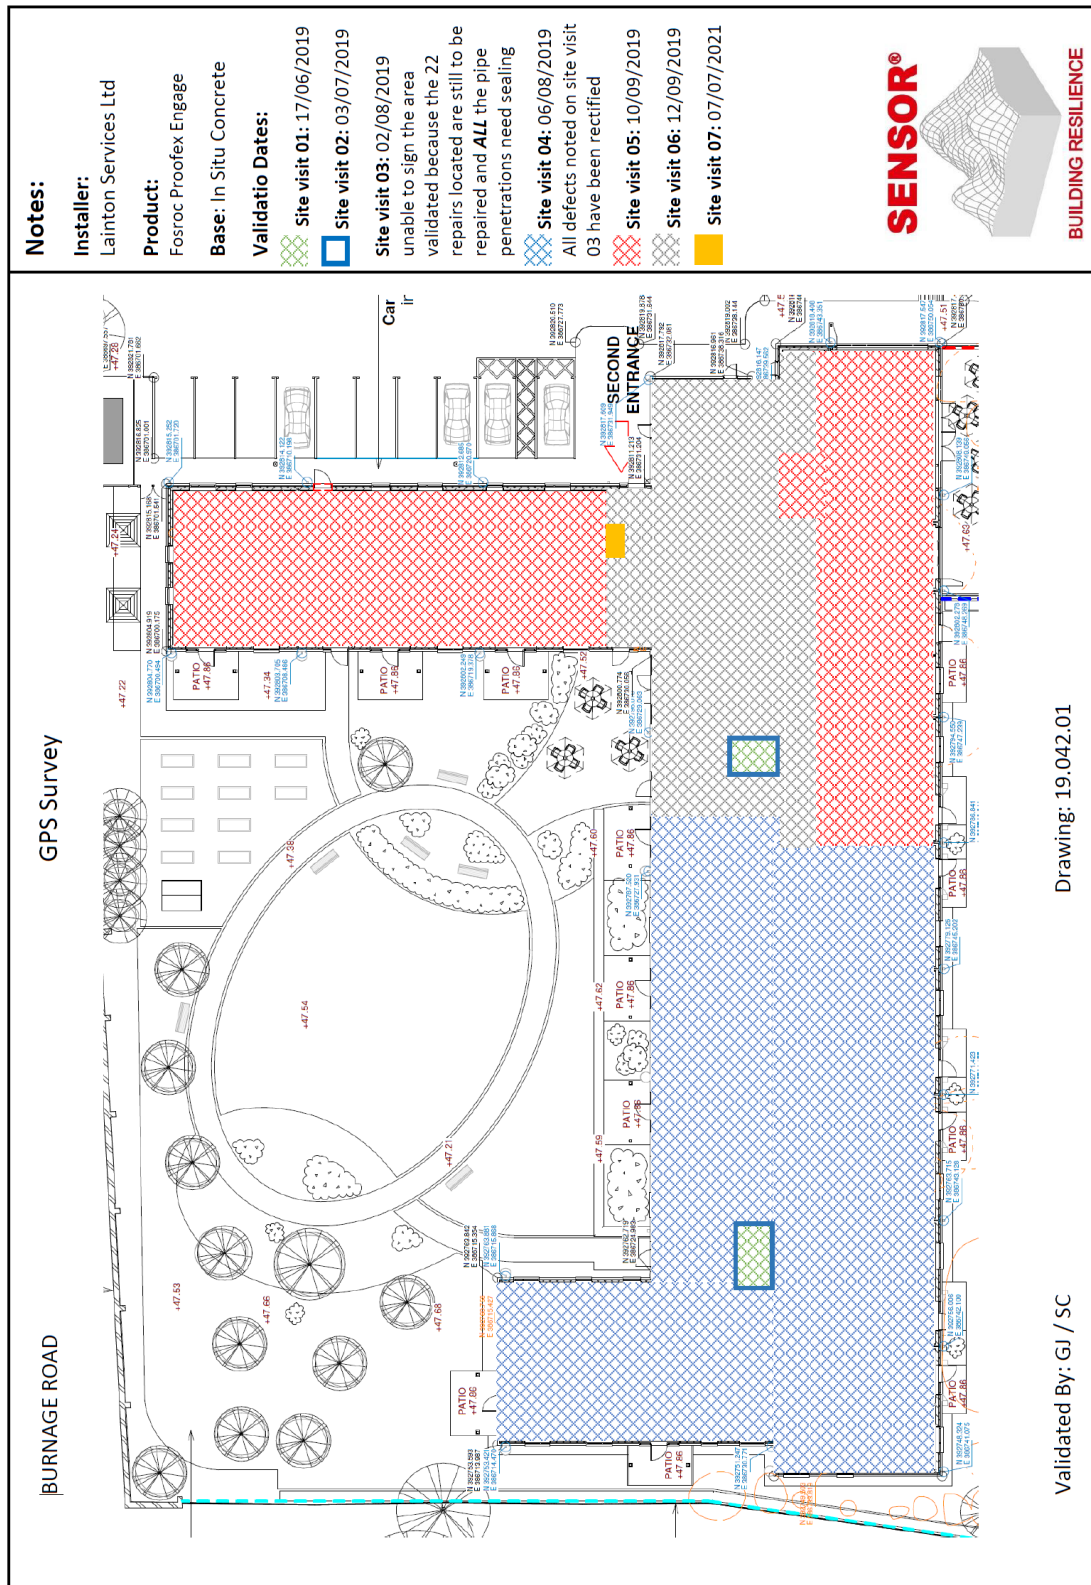
## APPENDIX 2: Sensor Site Plan

| <u>Works Carried Out</u> GPS SURVEY<br>PRODUCT INSPECTED<br>PROOFEX TOTAL<br>PROOFEX 3000MR<br>PROOFEX TOTAL TAPE<br>UNABLE TO PASS OFF DUE TO ONGOING WORKS, PIPE ENTRIES IN CORRIDOR/HALLWAY<br>X22 REPAIRS LOCATED, NOT YET REPAIRED<br>SEE SENSOR DRAWING | |

| <b>Works Carried Out</b> <b>GPS SURVEY</b><br>PROOFEX TOTAL LAID ONTO BLOCK & TEAM. PROOFEX<br>3000 ML TO SEAL PIPE ENTRY'S AND CORNERS.<br><br>111 NO DEFECTS FOUND. REPAIRED AND RETESTED.<br>23 NO PIPE ENTRY'S<br>SEE SENSOR DRAWING FOR AREAS TESTED. | |

| Sensor on site at Burnage Road validating the remaining area as shown on the Sensor site drawing | | | | | |
