## MMU - Righton Basement Asbestos removal project

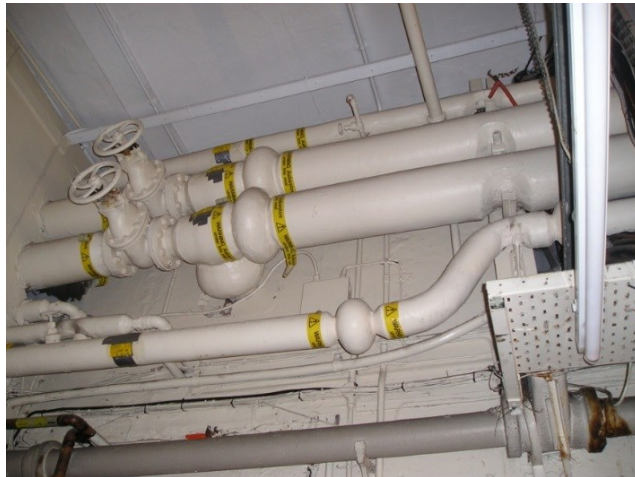
**An example of thermal insulation in good condition installed to M&E services**

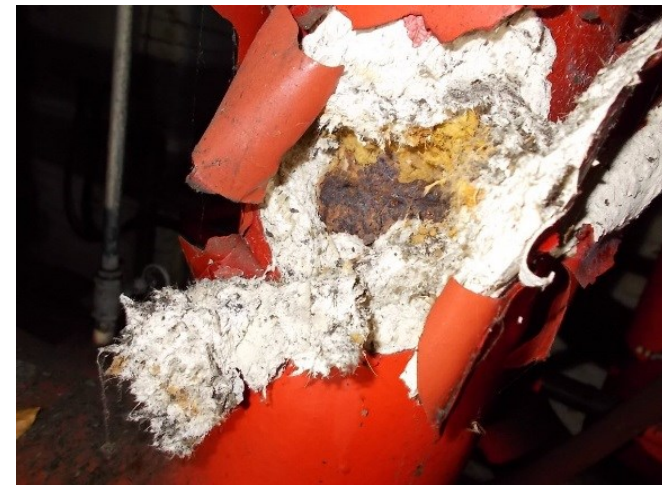
**An example of thermal insulation in poor condition in situ**

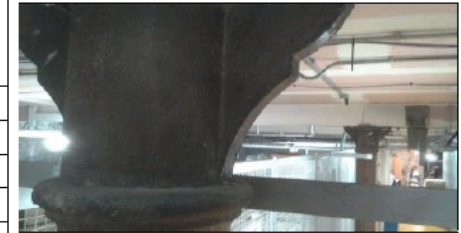
| Laboratory sample no: | DH000974 |

| Main building - Basement - B02 - Debris to top of 6th column from goods lift on left hand side when facing goods lift. | |
| Moderate | |
| Debris (3) | |
| Chrysotile + Amosite (2) | |
| High damage (3) | Surface Treatment: Unsealed (3) |

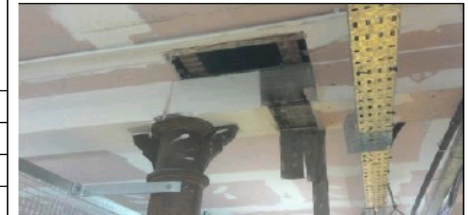
| Laboratory sample no: | DH000973 |

| Main building - Basement - B02 - Residual insulation to timber beam at ceiling level next to 5th column from goods lift on left hand side when facing goods lift. | |
| Moderate | |
| Residual insulation (3) | |
| Amosite (2) | |
| Medium damage (2) | Surface Treatment: Unsealed (3) |

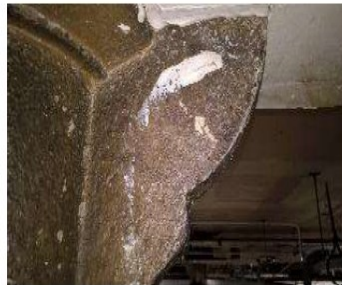
| Insulation residue to top of the column | |
| Insulation residue | |
| Small amounts | To top of the column |
| Analysis Results | Amosite |

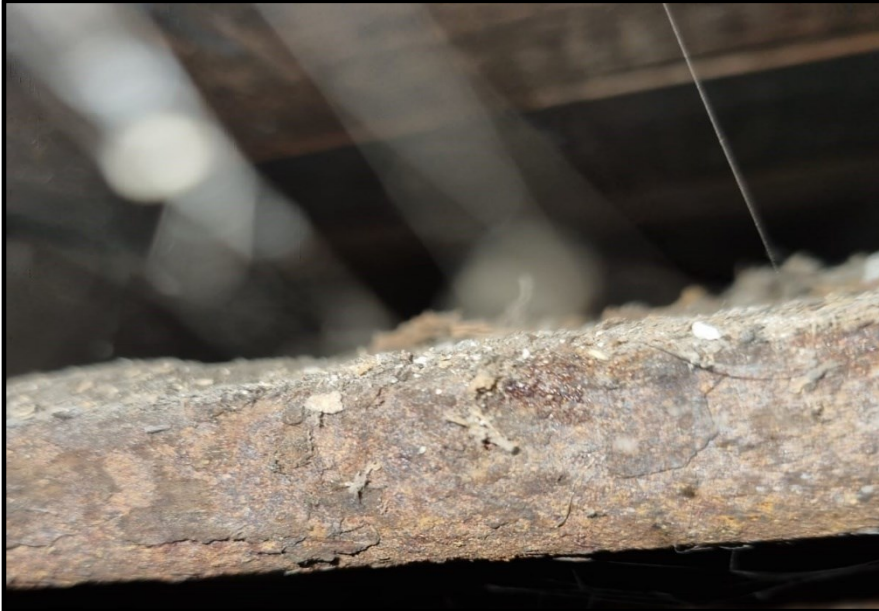
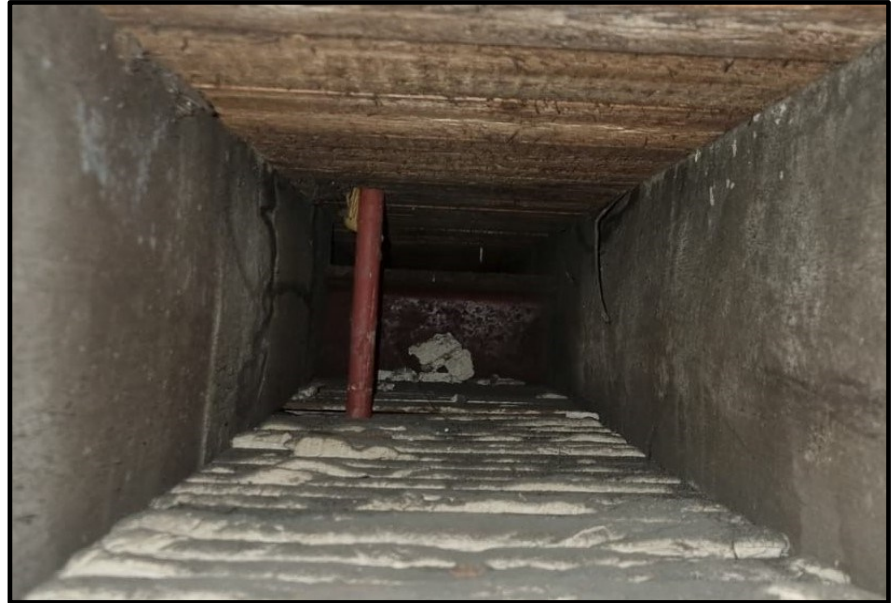
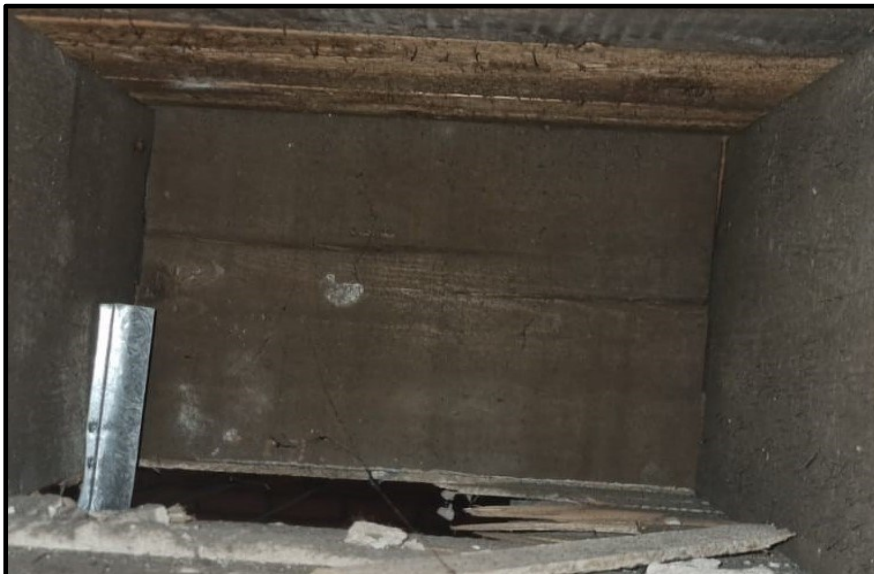
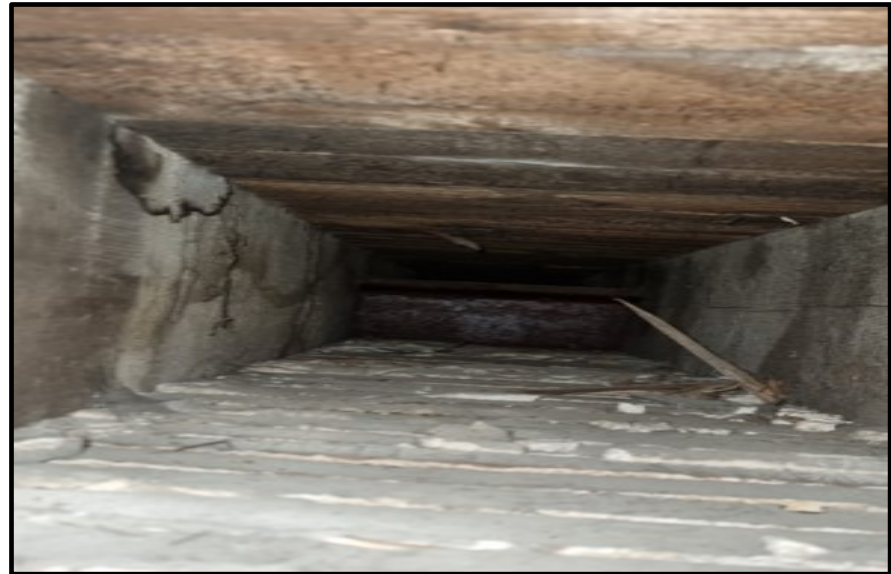
Upon removal of the underpinned modern board this uncovered historic penetrations for services and failed sections lath and plaster. Upon inspection above these (where possible without causing further damage to L&P) further asbestos contamination has been identified as shown below;

*Insulation debris to lath, damaged encasement/moulding to steel work adjacent penetration, residual insulation to beam, general photo of void*

As asbestos materials have been identified within void area and to the surrounding high-level surfaces this would not have been the substrate for original installation and evidence of migration either at the point of installation or subsequent removal. Asbestos removal regulations did come into force until 1983 so any historic maintenance activity or M&E upgrade would very likely have not considered any asbestos control measures.

If lath and plaster ceiling is not granted consent to be removed in full this will have implications for sign off for at stage 2 (visual inspection) and stage 3 (disturbance air test) which will result in the University receiving a clearance certificate with caveats that states that contamination remains to high level. The area cannot be signed off until the air test is below the required limit of detection (0.01f/ml) with the known contamination present above the void and open penetrations in place these will require sealing to pass the required air test.

These penetrations and openings will require sealing with a suitable material for segregation, commonly across the industry when this situation occurs the materials utilised are a modern fibreboard or Rockwell fire batt. This will hinder any future maintenance activities just as the boiler replacement scheme which is currently been designed as any activities to high level will require a licensed asbestos contractor to complete these work and as thermal Insulation is a notifiable material this requires 14 days notification to the HSE before any works can take place. To prevent exposure to others during these maintenance tasks the future occupiers of the basement area will not be allowed to be present during the duration of these works.

The only option to remove all caveats and ensuring a satisfactory air test for future occupation is the full removal and decontamination of the existing Lath & Plaster ceiling and subsequent void, this will also prevent any legacy of risk for the university to manage and will not hinder or suppress any future projects when upgrading Righton and preserving this buildings longevity.

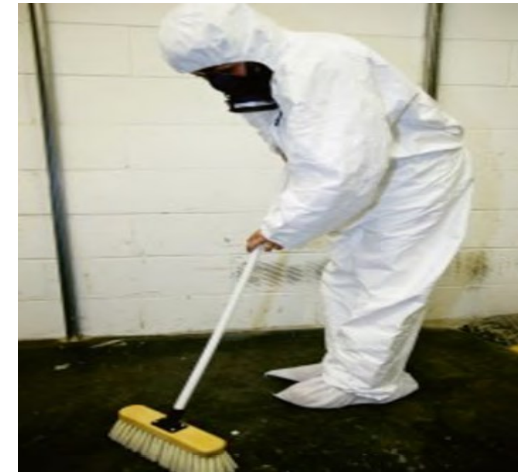
The monitoring is accompanied by activities which raise dust from the surfaces to a level consistent with normal ambient use of the area and possible future work activities. This activity during stage 3 involves a simulated brush disturbance to create this level of airborne particles. This involves all surfaces and services to be subjected to this type of disturbance. See figure adjacent as an example.
