# LIGHTING VERIFICATION REPORT

West Didsbury & Chorlton AFC, Manchester

Document No. 22/074/LR/02

December 2021

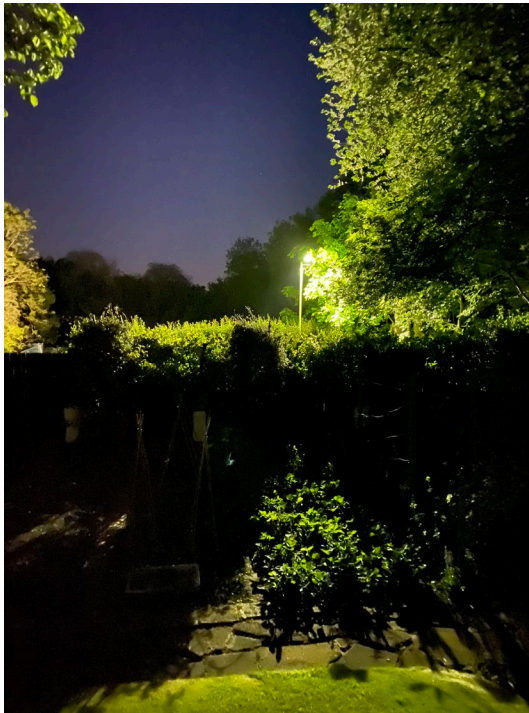
Fig A – Original Photograph of Luminaire (Obtained from Report 22/074/LS/01/B)

*In particular, one floodlight is angled towards the entrance gate; this also causes high amounts of glare into a neighbouring house. It is noted that the illuminance readings within the garden do not exceed the planning maximum value of 10 lux during curfew times. Post curfew, the illuminance levels are exceeded.*

The photo identified in Fig a, shows the level of intrusive light by the beam direction of the lighting and shadowing of the surrounding area within the garden. Original test result identified the lighting measurement results did not exceed the 10-lux pre-curfew but did exceed the 2-lux post curfew allowance, it was also noted that glare into the garden was causing issues.

*It has been determined that the obtrusive light can be nullified by angling the luminaire more towards the gate and introducing a shield to block the light entering the garden. Photographs of the intrusive light are detailed on the layout drawing appended to this report. (Appendix B)'*

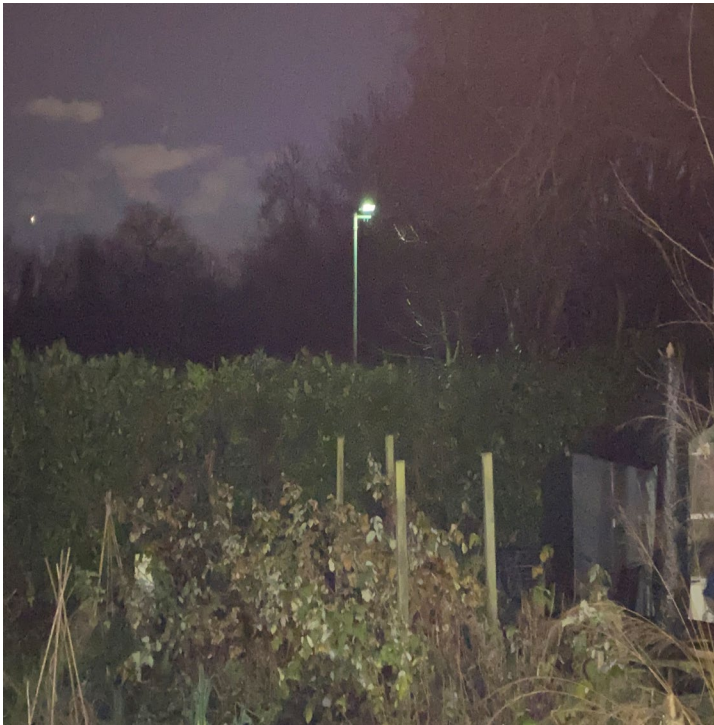
Fig B – Luminaire Position (Photo Obtained 01/12/2021)

Under the initial inspection it was noted that the luminaire angle has now been adjusted by approximately 20 Degrees down, and re-orientated to ensure the light beam is directed towards the entrance way.

Fig B shows the new angle of the luminaire with no noticeable beam moving passed the hedgerow into the garden.

It was confirmed via measurement that with the column lighting on the illuminance within the garden does not exceed the 2-lux post curfew limit, ECS also received confirmation from the property owner that the glare issue has been eliminated.

Following this, the club implemented the recommended works by adjusting the angle of the luminaire to direct all lighting to the entrance, in doing so it was envisaged the intrusive light would no longer cause issues into the neighbouring properties.
