## Phase IV Validation Completion Report

Prospect House School  
Blackley

Reference: 30186-SUT-ZZ-00-RP-G-704-0001

Date: January 2022

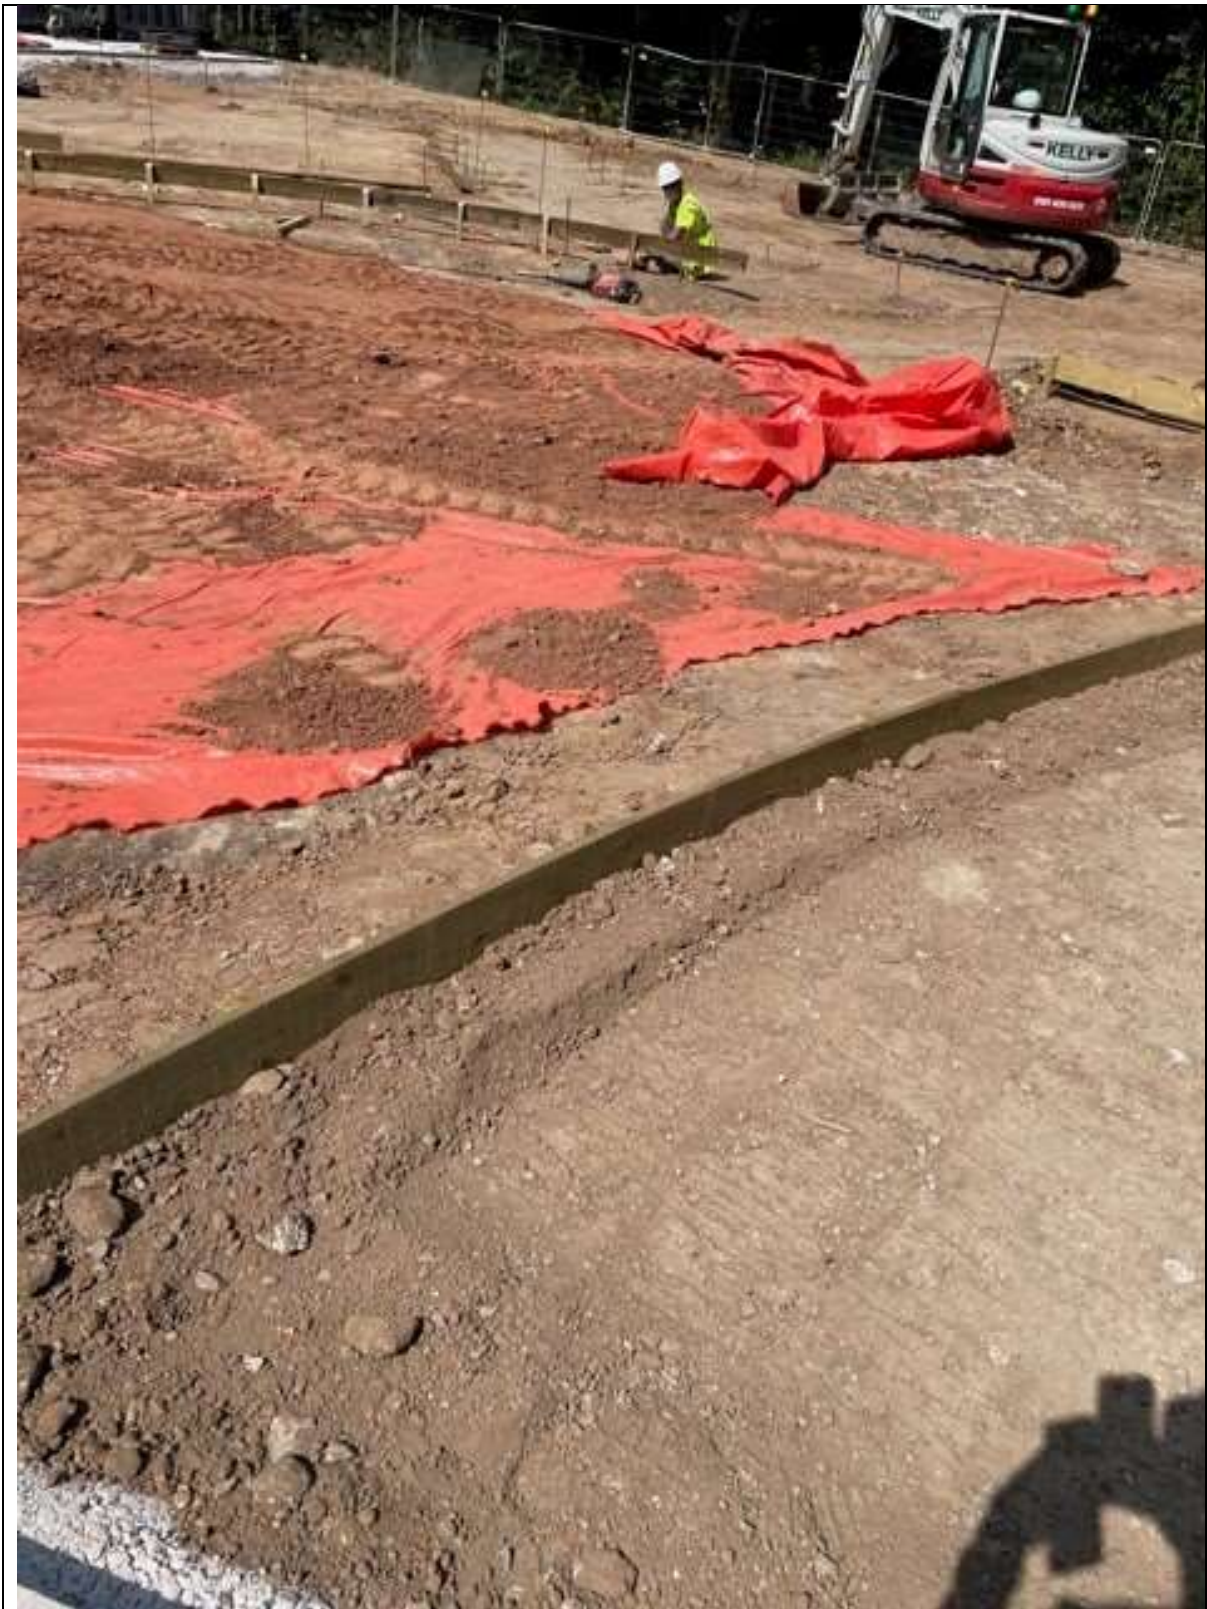
Plate 1: View showing the installation of the geotextile membrane beneath the landscaped areas.

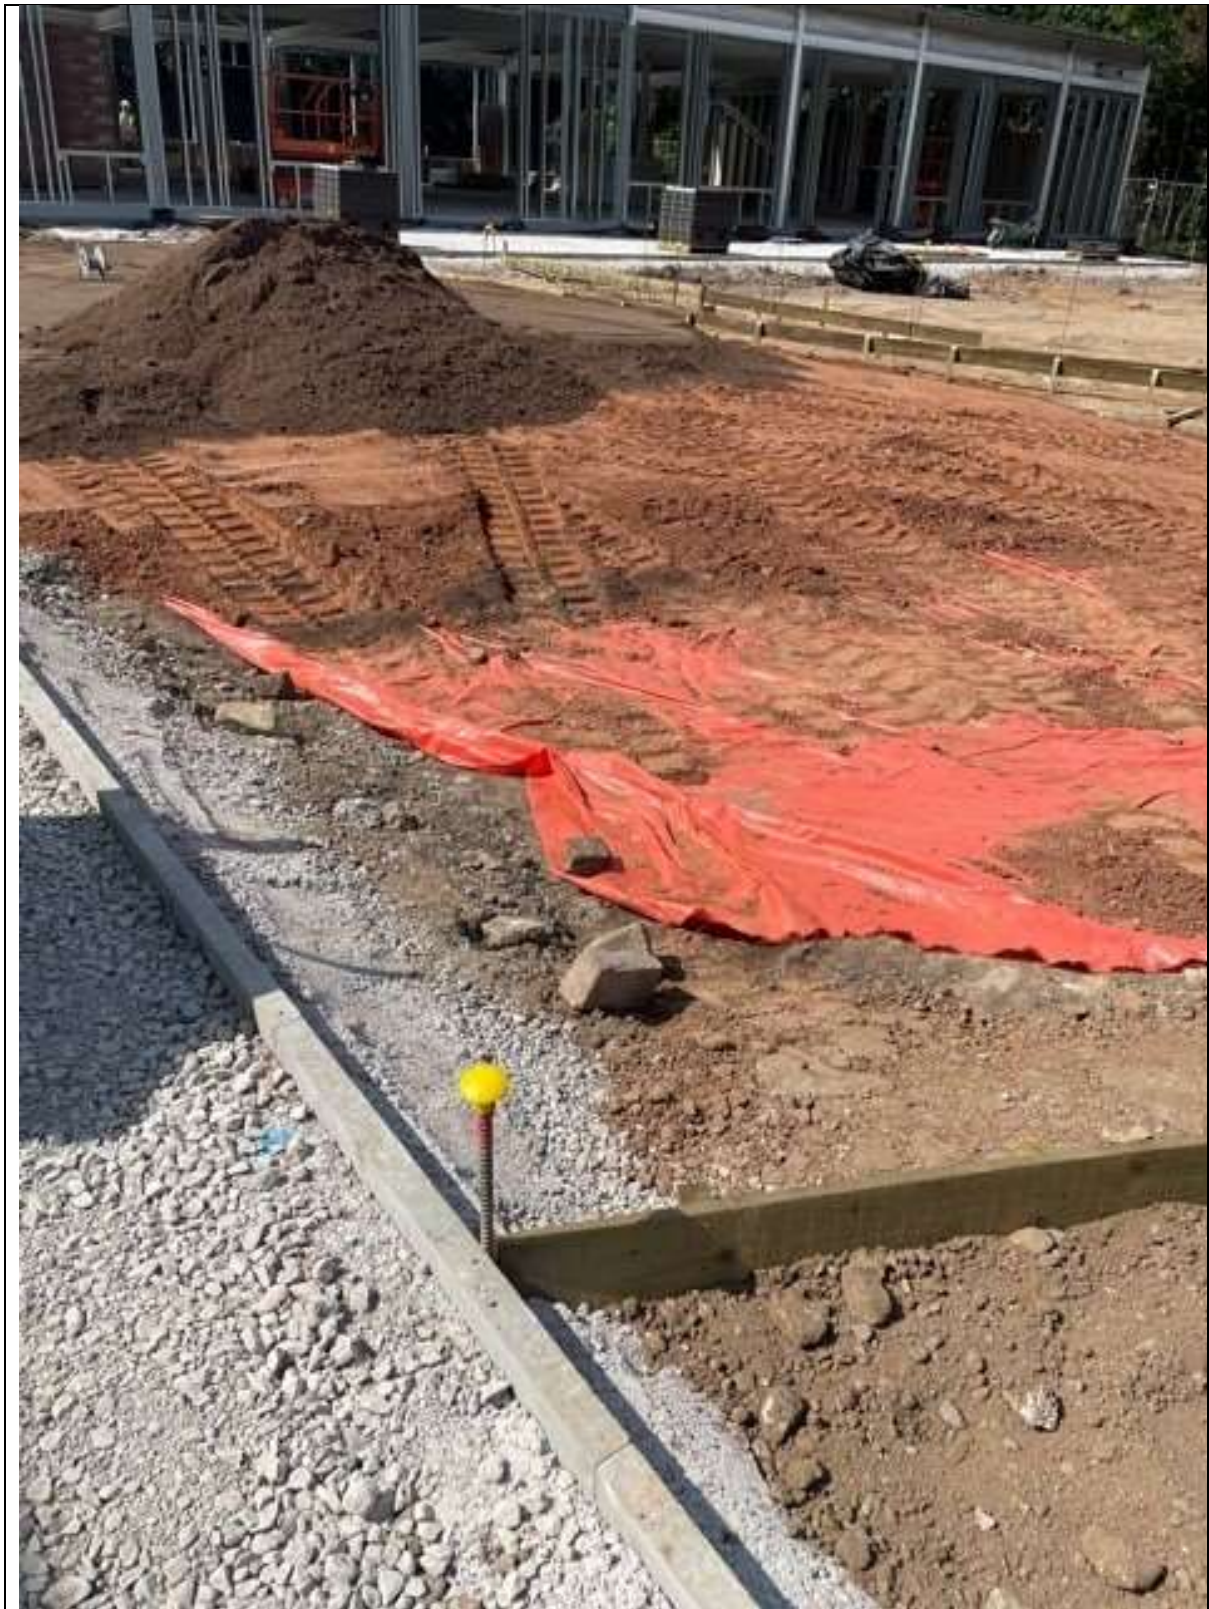
Plate 2: View showing the installation of the geotextile membrane beneath the landscaped areas.

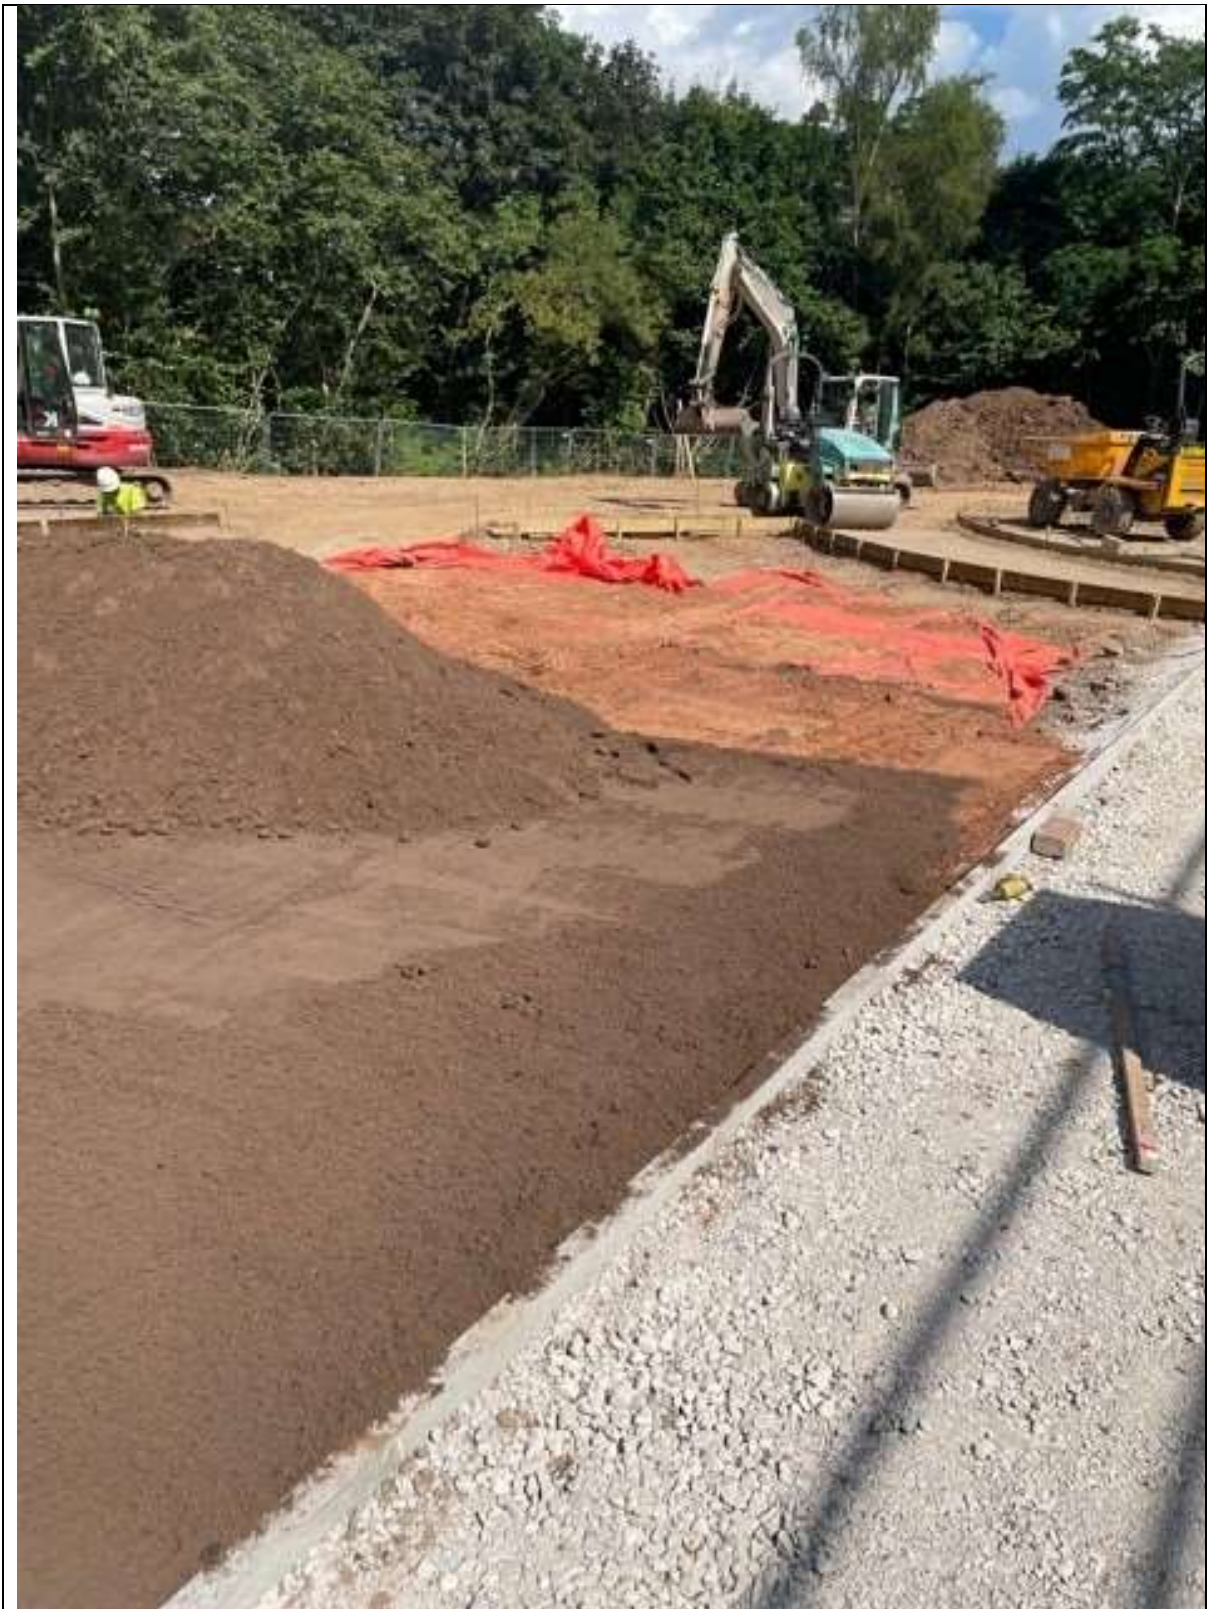
Plate 3: View showing the installation of the geotextile membrane beneath the landscaped areas.

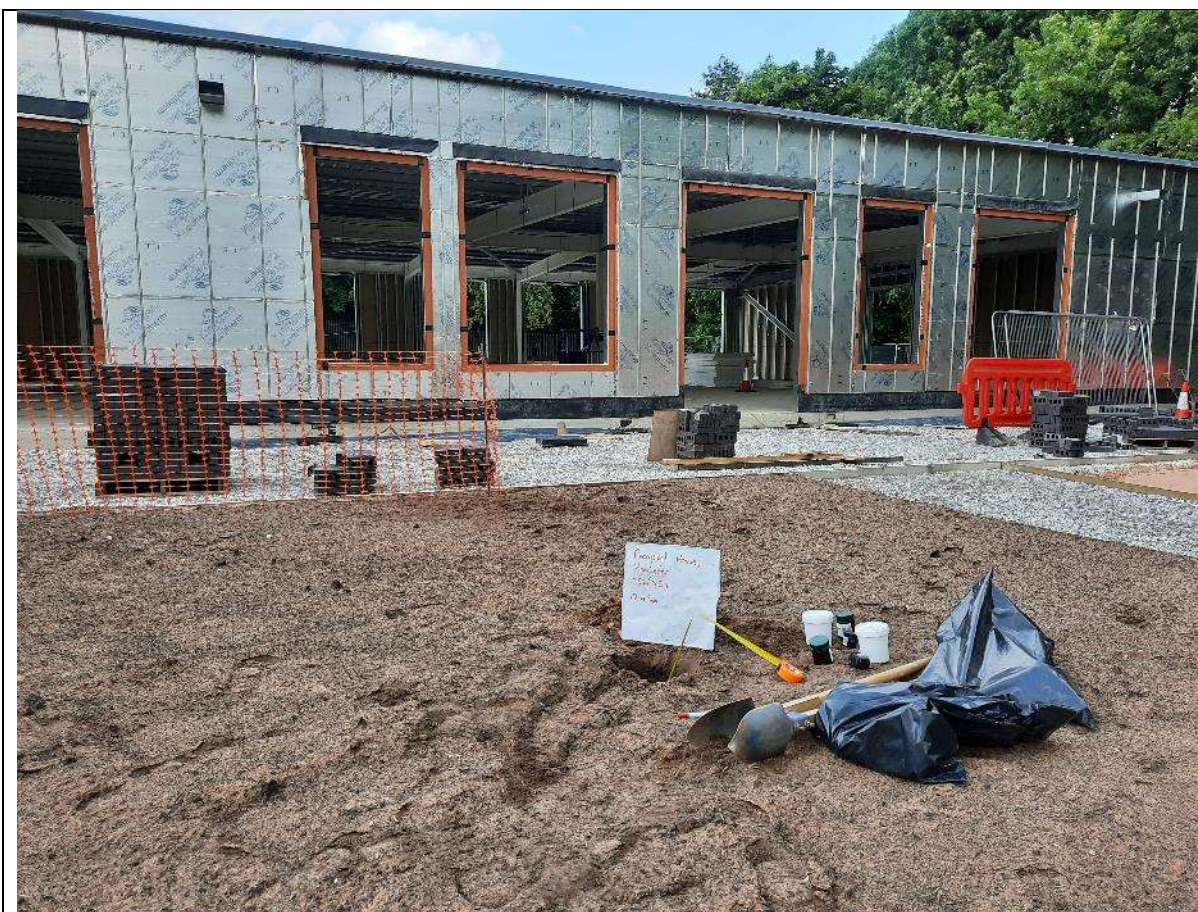
Plate 4: View showing location of depth validation pit for TS1/SS1.

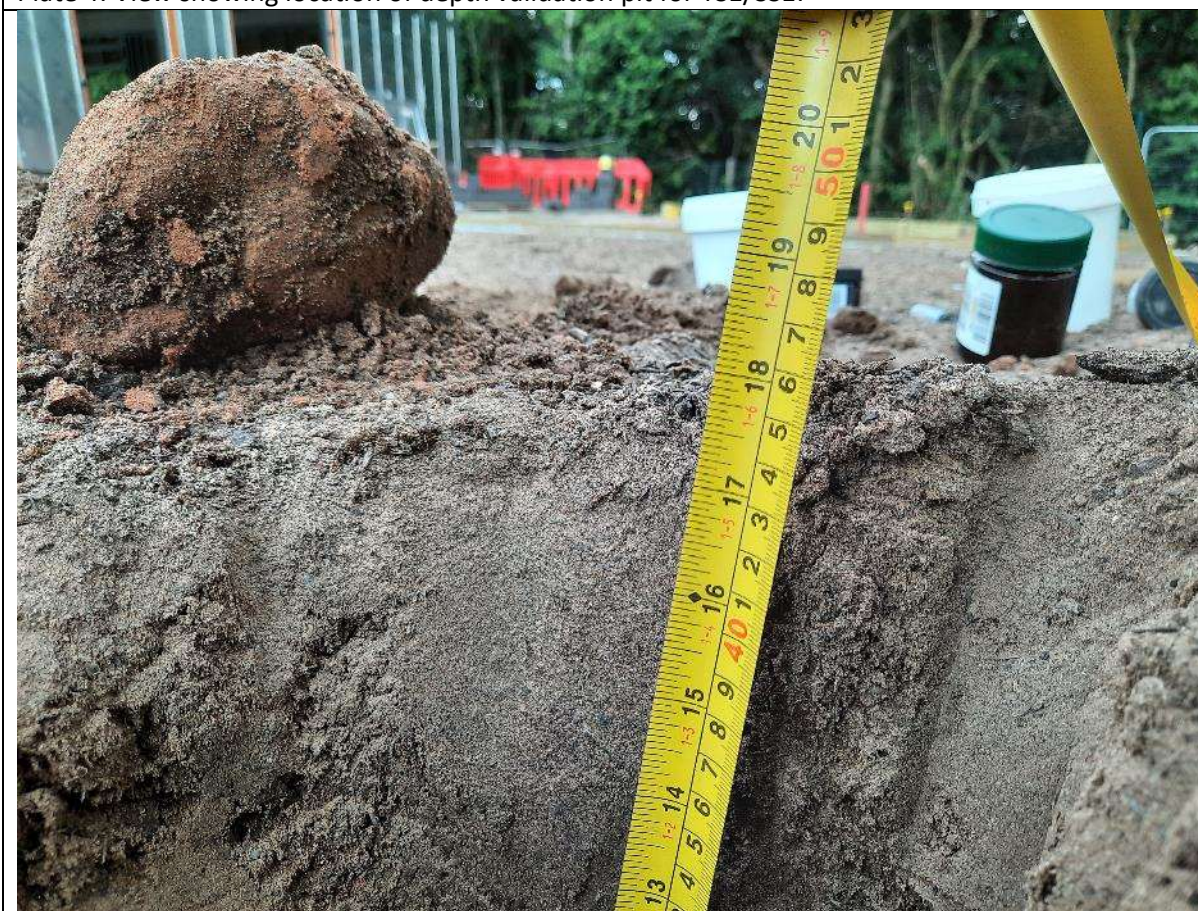
Plate 5: View showing depth of imported material at TS1/SS1.

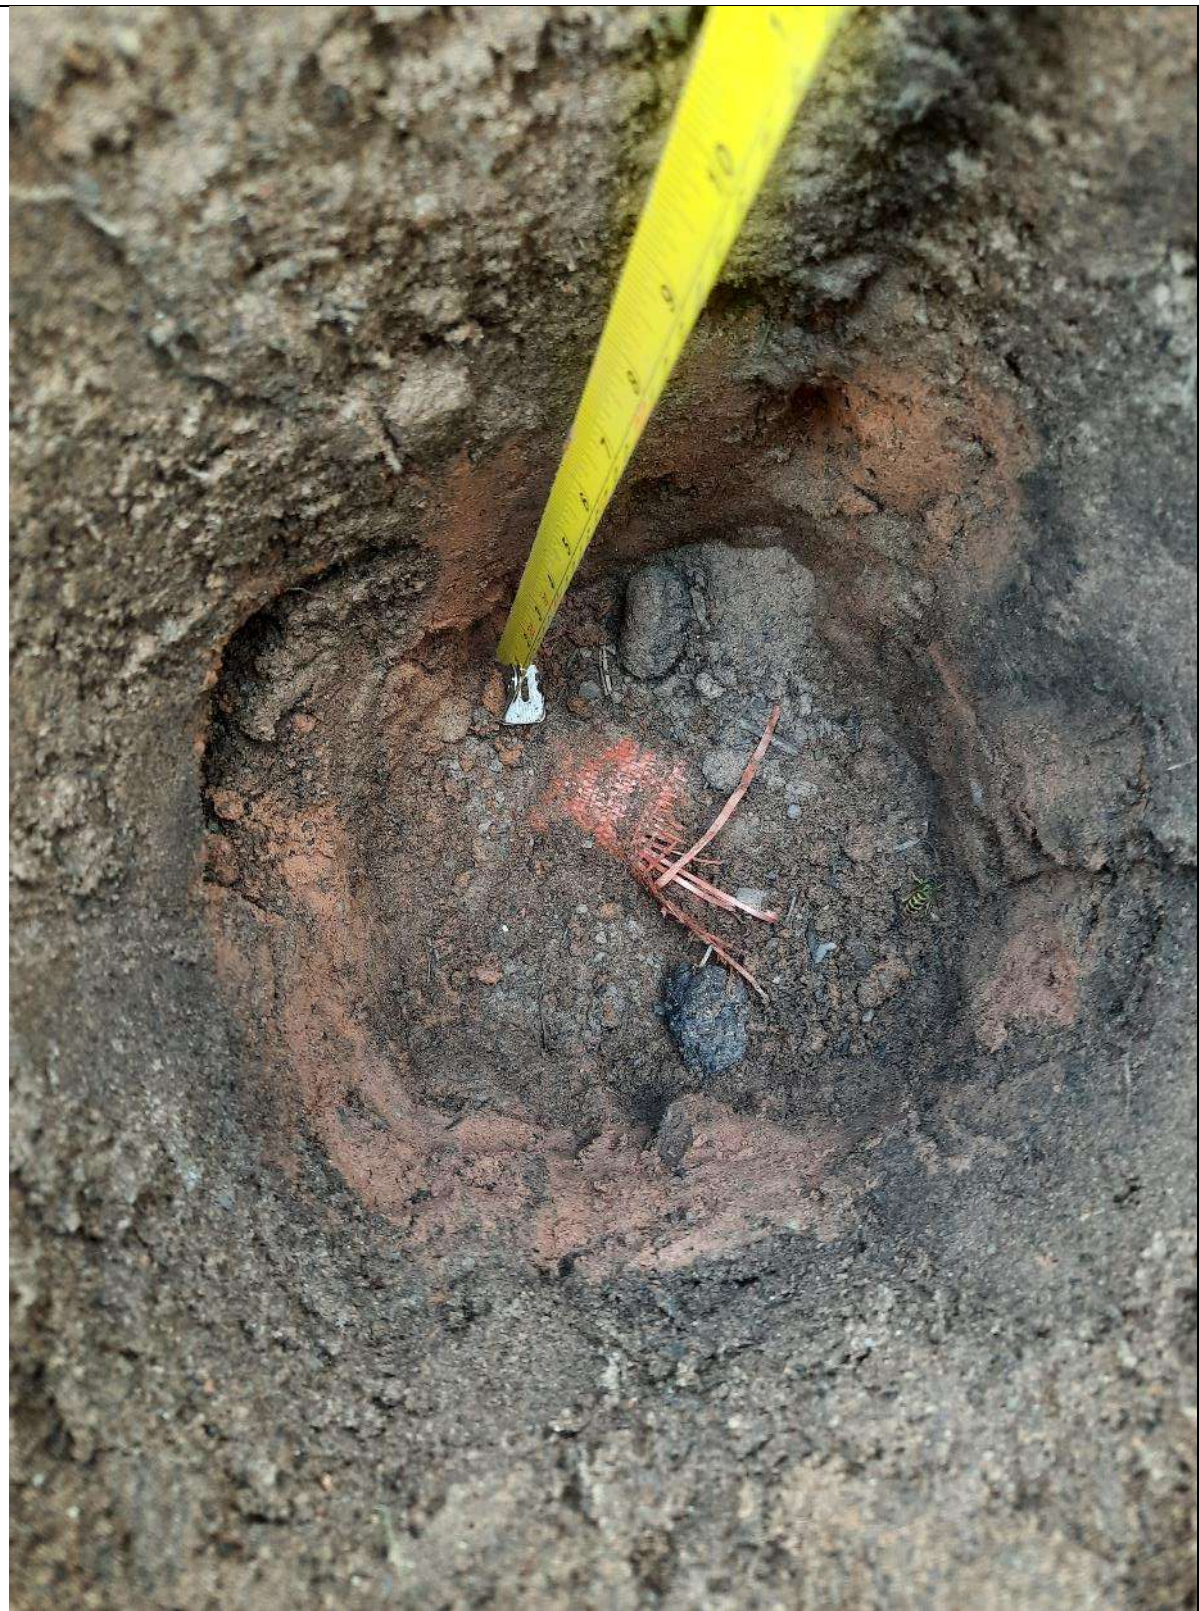
Plate 6: View down hole at TS1/SS1.

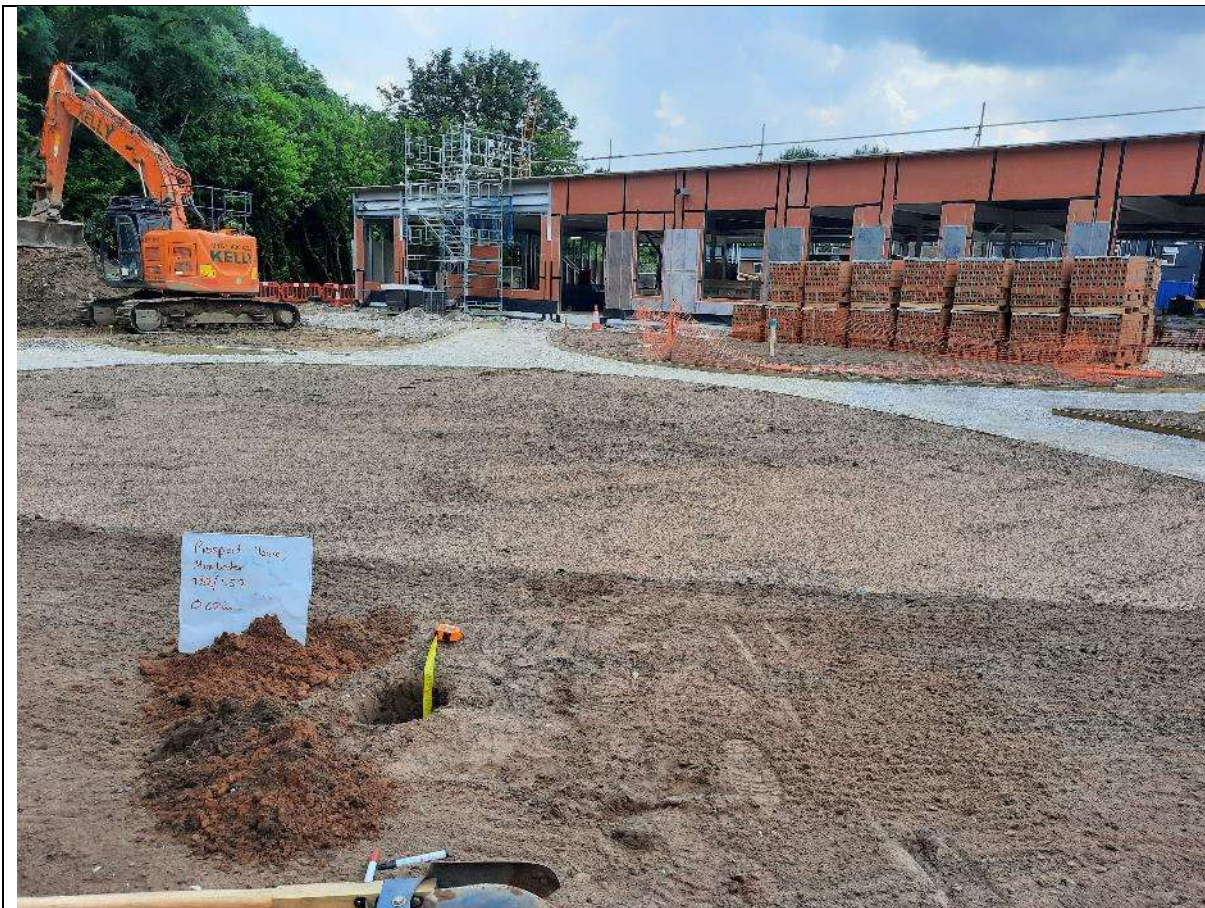
Plate 7: View showing location of depth validation pit for TS2/SS2.

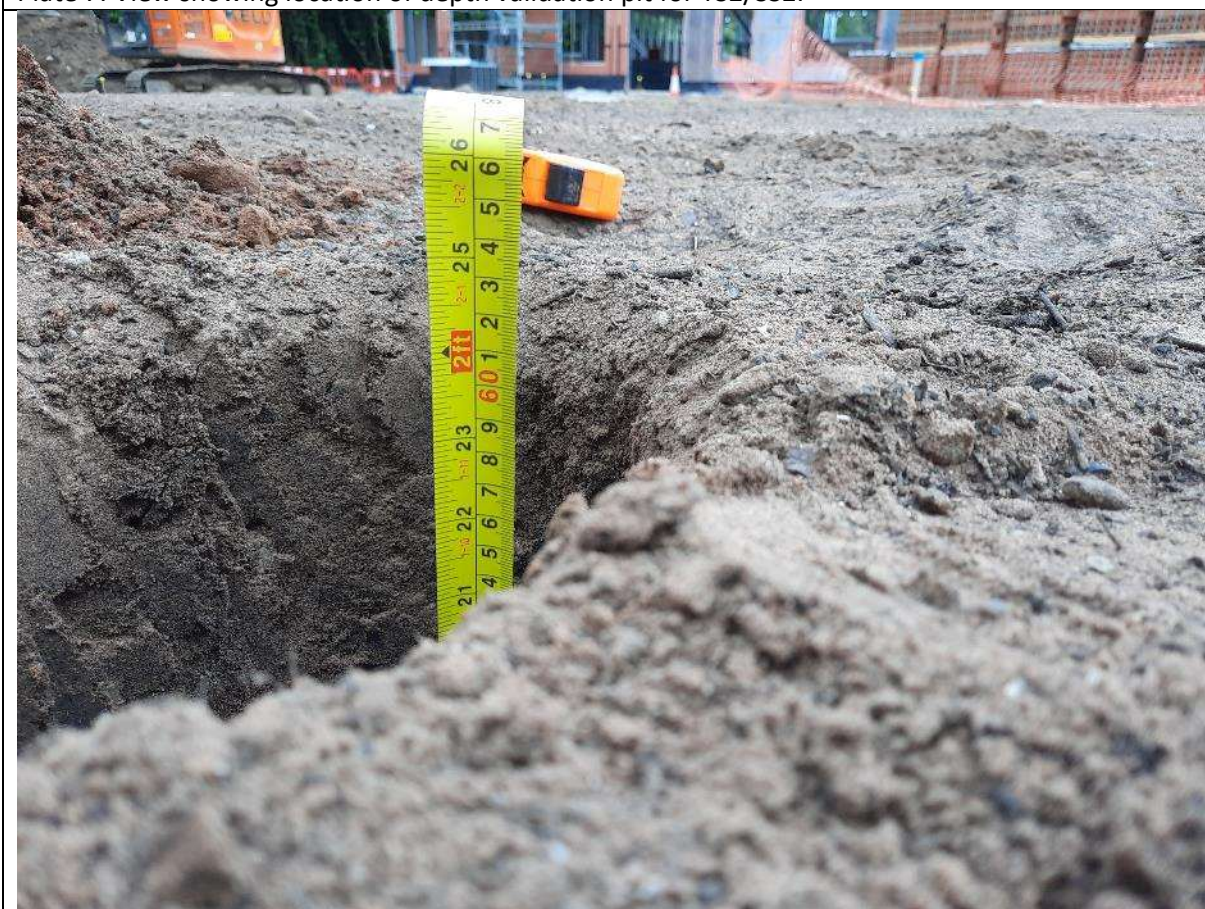
Plate 8: View showing depth of imported material at TS2/SS2.

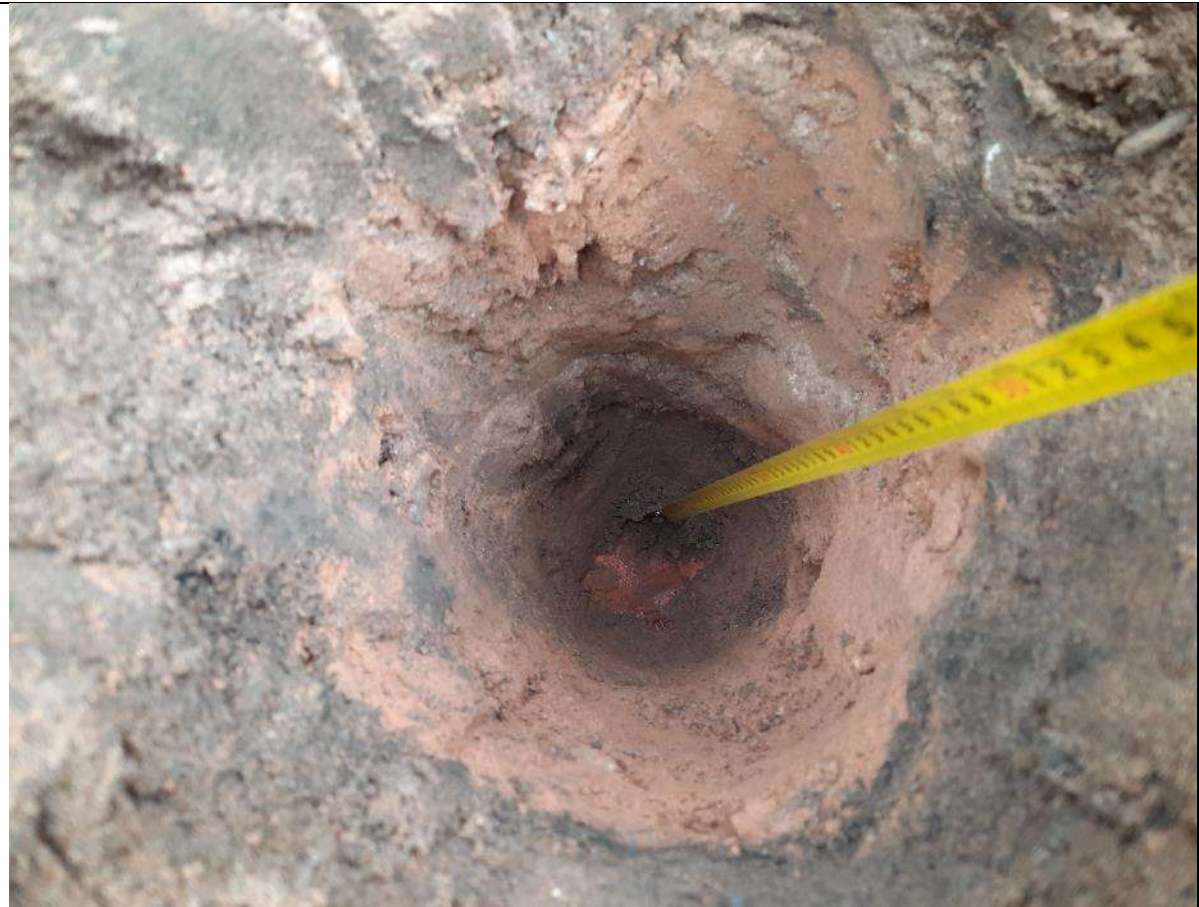
Plate 9: View down hole at TS2/SS2.

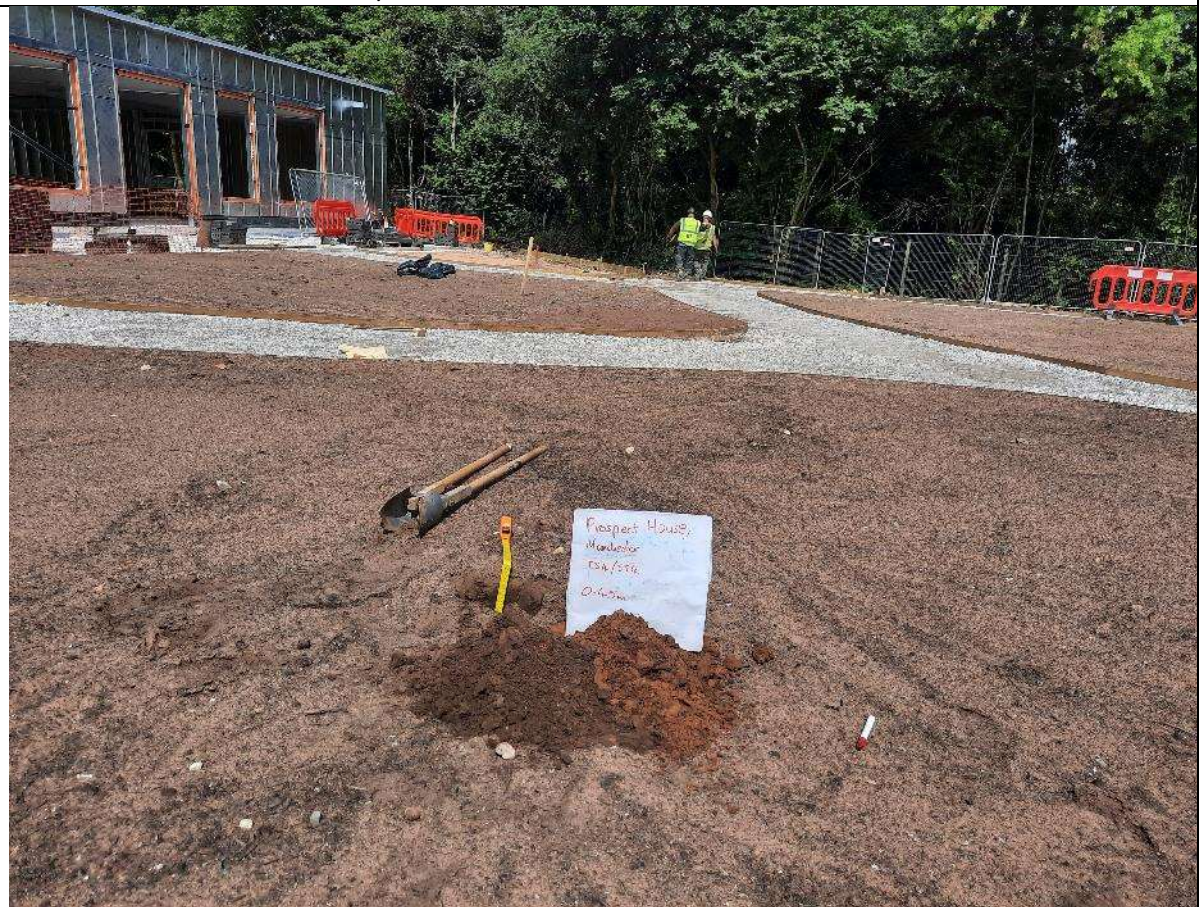
Plate 10: View showing location of depth validation pit for TS4/SS4.

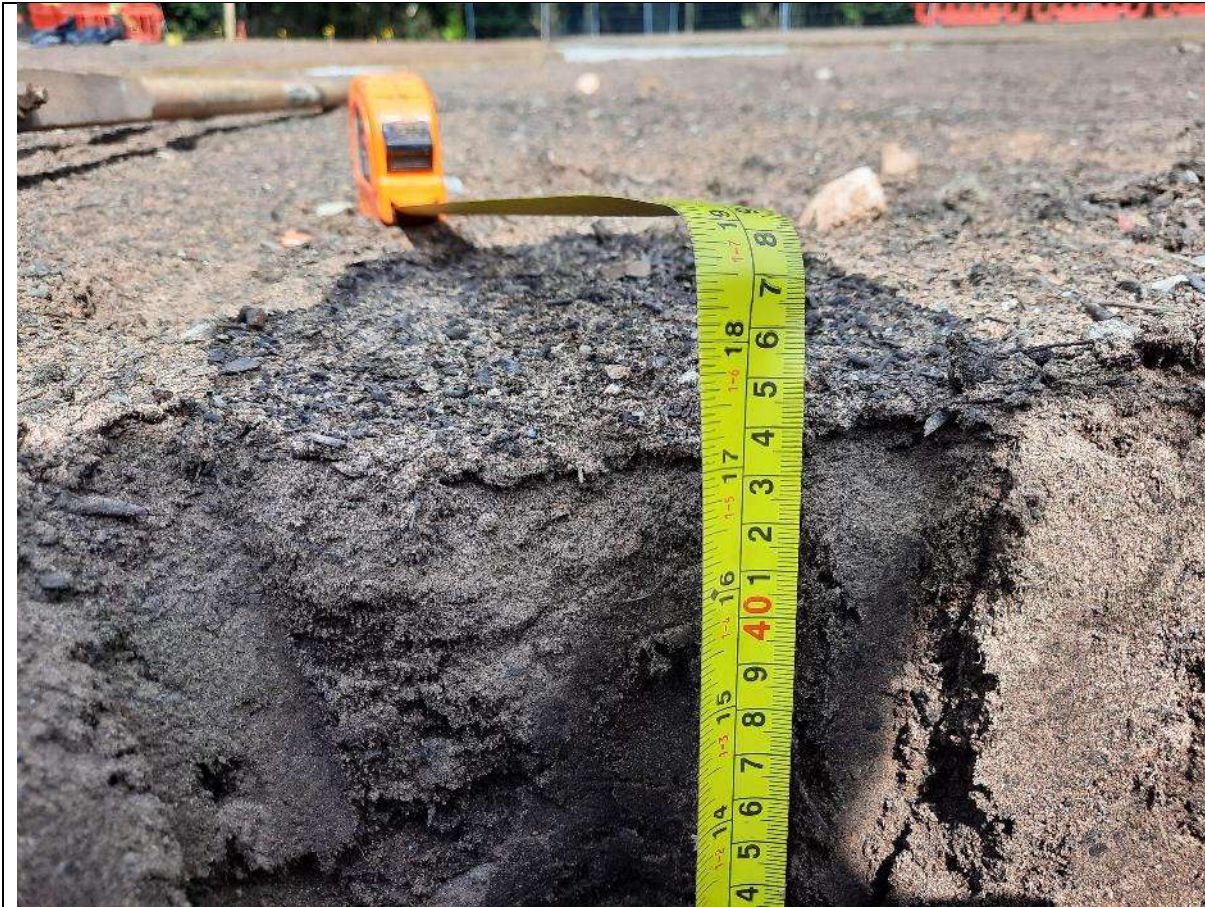
Plate 11: View showing depth of imported material at TS4/SS4.

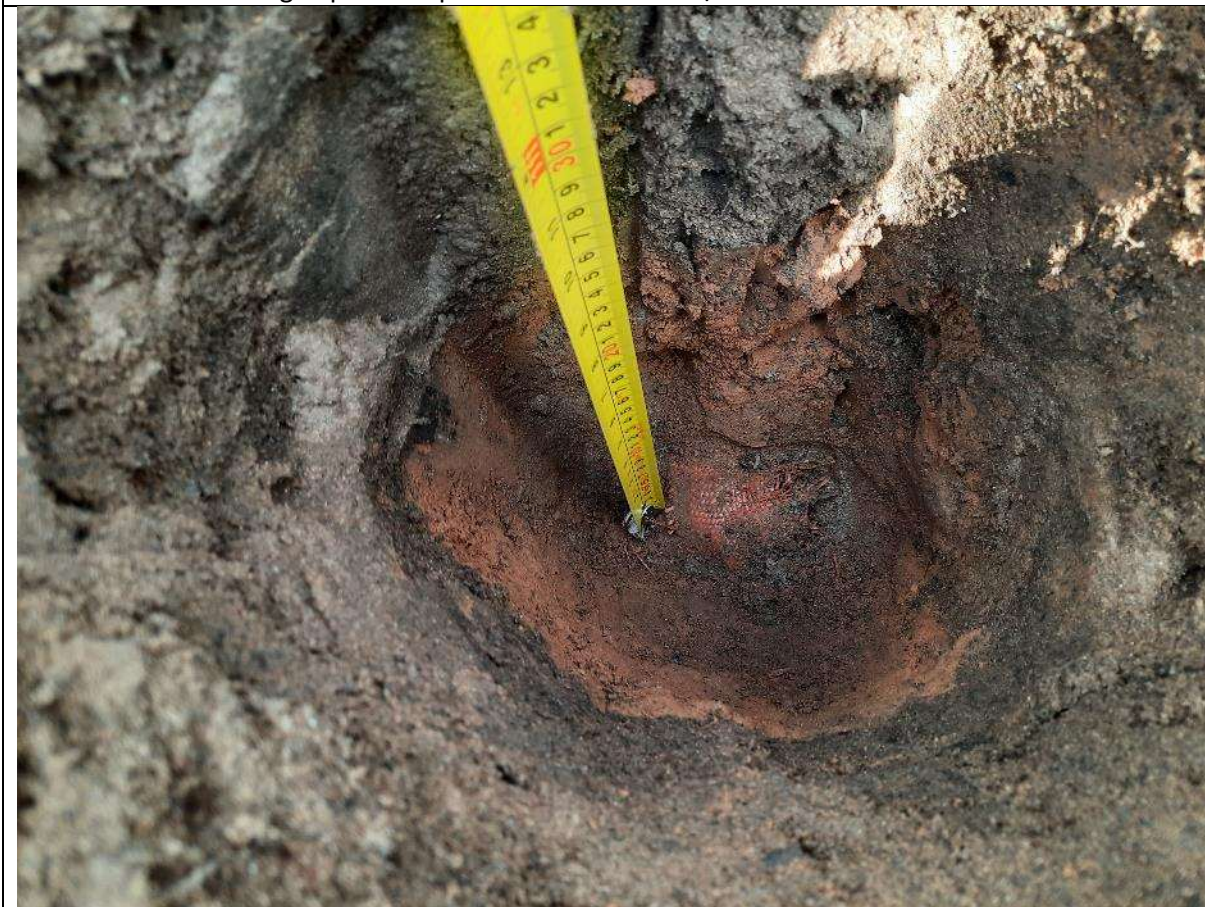
Plate 12: View down hole at TS4/SS4.

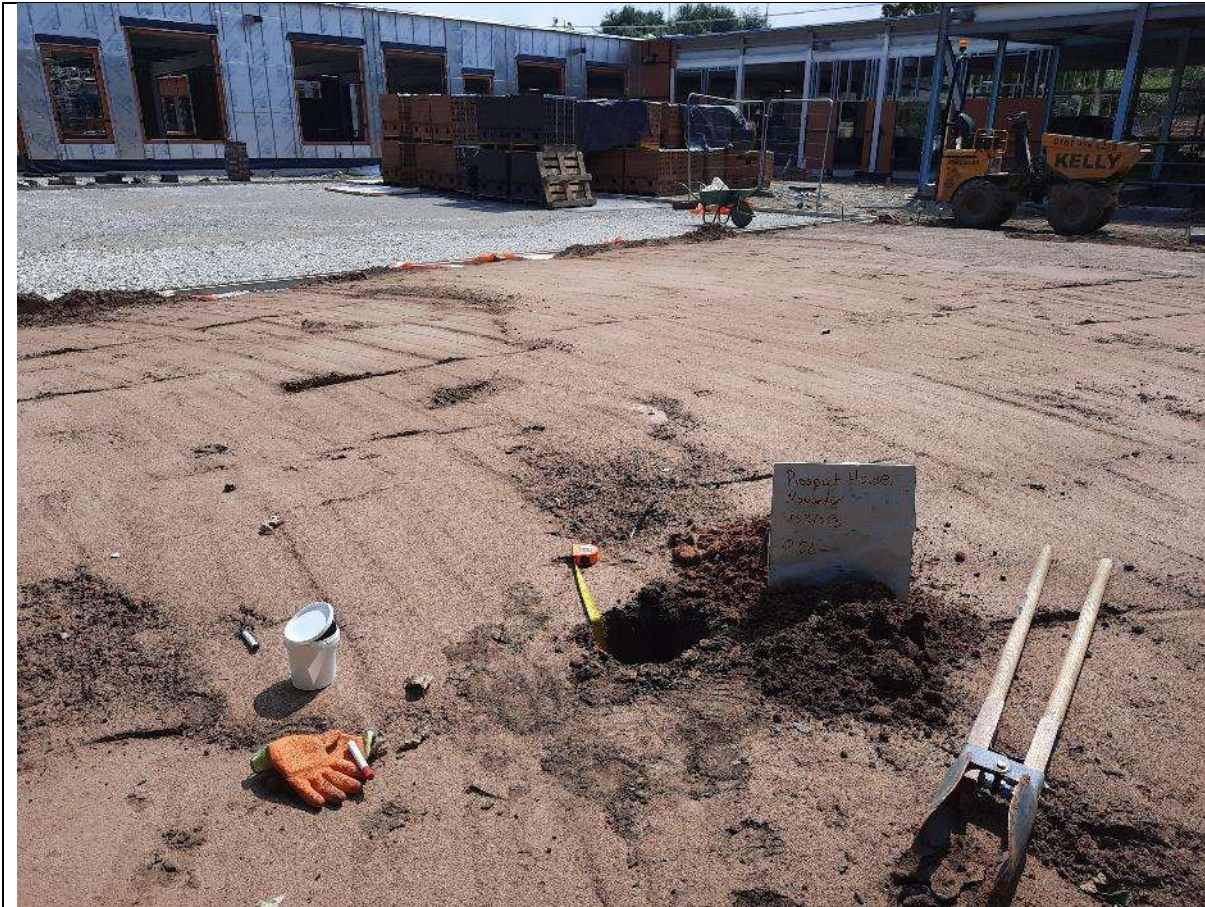
Plate 13: View showing location of depth validation pit for TS3/SS3.

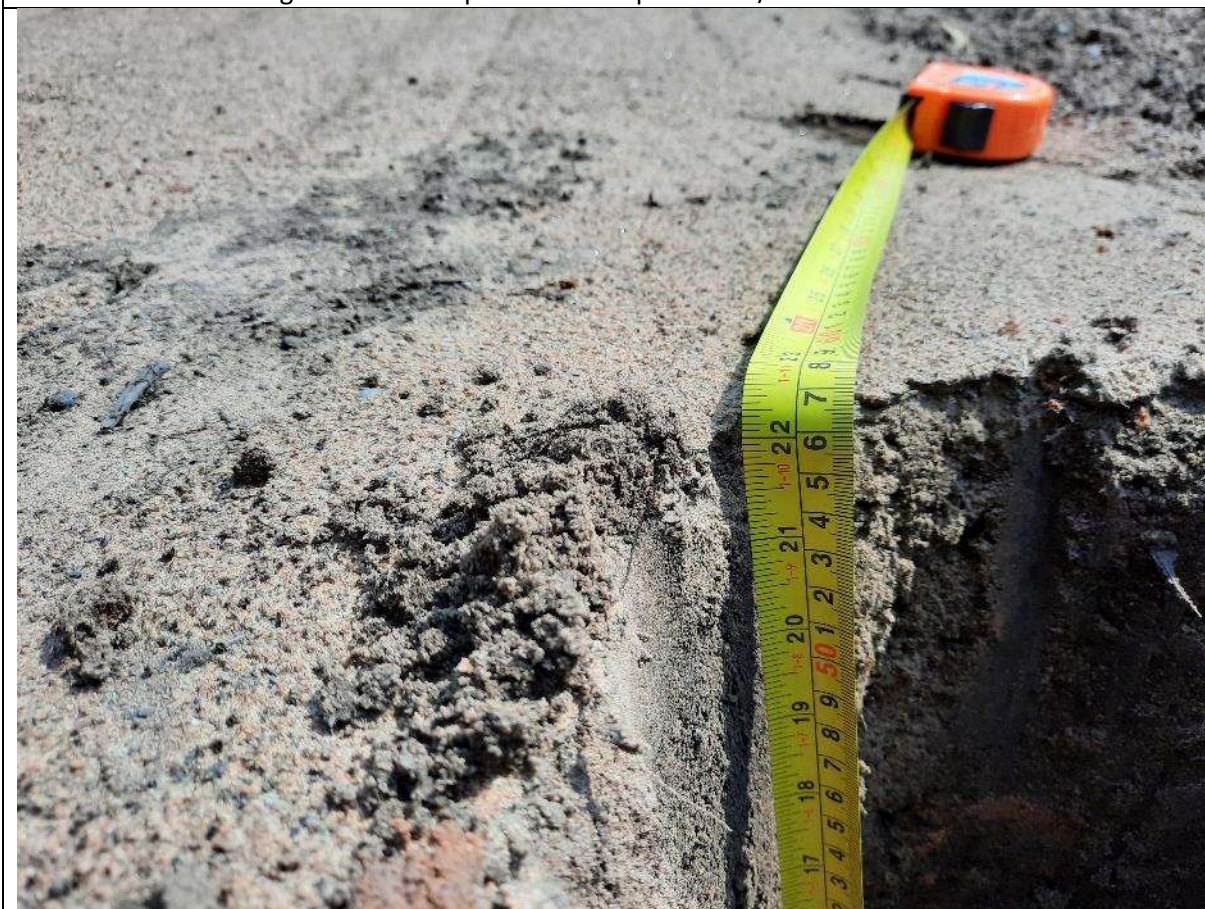
Plate 14: View showing depth of imported material at TS3/SS3.

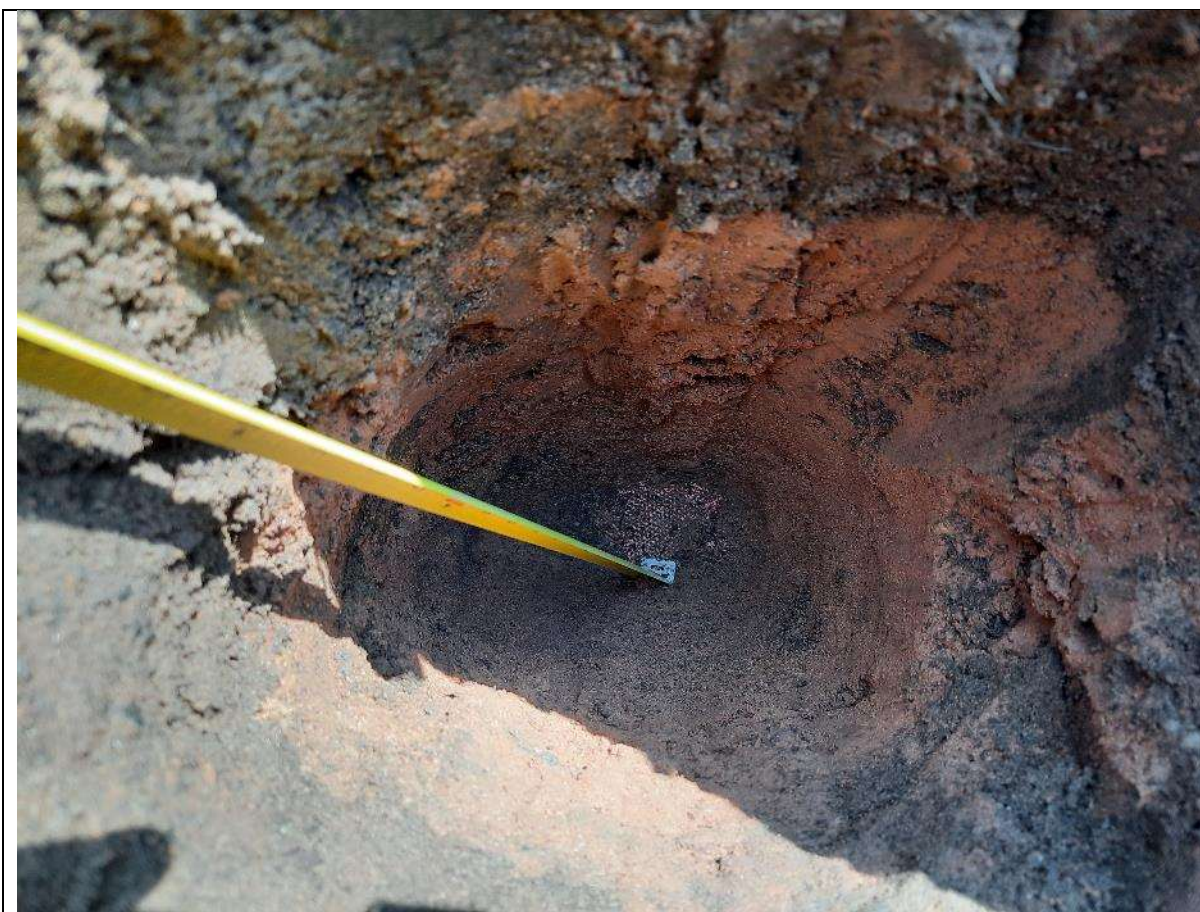
Plate 15: View down hole at TS3/SS3.

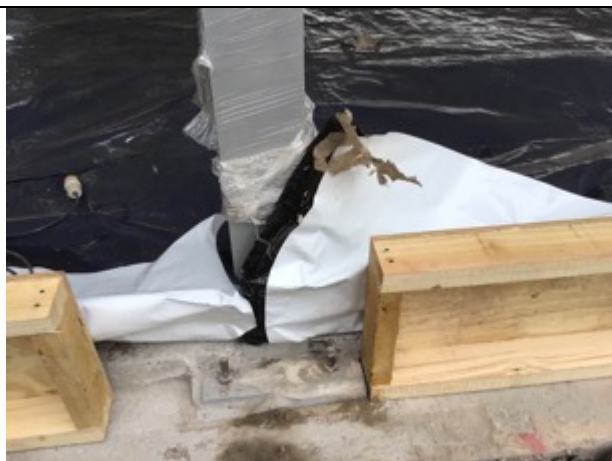
At the perimeter edge along gridline G, the membrane has been damaged during the installation of the timber shuttering and requires repairing, all other work in this area has passed inspection

Damage to perimeter edge

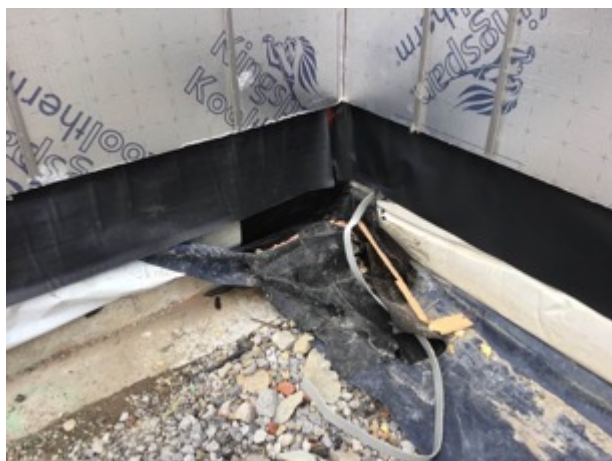
During our inspection the following defects and repairs were carried out: The stanchions have been sealed using SAGM, however, the membrane has been damaged (Repairs have successfully been carried out on 02/09/21 & 13/09/21)

Damage and unsealed in corner

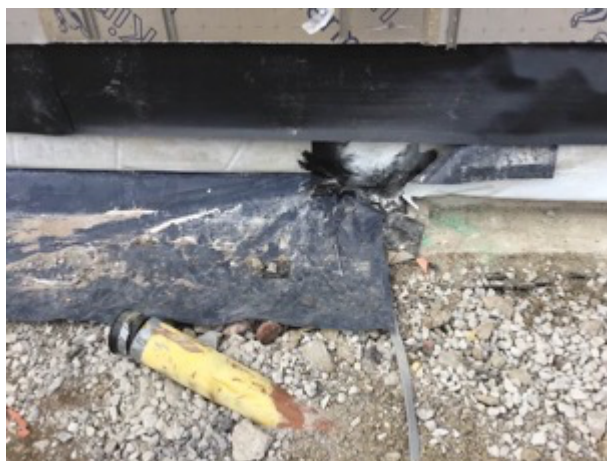
Membrane not joined

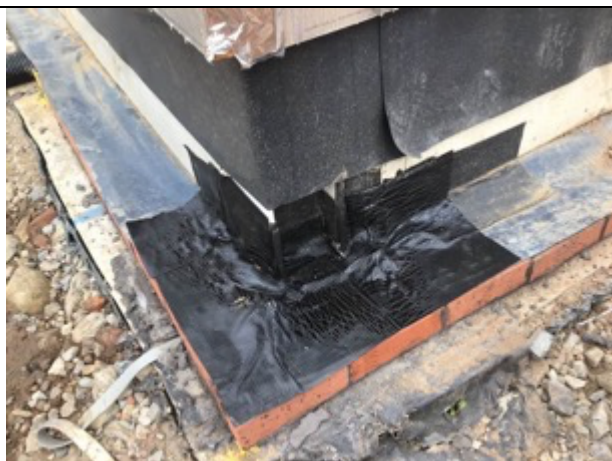
During our inspection the following defects and repairs were carried out: 93no repairs made by the installers using SAGM.

Perimeter corner repair

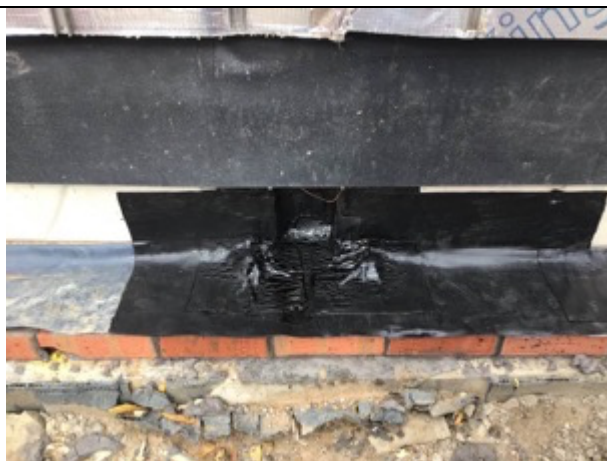
Perimeter steel repair

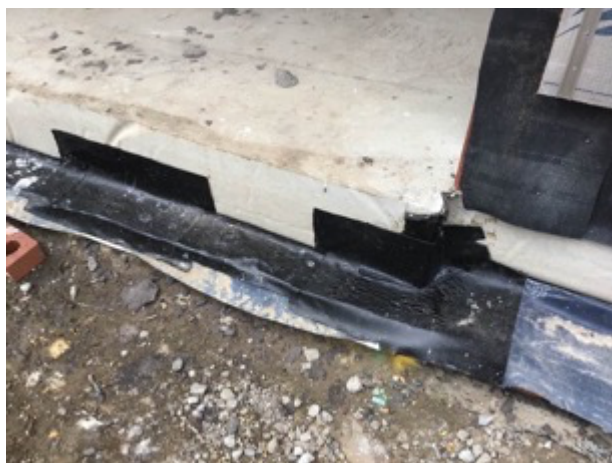
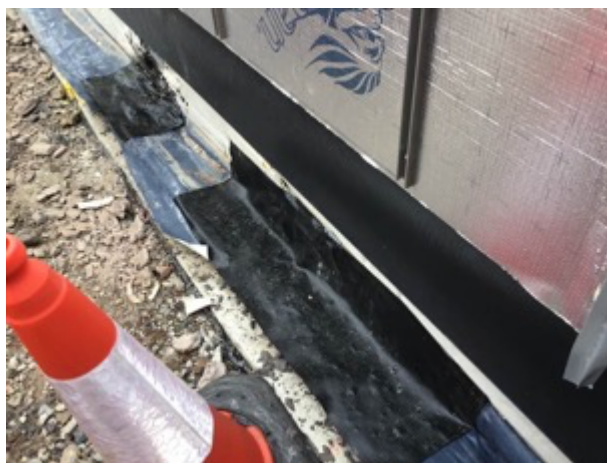
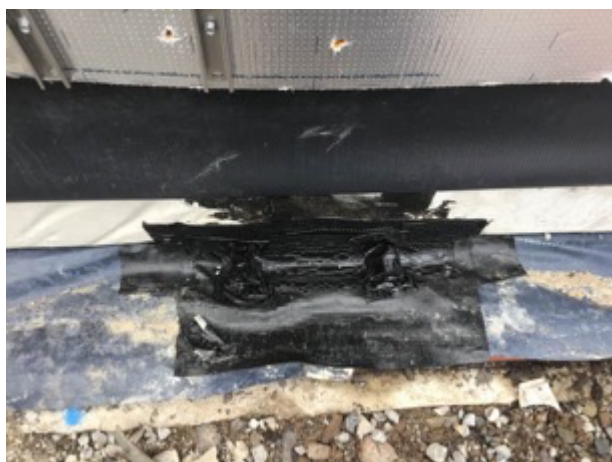
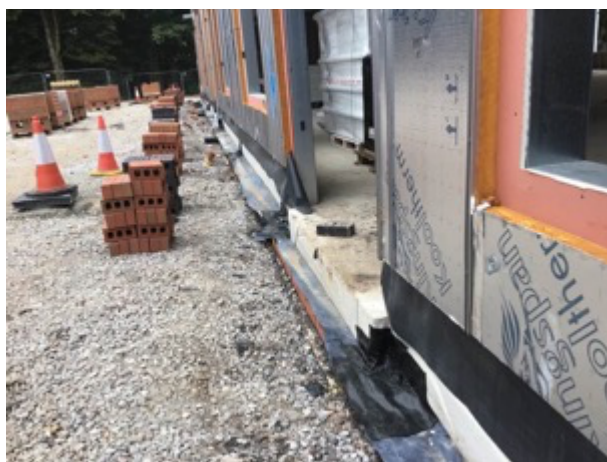
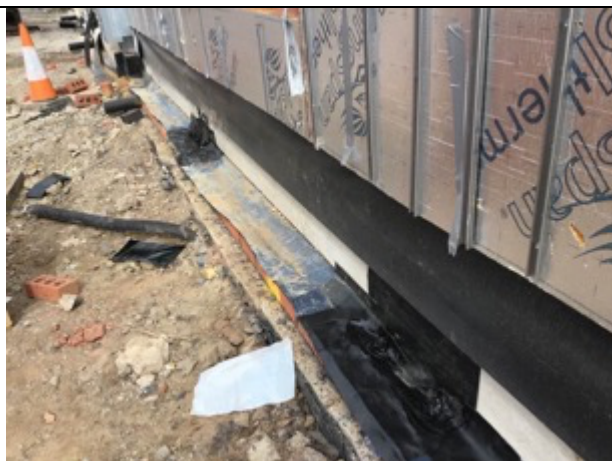
Perimeter repairs

Perimeter repair

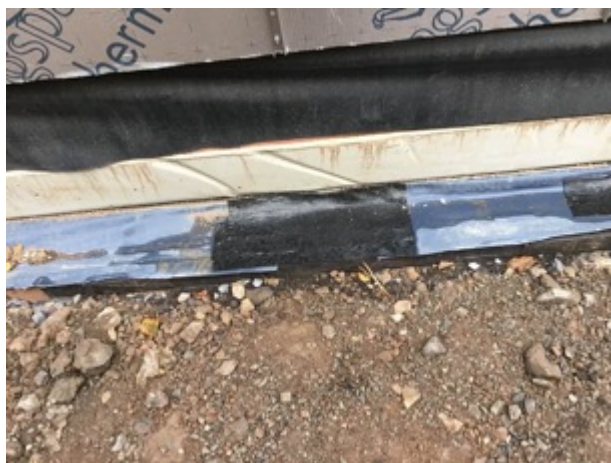
Patch repairs
