# MAG Building 401

Tree Survey Report

Project number: 60625935

August 2021

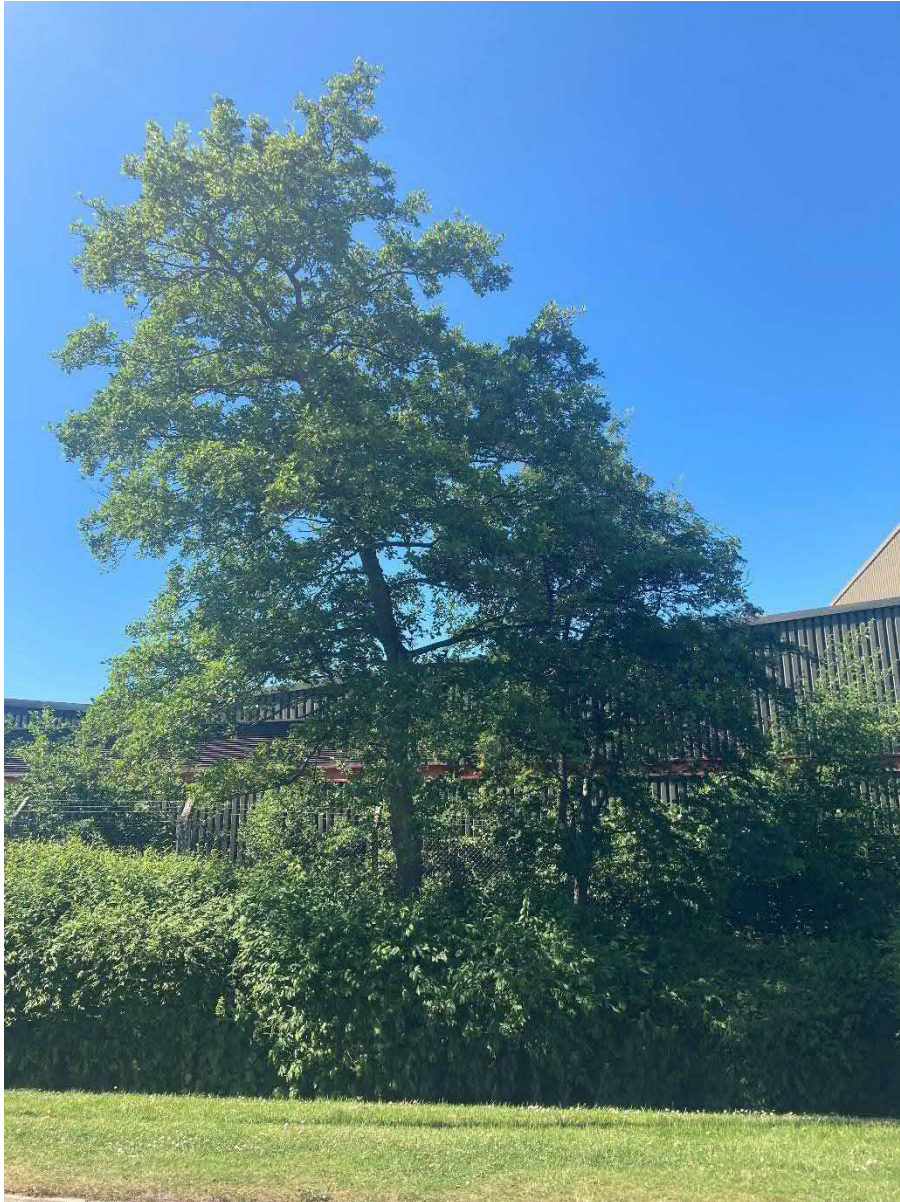
Picture 1 Planted trees within a hedgerow (T2 & T3)

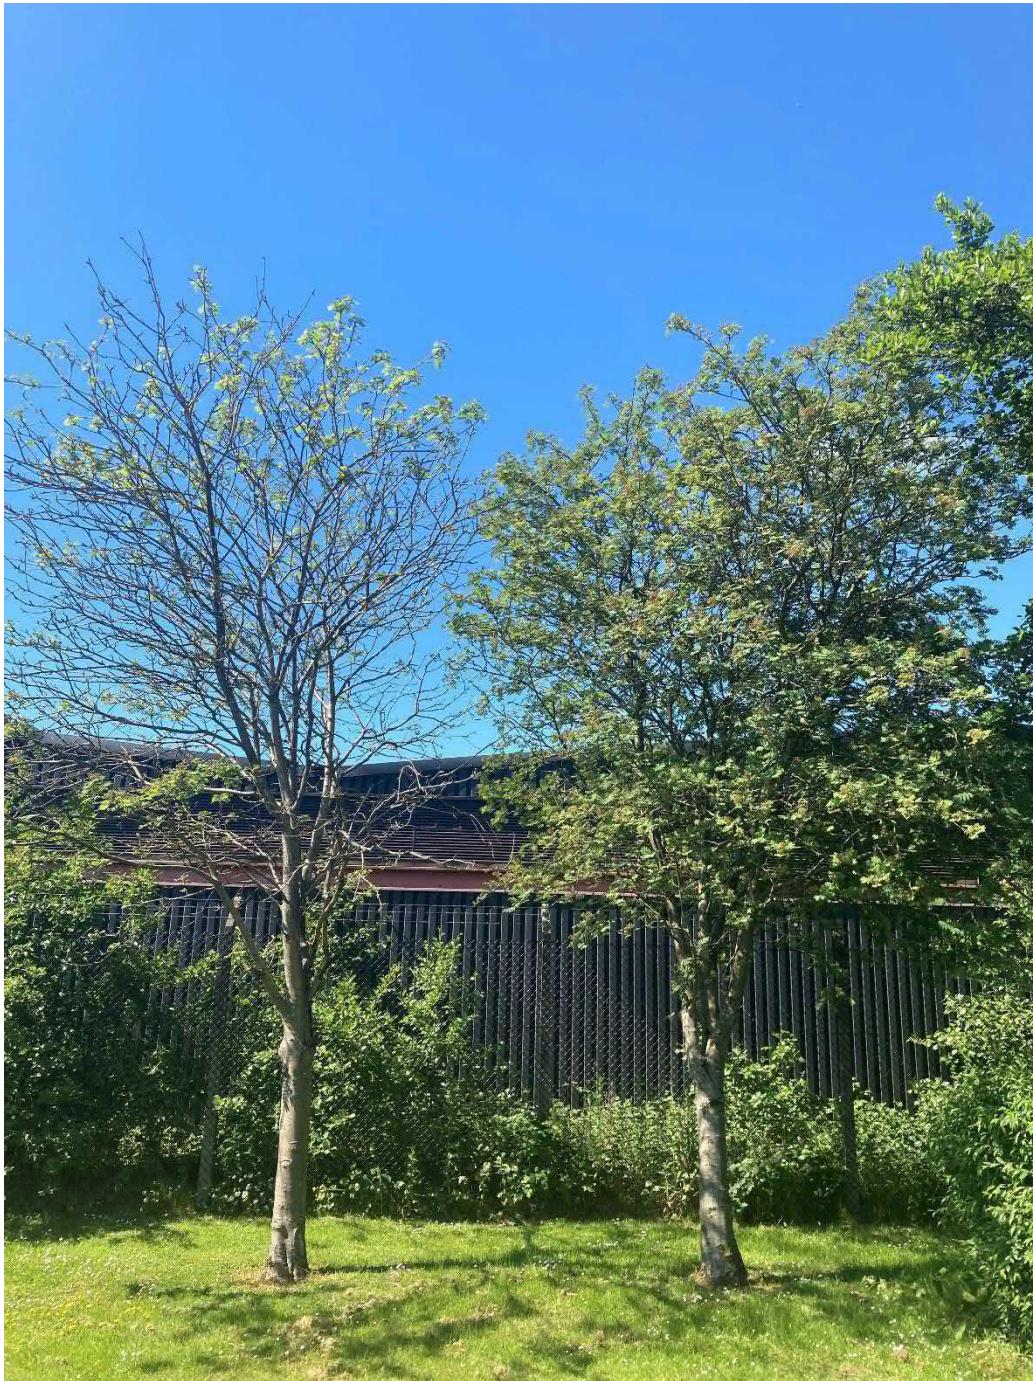
Picture 2 Planted rowan trees with T6 being in poor condition (T5 & T6)

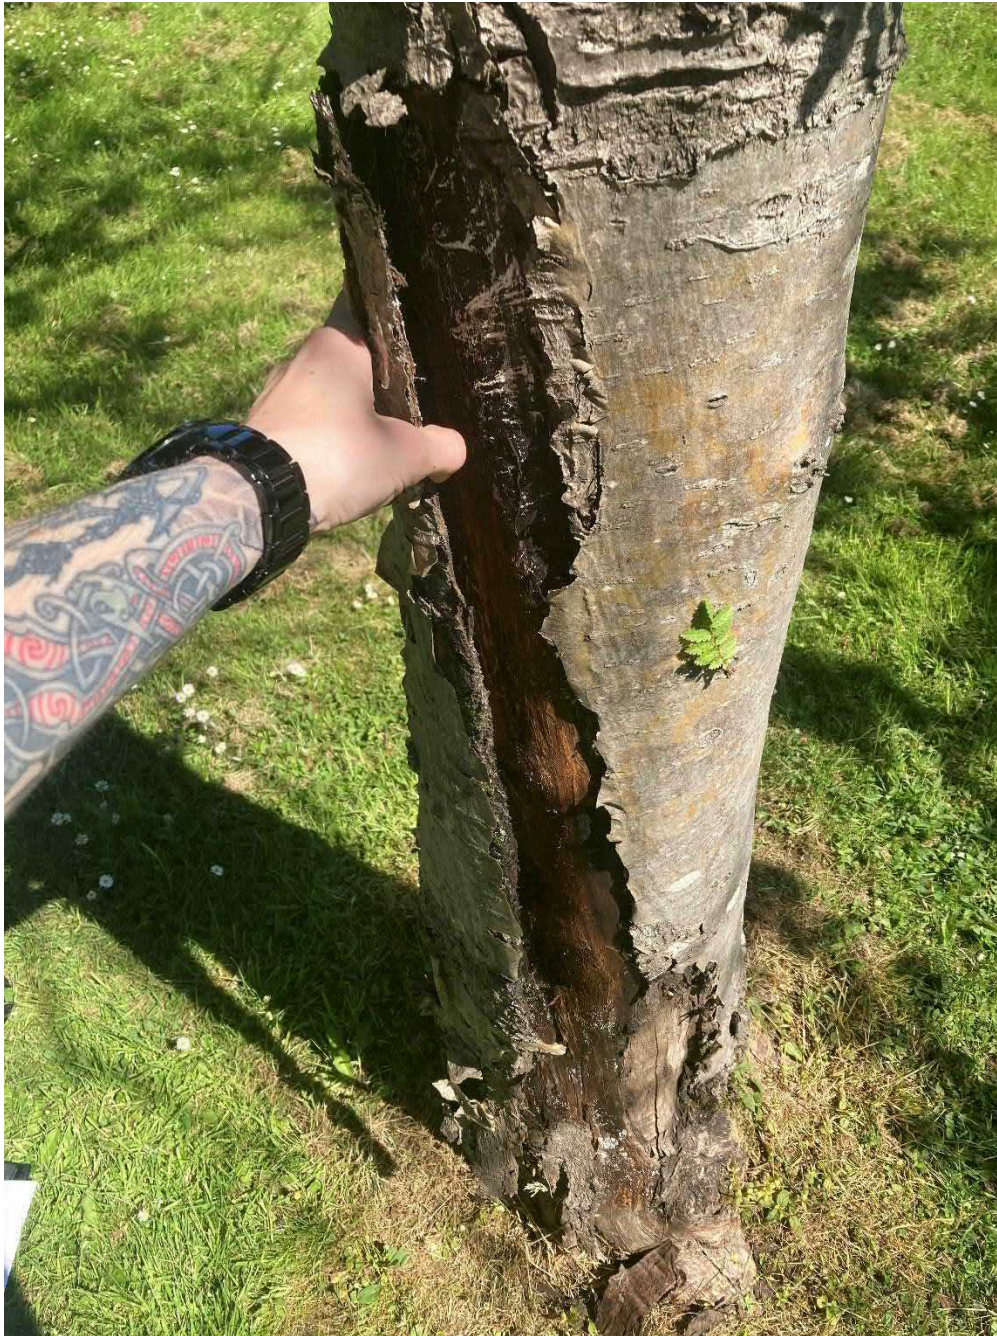
A number of trees have defects that require remedial pruning works or felling. This includes tree T6; a rowan tree with major wounding from the base into the crown, tree T16; a dying cherry and G39; a group of leaning trees in poor condition. Tree T18 is a large English oak which has also been identified to be in poor condition, with many large dead limbs present and the stem is covered with dense ivy growth.

| Ref. No | Species<br>Common Name<br>(Scientific name) | Estimated Height (m) | Stem Diameter<br>(mm) | Canopy Spread (m) | | | | First Significant<br>Branch & direction<br>(m) | Canopy Clearance<br>height (m) | Physiological<br>Condition | Life Stage | Structural Condition | Observations | Preliminary<br>Management<br>Recommendations | Work Required to<br>Facilitate the<br>Proposed<br>Development | Estimated Remaining<br>Contribution (yrs) | Category | RPA<br>(m²) | RPA<br>Radius<br>(m) |
|---|---|---|---|---|---|---|---|---|---|---|---|---|---|---|---|---|---|---|---|
| T6 | Rowan ( <i>Sorbus aucuparia</i> ) | 5 | 240 | 3 | 3 | 0.5 | 3 | 3.0/W | 2 | Poor | SM | Poor | Failure to come into full leaf with very small and sporadic foliage. Likely dead buds throughout. Decay throughout the main stem, major wounds from base upwards into the crown. | Fell to ground level and replant. <3 months | | <10 | U1 | 2.9 | 0.96 |

Picture 3 Damage to T6 that exists from base into the tree's canopy

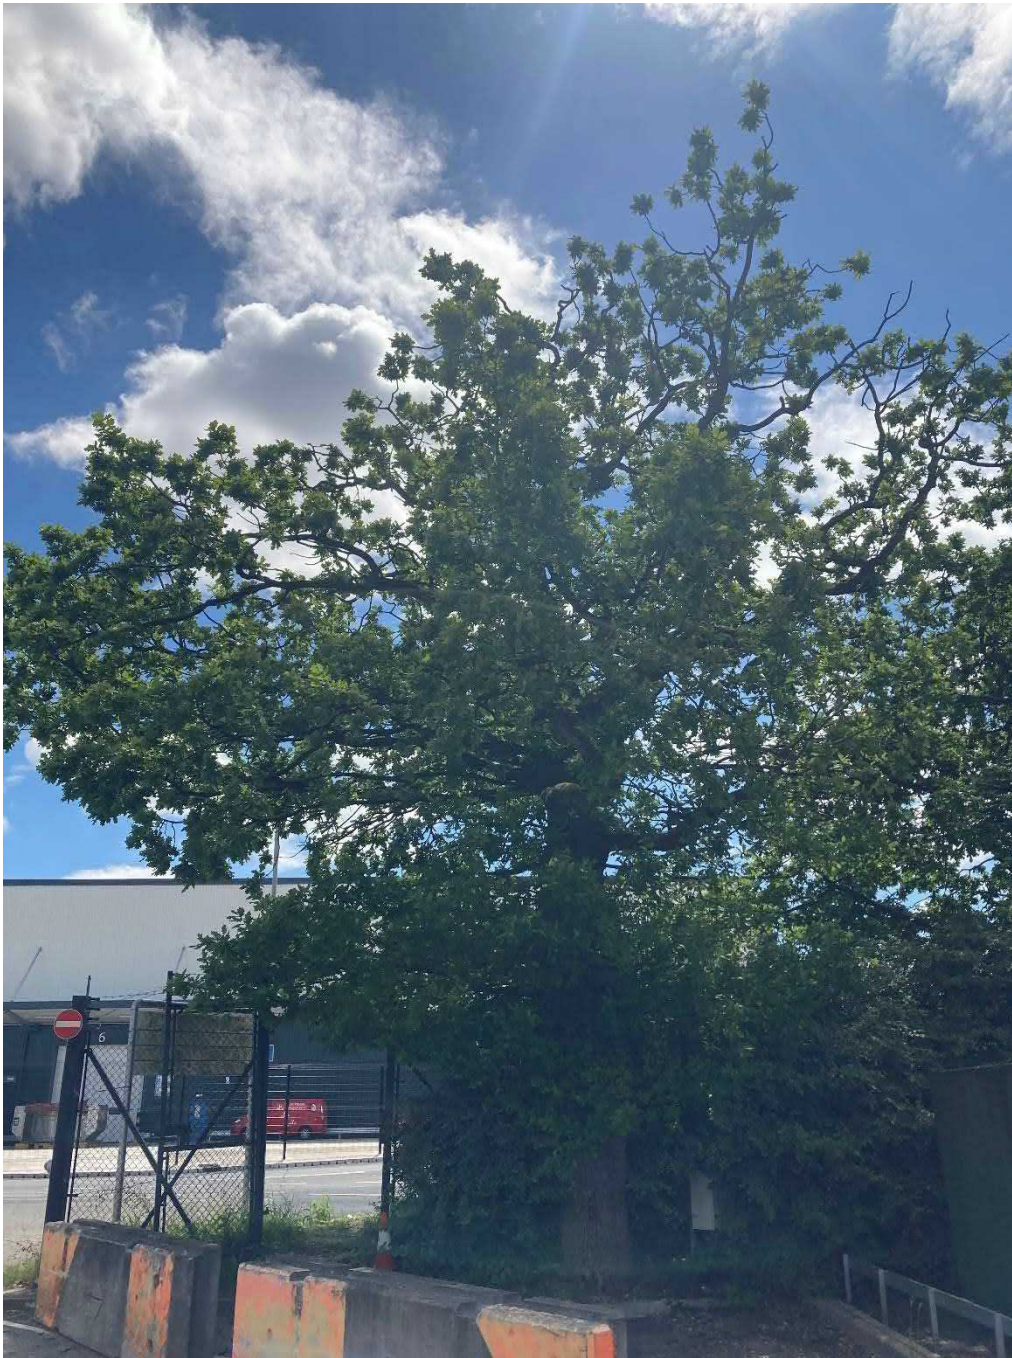
Picture 4 A mature oak (T14) at the entrance to the site.

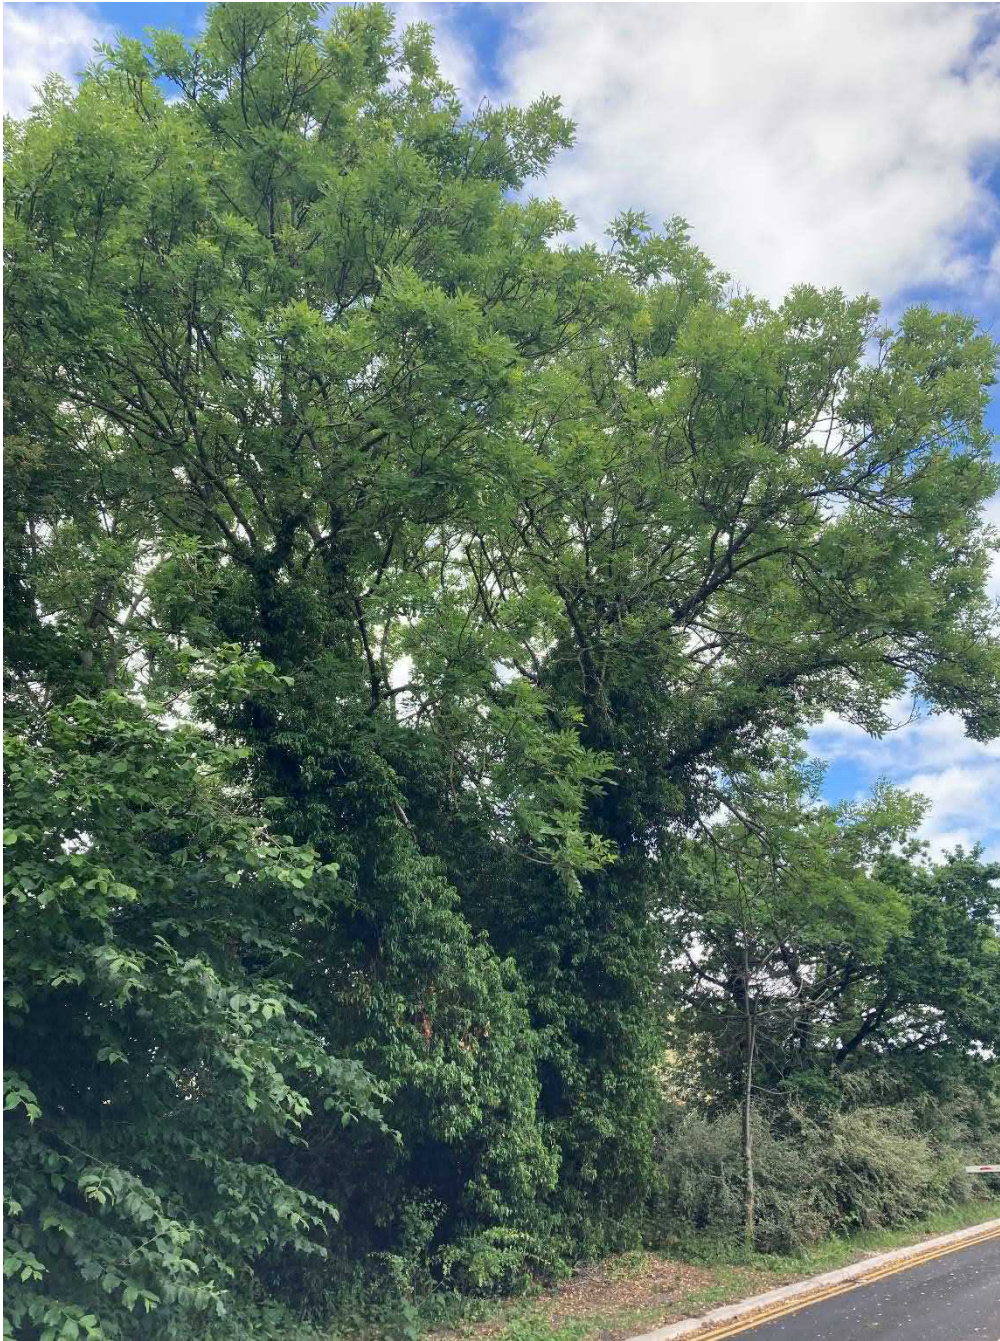
Picture 5 T17, a mature ash with dense ivy growth obscuring visibility

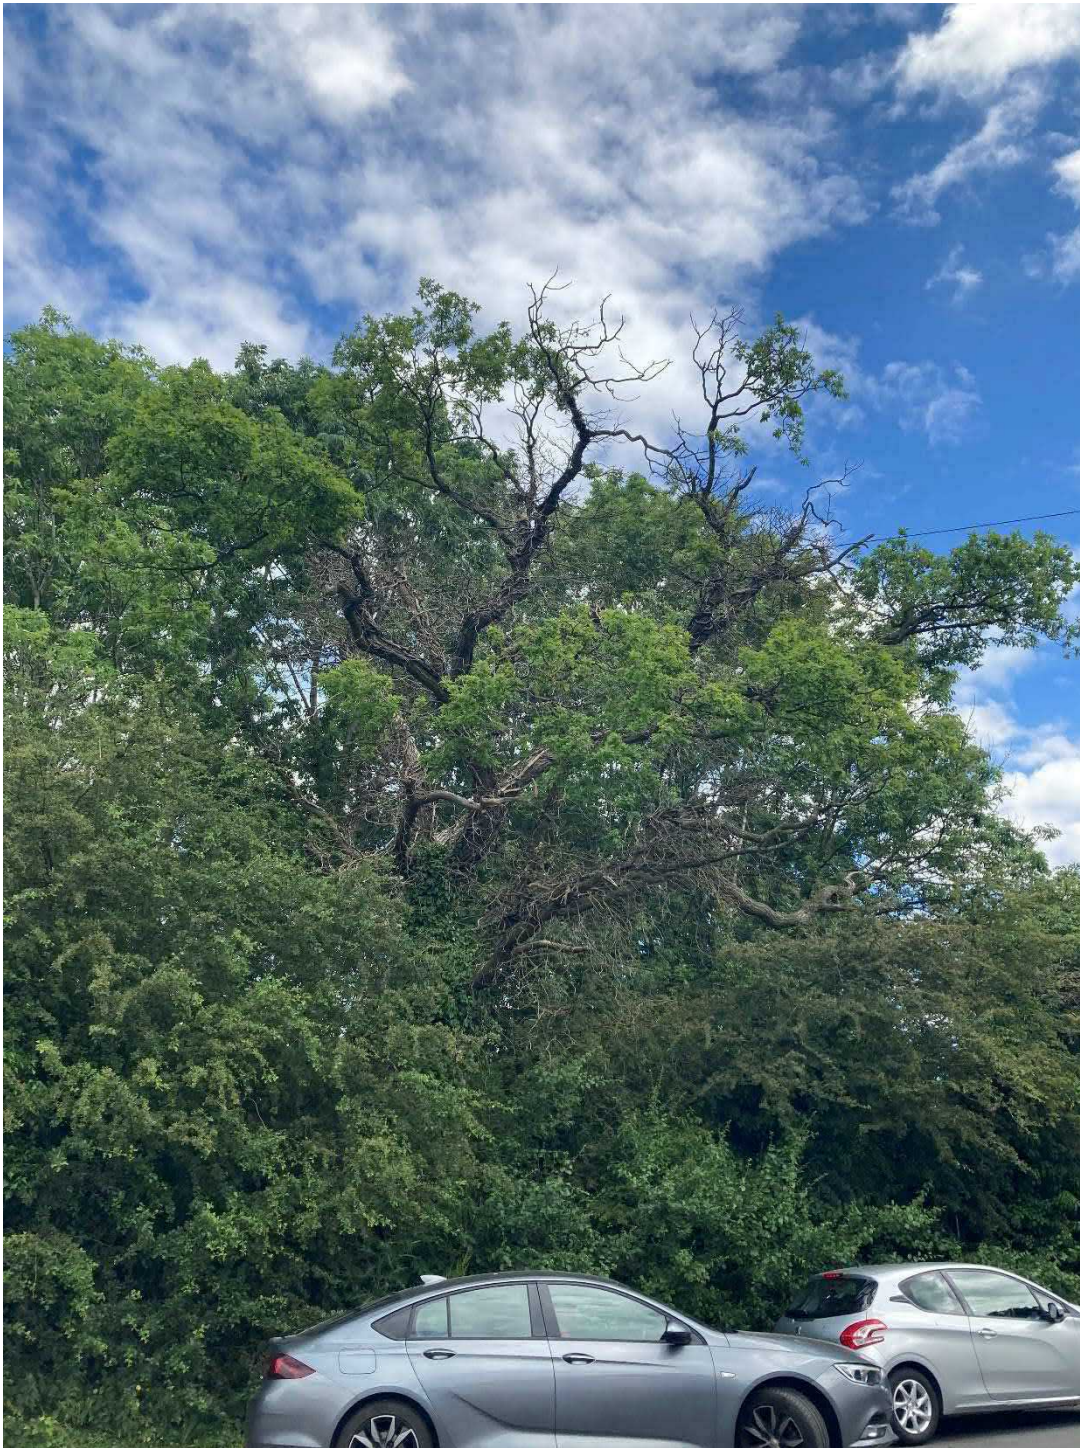
| Ref. No | Species Common Name<br>(Scientific name) | Estimated Height (m) | Stem Diameter (mm) | Canopy Spread (m) | | | | First Significant Branch & direction (m) | Canopy Clearance height (m) | Physiological Condition | Life Stage | Structural Condition | Observations | Preliminary Management Recommendations | Work Required to Facilitate the Proposed Development | Estimated Remaining Contribution (yrs) | Category | RPA (m²) | RPA Radius (m) |
|---|---|---|---|---|---|---|---|---|---|---|---|---|---|---|---|---|---|---|---|
| T18 | Common Oak ( <i>Quercus robur</i> ) | 13 | 600 | 6 | 4 | 6 | 7 | 5.0/E | 6 | Poor | M | Fair - Poor | Low vitality with sparse foliage and significant sections of deadwood throughout its crown. Potentially in terminal decline. Lower stem swamped in ivy from the base. Overhead wires running through tree's crown. Sounding hammer test didn't suggest any extensive decay but ivy preventing full visual assessment. | Sever ivy, remove dead wood over hard surfacing < 3 months | | 10+ | C1 | 7.2 | 1.51 |

Picture 6 A large declining oak (T18) at the edge of the woodland group, large dead limbs but still some sparse live growth in the crown

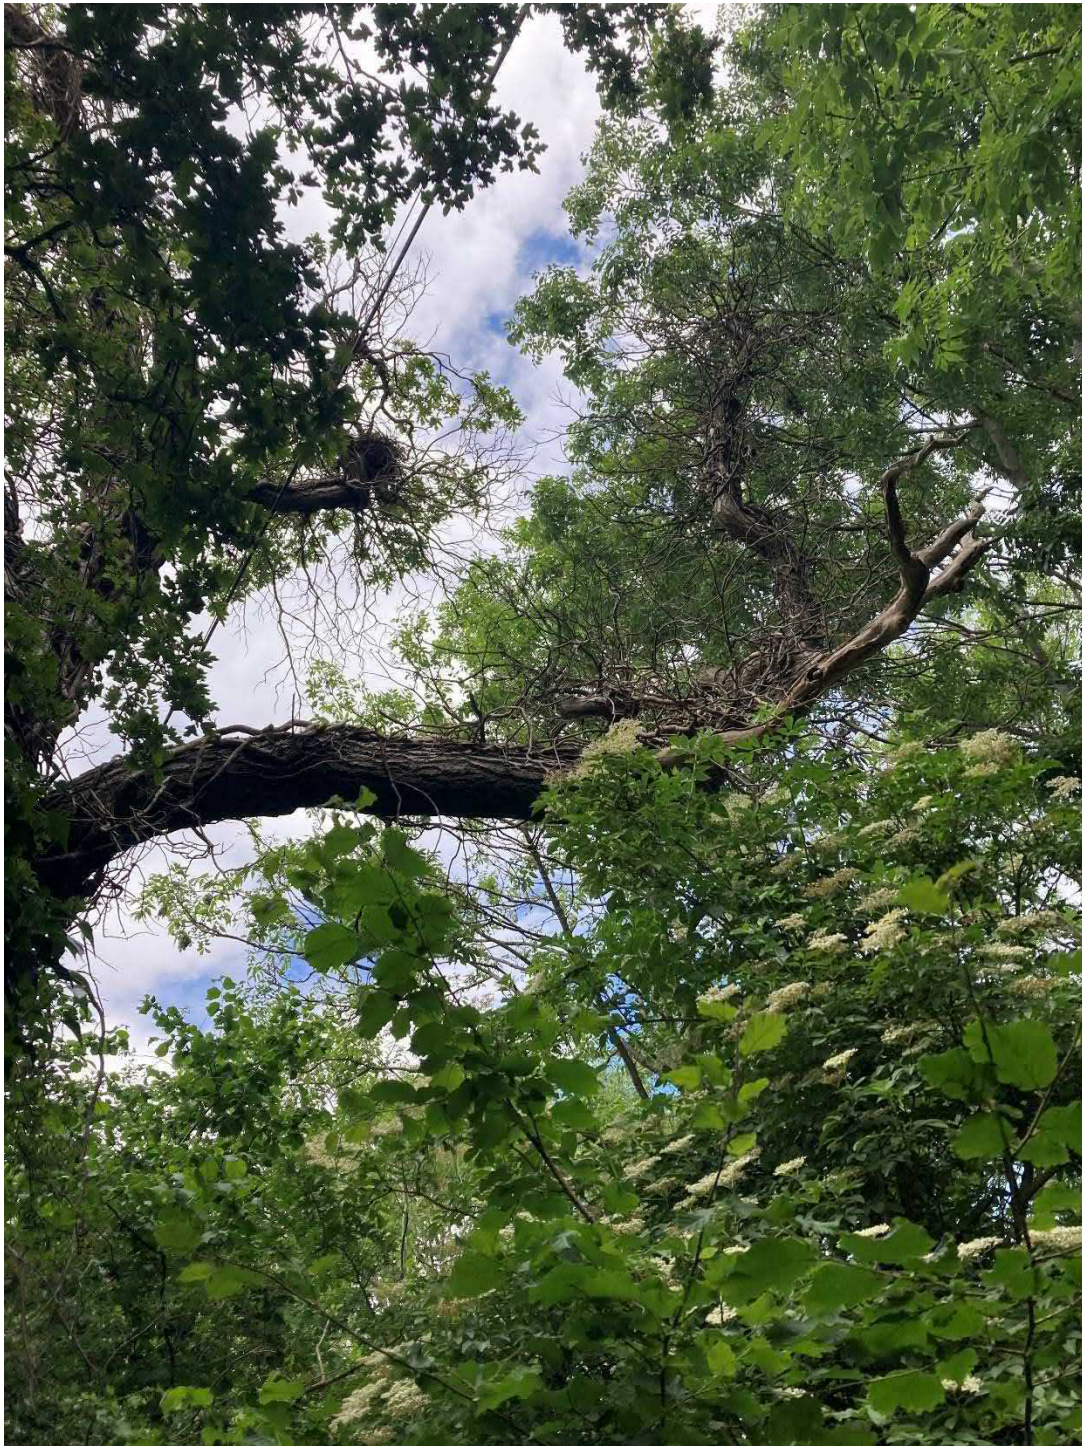
Picture 7 A large dead limb seen on T18, overhead wires can also be seen running through the trees crown

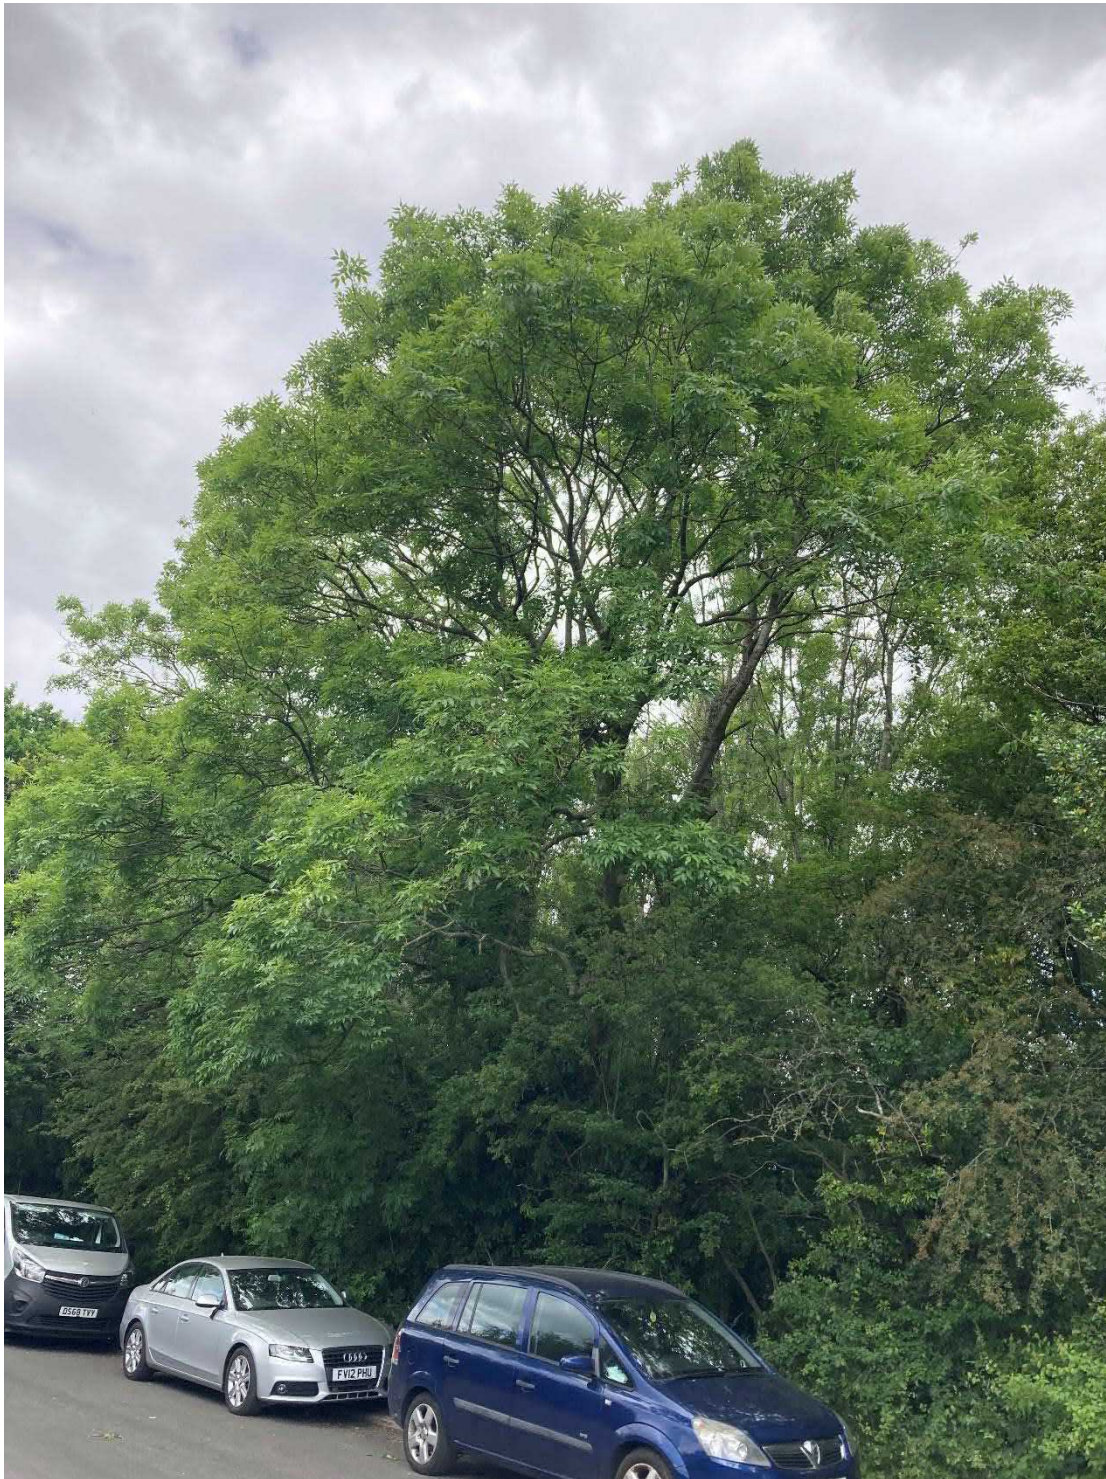
Picture 8 One of many mature ash trees lining the woodland edge

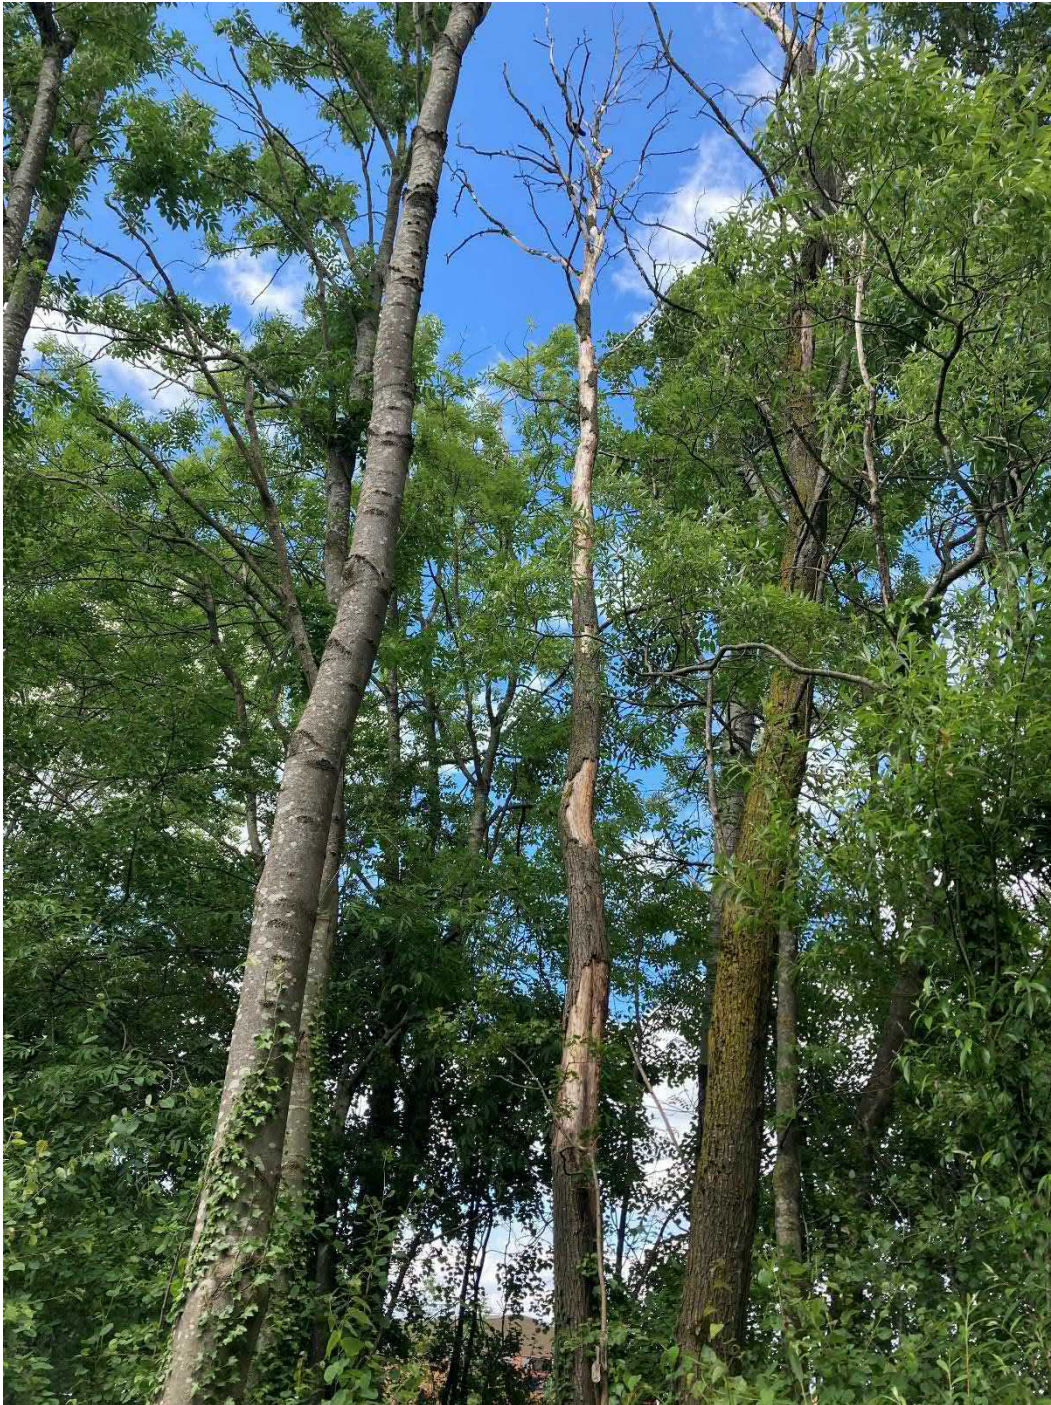
Picture 9 Standing dead tree within the woodland group

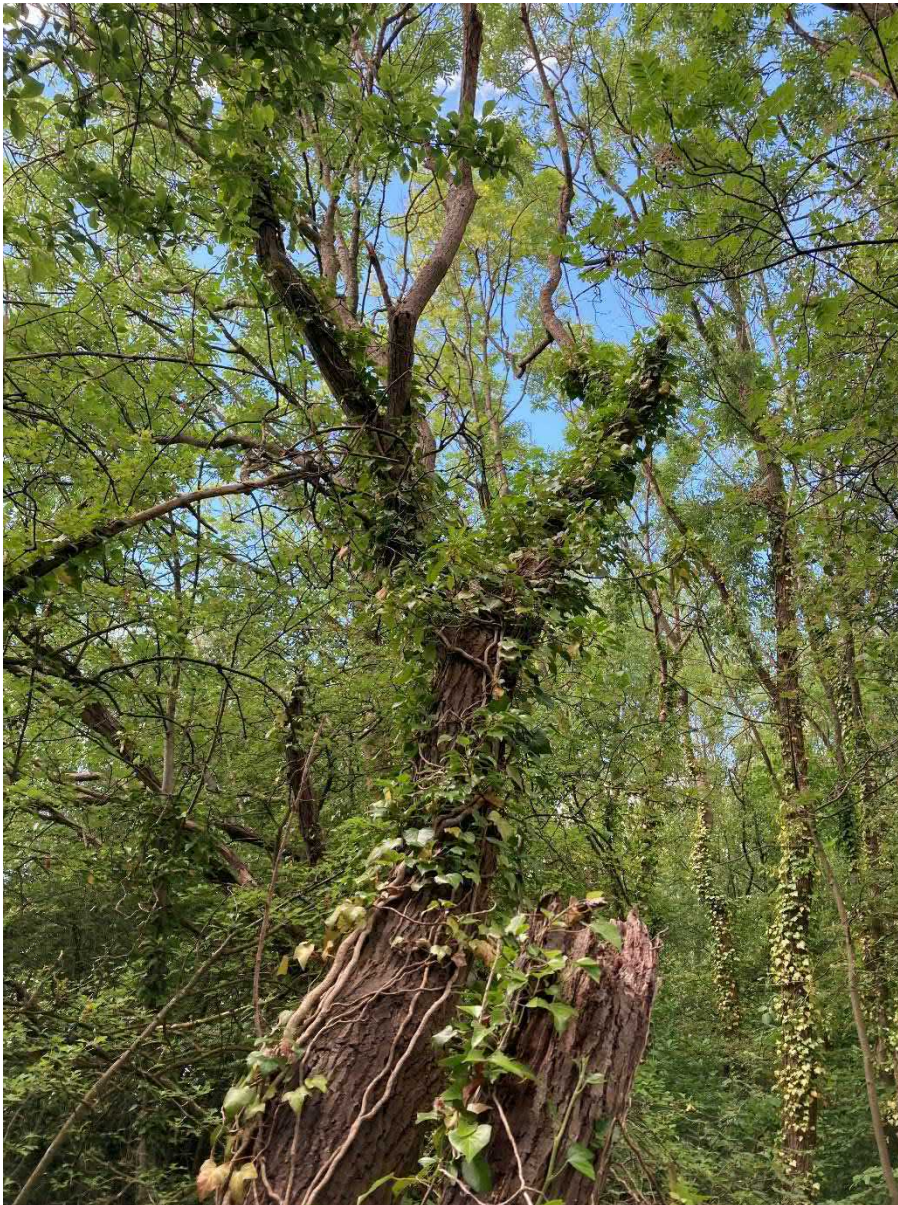
Picture 10 Another section of standing deadwood within the woodland group providing habitat value

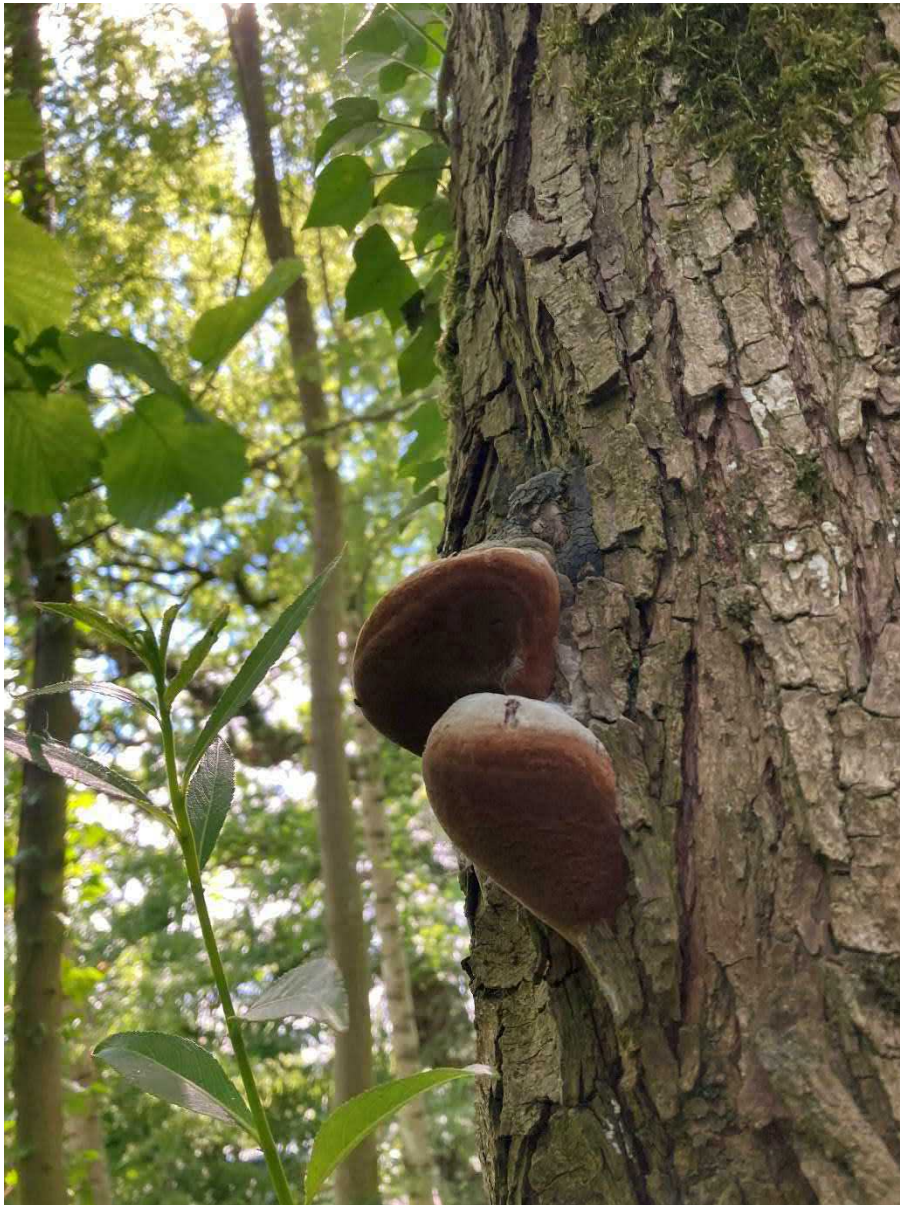
Picture 11 Decay fungi on standing deadwood

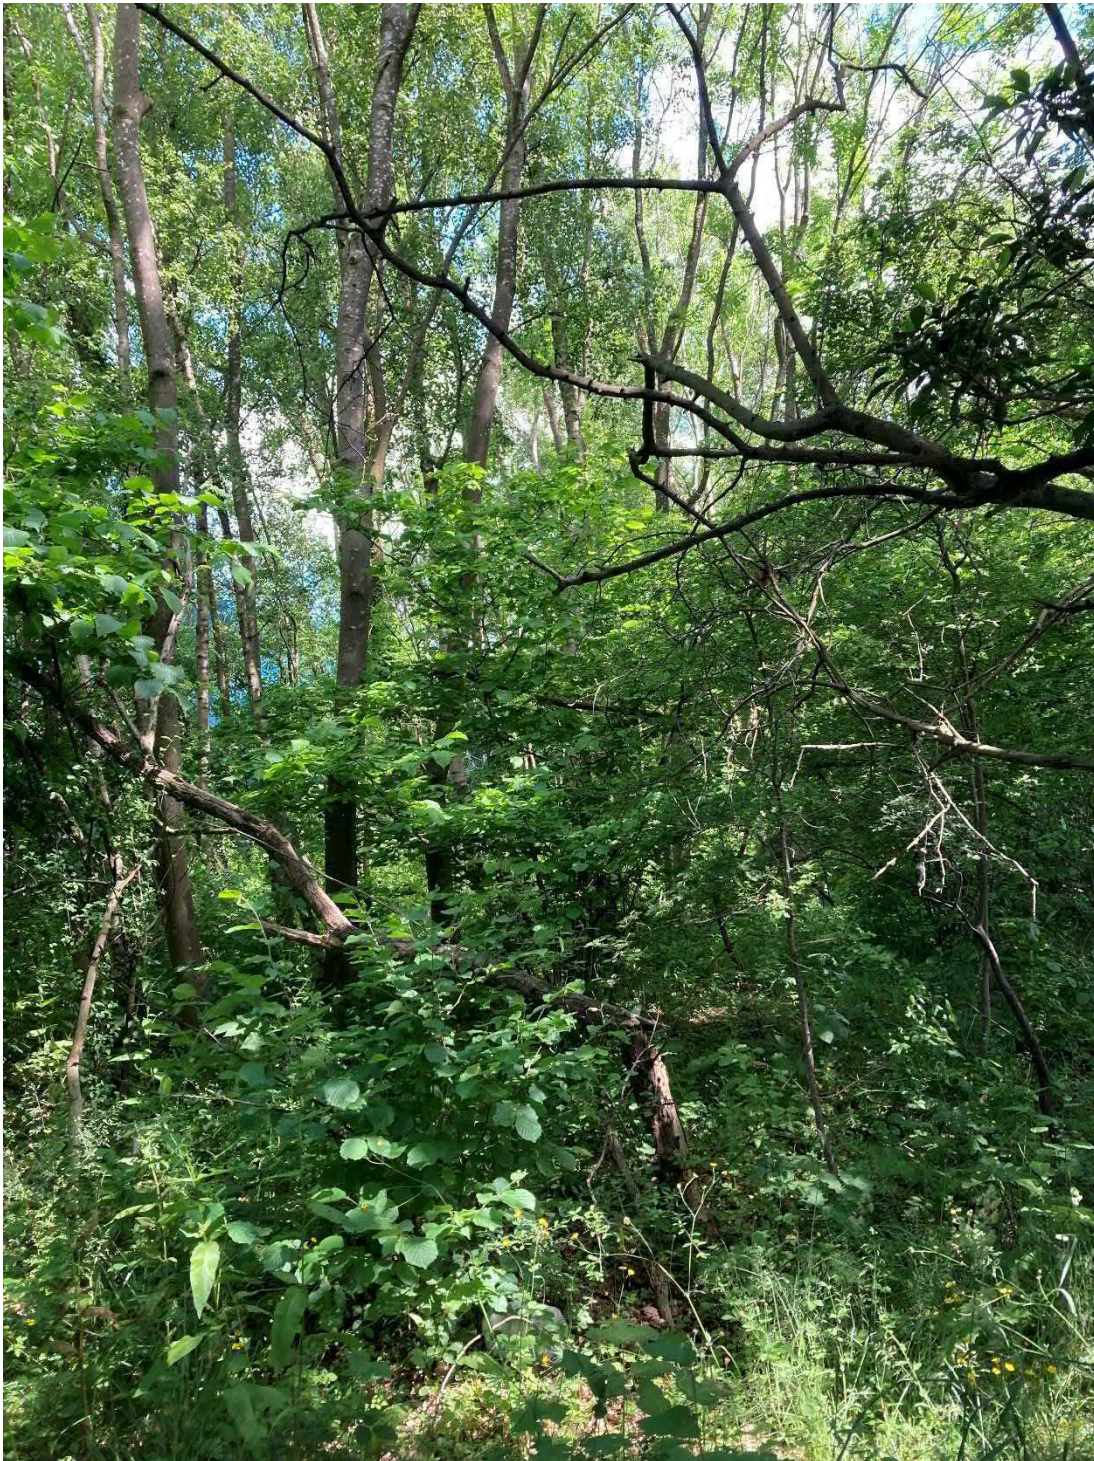
Picture 12 An example of the dense spacing of trees within the woodland

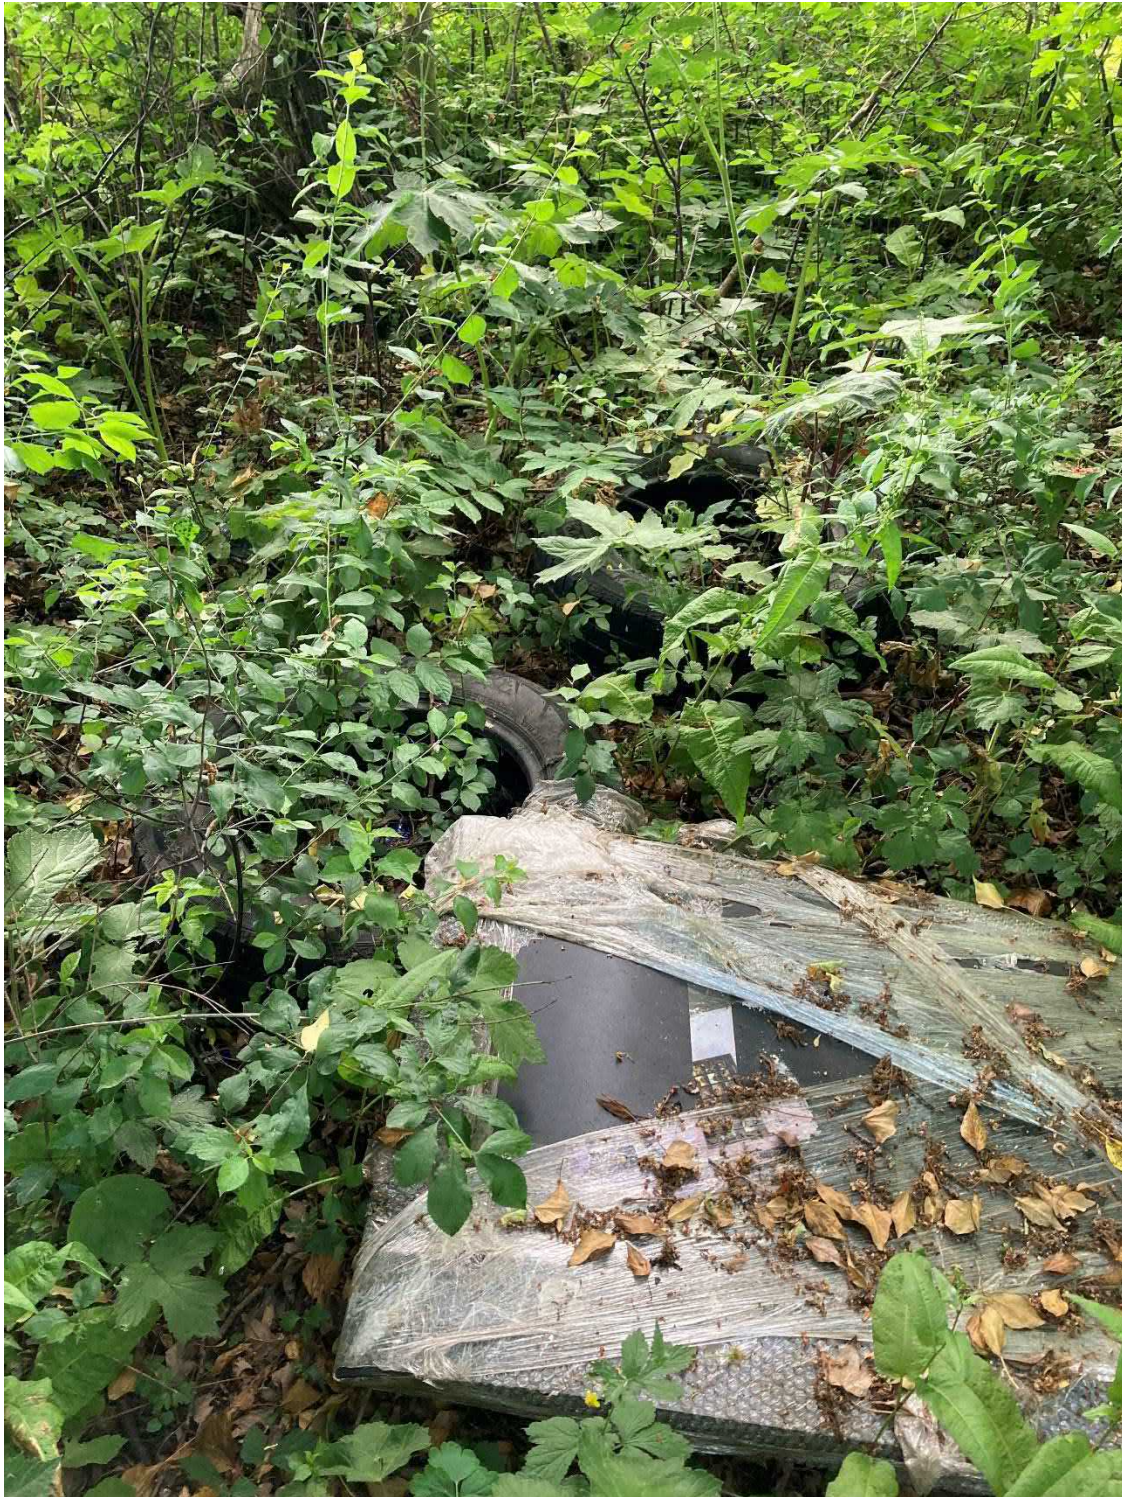
**Picture 13 Rubbish tipped throughout woodland**

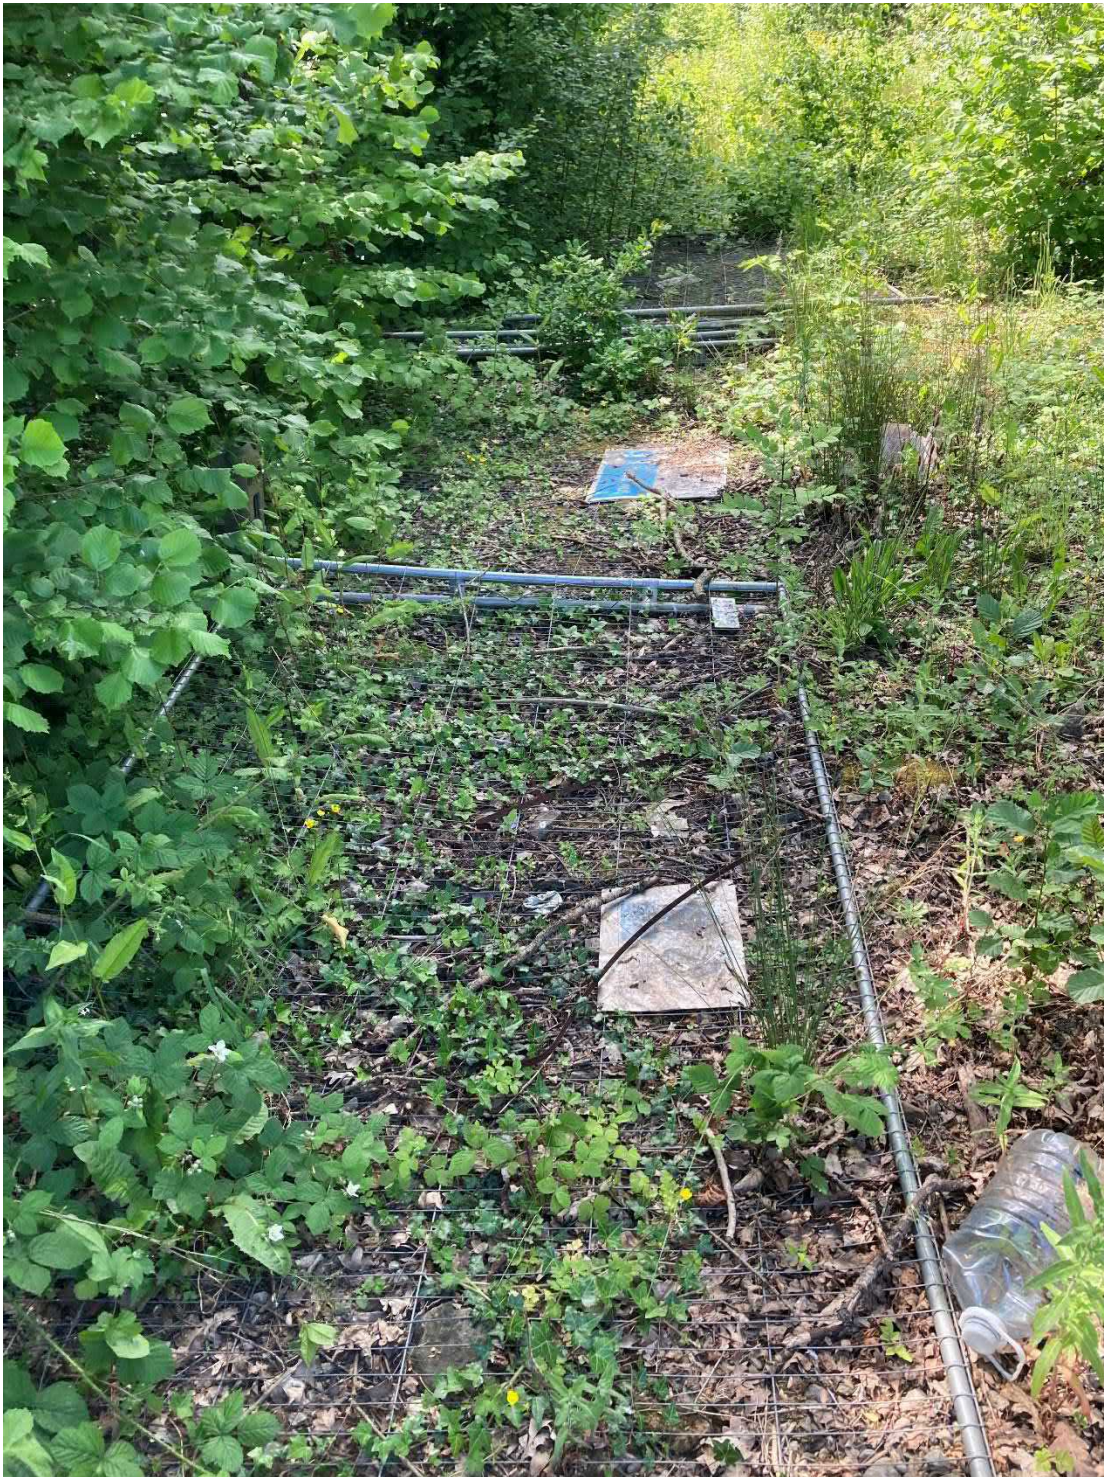
Picture 14 Heras fence panels tipped in woodland
