# Pre-Demolition Asbestos Survey

**Longacre Street Site  
Manchester  
M1 2WL**

| <b>Report Number:</b> | M20196/03 | <b>Report Status:</b> | Final |
| <b>Report Type:</b> | Pre-Demolition Survey | | |

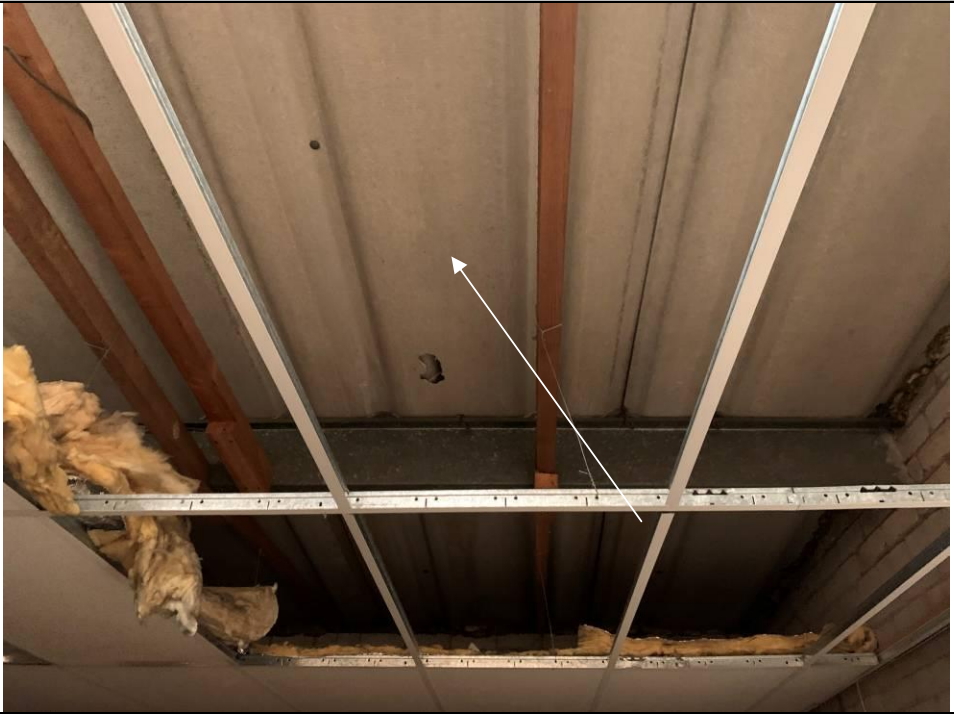
| Sample No. | PS2/02/01 | |

| Result | <b>CHRYSTILE</b> | |

| Sample variable | Score | Examples of scores |
|---|---|---|
| Product type or debris from product | <b>1</b><br>2<br>3 | Asbestos – reinforced composites (plastics, resins, mastics, roofing felts, vinyl floor tiles, semi rigid paints, or decorative finishes, asbestos cement etc.)<br>Asbestos insulating board, asbestos millboard, other low-density insulation boards, asbestos textiles, gaskets ropes and woven textiles, asbestos paper and felt.<br>Thermal insulation (e.g. Pipe and boiler lagging) loose and sprayed asbestos, asbestos mattresses and packing. |
| Extent of damage or deterioration | 0<br><b>1</b><br>2<br>3 | Good condition – no visible damage<br>Low damage – a few scratches or surface marks; broken edges on boards, tiles etc.<br>Medium damage; significant breakage of materials or several small areas where material has been damaged revealing loose asbestos fibres.<br>High damage or delamination of materials, sprays and thermal insulation. Visible asbestos debris. |

| Sample variable | Score | Examples of scores |
|---|---|---|
| Recommendations | Remove under controlled conditions, by adequately trained persons (category B training minimum). | |

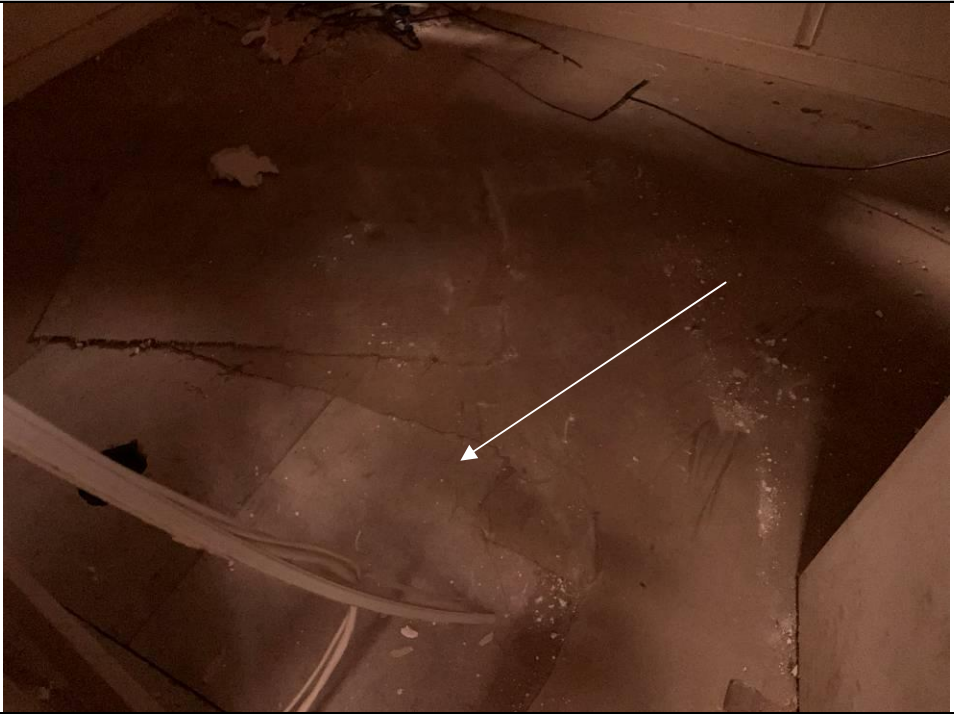
| <b>Site</b> | Longacre Street Site,<br>Manchester,<br>M1 2WX | |
|---|---|---|
| <b>Zone</b> | Building PS2 | |
| <b>Loc.</b> | Internal, First Floor,<br>Rooms 5 & 6 | |

| <b>Site</b> | Longacre Street Site,<br>Manchester,<br>M1 2WX | |
|---|---|---|
| Recommendations | No further action required. | |

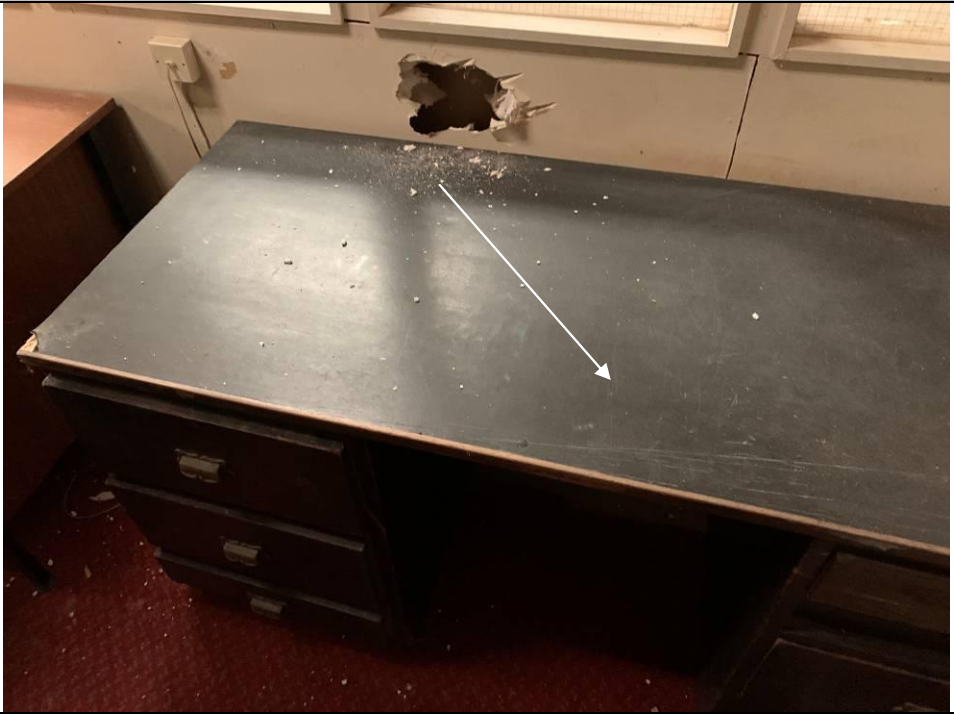
| <b>Site</b> | Longacre Street Site,<br>Manchester,<br>M1 2WX | |
|---|---|---|
| <b>Zone</b> | Building PS2 | |
| <b>Loc.</b> | Internal, First Floor,<br>Room 6 | |

| <b>Site</b> | Longacre Street Site,<br>Manchester,<br>M1 2WX | |
|---|---|---|
| Recommendations | No further action required. | |

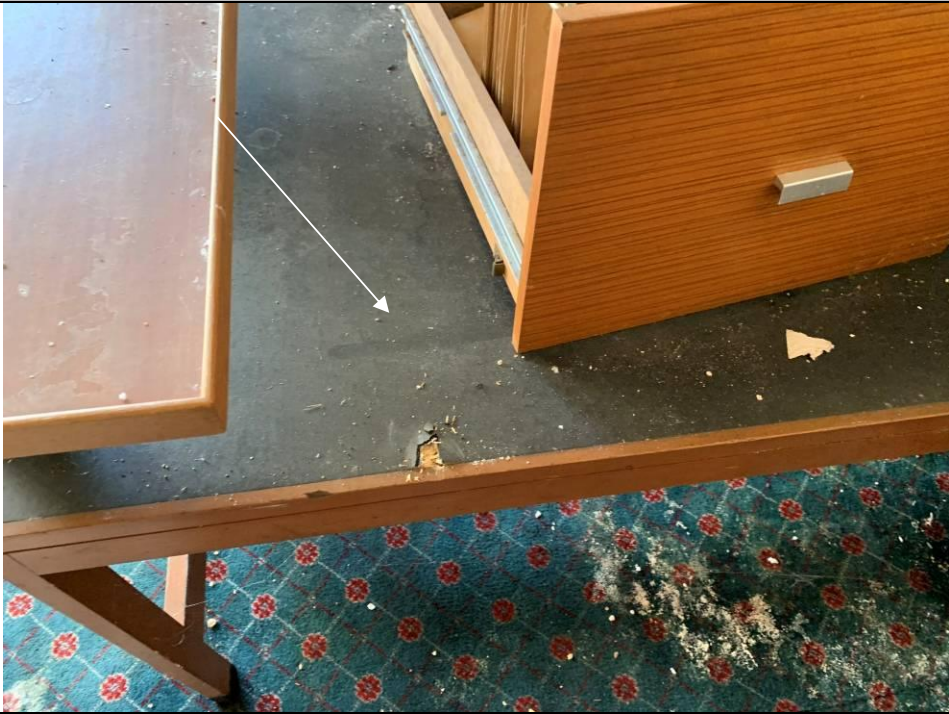
| Site | Longacre Street Site,<br>Manchester,<br>M1 2WX | | |
|---|---|---|---|
| Zone | Building PS2 | | |
| Loc. | Internal, First Floor,<br>Rooms 8 & 10 | | |

| Site | Longacre Street Site,<br>Manchester,<br>M1 2WX | | |
|---|---|---|---|
| Recommendations | No further action required. | | |

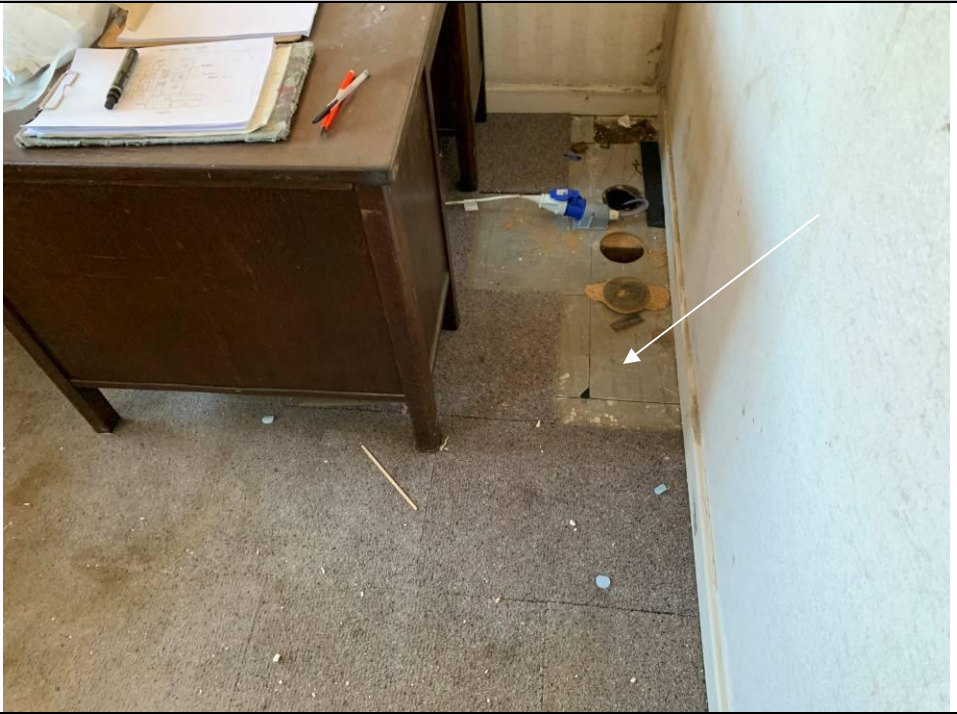
| <b>Sample Ref</b> | <b>Location</b> | <b>Product Type</b> | <b>Asbestos Type</b> | <b>Extent</b> | <b>Material Assessment Sheet</b> |
|---|---|---|---|---|---|
| PS2/10/01 | Building PS2, Internal, First Floor, Rooms 10, 11, 12, & 13, Floor Tile (under new floor coverings) | Asbestos Vinyl Product | Chrysotile (White asbestos) in tile only | 48m <sup>2</sup> | MA Sheet 7 |

| Site | Longacre Street Site,<br>Manchester,<br>M1 2WX | | |
|---|---|---|---|
| Zone | Building PS2 | | |
| Loc. | Internal, First Floor,<br>Rooms 10, 11, 12 & 13 | | |
| Product type or debris from product | <b>1</b><br>2<br>3 | Asbestos – reinforced composites (plastics, resins, mastics, roofing felts, vinyl floor tiles, semi rigid paints, or decorative finishes, asbestos cement etc.)<br>Asbestos insulating board, asbestos millboard, other low-density insulation boards, asbestos textiles, gaskets ropes and woven textiles, asbestos paper and felt.<br>Thermal insulation (e.g. Pipe and boiler lagging) loose and sprayed asbestos, asbestos mattresses and packing. | |
| Extent of damage or deterioration | 0<br><b>1</b><br>2<br>3 | Good condition – no visible damage<br>Low damage – a few scratches or surface marks; broken edges on boards, tiles etc.<br>Medium damage; significant breakage of materials or several small areas where material has been damaged revealing loose asbestos fibres.<br>High damage or delamination of materials, sprays and thermal insulation. Visible asbestos debris. | |

| Site | Longacre Street Site,<br>Manchester,<br>M1 2WX | | |
|---|---|---|---|
| Recommendations | Remove under controlled conditions, by adequately trained persons (category B training minimum). | | |

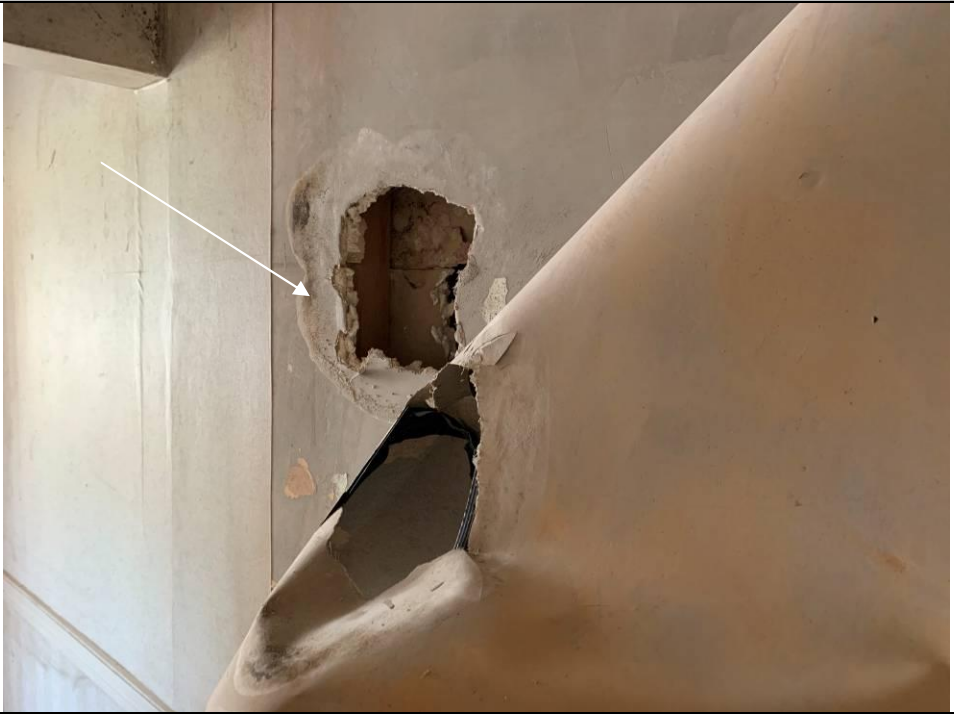
| <b>Site</b> | Longacre Street Site,<br>Manchester,<br>M1 2WX | |
|---|---|---|
| <b>Zone</b> | Building PS2 | |
| <b>Loc.</b> | Internal, Throughout<br>Offices | |

| <b>Site</b> | Longacre Street Site,<br>Manchester,<br>M1 2WX | |
|---|---|---|
| Recommendations | No further action required. | |

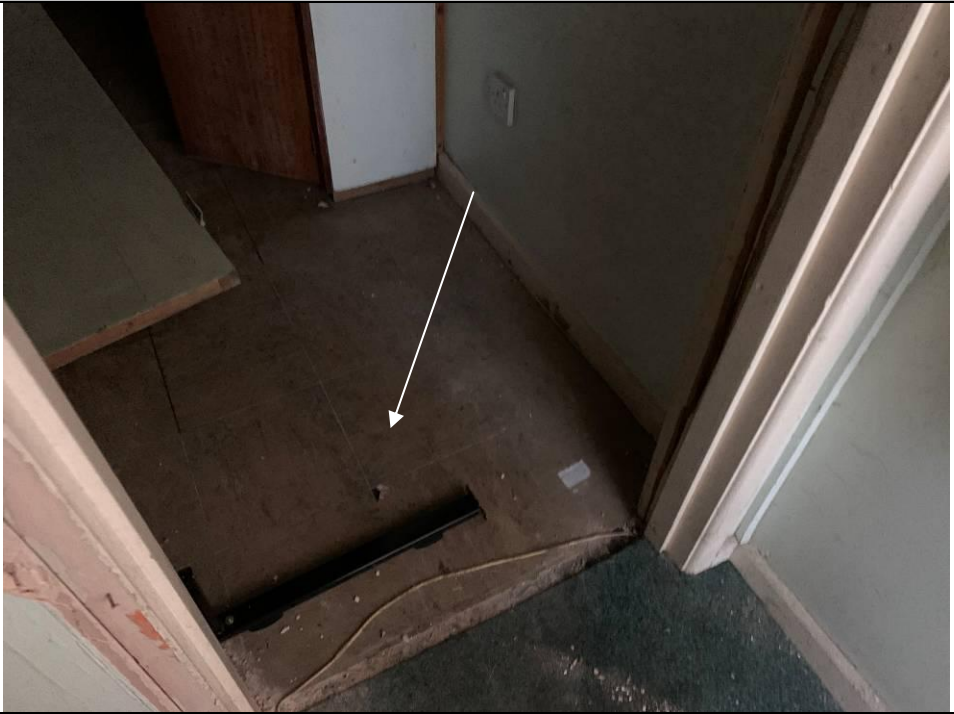
| <b>Site</b> | Longacre Street Site,<br>Manchester,<br>M1 2WX | |
|---|---|---|
| <b>Zone</b> | Building PS2 | |
| <b>Loc.</b> | Internal, Ground Floor,<br>Room 17 | |

| <b>Site</b> | Longacre Street Site,<br>Manchester,<br>M1 2WX | |
|---|---|---|
| Recommendations | No further action required. | |

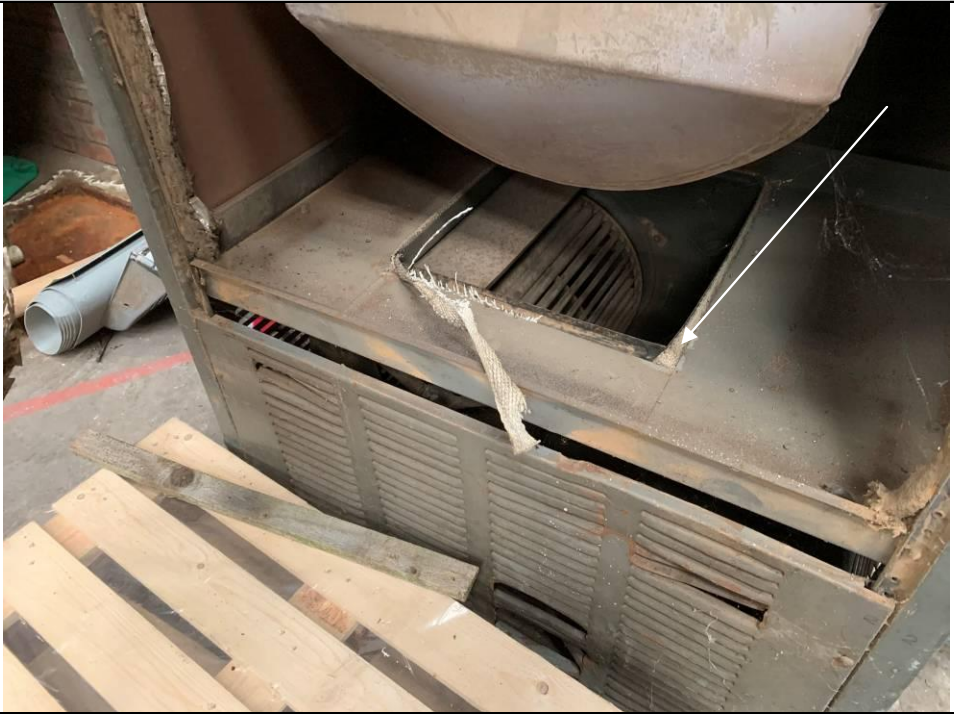
| Sample Ref | Location | Product Type | Asbestos Type | Extent | Material Assessment Sheet |
|---|---|---|---|---|---|
| PS2/30/01 | Building PS2,<br>Internal, Ground<br>Floor, Room 30,<br>Rope Seal<br>(throughout<br>heater unit) | Asbestos<br>Textile<br>Product | Chrysotile (White<br>asbestos) | Small<br>Amounts | MA Sheet 10 |

| Zone | Building PS2 | |
| Loc. | Internal, Ground Floor,<br>Room 30 | |

| Sample variable | Score | Examples of scores |
|---|---|---|
| Product type or debris from product | 1<br><b>2</b><br>3 | Asbestos – reinforced composites (plastics, resins, mastics, roofing felts, vinyl floor tiles, semi rigid paints, or decorative finishes, asbestos cement etc.)<br>Asbestos insulating board, asbestos millboard, other low-density insulation boards, asbestos textiles, gaskets ropes and woven textiles, asbestos paper and felt.<br>Thermal insulation (e.g. Pipe and boiler lagging) loose and sprayed asbestos, asbestos mattresses and packing. |
| Extent of damage or deterioration | 0<br><b>1</b><br>2<br>3 | Good condition – no visible damage<br>Low damage – a few scratches or surface marks; broken edges on boards, tiles etc.<br>Medium damage; significant breakage of materials or several small areas where material has been damaged revealing loose asbestos fibres.<br>High damage or delamination of materials, sprays and thermal insulation. Visible asbestos debris. |

| Sample variable | Score | Examples of scores |
|---|---|---|
| Recommendations | Remove under controlled conditions, by adequately trained persons (category B training minimum). | |

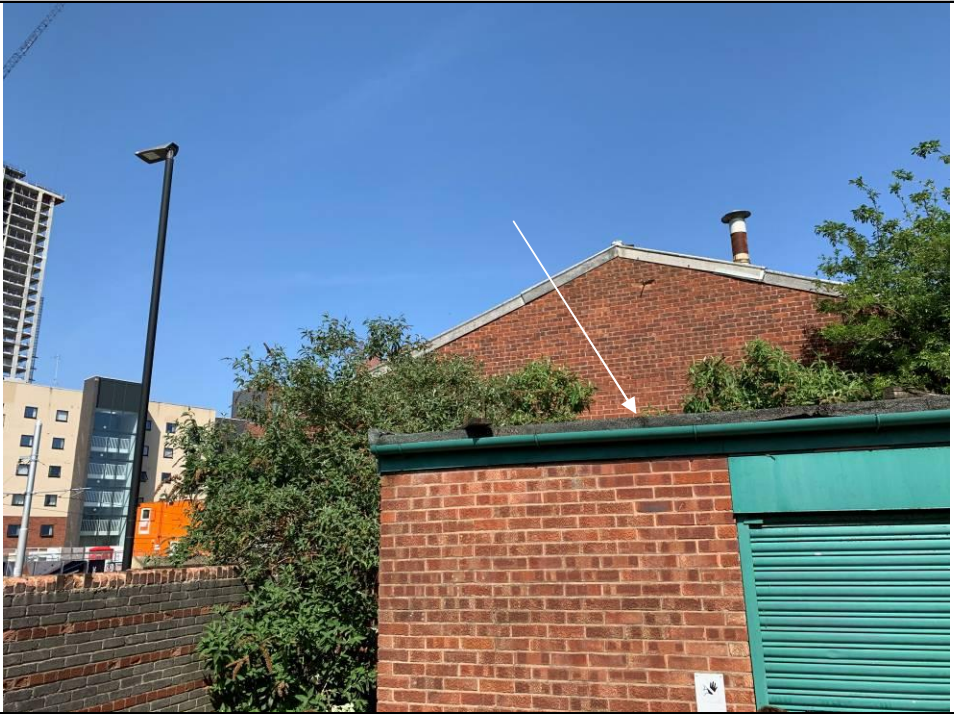
| <b>Site</b> | Longacre Street Site,<br>Manchester,<br>M1 2WX | |
|---|---|---|
| <b>Zone</b> | Building PS3 | |
| <b>Loc.</b> | External | |

| <b>Site</b> | Longacre Street Site,<br>Manchester,<br>M1 2WX | |
|---|---|---|
| Recommendations | No further action required. | |
