| ELR: MAJ | Structure No: 289 | Mileage: | Examination date: 07/09/2020 |
| Name: Castlefield Viaduct | | | Type: Viaduct |
| Carrying/Over: Disused rail / Canal, rail, road & land | | | No. of spans: 8 |

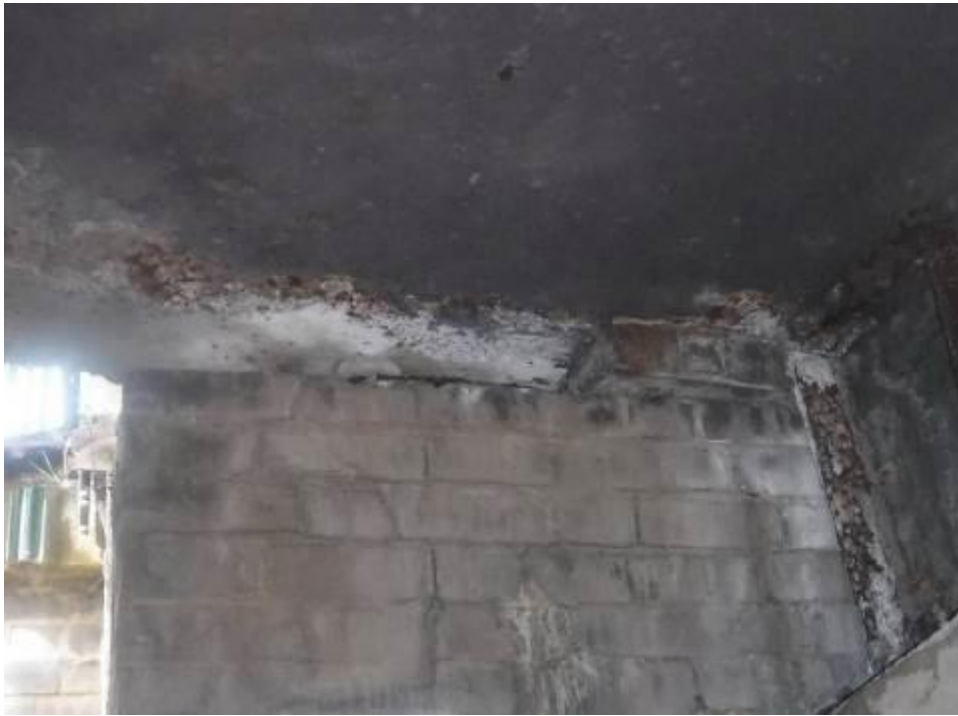
1. 3No. missing bricks and 2No. bricks displaced outwards by +80mm. (photo 27)
2. Spot areas of seepage, water staining and leachate deposits totalling 9m<sup>2</sup>. (photo 28)
3. Area of mortar loss, 2000 x 500 x up to 30mm, with light vegetation growth. (photo 29)
4. 2No. areas of non-offensive graffiti. (photo 28)
5. Area of spalled concrete to bearing plinth, 300 x 200 x up to 50mm. (photo 30)
6. Area of spalled concrete to bearing plinth, 300 x 20 x up to 20mm.
7. Area of rust debris to bearing plinth, 600 x 300mm. (photo 31)
8. Vertical fracture through concrete to bearing plinth, 300 x 1mm. (photo 32)
9. Sapling growing to bearing shelf, 30mm in diameter. (photo 33)
10. Area of missing / spalled brickwork, possibly due to vehicle strike, 120 x 150 x up to 30mm. (photo 34)

Photograph 27: Area of missing & displaced brickwork to ballast wall of west abutment

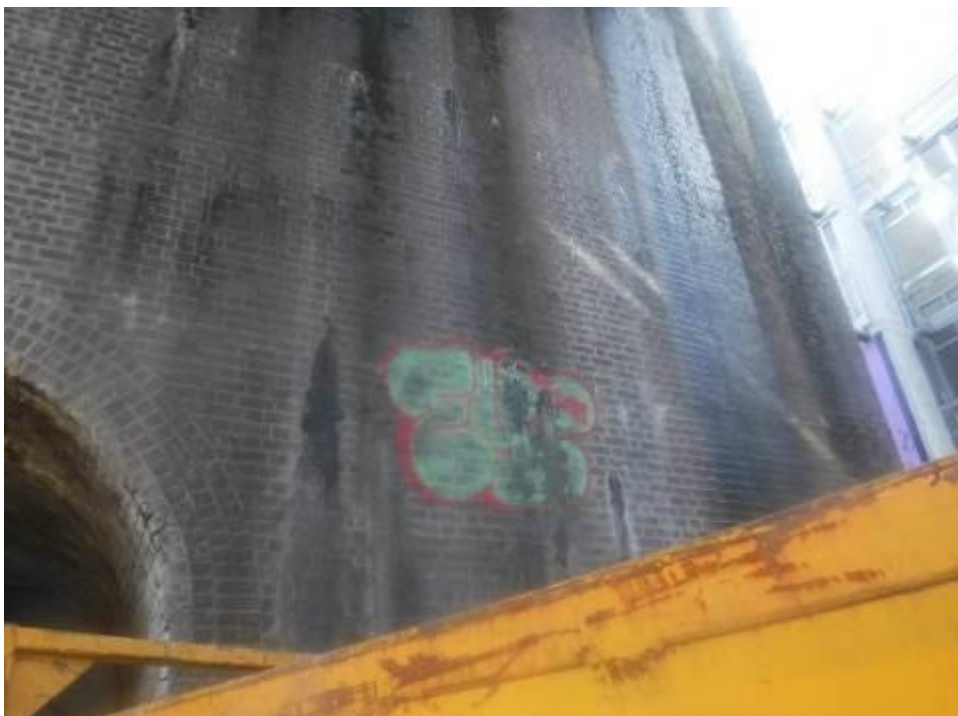
Photograph 28: Typical graffiti & seepage to west abutment

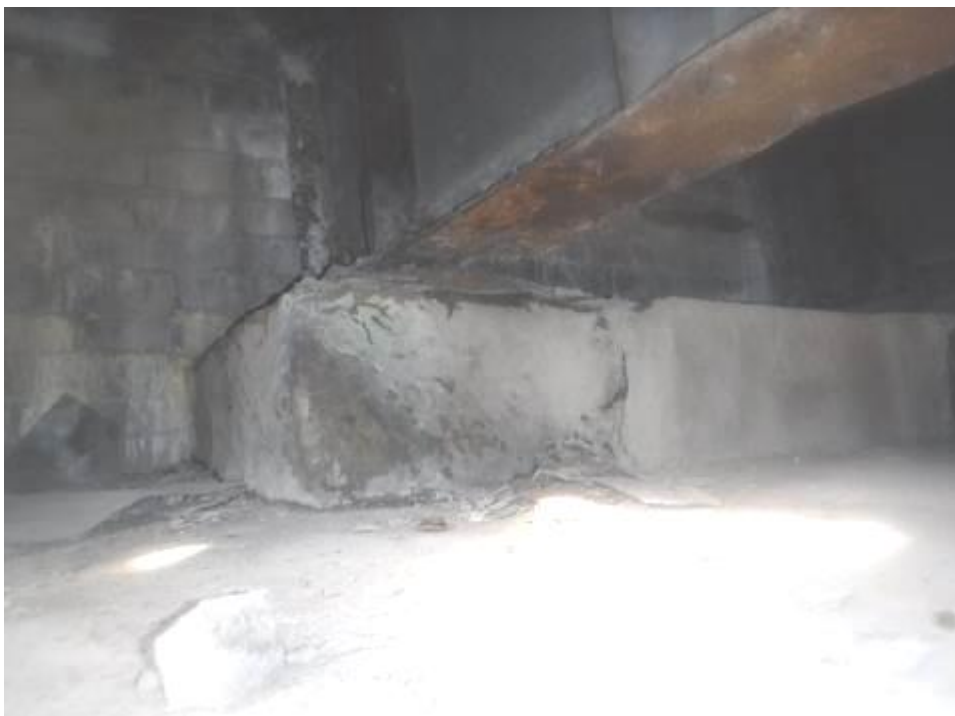
Photograph 30: Area of spalled concrete to bearing plinth of west abutment

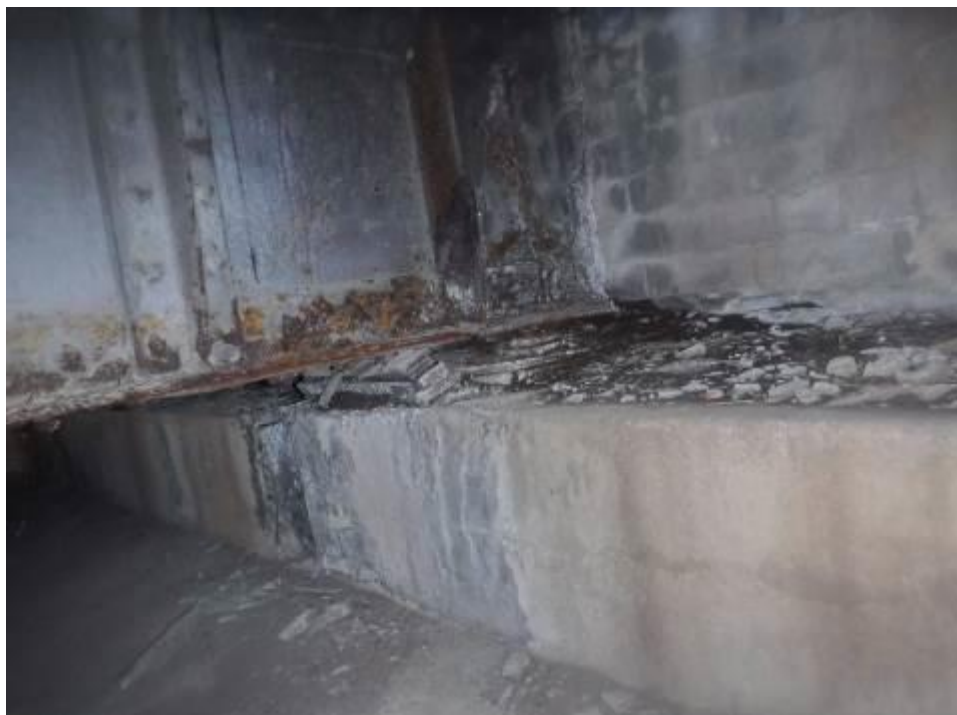
Photograph 31: Rust debris to bearing plinth of west abutment

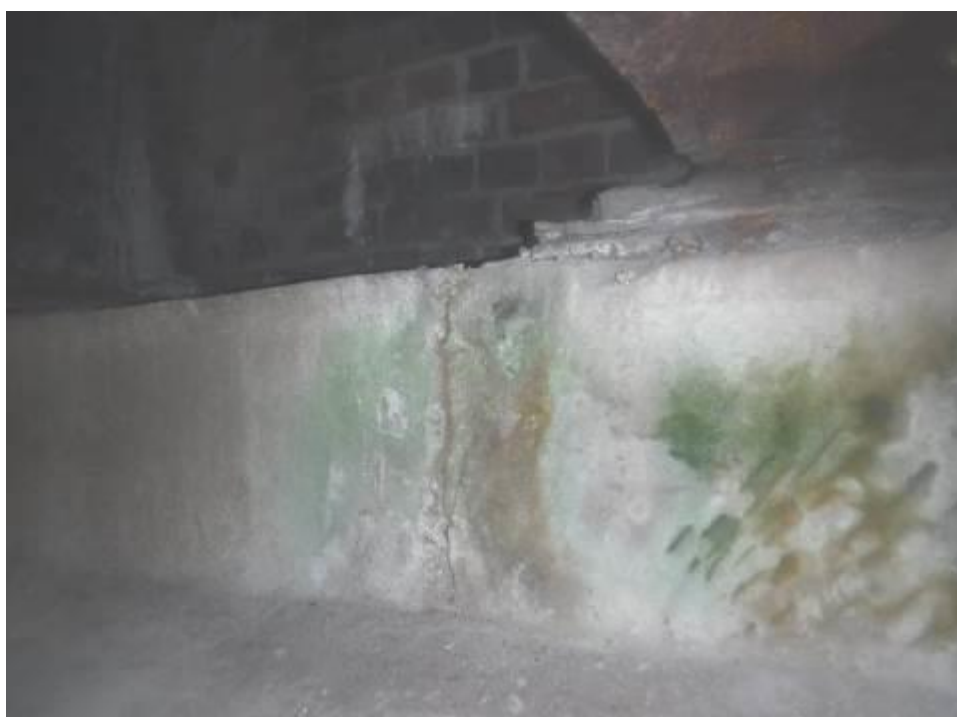
Photograph 32: Vertical fracture to bearing plinth of west abutment

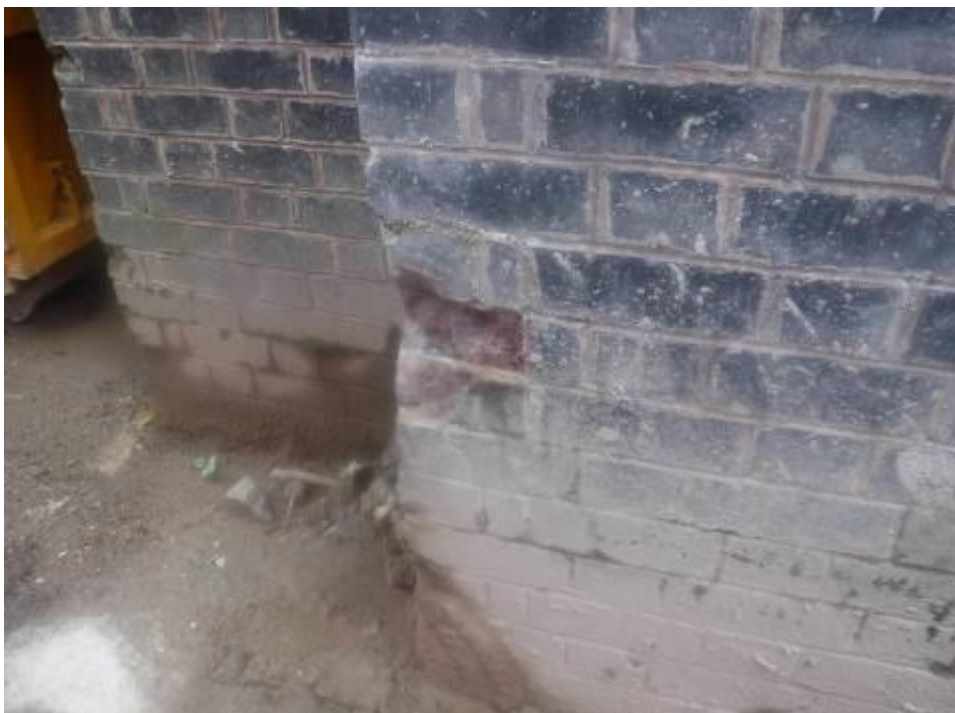
Photograph 34: Area of missing / spalled brickwork to west abutment

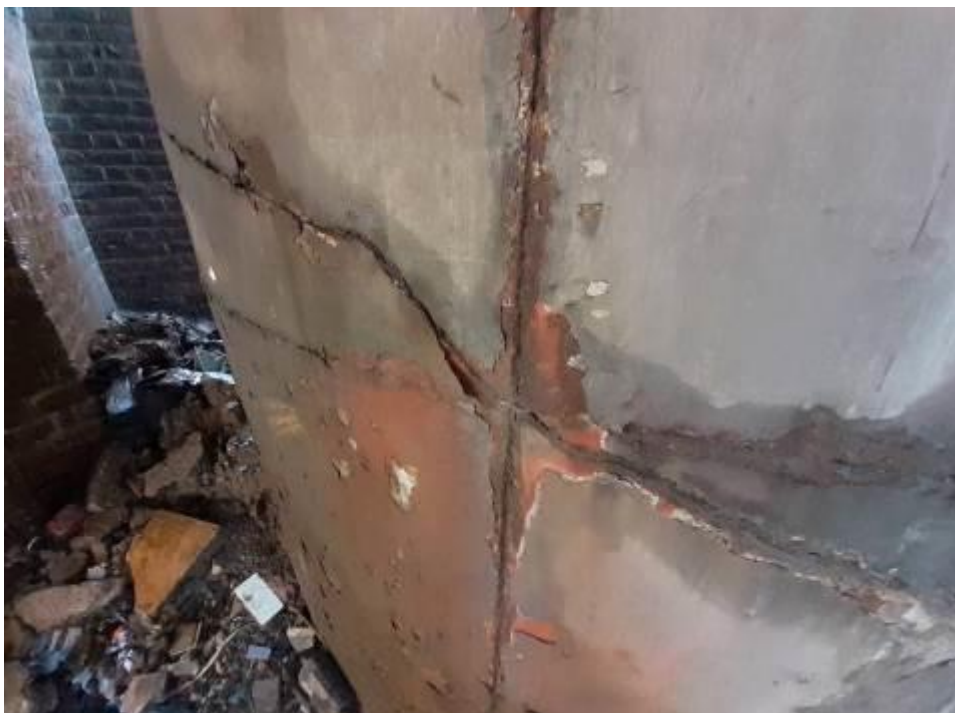
Photograph 42: Horizontal fracture to extra column of pier 1

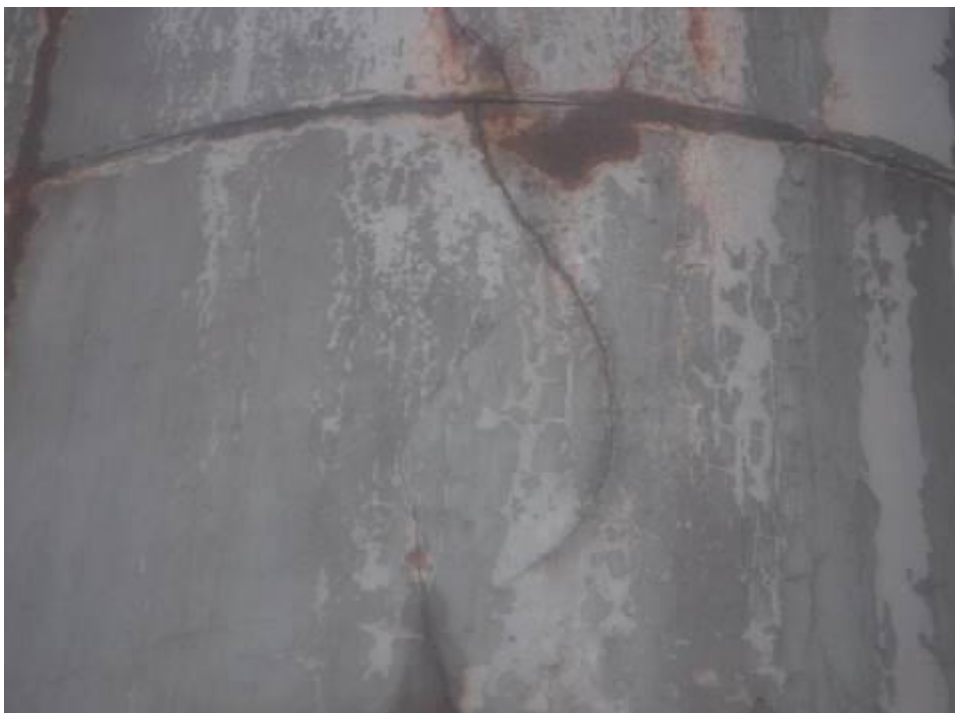
1. Diagonal hairline fracture, 400mm in length.
2. Vertical fracture, 1900 x 1mm.
3. Diagonal fracture, 900 x 1mm. (photo 46)
4. Area of loss of section to upper angle, 1200 x 80mm.
5. Diagonal fracture, 1200 x up to 2mm. (photo 46)
6. Vertical fracture, 1900 x up to 2mm.
7. Area of loss of thickness, 20 x 10 x up to 3mm. (photo 47)
8. Vertical fracture, 1800 x 1mm.
9. Area of loss of section to lower angle, 2000 x 45mm. (photo 48)
10. Area of loss of section to upper angle, 600 x 80mm.

Photograph 46: Diagonal fractures to north column of pier 2

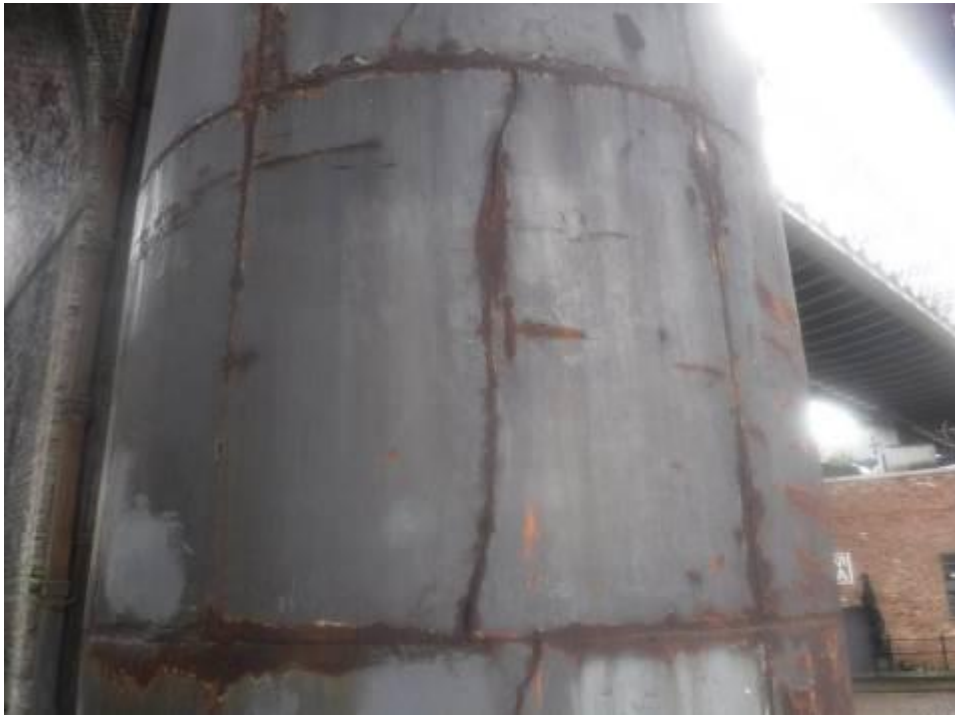
19. Vertical fracture, 2000 x up to 3mm. [\(photo 51\)](#)
20. Vertical fracture, 2000 x up to 2mm.
21. Area of loss of section to upper angle, 2000 x 80mm.

Photograph 51: Vertical fracture to south column of pier 2

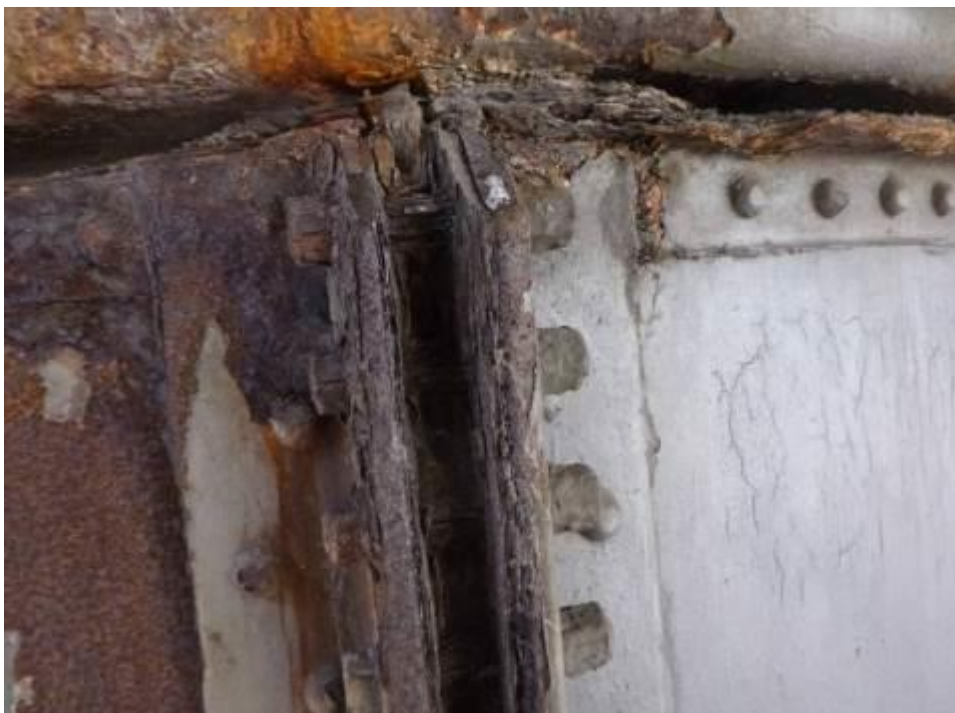
25. Diagonal fracture, 2800 x up to 2mm.
26. Diagonal fracture, 2000 x up to 2mm.
27. Vertical hairline fracture, 2000mm in length.
28. Clamp / stiffener missing packing timber with loss of thickness of up to 6mm to connection bolts. [\(photo 52\)](#)

Photograph 52: Missing packing timber & loss of thickness to south column of pier 2

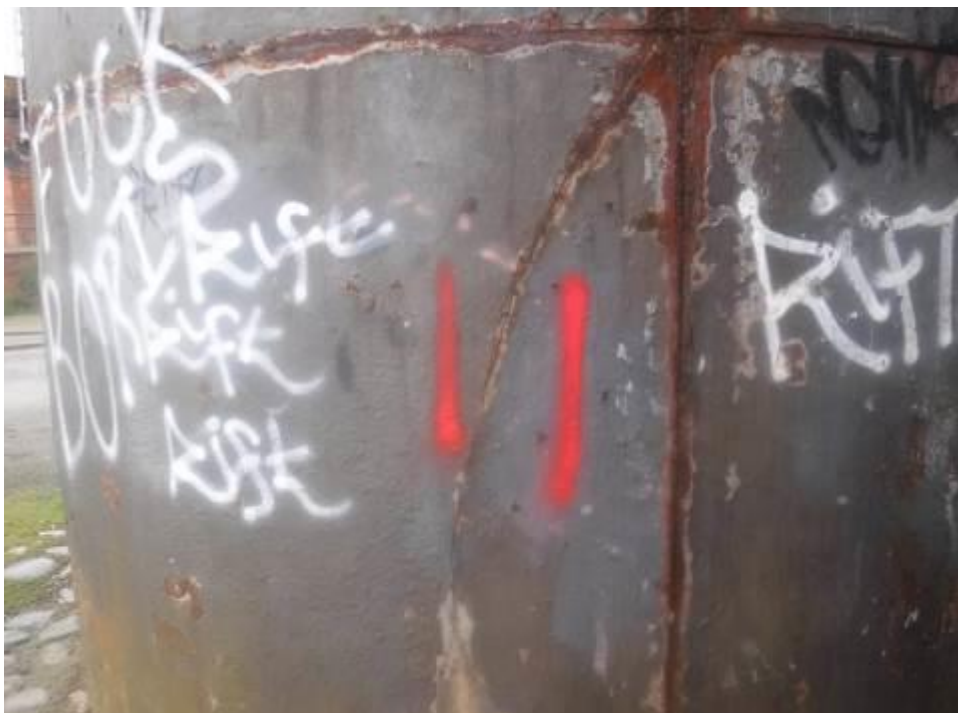
**North column:** [\(photo 53\)](#) There were areas of hairline map cracking to paintwork, paint loss and surface corrosion throughout, especially to panel joints. There were spot areas of graffiti to the base of the column, occasionally offensive. [\(photo 54\)](#)

9. Diagonal hairline fracture, 1200mm in length. [\(photo 54\)](#)
10. Diagonal hairline fracture, 900mm in length.
11. Vertical fracture, 2000 x up to 2mm. [\(photo 57\)](#)

Photograph 54: Graffiti & diagonal fracture to north column of pier 3

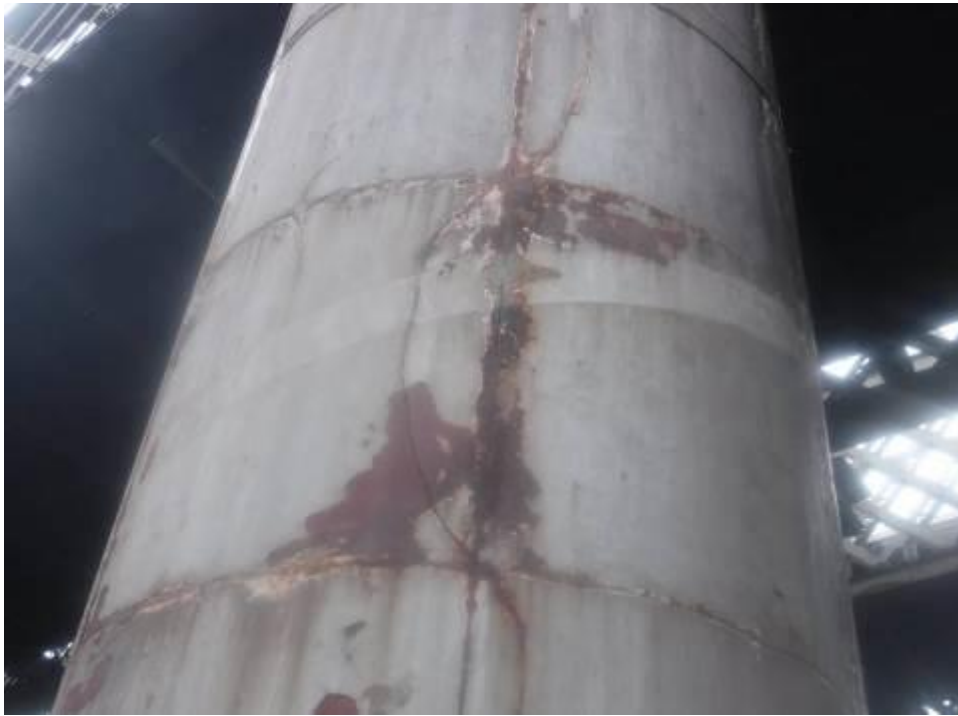
5. Vertical hairline fracture, 900mm in length.
6. Area of loss of thickness, 1000 x 600 x up to 2mm.
7. Vertical hairline fracture, 300mm in length.
8. Vertical fracture, 2000 x 1mm. [\(photo 57\)](#)

12. Area of loss of thickness, 2000 x 200 x 1mm. [\(photo 57\)](#)
13. Vertical fracture, 1700 x 1mm. [\(photo 57\)](#)
14. Area of loss of section to upper angle, 2000 x 80mm.

Photograph 57: Vertical fractures & loss of thickness to north column of pier 3

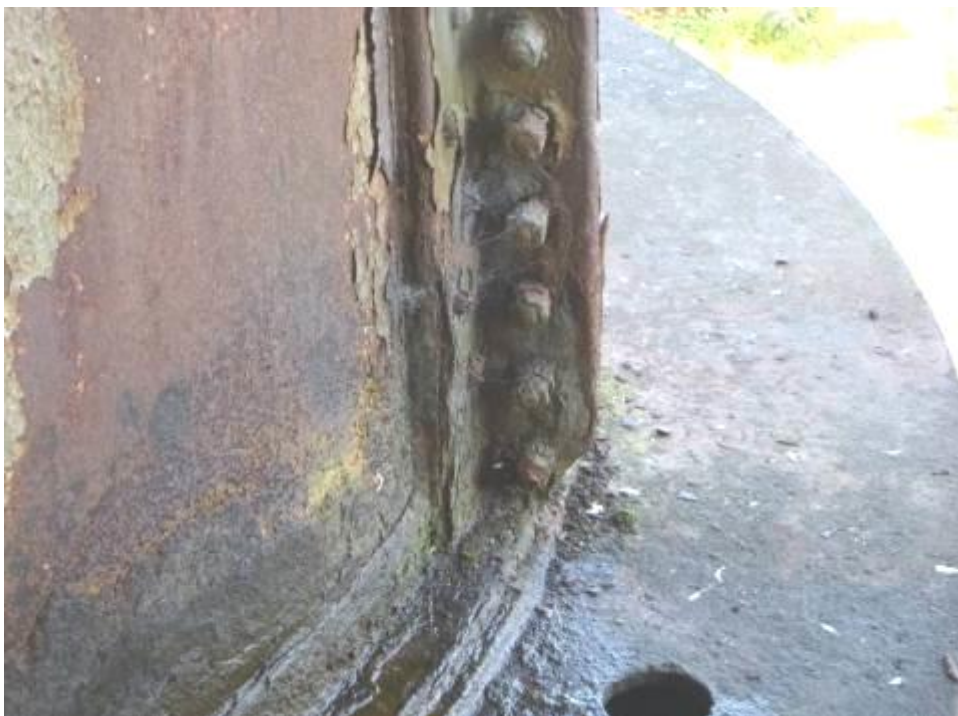
Photograph 58: Area of loss of thickness to stiffener of north column of pier 3

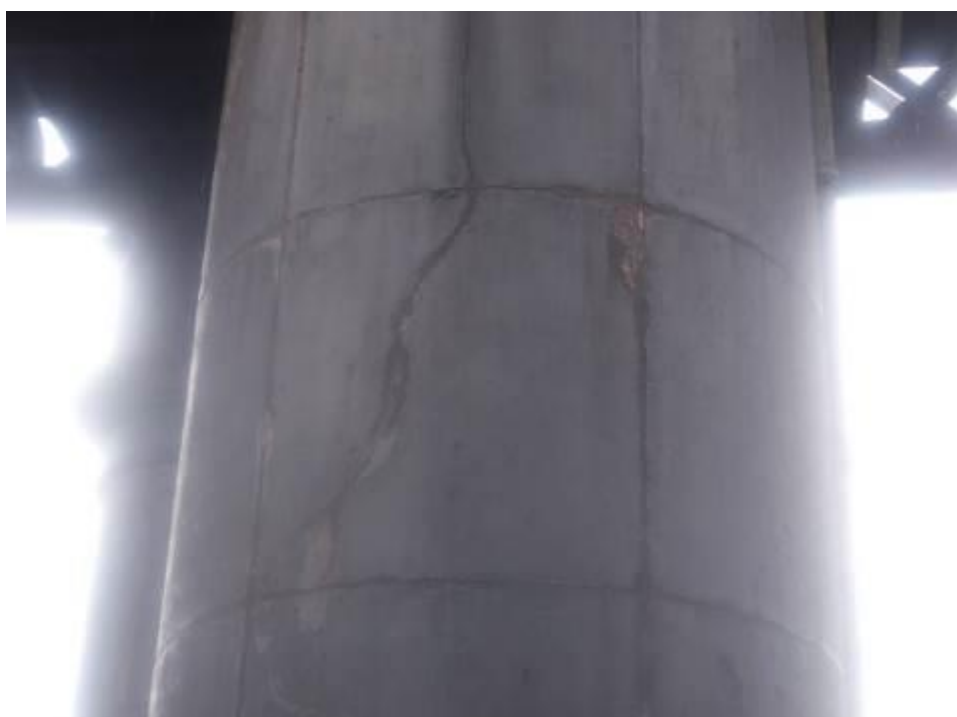
39. Vertical fracture, 2000 x up to 2mm. [\(photo 62\)](#)
40. Diagonal fracture, 2000 x up to 2mm. [\(photo 62\)](#)
41. Vertical hairline fracture, 600mm in length.

Photograph 62: Vertical & diagonal fractures to south column of pier 3

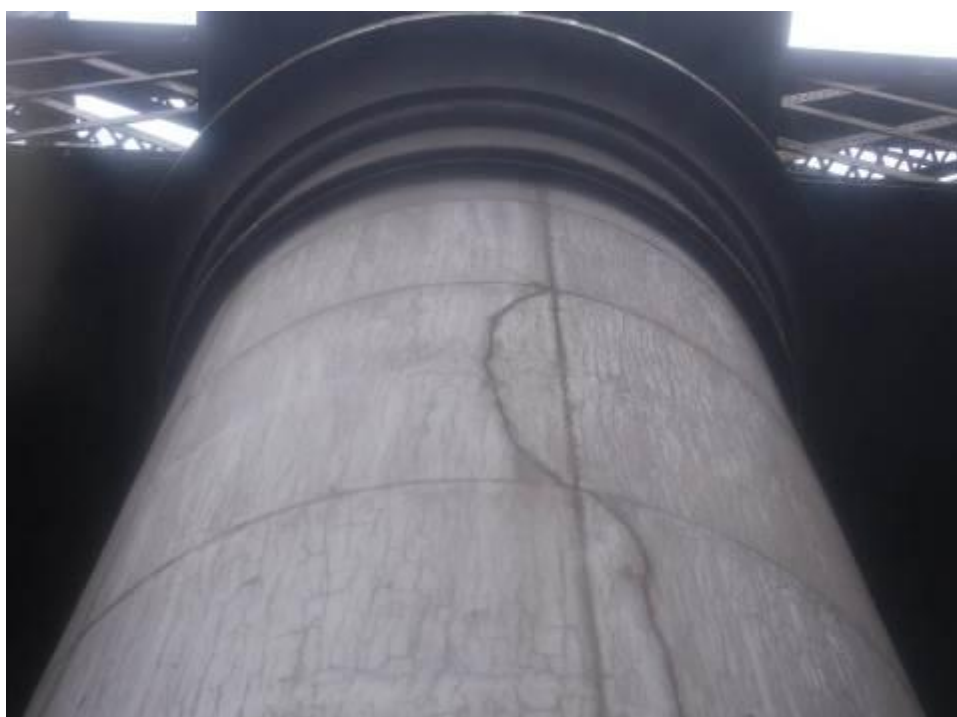
7. Diagonal hairline fracture, 300mm in length.
8. Diagonal hairline fracture, 300mm in length.
9. Diagonal hairline fracture, 400mm in length. [\(photo 66\)](#)

10. Vertical fracture, 2000 x up to 2mm. [\(photos 66 & 67\)](#)
11. Vertical fracture, 2000 x up to 2mm. [\(photo 66 & 67\)](#)
12. Vertical fracture, 1200 x 1mm.

Photograph 66: Vertical & diagonal fractures to north column of pier 4

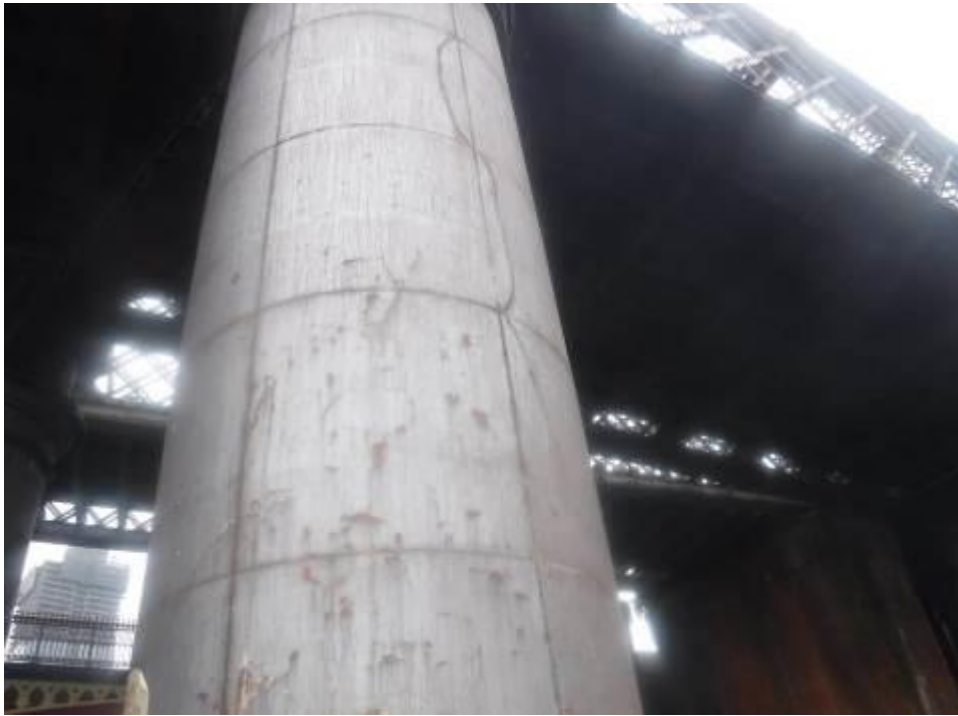
Photograph 67: Vertical fractures to north column of pier 4

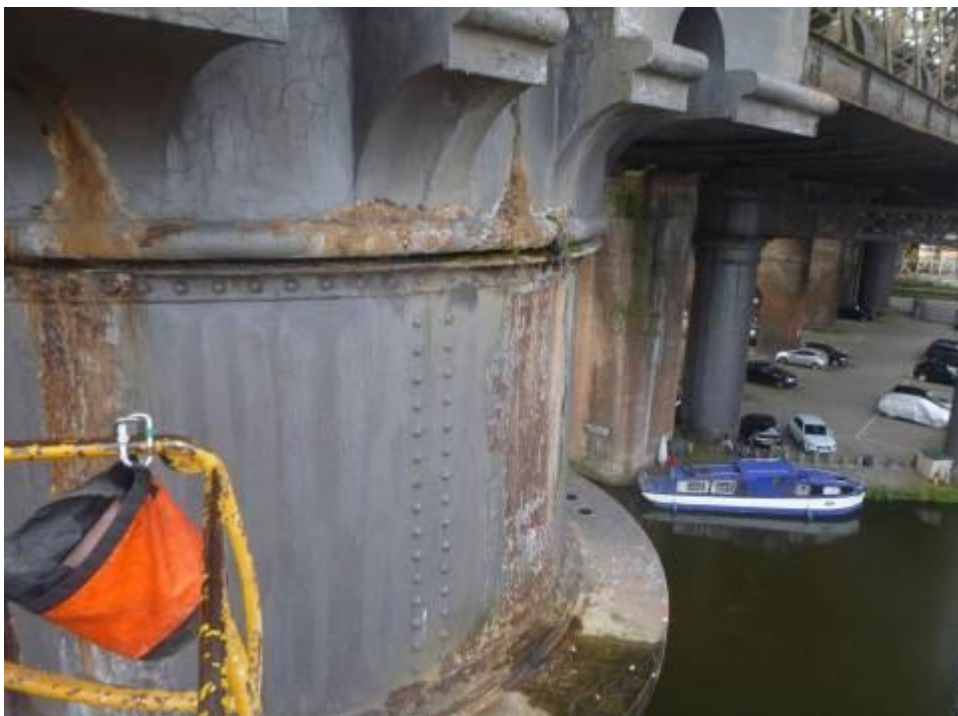
13. Area of seepage and loss of thickness, 1500 x 300 x up to 3mm. [\(photo 68\)](#)
14. Vertical fracture, 2000 x up to 2mm. [\(photo 69\)](#)
15. Vertical fracture, 2000 x up to 2mm. [\(photo 69\)](#)

Photograph 68: Area of seepage & loss of thickness to north column of pier 4

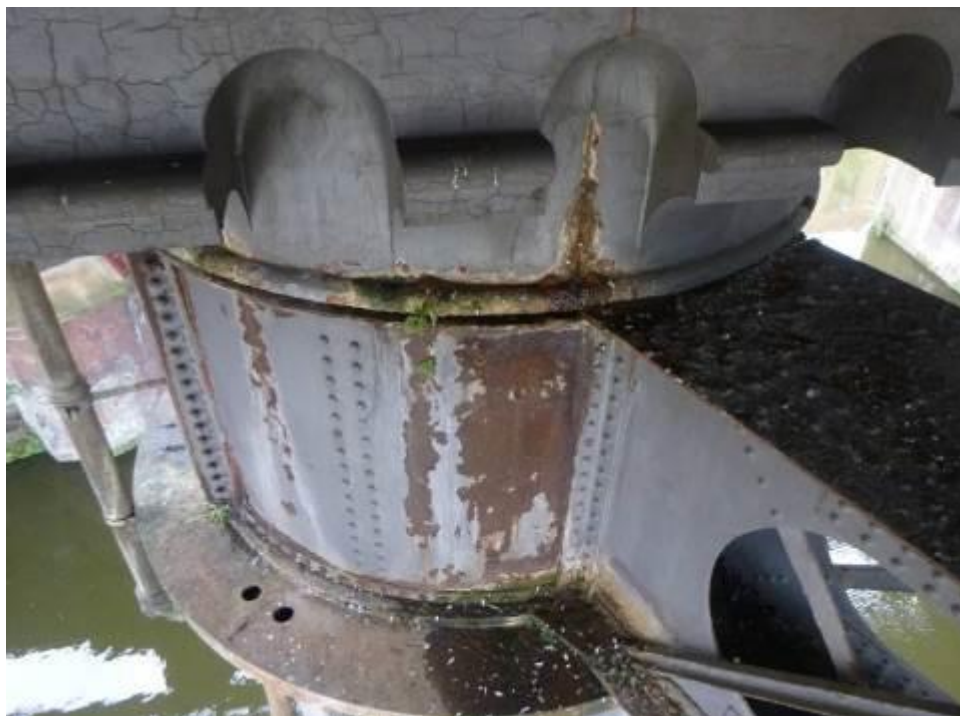
Photograph 70: Area of seepage & loss of thickness to south column of pier 4

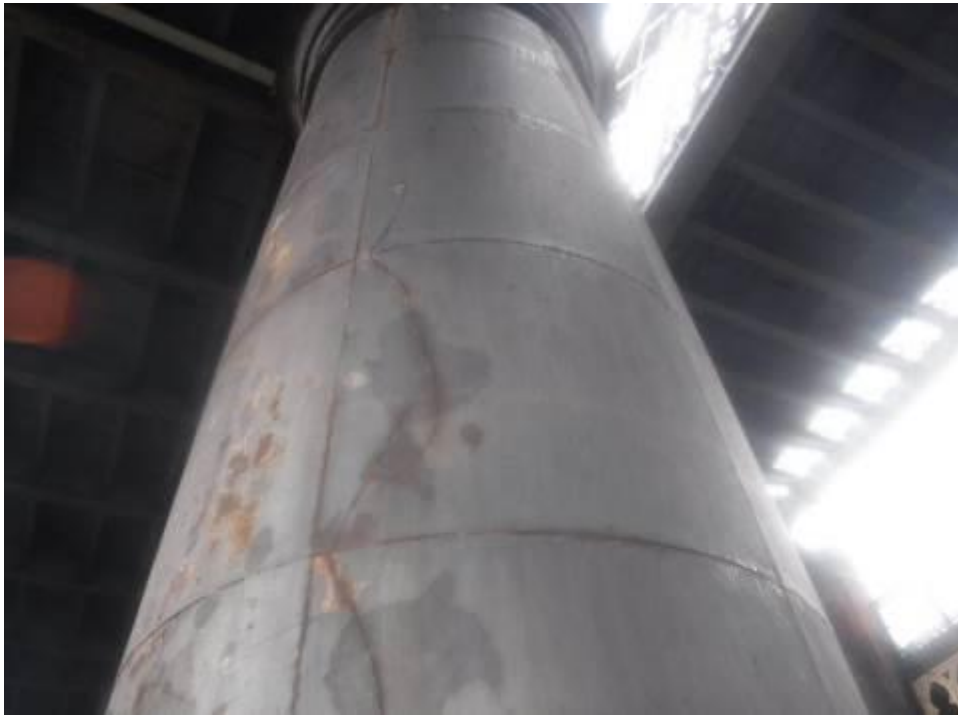
22. Diagonal hairline fracture, 1400mm in length. [\(photo 71\)](#)

- 23. Vertical fracture, 1800 x up to 2mm. [\(photo 71\)](#)
- 24. Vertical fracture, 900 x up to 2mm. [\(photo 71\)](#)
- 25. Vertical branched fracture, 2000 x up to 2mm. [\(photo 72\)](#)
- 26. Vertical hairline fracture, 400mm in length.
- 27. Vertical fracture, 600 x 1mm.
- 28. Area of loss of thickness to upper angle, 4000 x 80 x up to 3mm, with loss of section 2000 x 70mm.
- 29. Vertical fracture, 2000 x 1mm.
- 30. Area of seepage and spot vegetation growth. [\(photo 73\)](#)
- 31. Area of loss of thickness, 1500 x 1000 x up to 5mm.
- 32. Area of loss of thickness, 100 x 120 x up to 2mm. [\(photo 74\)](#)
- 33. Vertical fracture, 2000 x 1mm. [\(photo 74\)](#)
- 34. Area of loss of thickness to drainpipe bracket, 80 x 30 x up to 5mm, with loss of section, 60 x 15mm. [\(photo 75\)](#)

Photograph 71: Vertical fractures to south column of pier 4

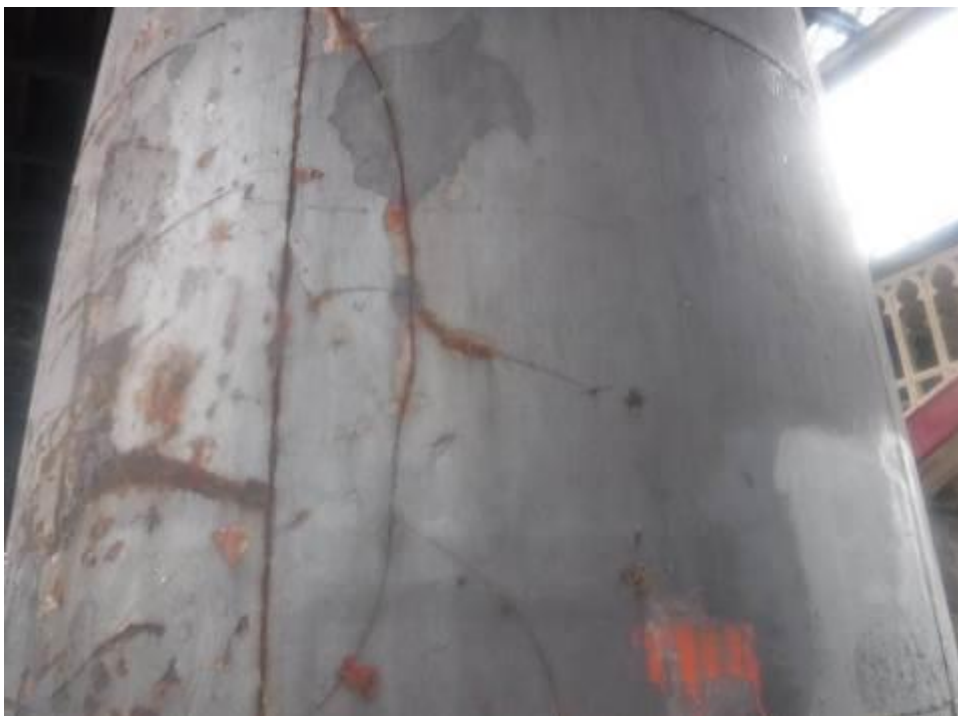
Photograph 72: Vertical branched fracture to south column of pier 4

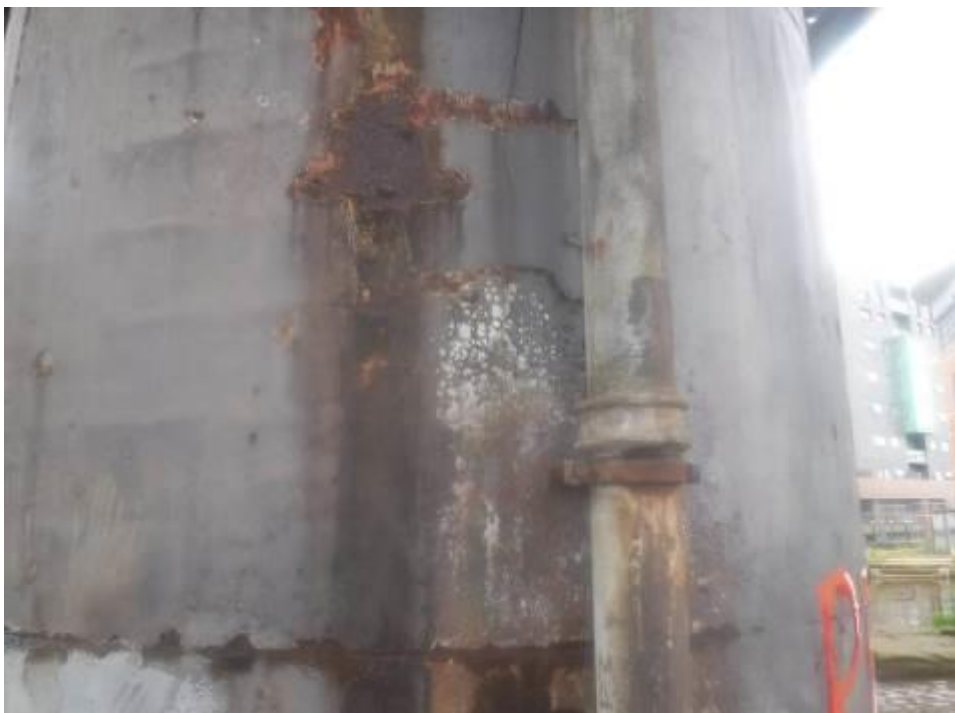
Photograph 74: Area of loss of thickness & vertical fracture to south column of pier 4

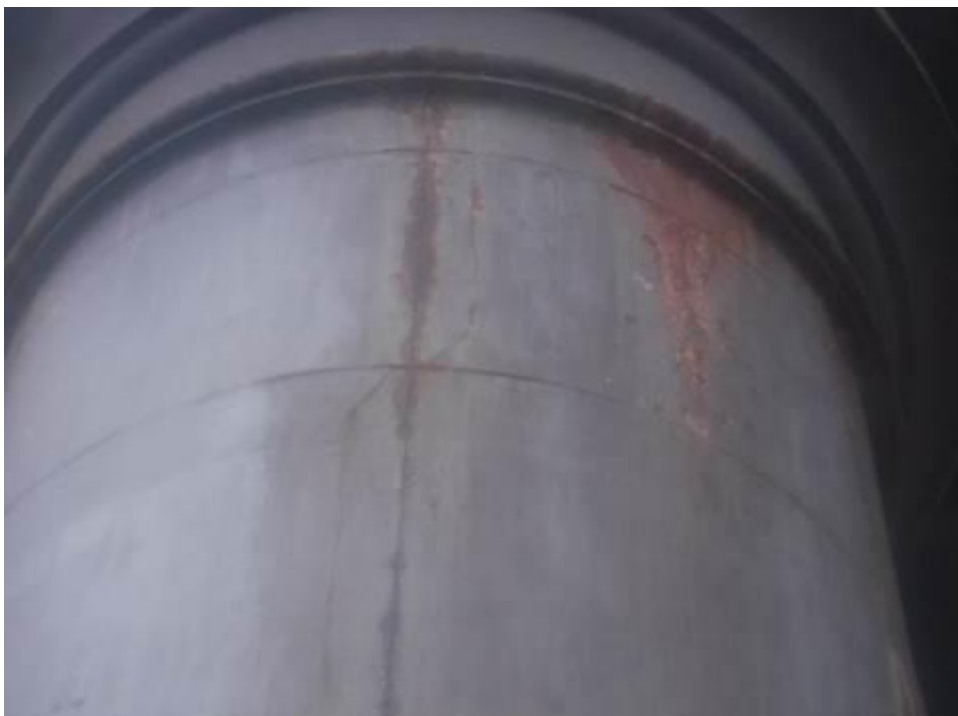
1. Horizontal hairline fracture, 1000mm in length.
2. Vertical fracture, 5000 x up to 2mm. [\(photo 78\)](#)
3. Vertical fracture, 5000 x 1mm.
4. Area of loss of thickness, 5000 x 200 x 1mm. [\(photo 79\)](#)
5. Diagonal hairline fracture, 1200mm in length.
6. Area of loss of thickness, 5000 x 200 x 1mm.

Photograph 78: Vertical fracture to north column of pier 5

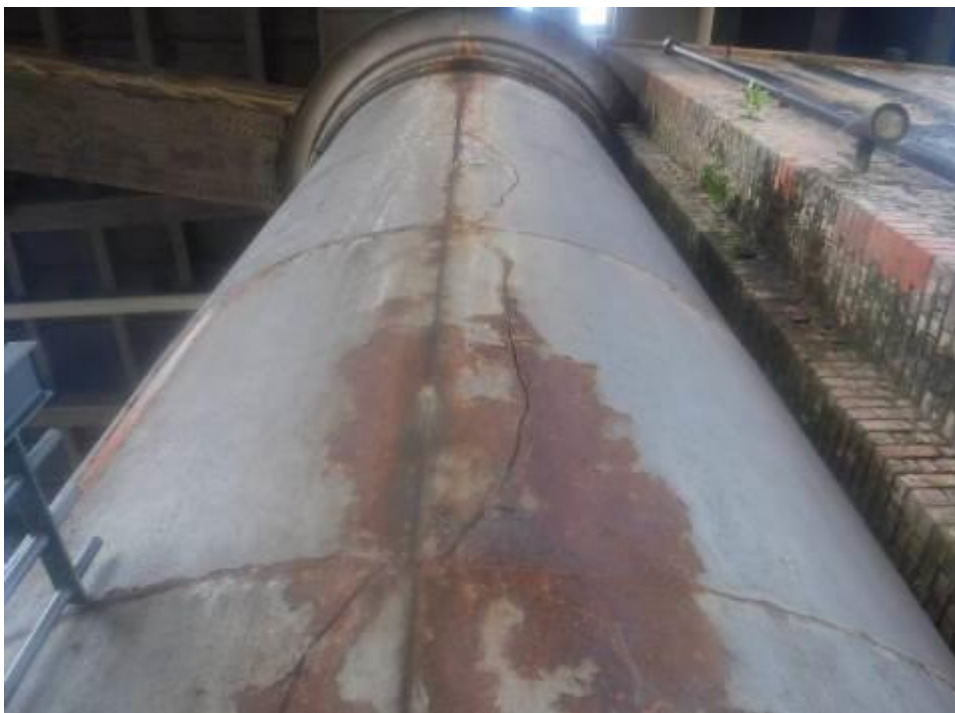
Photograph 82: Vertical fracture & area of loss of thickness to south column of pier 6

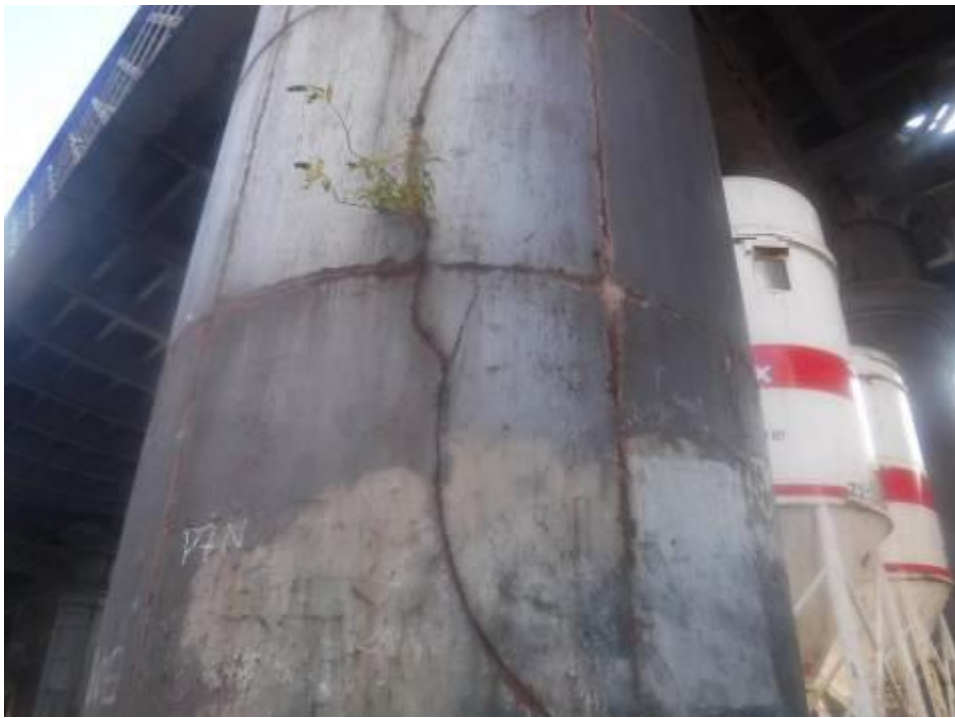
Photograph 85: Vertical branched fracture & buddleia growth to north column of pier 7

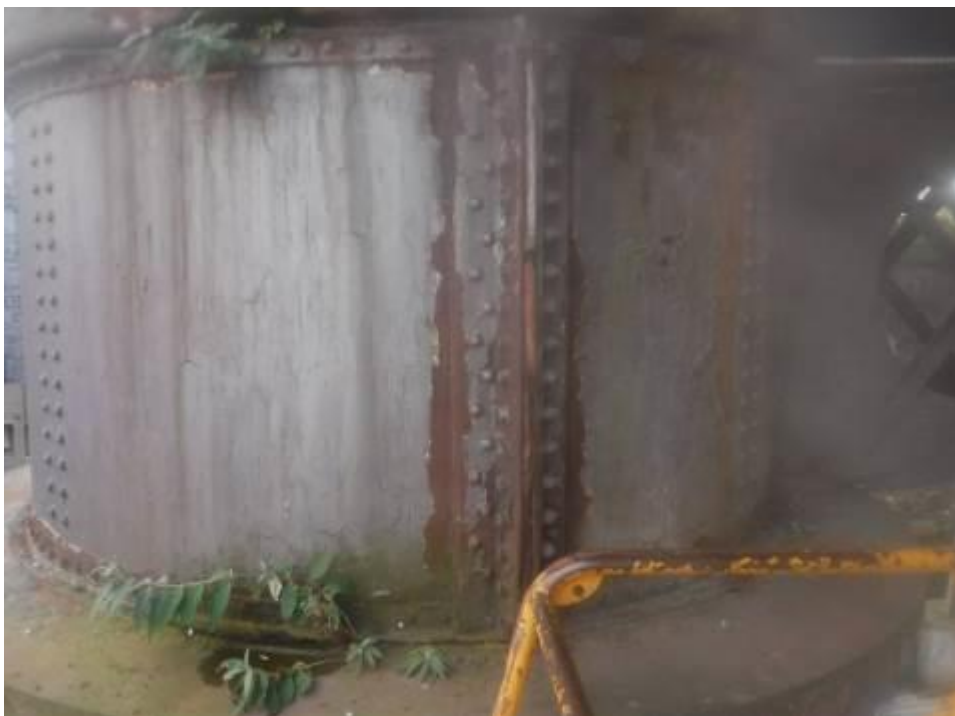
Photograph 86: Vegetation growth & loose / missing / rotten packing timber to north column of pier 7

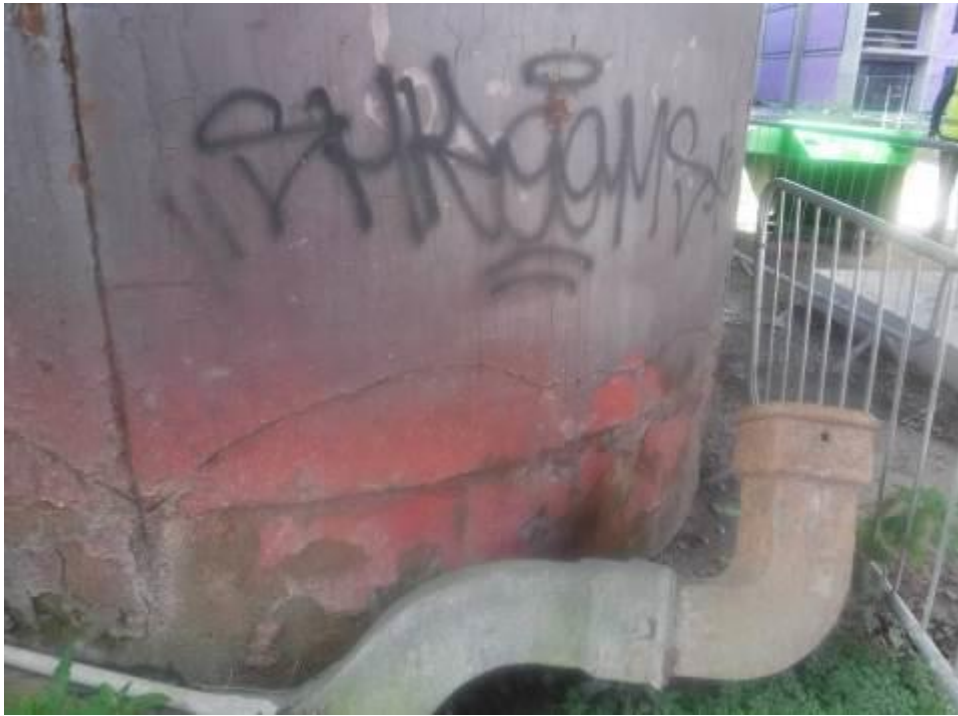
Photograph 87: Horizontal fracture to south column of pier 7

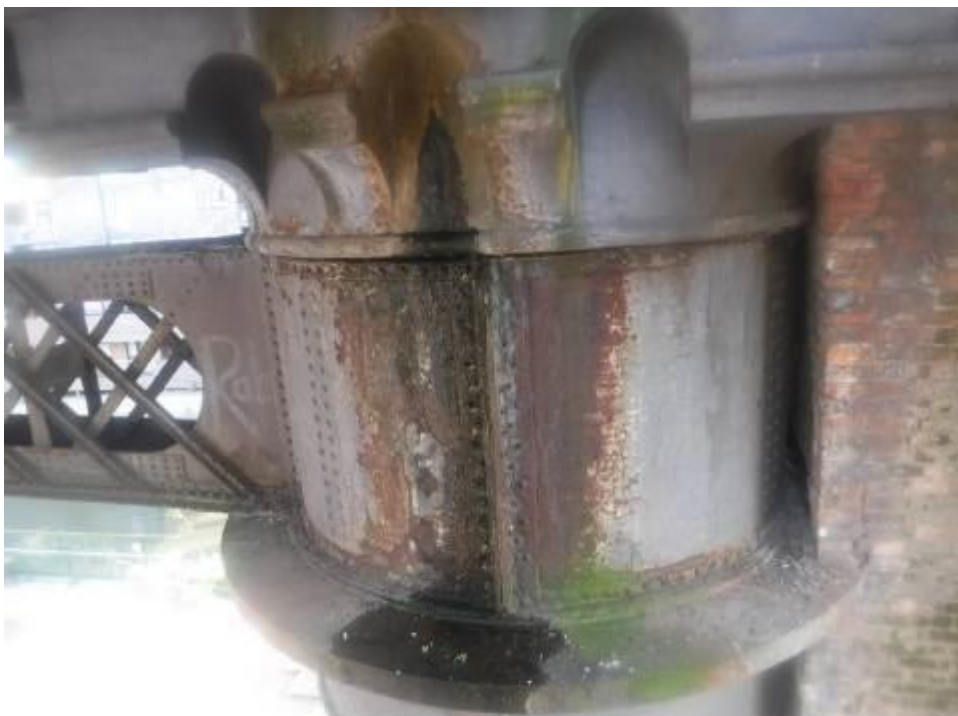
Photograph 88: Area of seepage to south column of pier 7

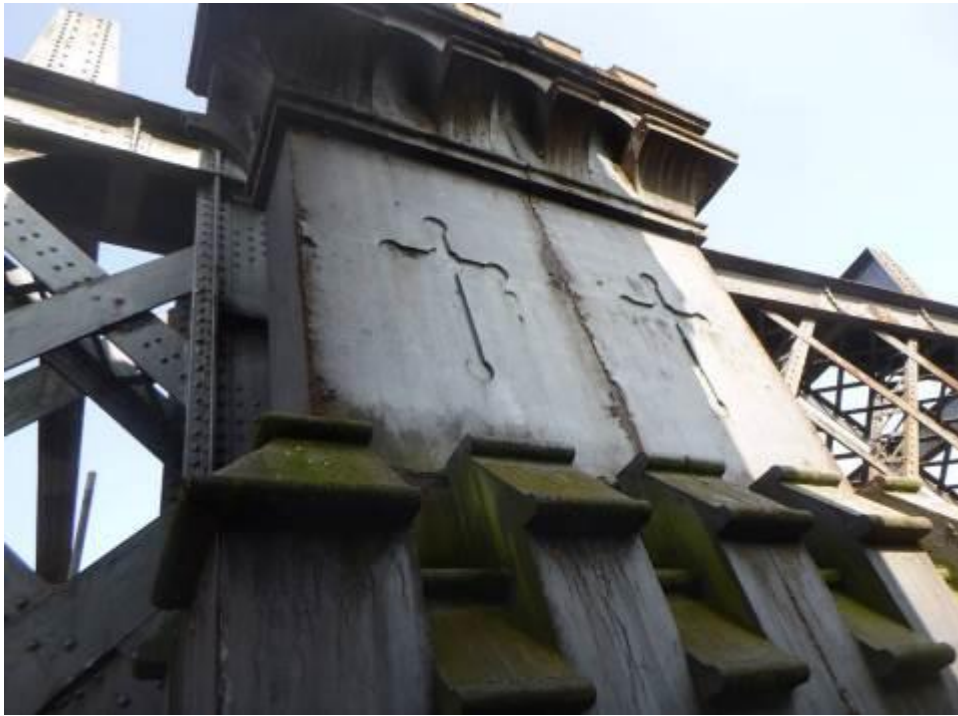
Photograph 89: Typical condition of castle façades to piers

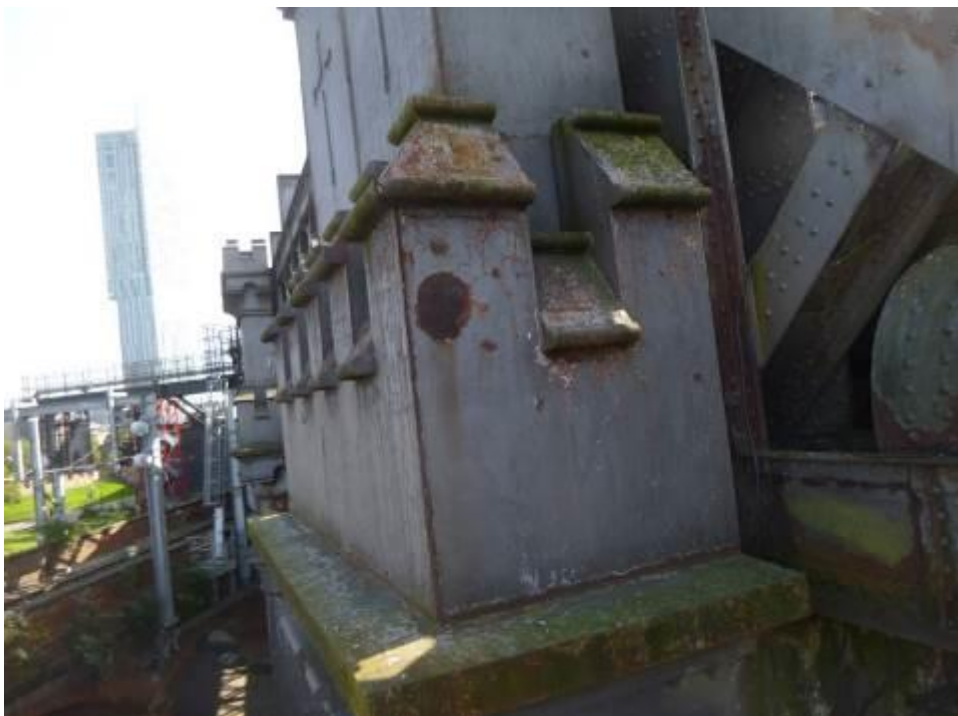
Photograph 90: Typical paint loss & surface corrosion to castle façades of piers

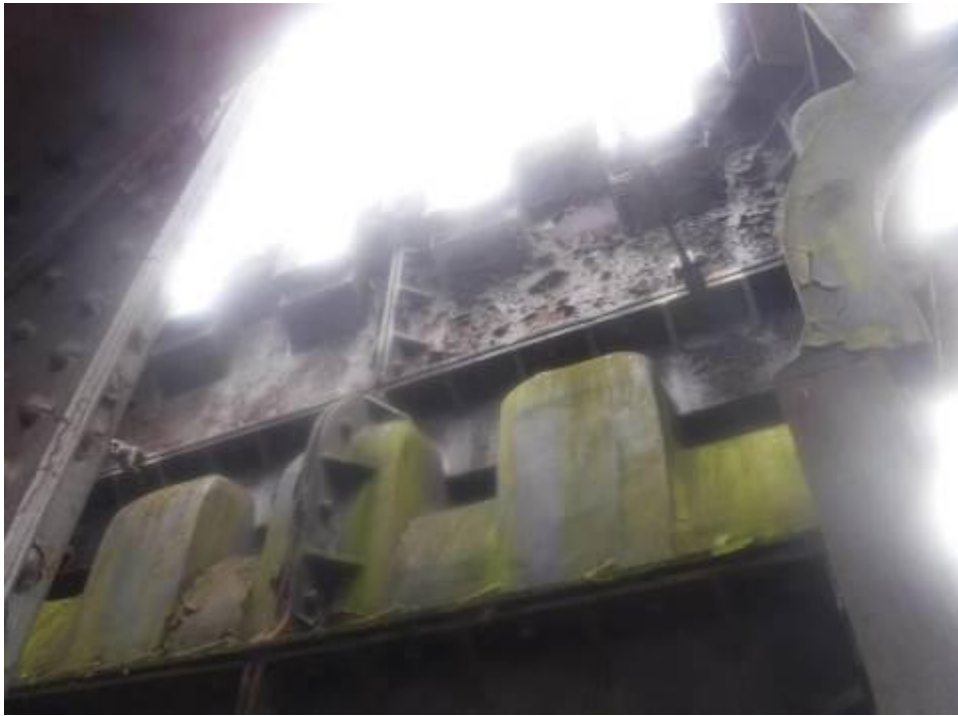
Photograph 91: Typical paint loss & surface corrosion to castle façades of piers

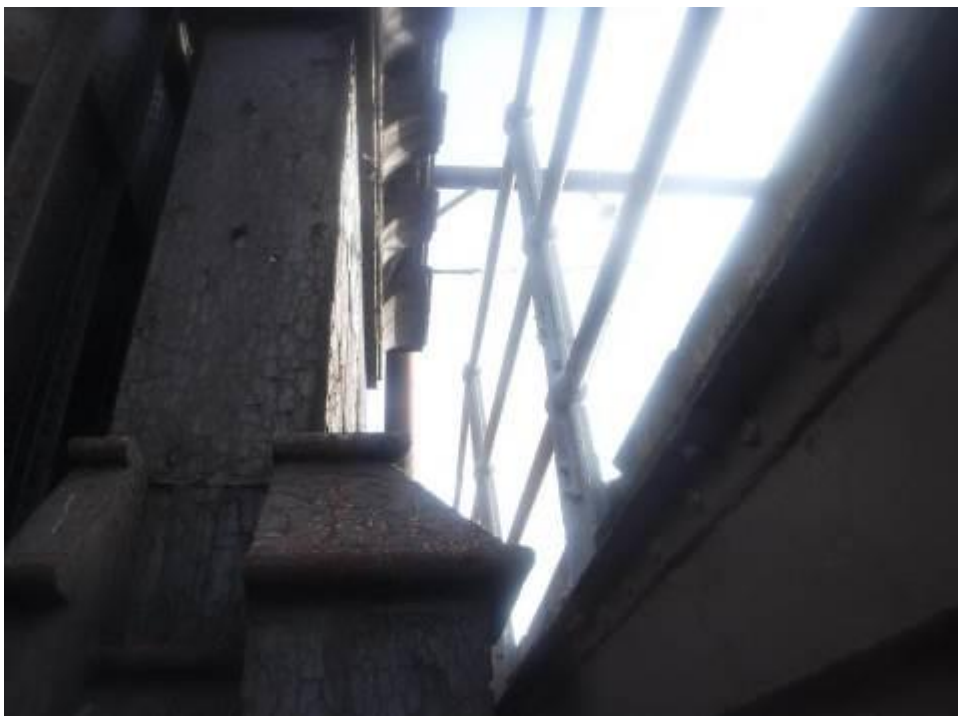
Photograph 92: Typical proximity to Metrolink bridge & OLE of south castle façades to piers
