| ELR: MAJ | Structure No: 289 | Mileage: | Examination date: 07/09/2020 |
| Name: Castlefield Viaduct | | | Type: Viaduct |
| Carrying/Over: Disused rail / Canal, rail, road & land | | | No. of spans: 8 |

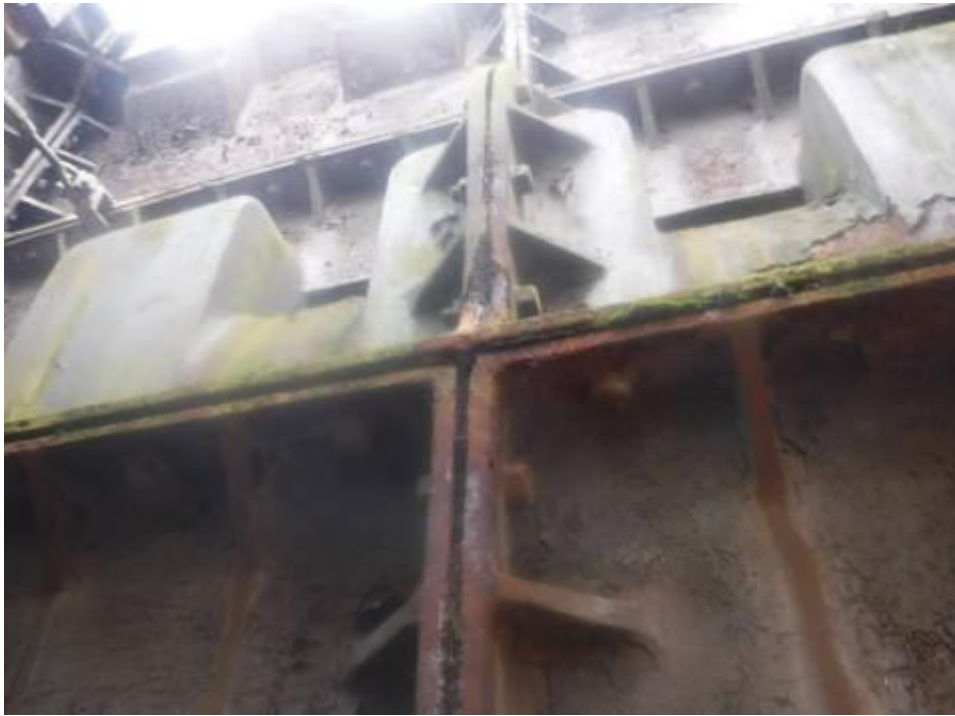
Photograph 93: Typical loss of thickness & rust jacking to panel joints of castle façades to piers

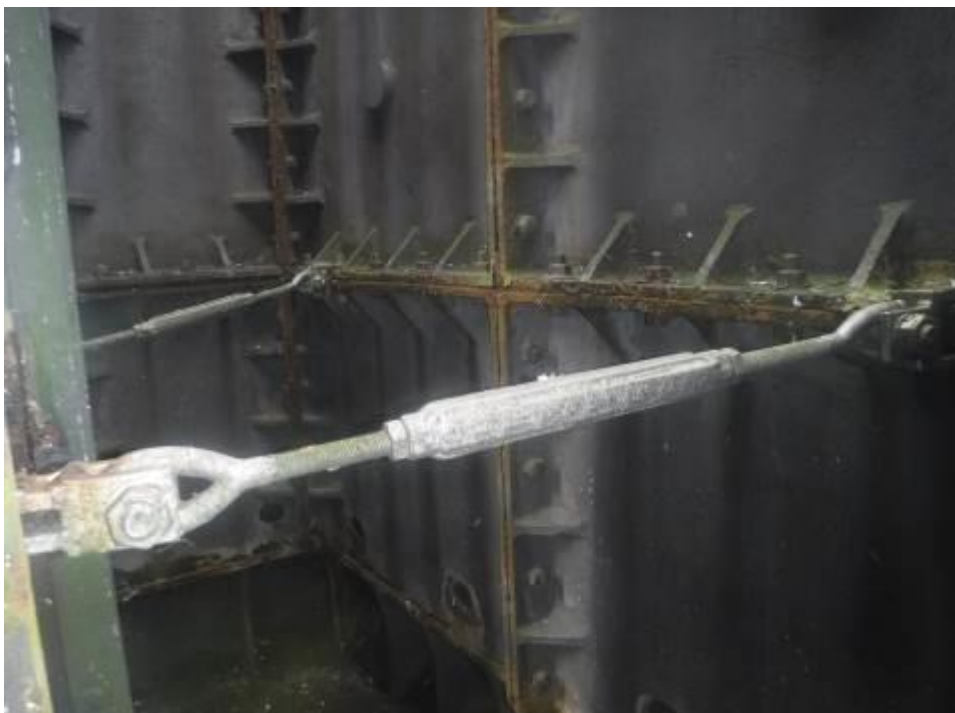
Photograph 94: Typical condition of tie bar connections to castle façades of piers

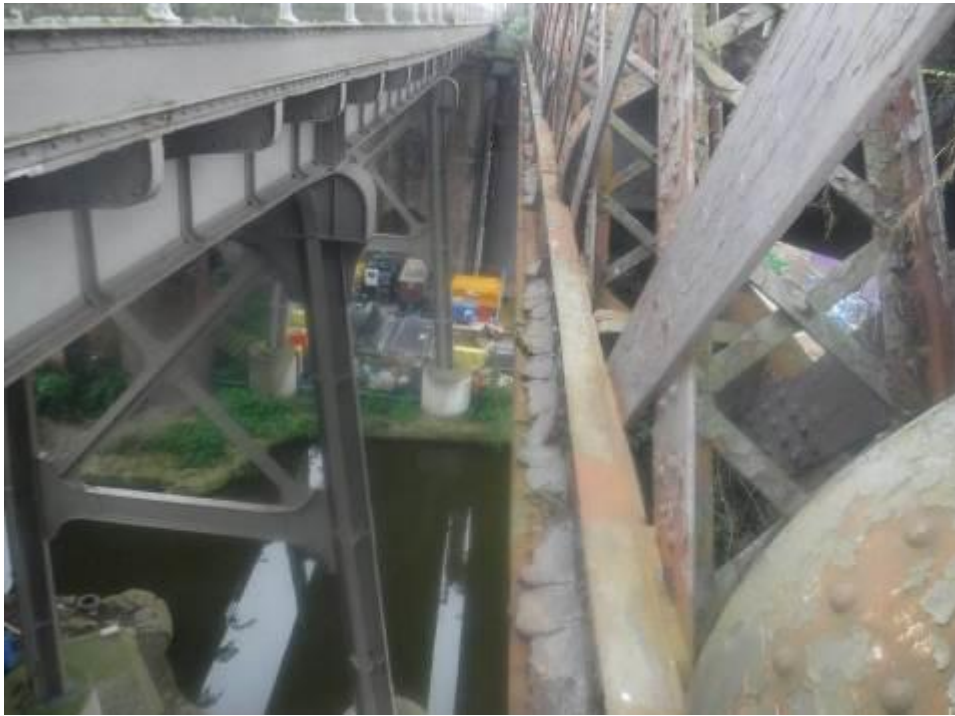
Photograph 97: Typical cracked / loose / missing mortar to bottom flanges of bottom booms

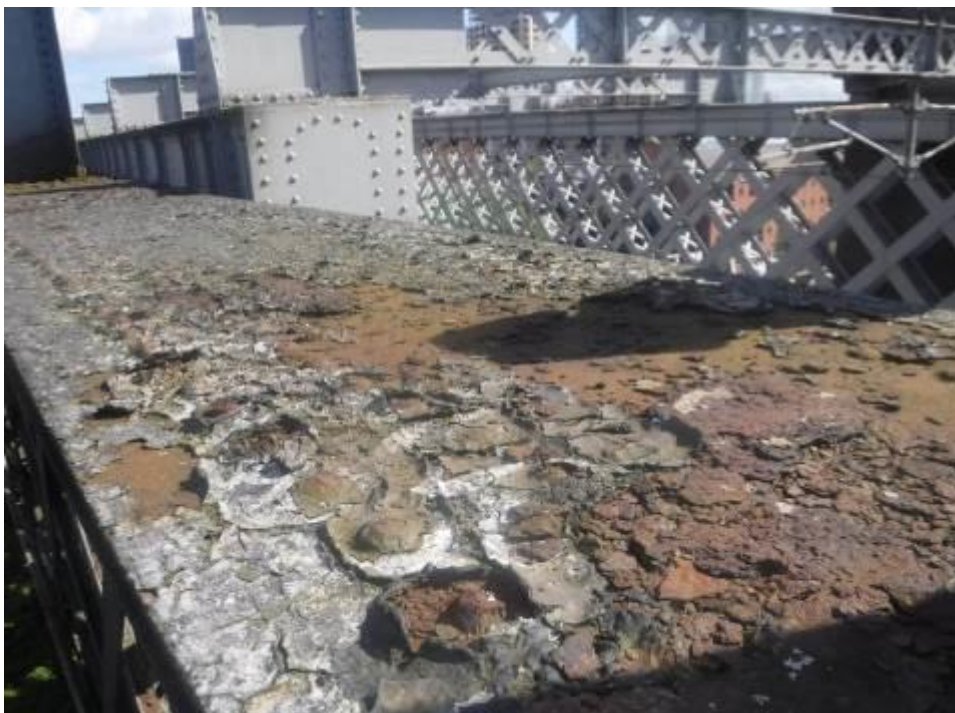
Photograph 98: Typical pitting & missing / pointed rivet heads to top flanges of top booms

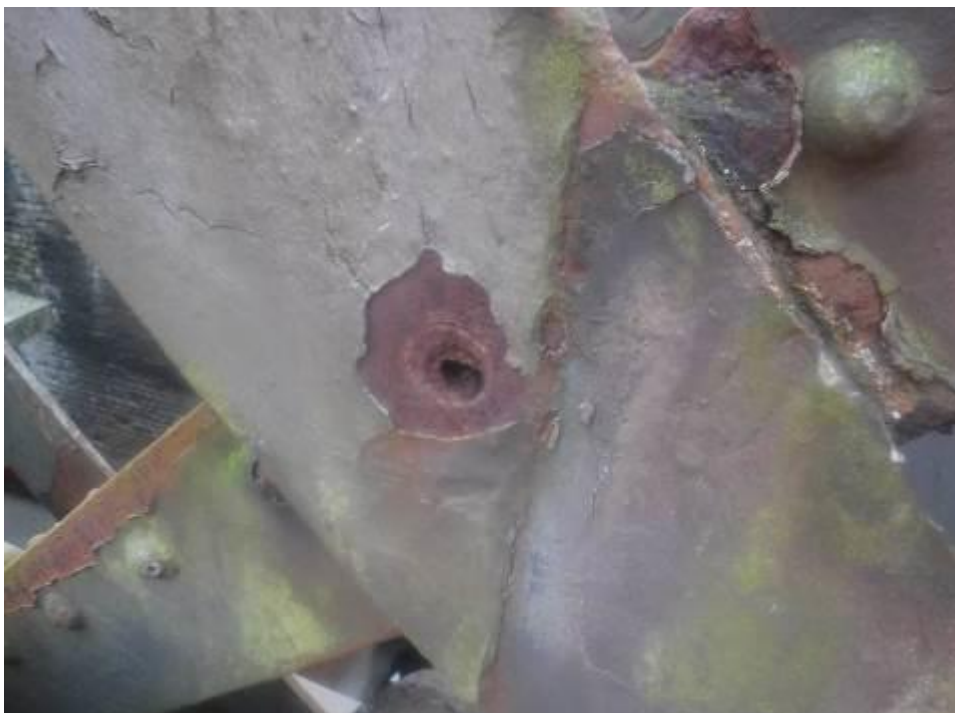
Photograph 108: Missing rivet to south truss of span 2

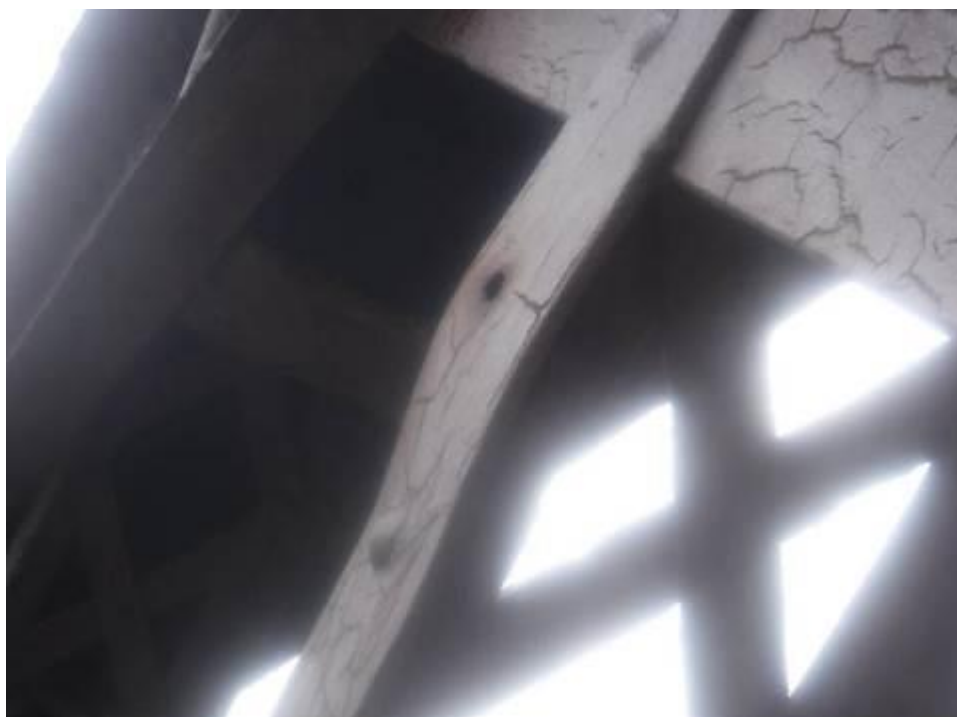
Photograph 127: Deformation & missing rivet to diagonal member of south truss of span 4

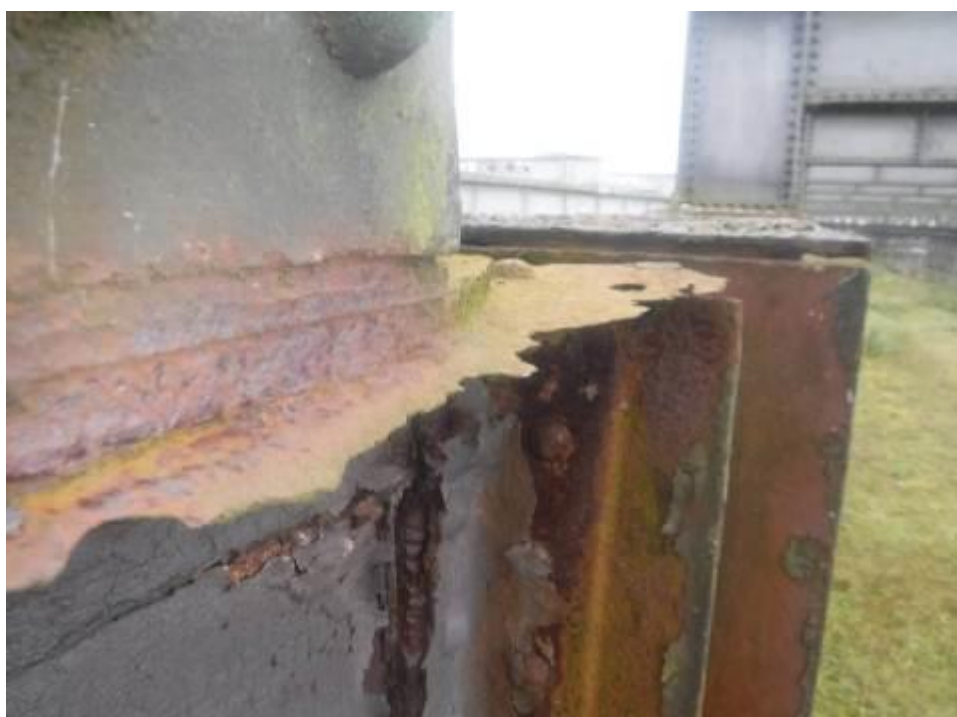
Photograph 128: Loss of section to top boom of south truss of span 4

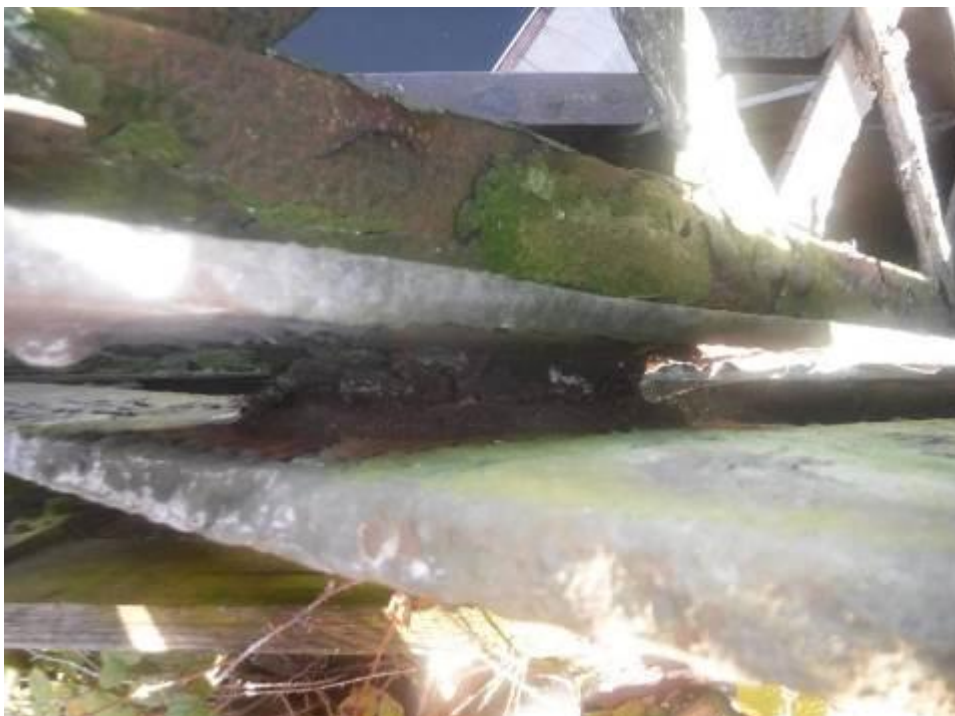
Photograph 136: Rust jacking to diagonal member of north truss of span 5

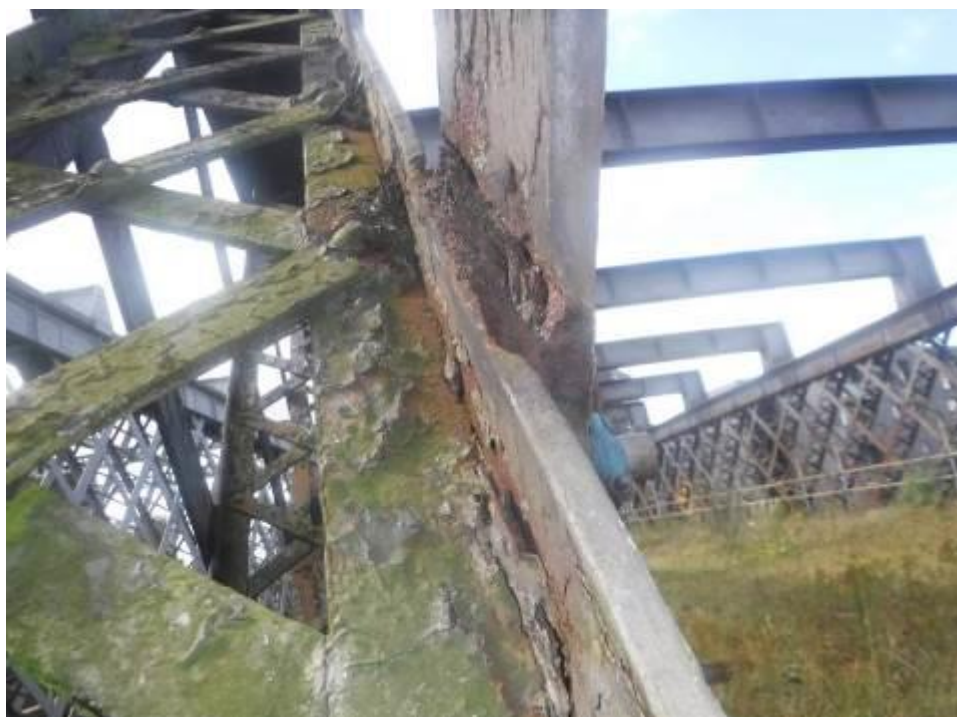
Photograph 143: Loss of thickness & rust jacking to diagonal member of south truss of span 5

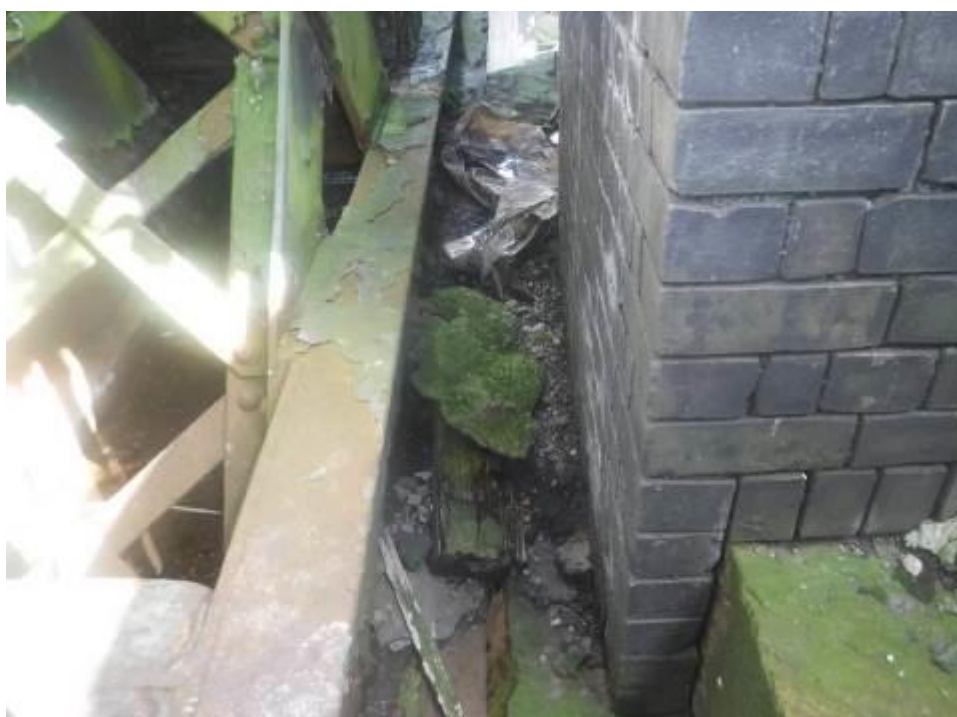
Photograph 144: Debris build-up between south truss of span 5 & adjacent structure

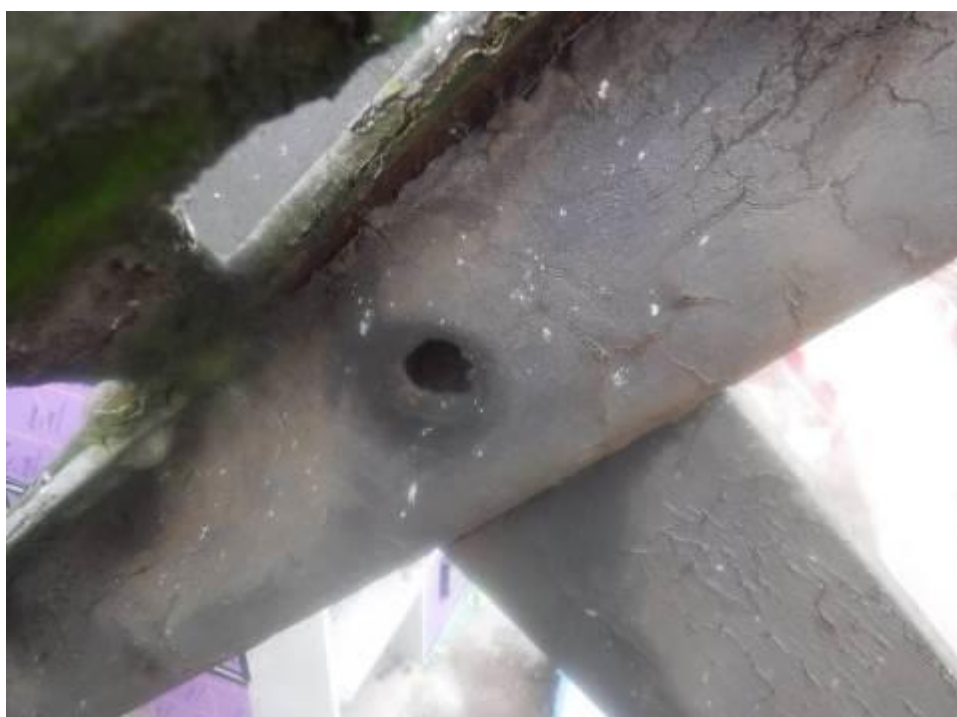
Photograph 164: Missing rivet to diagonal bracing of north truss of span 8

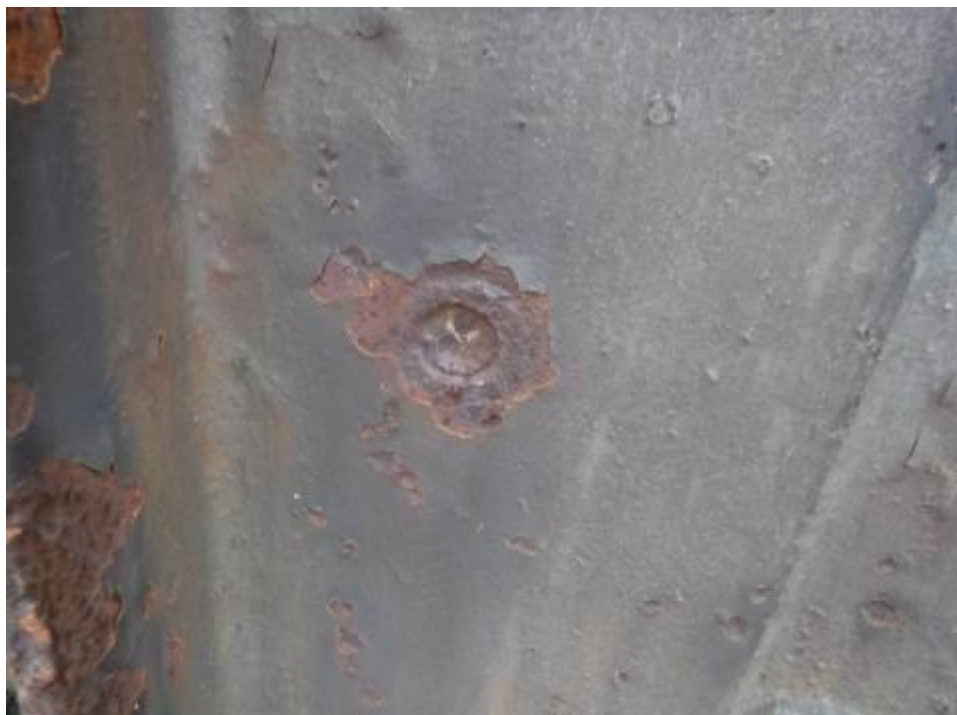
Photograph 169: Missing rivet to end plate of south truss of span 8

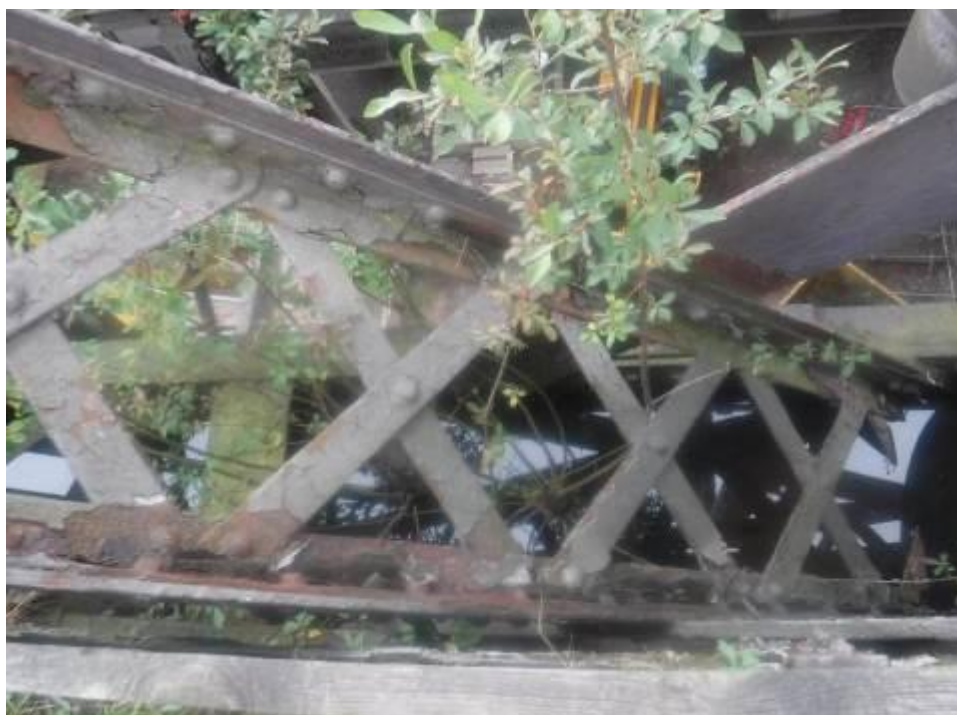
Photograph 170: Sapling growth to bottom boom of south truss of span 8

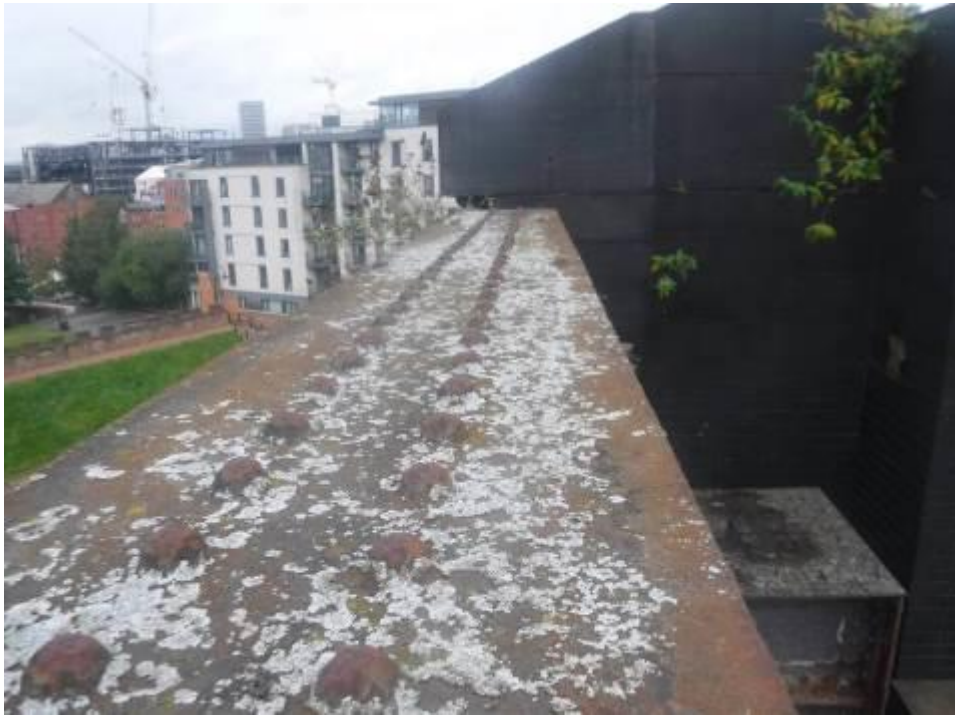
Photograph 173: Typical paint loss, surface corrosion & pitting to tops of upper transverse steelworks

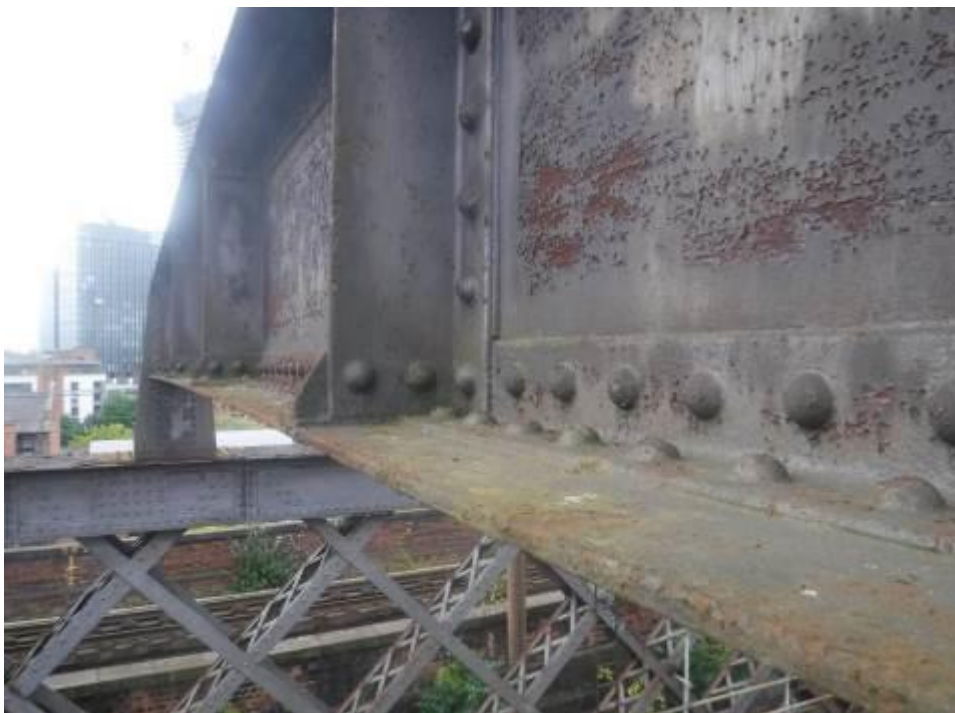
Photograph 174: Typical corrosion & pitting to webs of upper transverse steelworks

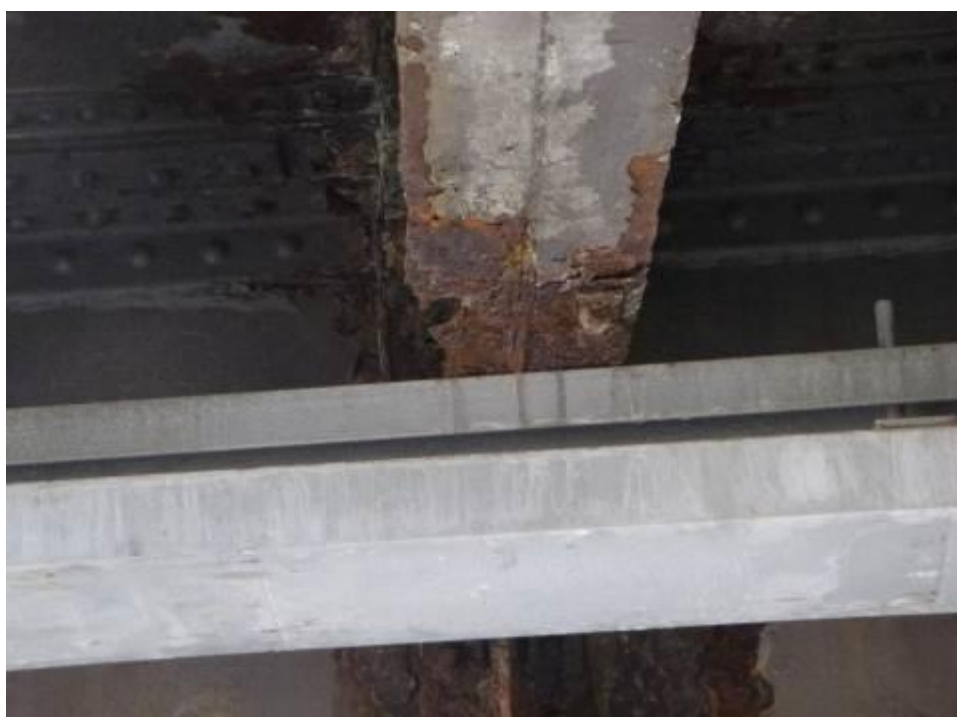
Photograph 182: Corrosion, pitting & loss of section to MG14 of soffit of span 2

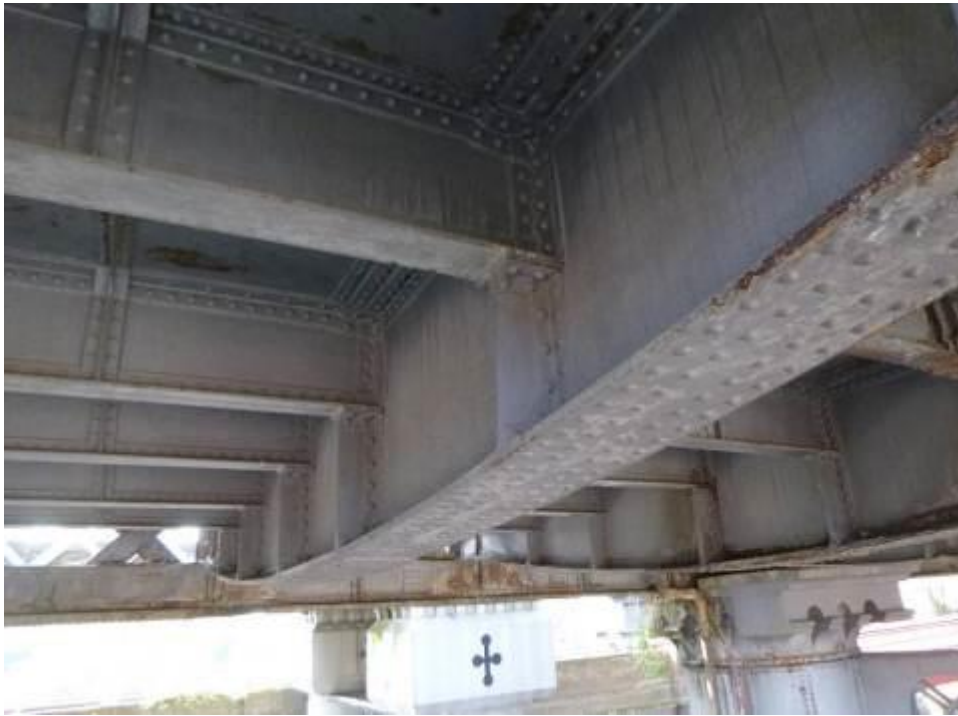
Main and transverse girders had minor areas of spot paint loss and surface corrosion. **(photo 185)** A new gutter system had been installed since the previous detailed examination. A lighting junction box to the soffit was in fair condition. **(photo 186)** Fault 1 was a good representation of all of span 3 at this location, i.e. 6 – 9mm loss of thickness to upper and lower flanges along lengths between 300 x 500mm and total loss of section to rivet heads. These faults were located just under the decks where water runs off. The bottom and rounded top flanges on the outside of these faults were generally also corroded with 2mm loss of thickness; where loss of section was significantly greater than this, it had been recorded. The end 50 to 100mm of the soffit decking was heavily corroded with 3-5mm loss of thickness and 50% loss of section to rivet heads.

Photograph 185: Typical spot paint loss & surface corrosion to soffit of span 3

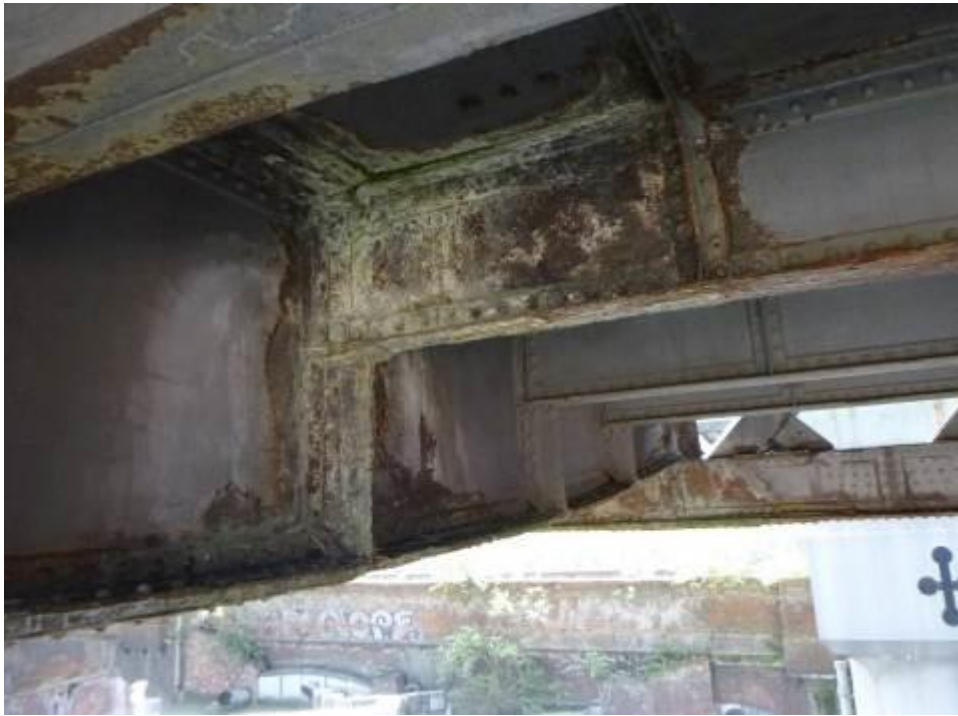
Photograph 189: Surface corrosion & loss of thickness to MG14 of soffit of span 3

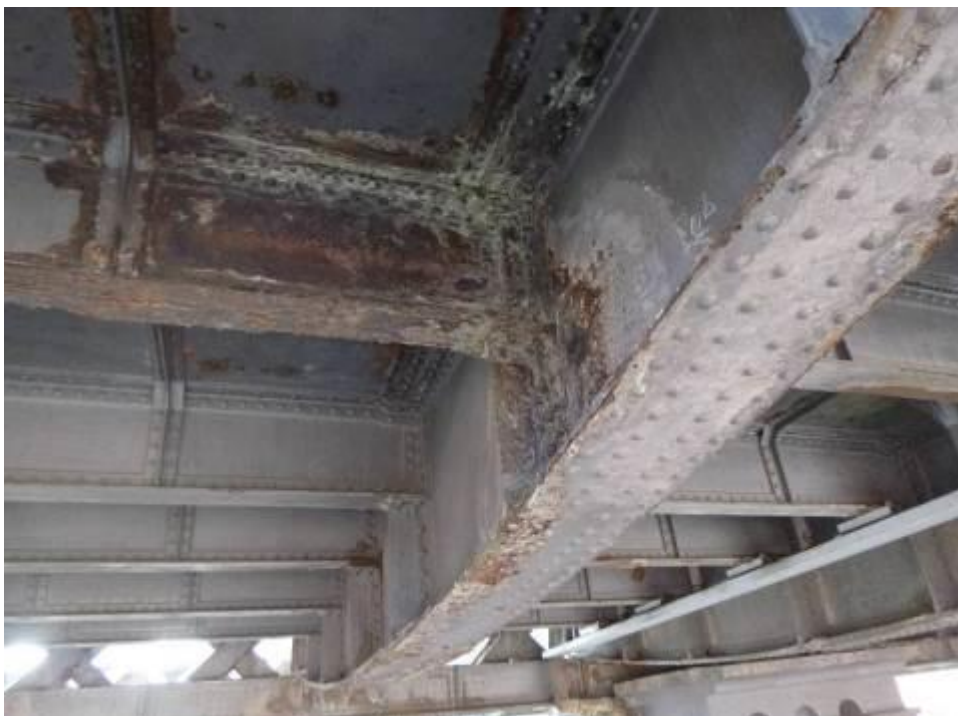
Photograph 190: Loss of thickness & pitting to MG12 & T31 of soffit of span 3

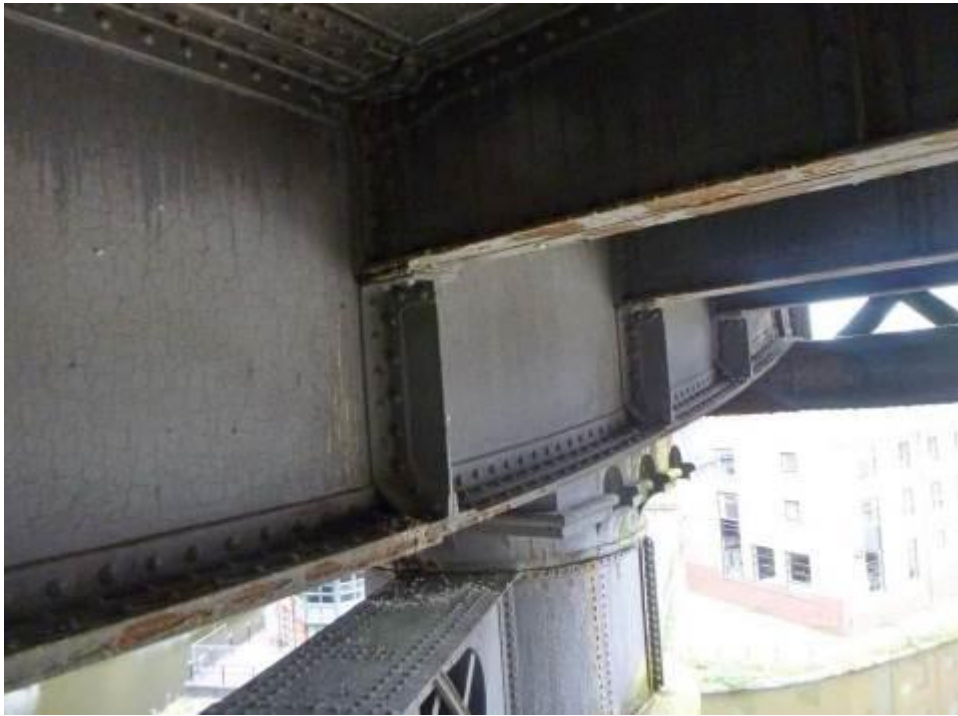
Photograph 193: Typical spot paint loss & surface corrosion to soffit of span 4

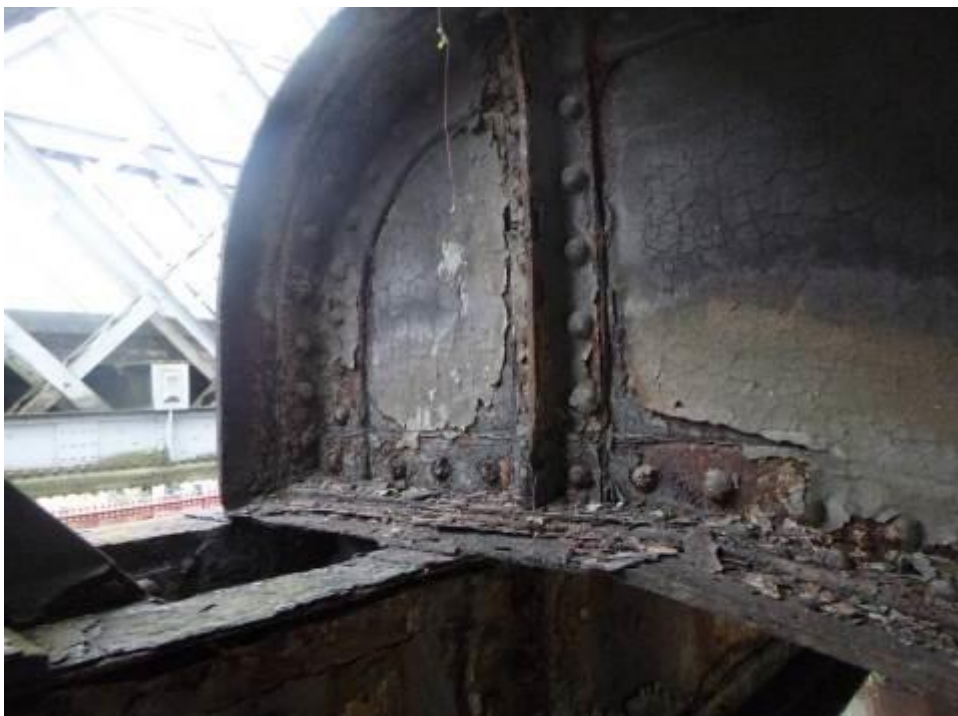
Photograph 194: Typical condition of main / transverse girder connections to soffit of span 4

Remove all areas of corrosion to connections between main and transverse girders at decks 2-8, repair/repaint - P3 £30k.

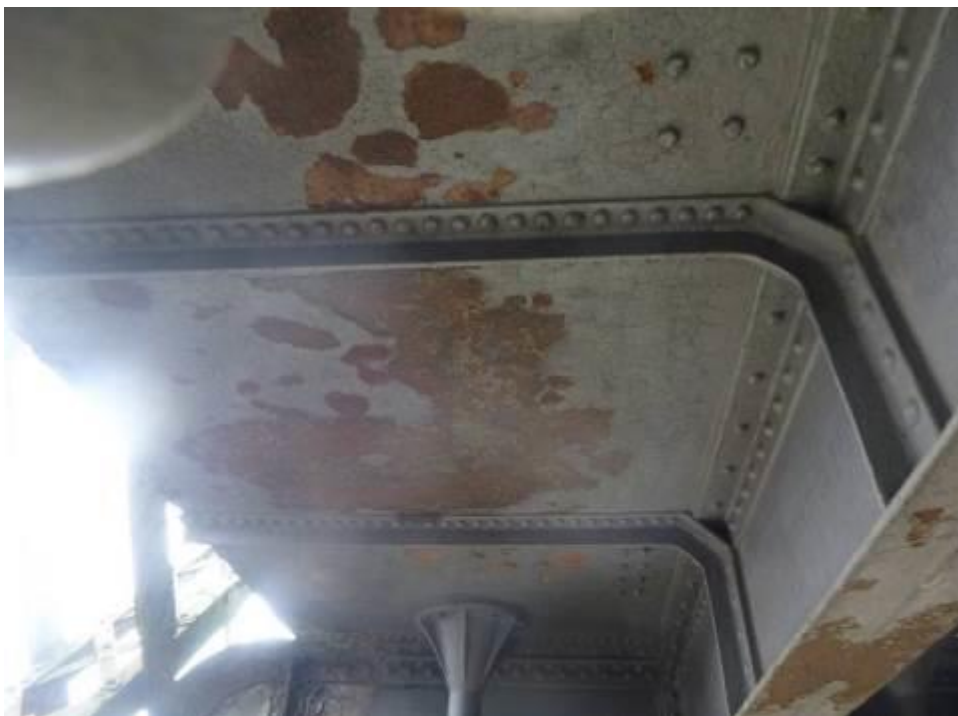
Photograph 196: Spot corrosion to deck of soffit of span 4

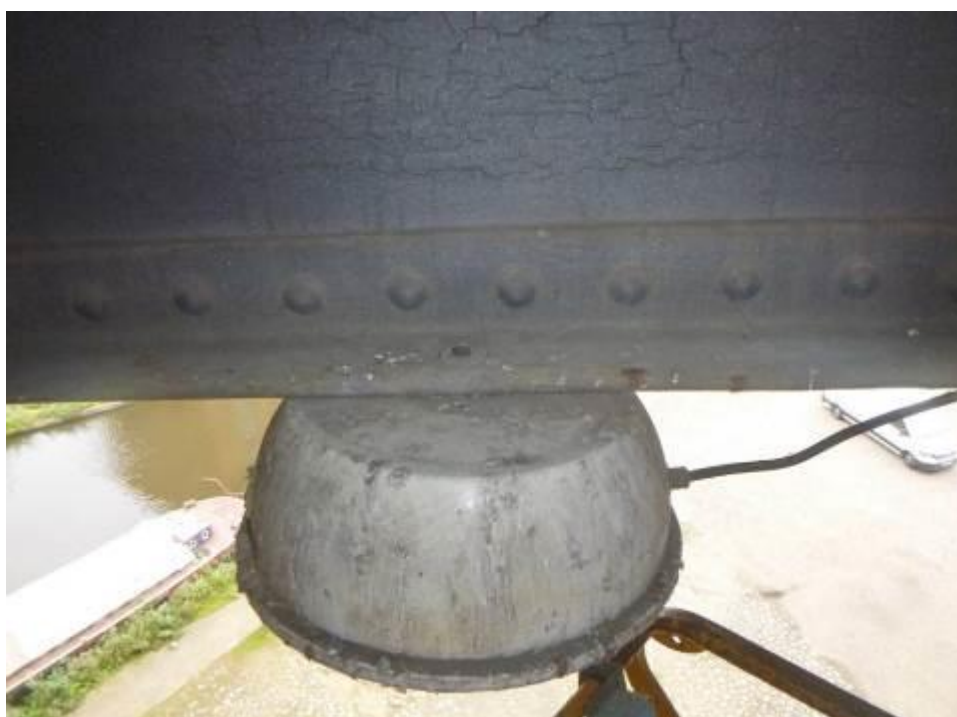
Photograph 198: Missing nut to fixing of lighting junction of soffit of span 4

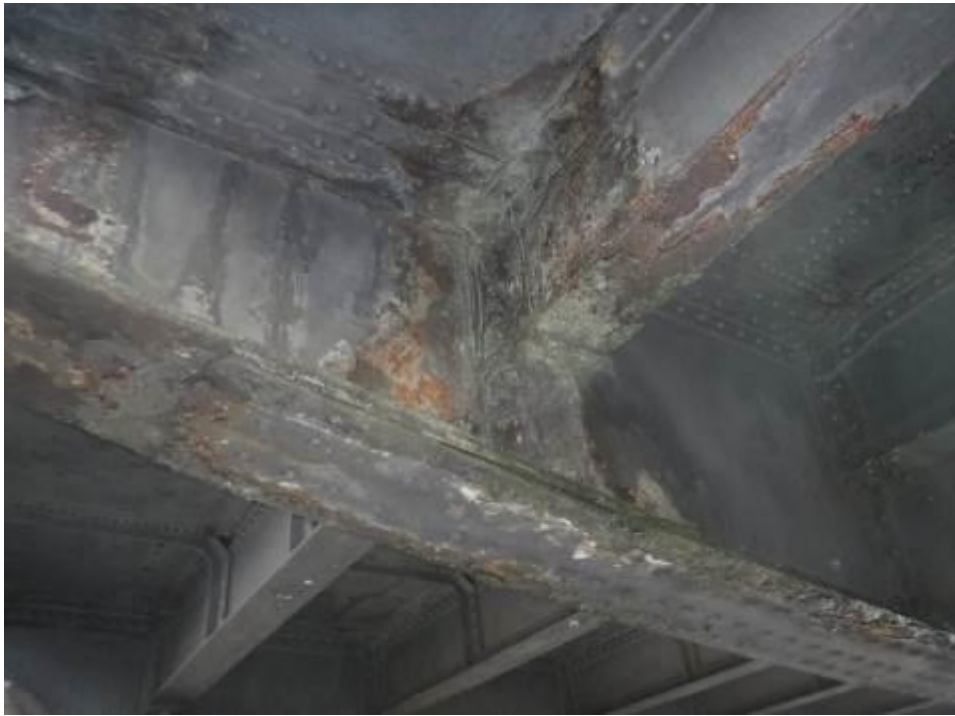
Photograph 203: Paint loss & surface corrosion to MGE1 & T45 connection to soffit of span 5

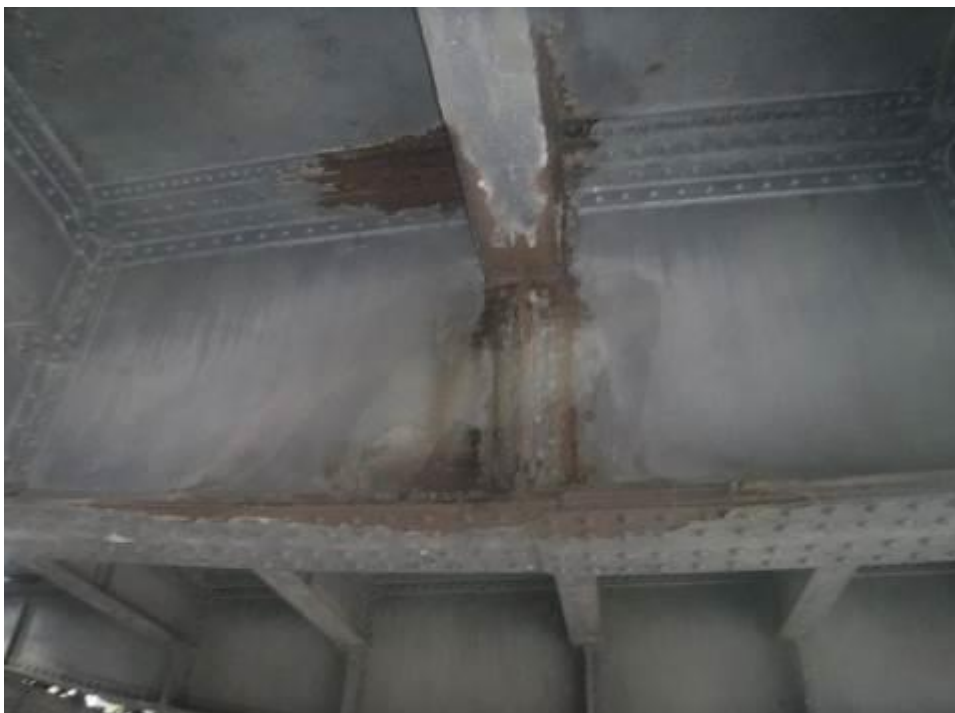
Photograph 204: Paint loss & surface corrosion to MGE1 & T47 connection to soffit of span 5

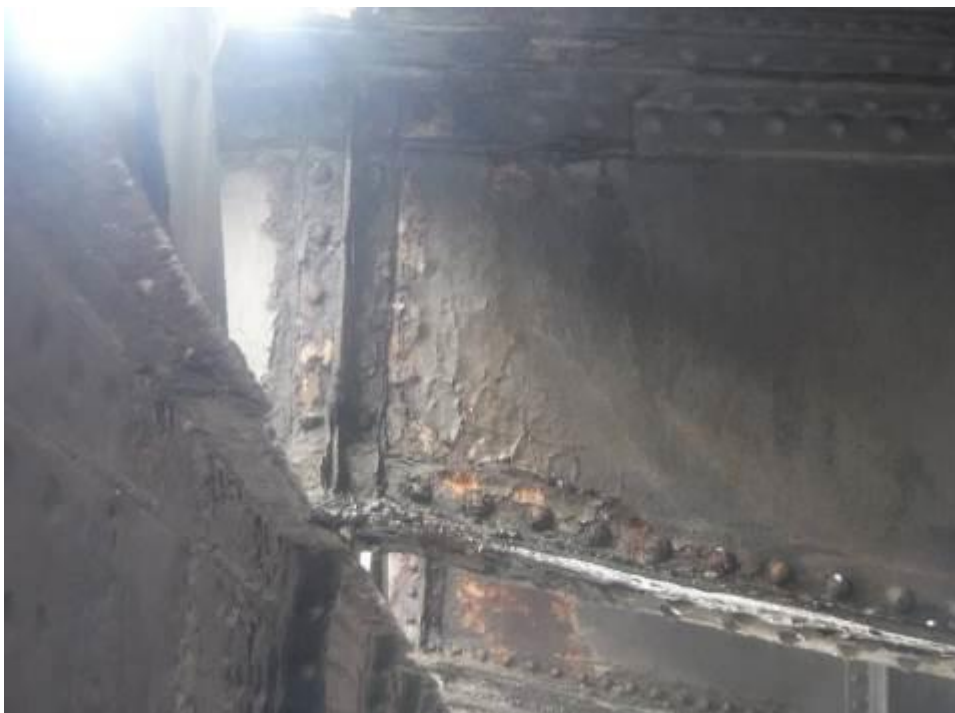
The vertical brace below the transverse connecting to the lower boom had 2mm loss of thickness. Below the vertical brace there was corrosion and 2mm pitting over 1000 x 100mm. (photo 208)

Photograph 208: Typical corrosion & pitting below vertical braces to T57 – T62 of soffit of span 6

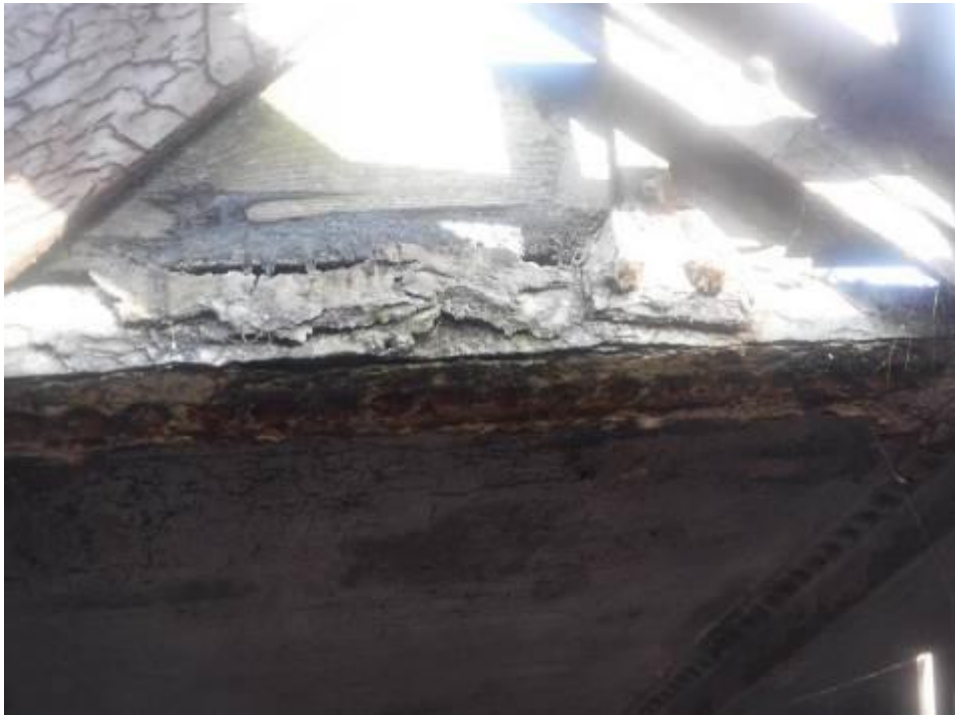
Photograph 217: Typical corrosion to deck edges of soffit of span 8

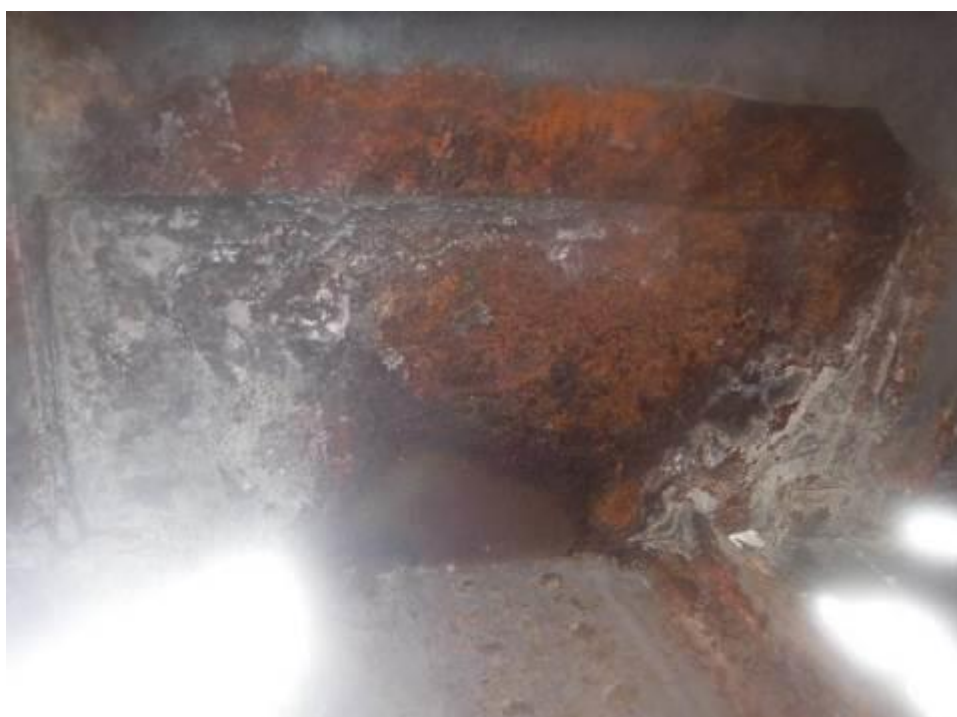
Photograph 224: Surface corrosion & loss of thickness to MGI2 of soffit of span 8

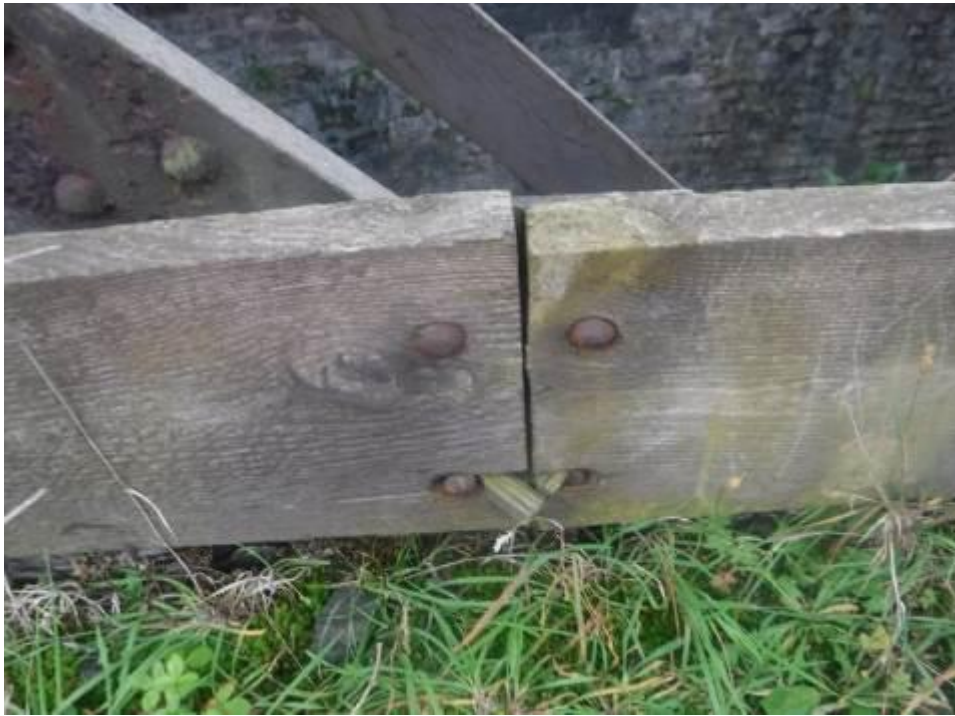
Photograph 231: Typical condition of ballast boards to top of deck

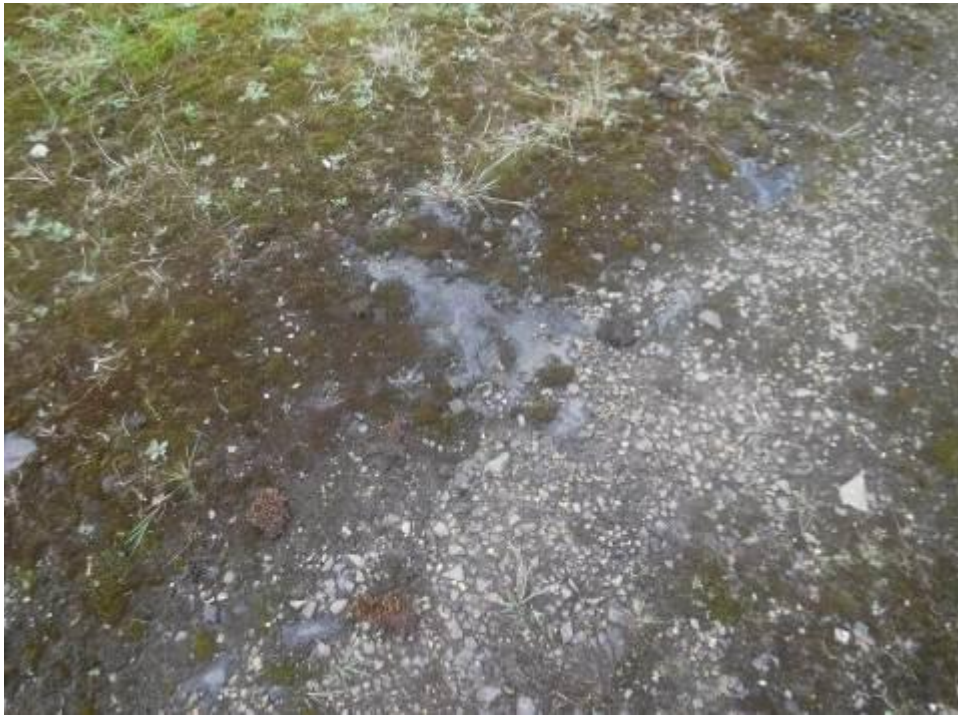
Photograph 235: Typical condition of exposed deck plates to top of deck

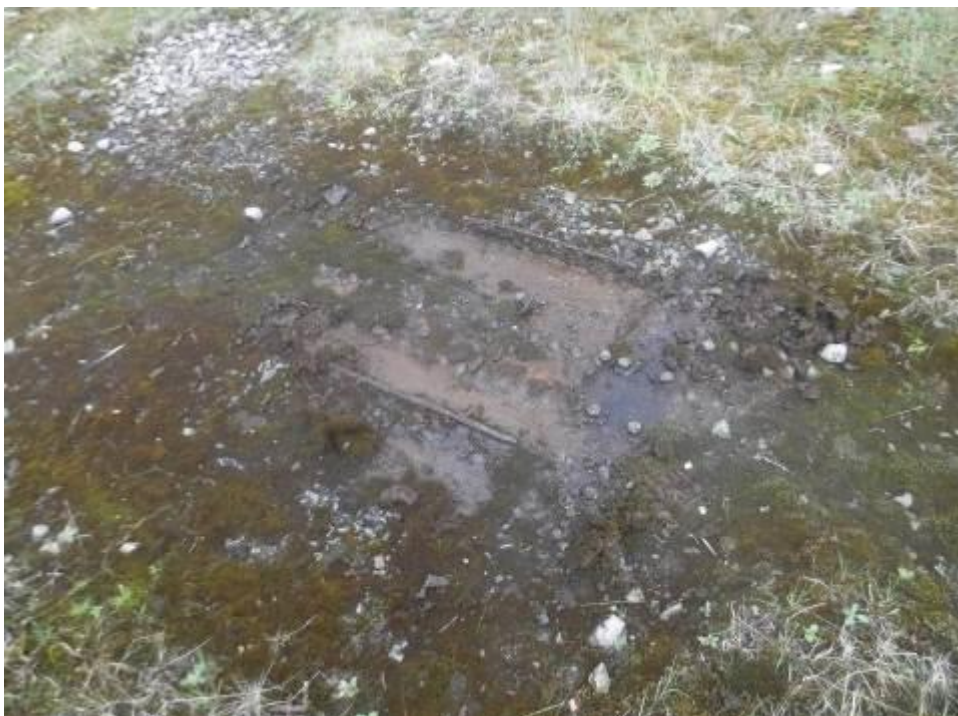
Photograph 236: Typical condition of exposed deck plates to top of deck

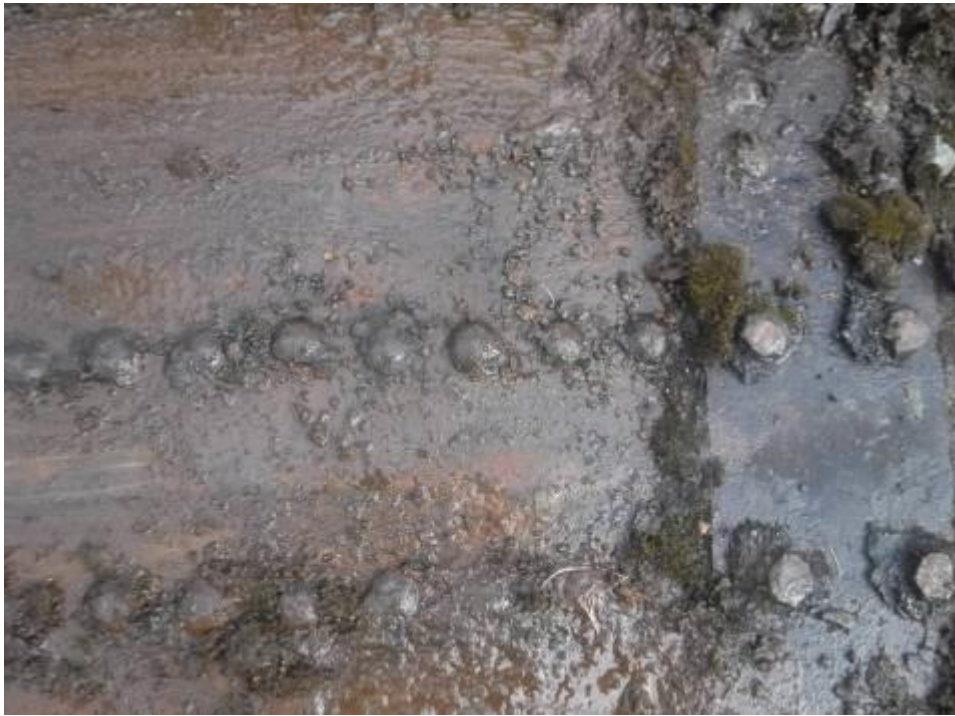
Photograph 237: Typical condition of exposed deck plates to top of deck
