# Cheshire Tree Surveys and Arboriculture

**A report on a tree at 11A/13 Cresswell Grove, Manchester**

**Paul Hanson – LANTRA Professional Tree Inspector**

**6<sup>th</sup> October 2021**

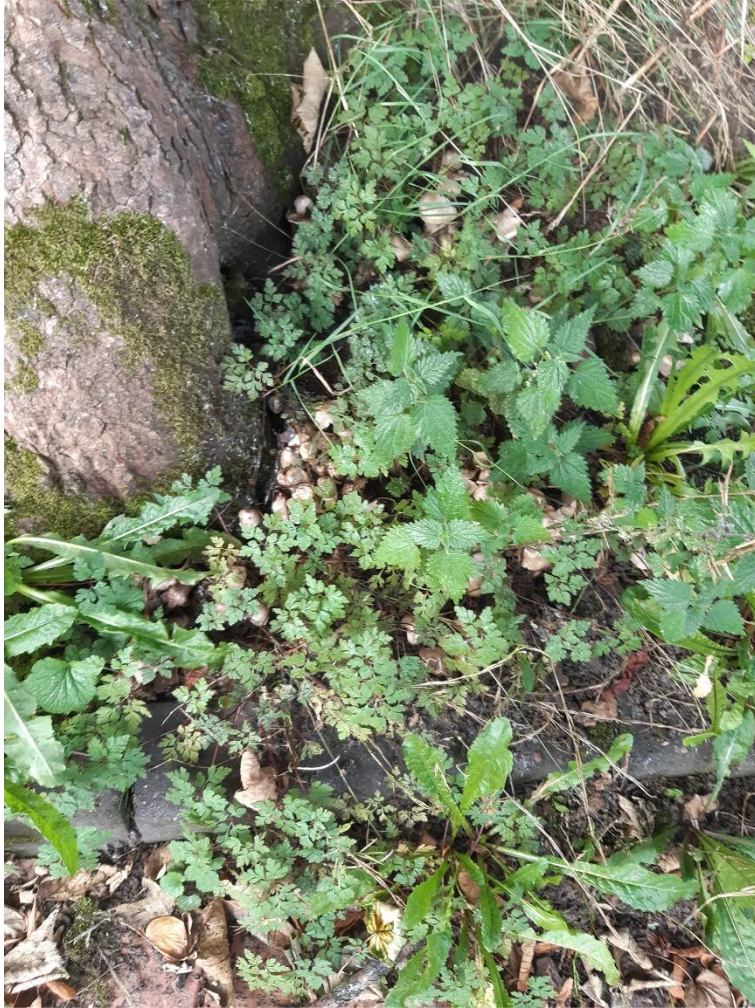
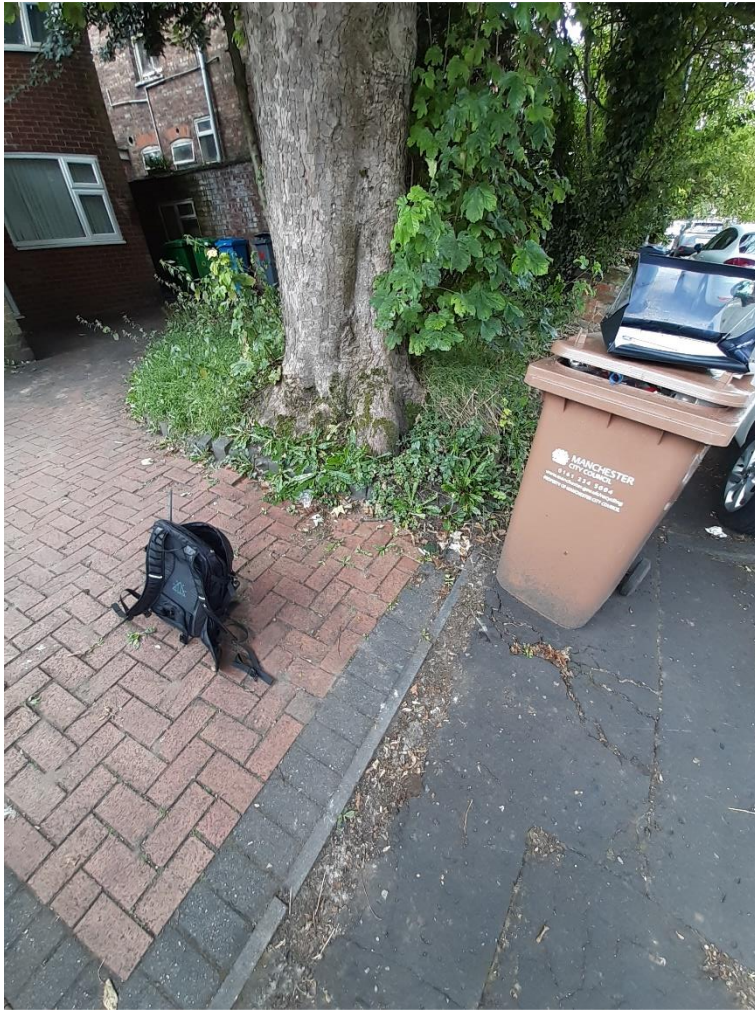
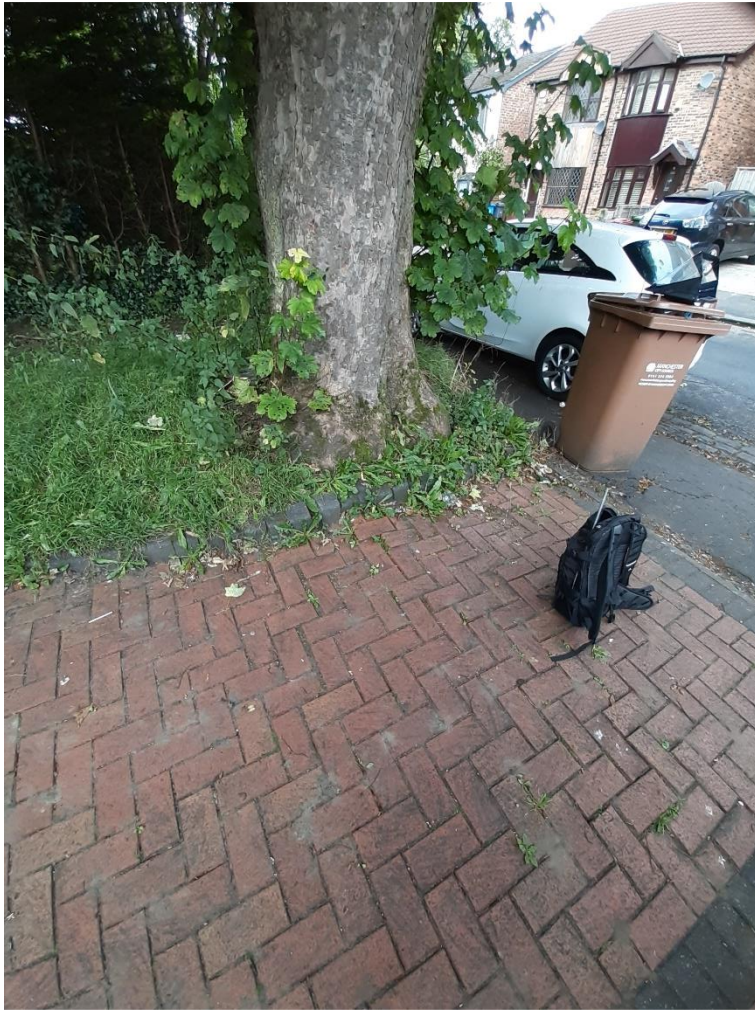
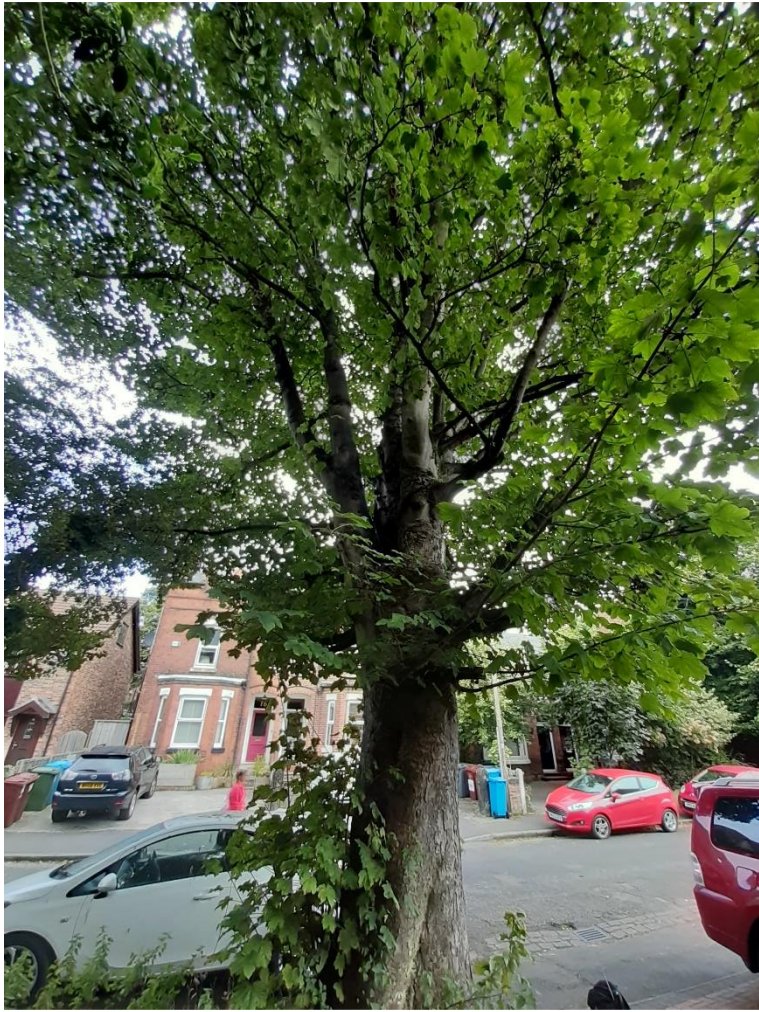
## Fungal Fruiting Bodies of Armillaria

The first thing I noted on this tree , were some fungal fruiting bodies, which were disintergrating on the root plate of the tree,I believed these to be Armillaria mella (honey fungus) photographs and details below. The tree has exposed roots and also what appears to be a girdling root.

**Tree 2- remove entire tree and grind stump.**

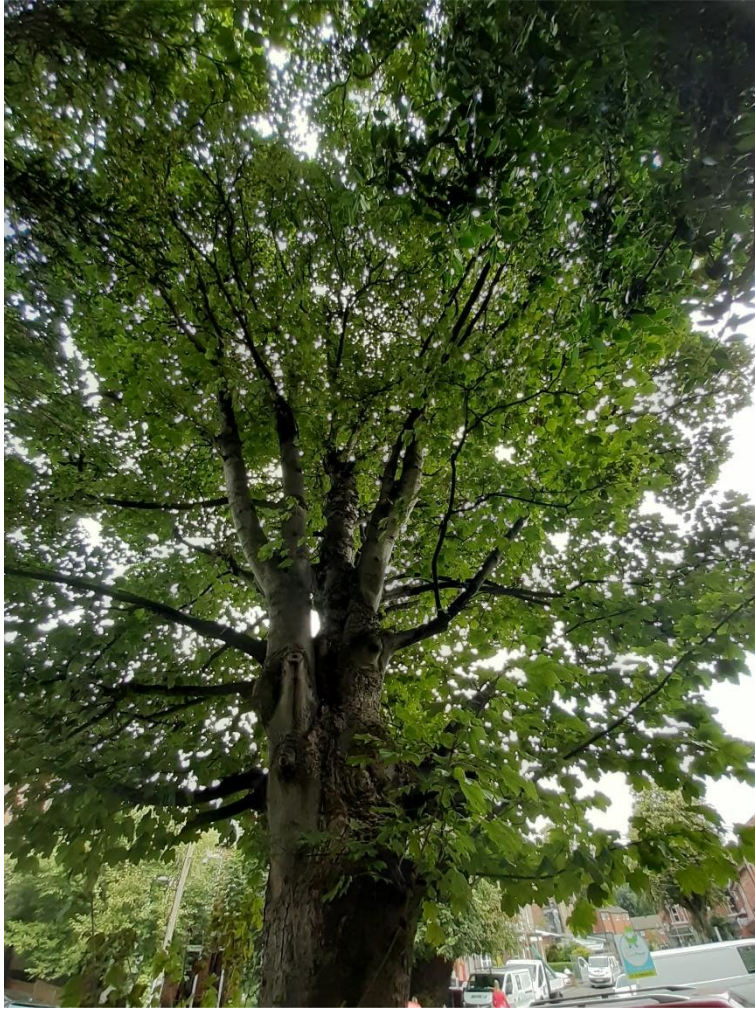
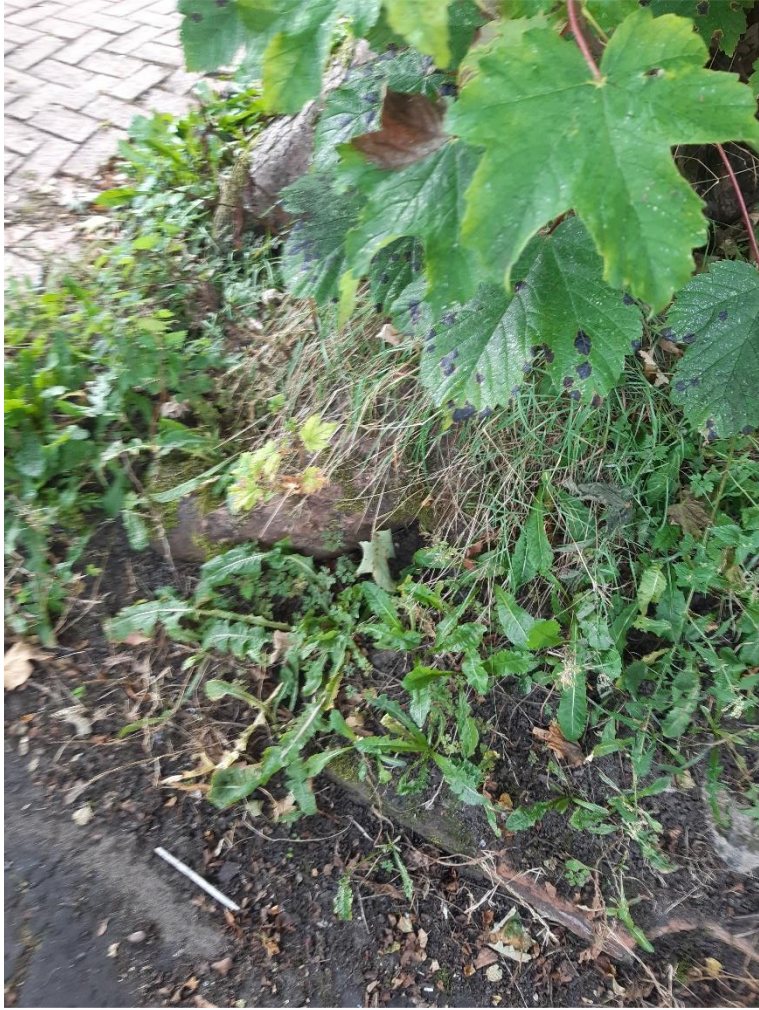
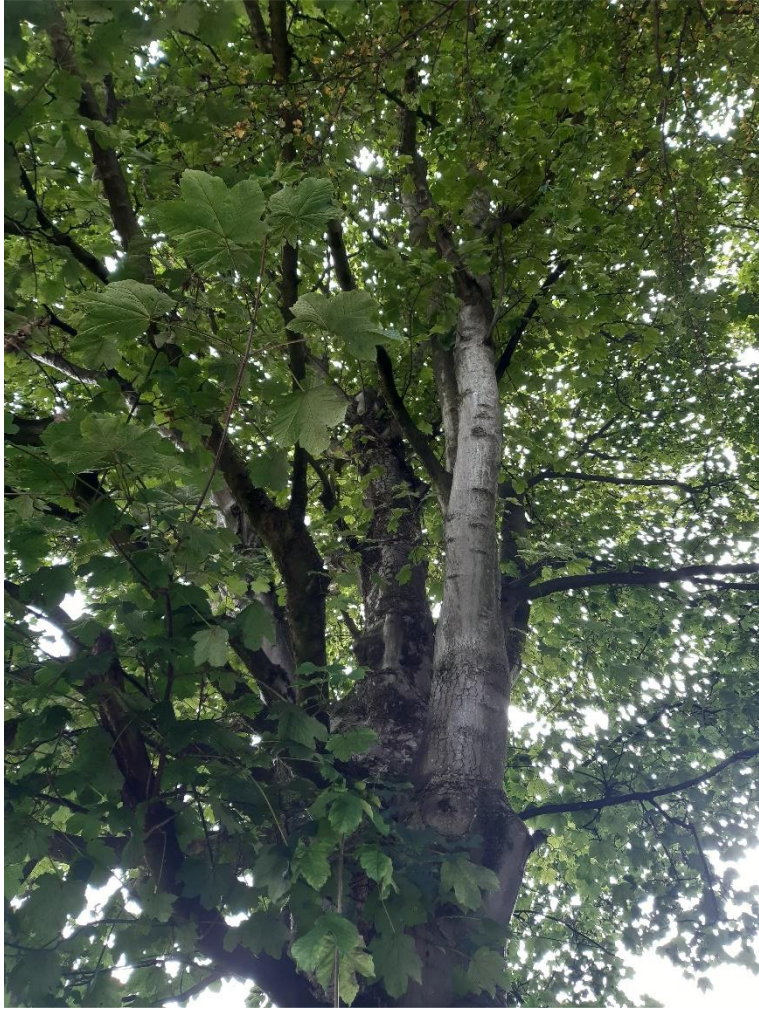
## Bad Branch inclusions

The root system is lifting the driveway paving stones . moving my attention to the canopy of the tree, I noted several bad branch unions,photographs below.

The tree is between the two properties touching the roofs of them, it is possible that squirrels are using the tree to ingress into the properties to nest. I noted several bad branch unions in the crown, the tree is being suppressed by tree 2. I also noted high in the canopy some bleeding cankers. I also noted some tar spot of sycamore on the foliage. This tree is extremely close to the houses and in the event of a catastrophic failure would cause some serious damage to the properties.

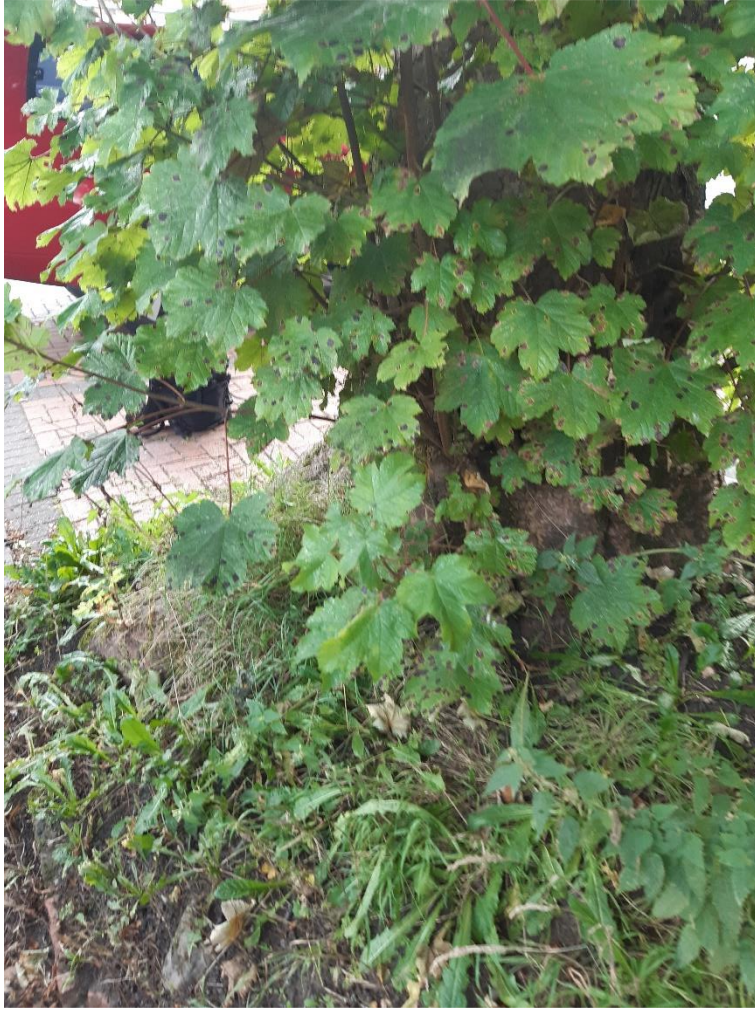
## Black Tar Spot of Sycamore

Canopy csd was fair to medium and I also noted the presence of tar spot of sycamore on some of the leaves.

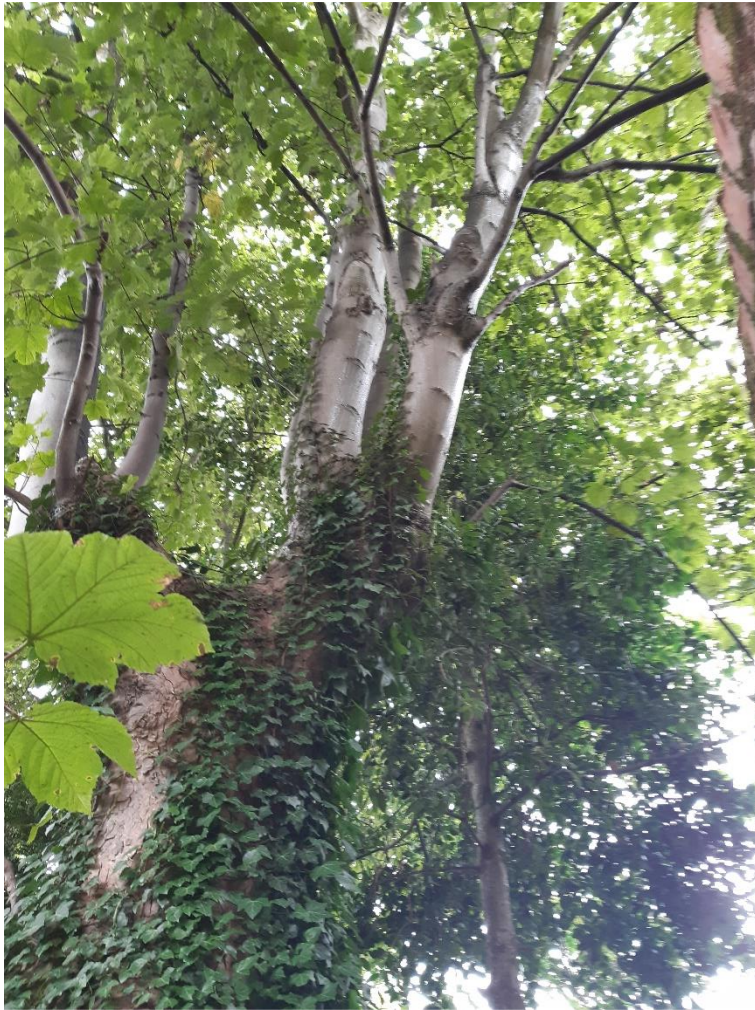
Bifurcated stem on tree 3

**Tree 3- remove entire tree and grind stump.**

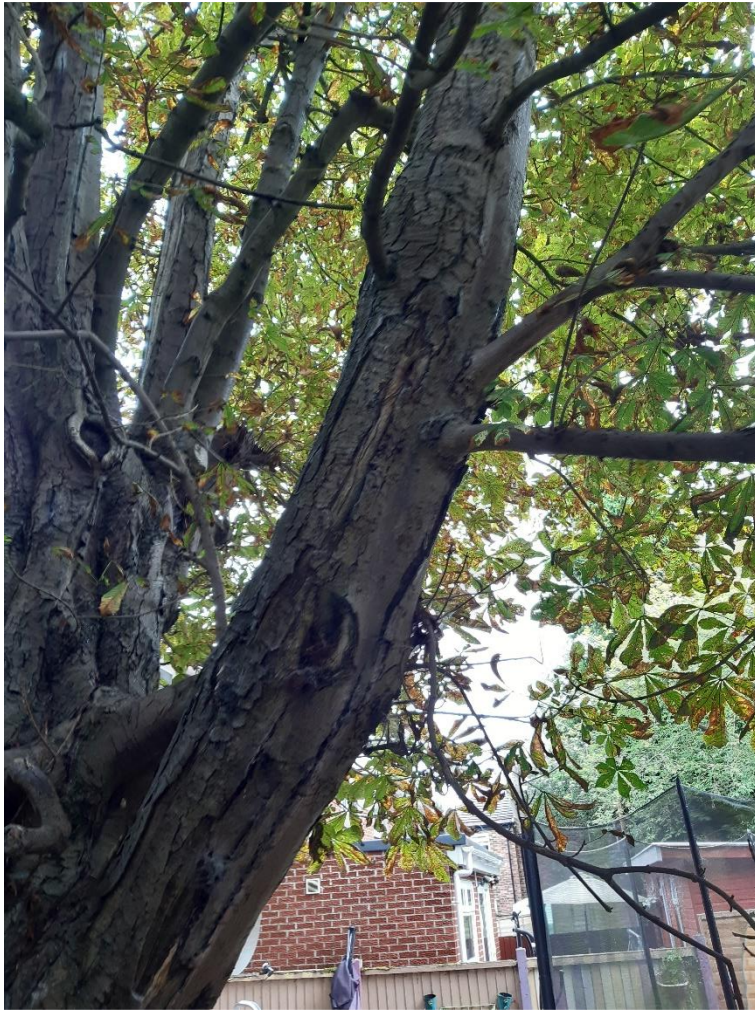
## Possible Psuedomonas Syringie PV.Aesculi

There seems to be some evidence of bacterial canker present, I would possibly say that it is *Pseudomonas syringae* pv. *aesculi*, a detailed description is included below. The tree is extremely close to the property as shown in the photographs below.

**Tree 4- remove entire tree and grind stump.**

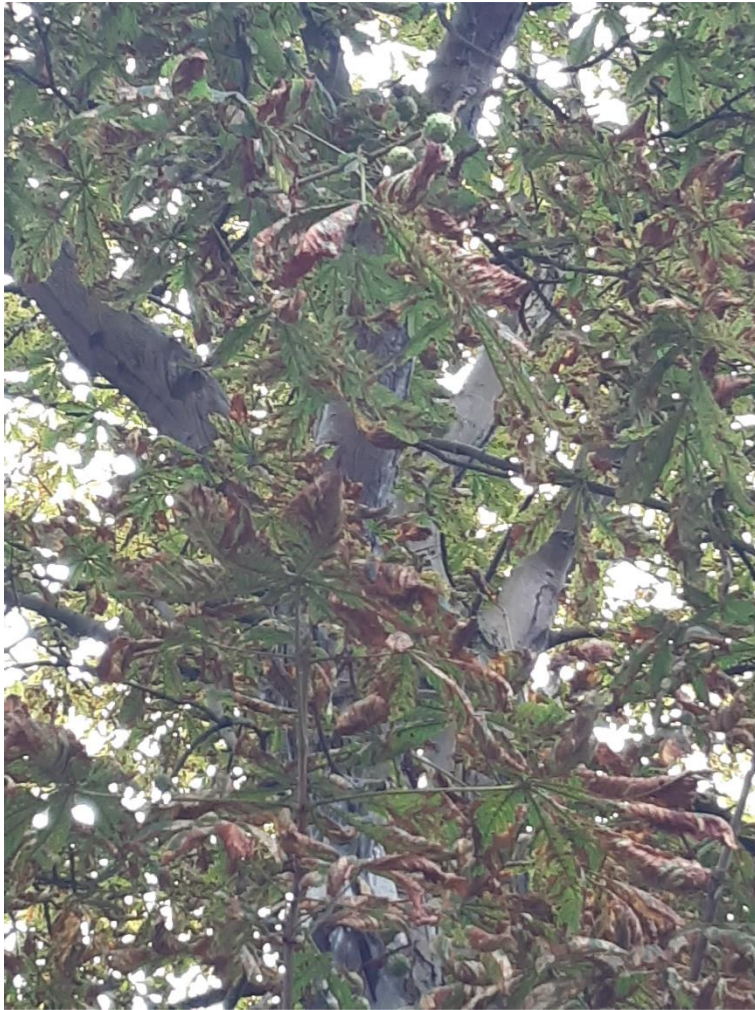
## Evidence of Horsechestnut Leaf miner damage

The first thing I noted was that the tree had pushed over the partition wall dividing the properties (the reason why my client engaged my services) causing extensive damage to the wall beyond repair. This in turn had left some of the root system exposed, which could then lead to an infection from the armillaria fungal spores, from the fungal fruiting bodies found in the front garden. The canopy condition was extremely poor, with some evidence of Horse chestnut leaf miner in the foliage (*cameraria ohridella*).
