ADM /151021

**Re 623 Burnage Lane Manchester-Structural Assessment of Cracking**

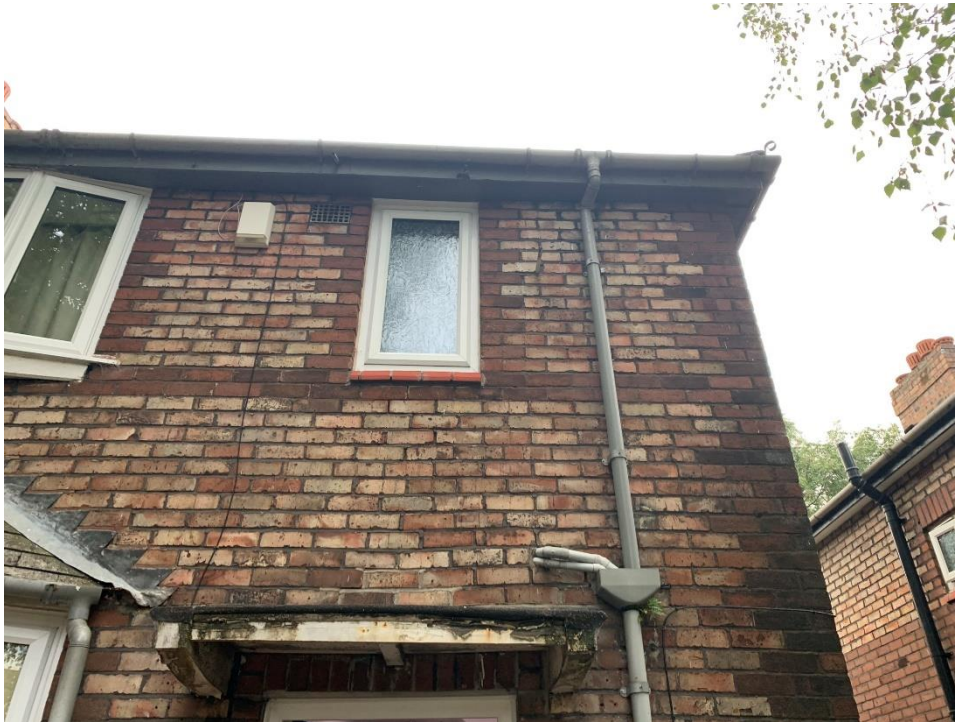
**Photograph 3**

The brick above the front door is cracked. Diagonal cracks, 2-3mm wide have formed above the door and the bricks above the door opening have dropped.

The cracking of the masonry above the front door and internally to the front of the hallway and in the upstairs bathroom is caused by the failure of the lintel above the front door. It is recommended that the lintel is replaced with a new proprietary lintel sized accordingly. The masonry could be repaired using crack stitching techniques however a better solution would be to re-build the masonry locally.

Masonry above Front Door
