## **STRUCTURAL SURVEY OF TEMPORARY METAL CABIN BUILDING (ANSON CABIN)**

**38 Meldon Road,**

**Date of Survey : 2<sup>nd</sup> September 2021**

**Date of Report : 14<sup>th</sup> September 2021.**

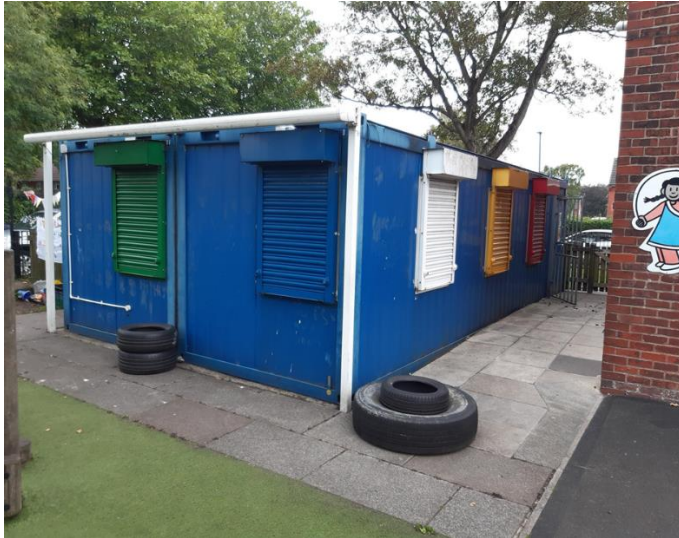
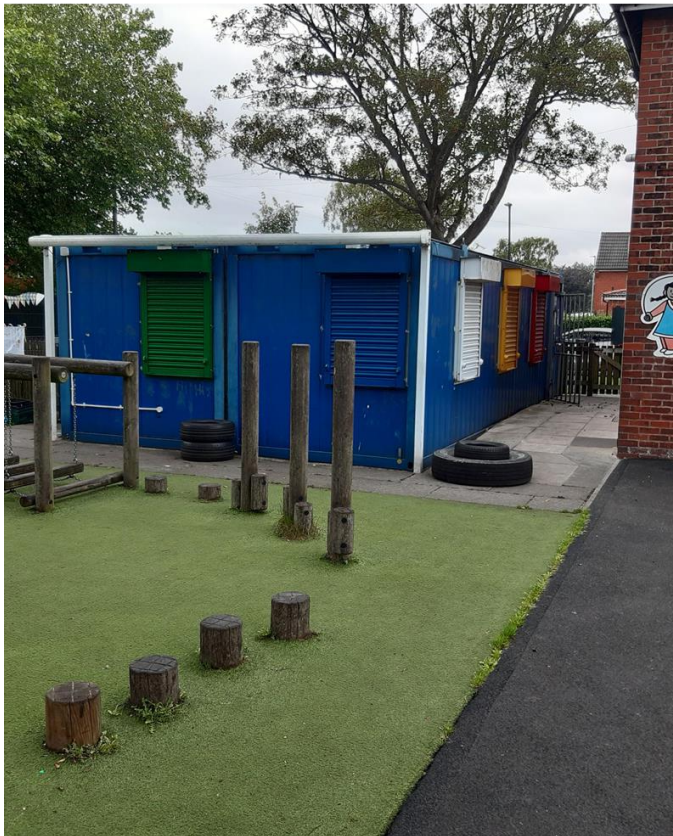
**Photograph 1&2-** Part *South/East* elevation.

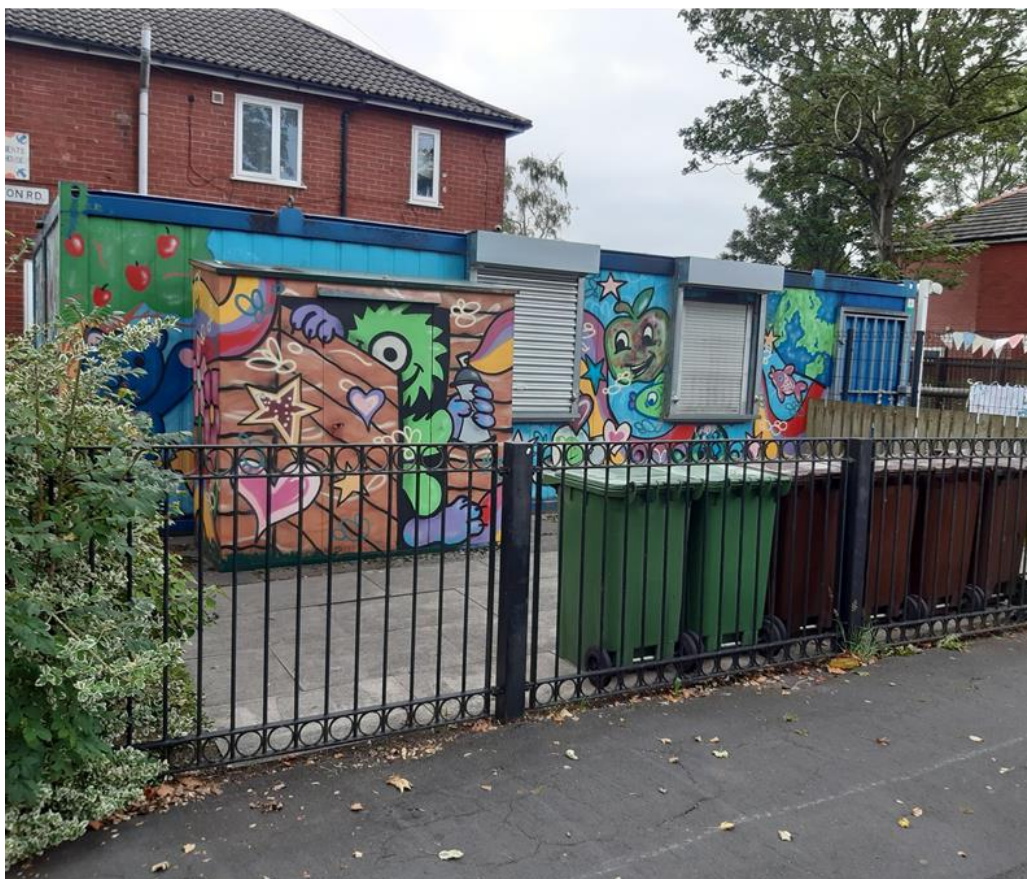
**Photograph 3** -West side elevation -showing the colourfully painted structure taken from Bryton Road

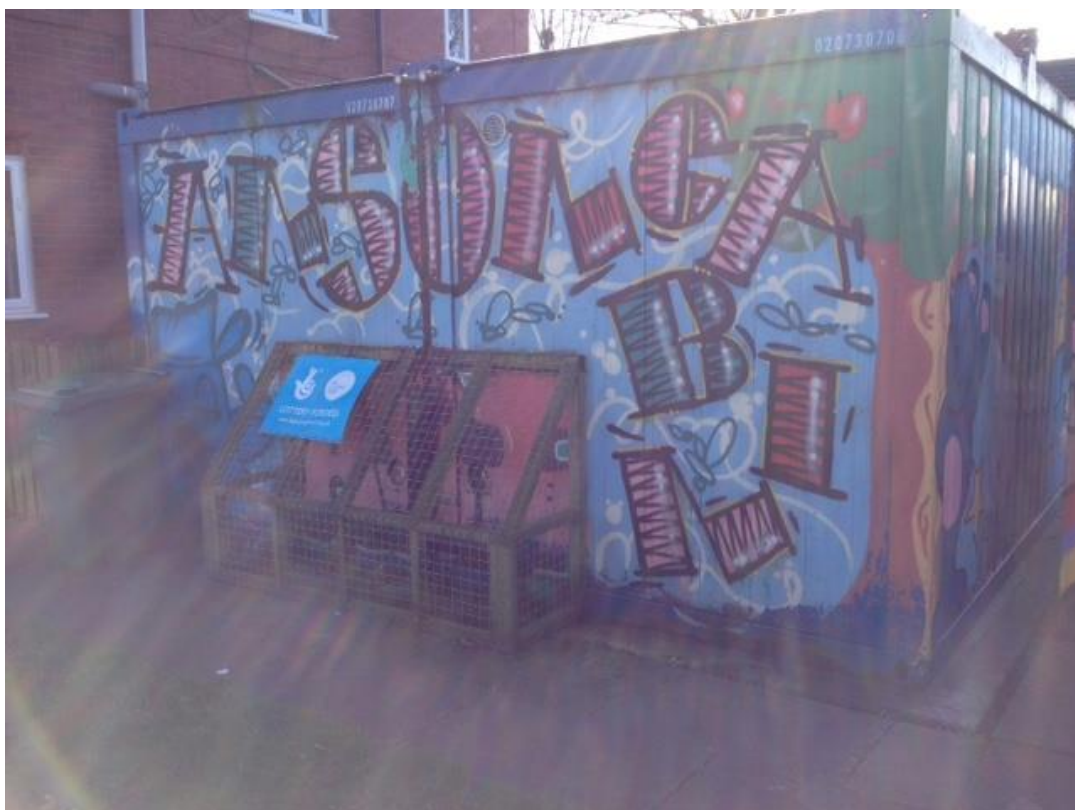
**Photograph 4** -North elevation

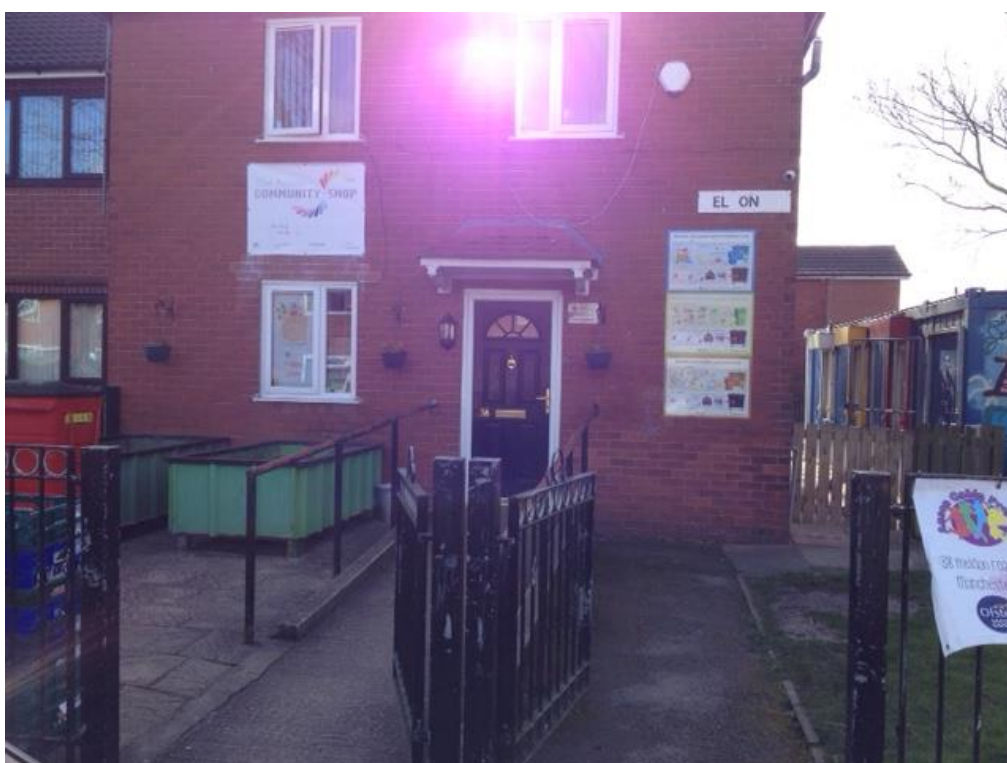
**Photograph 5**-38 Meldon Road front elevation

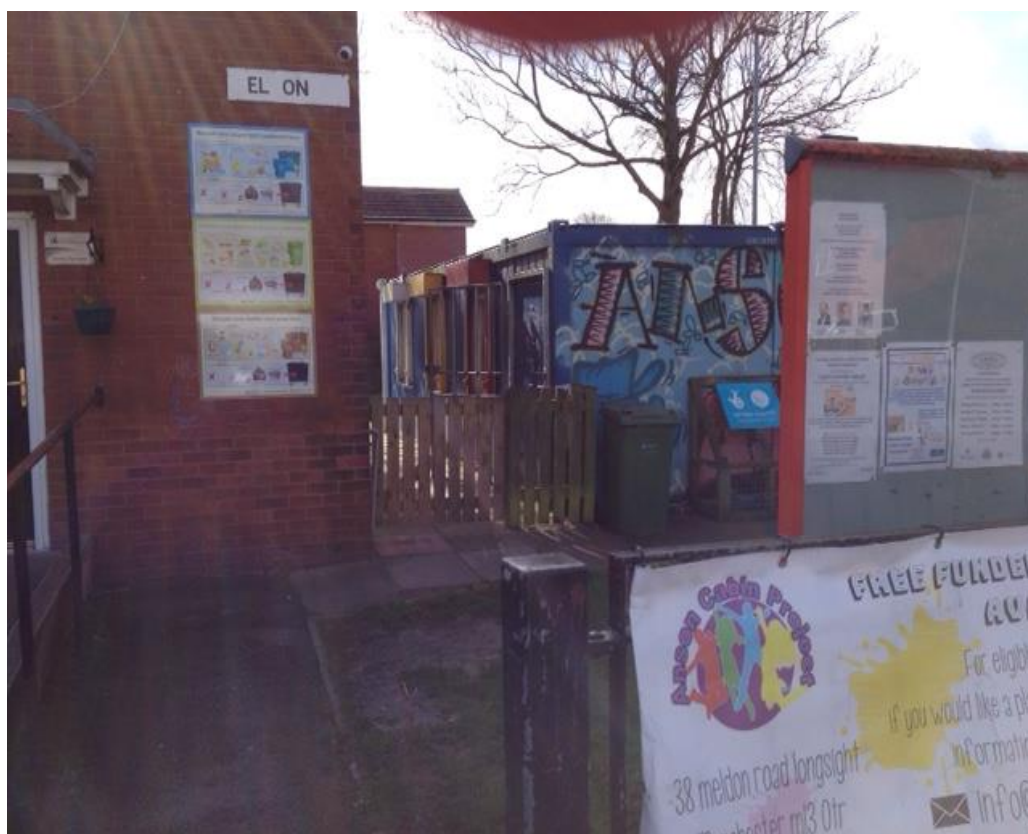
**Photograph 6-** Anson Cabin painted metal structure adjacent to 38 Meldon Road

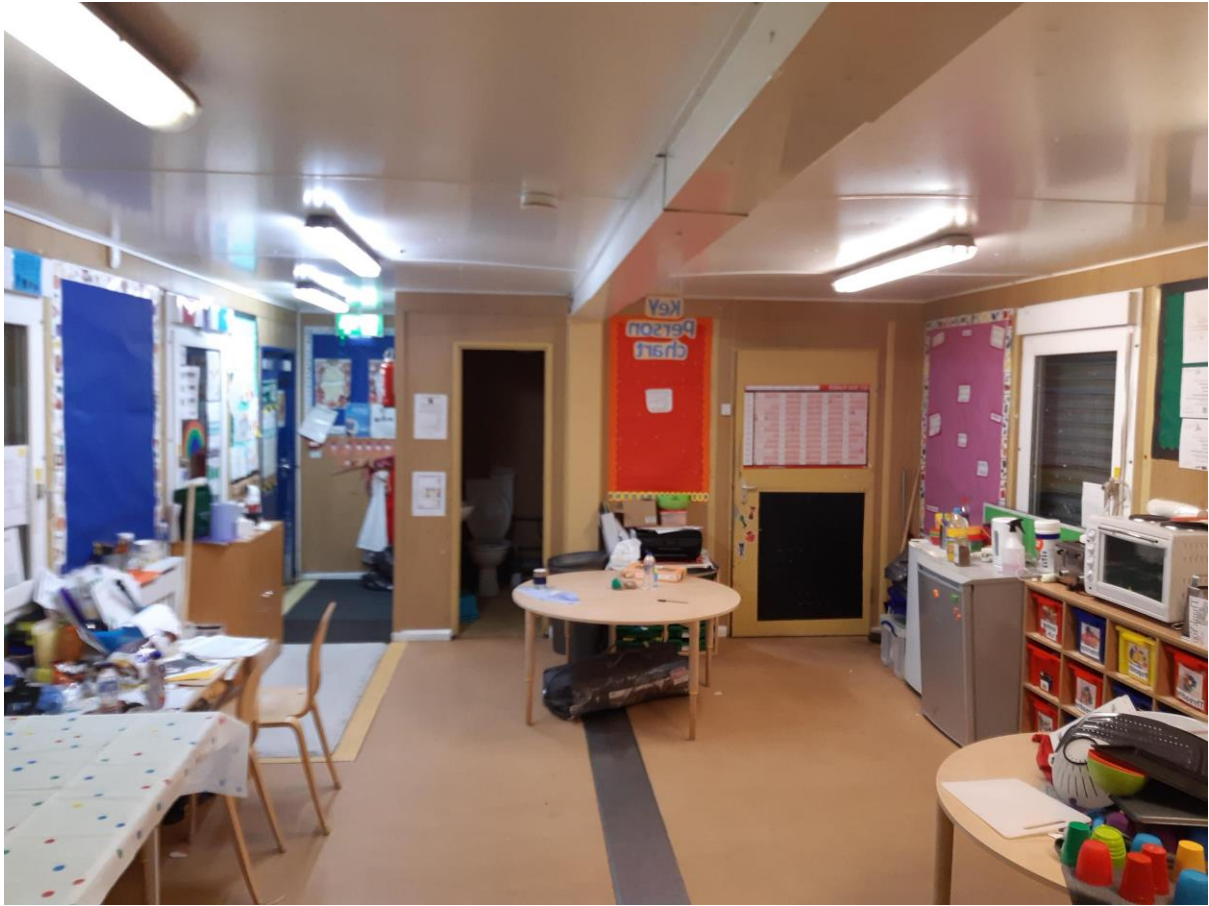
**Photograph 7- internal**

**Internal**- all surfaces were in reasonable condition and the floor was firm and sound underfoot
