# Pre-Demolition Asbestos Survey

**1 Portugal Street East  
Manchester  
M1 2WX**

| <b>Report Number:</b> | M20196/02 | <b>Report Status:</b> | Final |
| <b>Report Type:</b> | Pre-Demolition Survey | | |

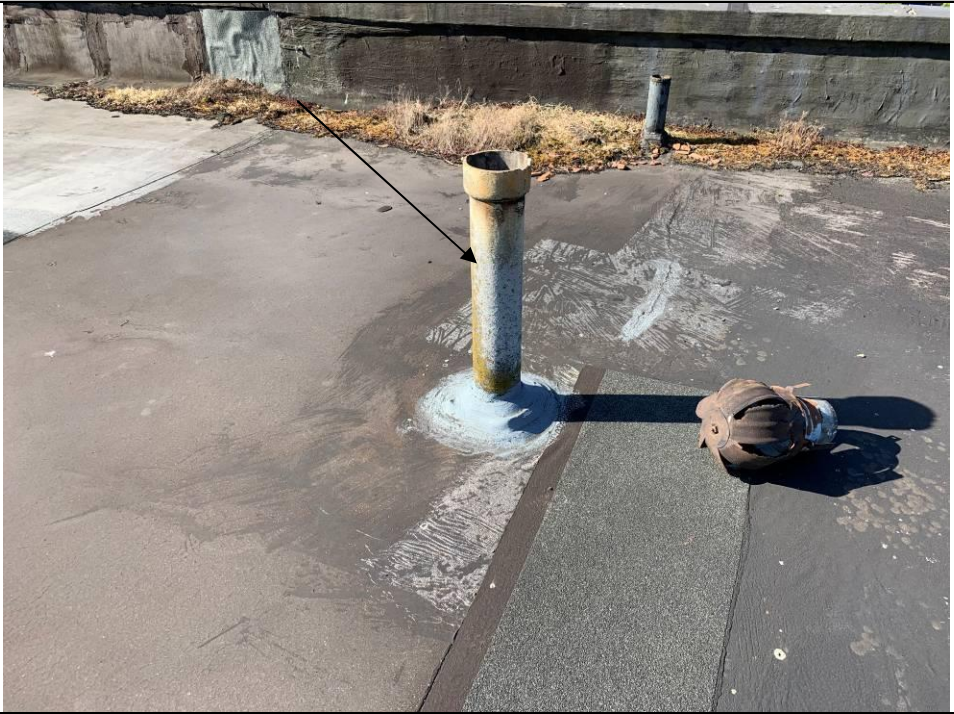
| Site | 1 Portugal Street East,<br>Manchester,<br>M1 2WX | | |
|---|---|---|---|
| Product type or debris from product | <b>1</b><br>2<br>3 | Asbestos – reinforced composites (plastics, resins, mastics, roofing felts, vinyl floor tiles, semi rigid paints, or decorative finishes, asbestos cement etc.)<br>Asbestos insulating board, asbestos millboard, other low-density insulation boards, asbestos textiles, gaskets ropes and woven textiles, asbestos paper and felt.<br>Thermal insulation (e.g. Pipe and boiler lagging) loose and sprayed asbestos, asbestos mattresses and packing. | |
| Extent of damage or deterioration | 0<br><b>1</b><br>2<br>3 | Good condition – no visible damage<br>Low damage – a few scratches or surface marks; broken edges on boards, tiles etc.<br>Medium damage; significant breakage of materials or several small areas where material has been damaged revealing loose asbestos fibres.<br>High damage or delamination of materials, sprays and thermal insulation. Visible asbestos debris. | |

| Site | 1 Portugal Street East,<br>Manchester,<br>M1 2WX | | |
|---|---|---|---|
| Recommendations | Remove under controlled conditions, by adequately trained persons (category B training minimum). | | |

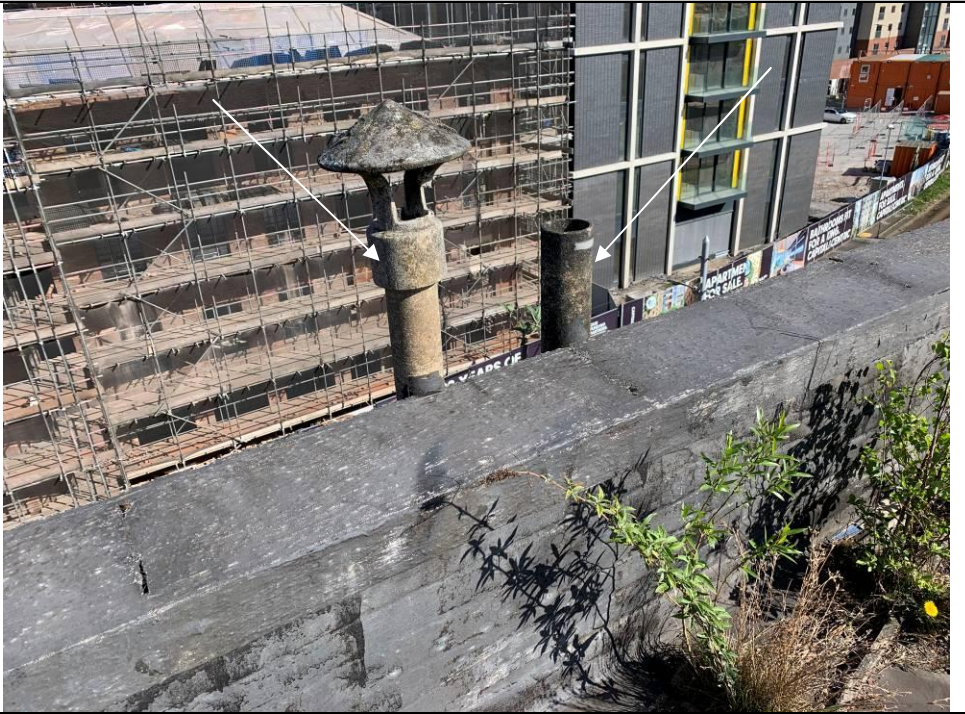
| Loc. | External, Main Roof | |

| Sample variable | Score | Examples of scores |
|---|---|---|
| Product type or debris<br>from product | <b>1</b><br>2<br>3 | Asbestos – reinforced composites (plastics, resins, mastics, roofing felts, vinyl floor tiles, semi rigid paints, or decorative finishes, asbestos cement etc.)<br>Asbestos insulating board, asbestos millboard, other low-density insulation boards, asbestos textiles, gaskets ropes and woven textiles, asbestos paper and felt.<br>Thermal insulation (e.g. Pipe and boiler lagging) loose and sprayed asbestos, asbestos mattresses and packing. |
| Extent of damage or<br>deterioration | 0<br><b>1</b><br>2<br>3 | Good condition – no visible damage<br>Low damage – a few scratches or surface marks; broken edges on boards, tiles etc.<br>Medium damage; significant breakage of materials or several small areas where material has been damaged revealing loose asbestos fibres.<br>High damage or delamination of materials, sprays and thermal insulation. Visible asbestos debris. |

| Sample variable | Score | Examples of scores |
|---|---|---|
| Recommendations | Remove under controlled conditions, by adequately trained persons (category B training minimum). | |

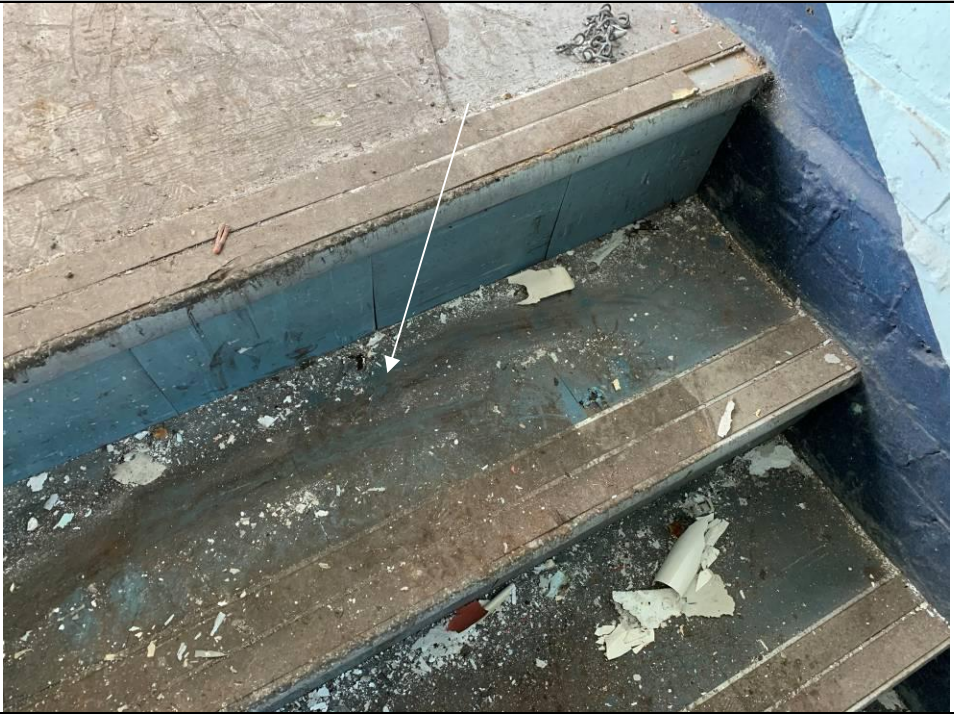
| Site | 1 Portugal Street East,<br>Manchester,<br>M1 2WX | | |
|---|---|---|---|
| Product type or debris from product | <b>1</b><br>2<br>3 | Asbestos – reinforced composites (plastics, resins, mastics, roofing felts, vinyl floor tiles, semi rigid paints, or decorative finishes, asbestos cement etc.)<br>Asbestos insulating board, asbestos millboard, other low-density insulation boards, asbestos textiles, gaskets ropes and woven textiles, asbestos paper and felt.<br>Thermal insulation (e.g. Pipe and boiler lagging) loose and sprayed asbestos, asbestos mattresses and packing. | |
| Extent of damage or deterioration | 0<br>1<br><b>2</b><br>3 | Good condition – no visible damage<br>Low damage – a few scratches or surface marks; broken edges on boards, tiles etc.<br>Medium damage; significant breakage of materials or several small areas where material has been damaged revealing loose asbestos fibres.<br>High damage or delamination of materials, sprays and thermal insulation. Visible asbestos debris. | |

| Site | 1 Portugal Street East,<br>Manchester,<br>M1 2WX | | |
|---|---|---|---|
| Recommendations | Remove under controlled conditions, by adequately trained persons (category B training minimum). | | |

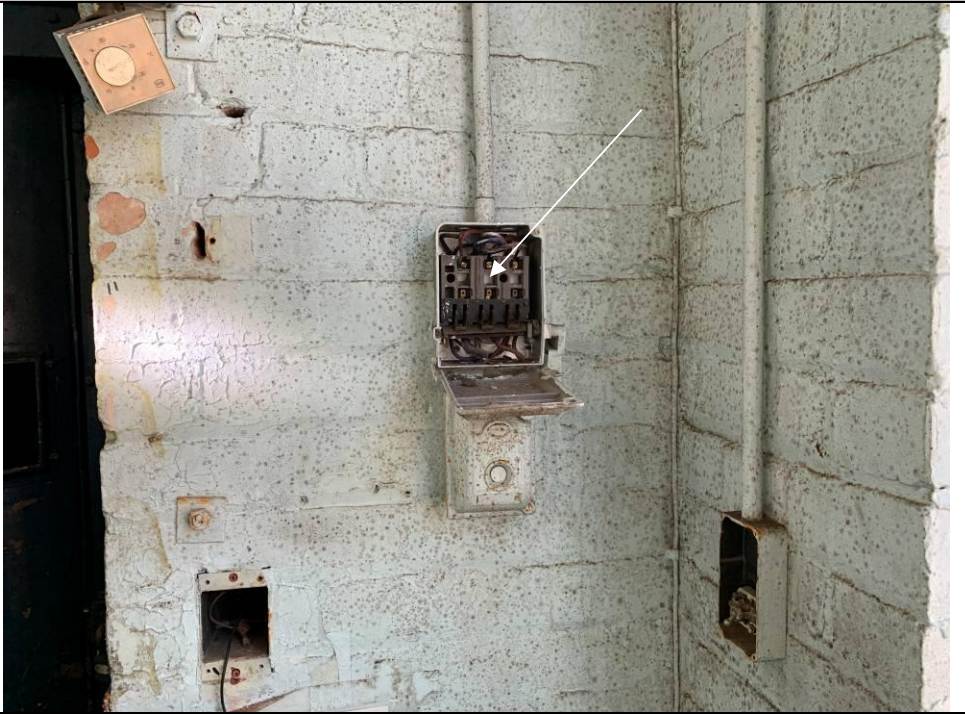
| Loc. | Internal, Second Floor,<br>Rooms 5 & 7 | |

| Sample variable | Score | Examples of scores |
|---|---|---|
| Product type or debris from product | 1<br><b>2</b><br>3 | Asbestos – reinforced composites (plastics, resins, mastics, roofing felts, vinyl floor tiles, semi rigid paints, or decorative finishes, asbestos cement etc.)<br>Asbestos insulating board, asbestos millboard, other low-density insulation boards, asbestos textiles, gaskets ropes and woven textiles, asbestos paper and felt.<br>Thermal insulation (e.g. Pipe and boiler lagging) loose and sprayed asbestos, asbestos mattresses and packing. |
| Extent of damage or deterioration | 0<br><b>1</b><br>2<br>3 | Good condition – no visible damage<br>Low damage – a few scratches or surface marks; broken edges on boards, tiles etc.<br>Medium damage; significant breakage of materials or several small areas where material has been damaged revealing loose asbestos fibres.<br>High damage or delamination of materials, sprays and thermal insulation. Visible asbestos debris. |

| Sample variable | Score | Examples of scores |
|---|---|---|
| Recommendations | Remove under controlled conditions, by adequately trained persons (category B training minimum). | |

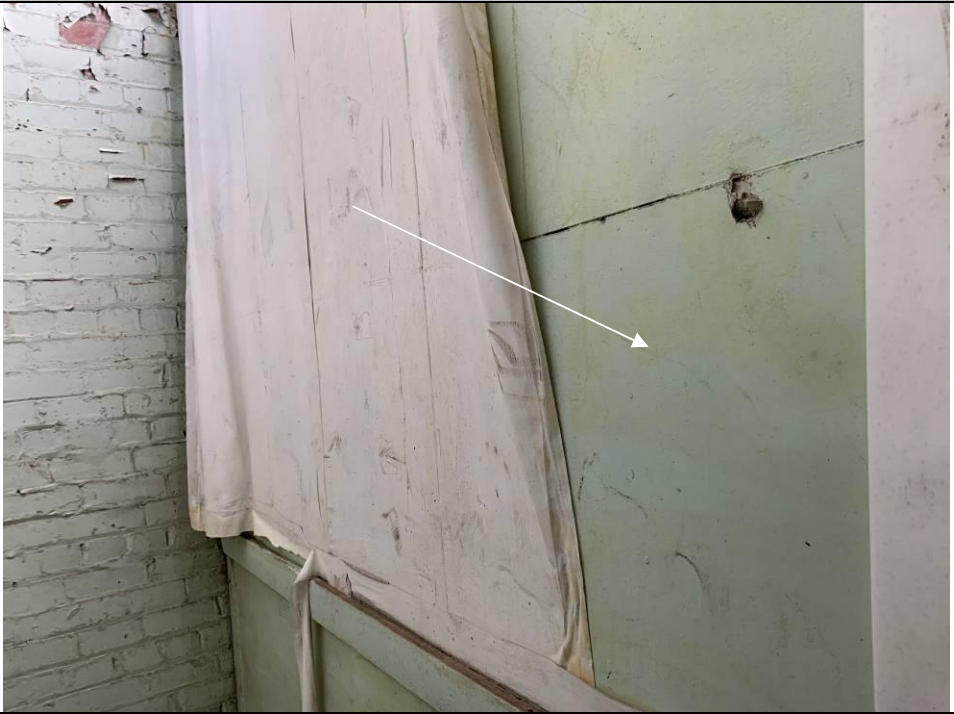
| Site | 1 Portugal Street East,<br>Manchester,<br>M1 2WX | | |
|---|---|---|---|
| Product type or debris from product | 1<br><b>2</b><br>3 | Asbestos – reinforced composites (plastics, resins, mastics, roofing felts, vinyl floor tiles, semi rigid paints, or decorative finishes, asbestos cement etc.)<br>Asbestos insulating board, asbestos millboard, other low-density insulation boards, asbestos textiles, gaskets ropes and woven textiles, asbestos paper and felt.<br>Thermal insulation (e.g. Pipe and boiler lagging) loose and sprayed asbestos, asbestos mattresses and packing. | |
| Extent of damage or deterioration | 0<br>1<br><b>2</b><br>3 | Good condition – no visible damage<br>Low damage – a few scratches or surface marks; broken edges on boards, tiles etc.<br>Medium damage; significant breakage of materials or several small areas where material has been damaged revealing loose asbestos fibres.<br>High damage or delamination of materials, sprays and thermal insulation. Visible asbestos debris. | |

| Site | 1 Portugal Street East,<br>Manchester,<br>M1 2WX | | |
|---|---|---|---|
| Recommendations | Removal must be carried out by licensed Asbestos Contractors | | |

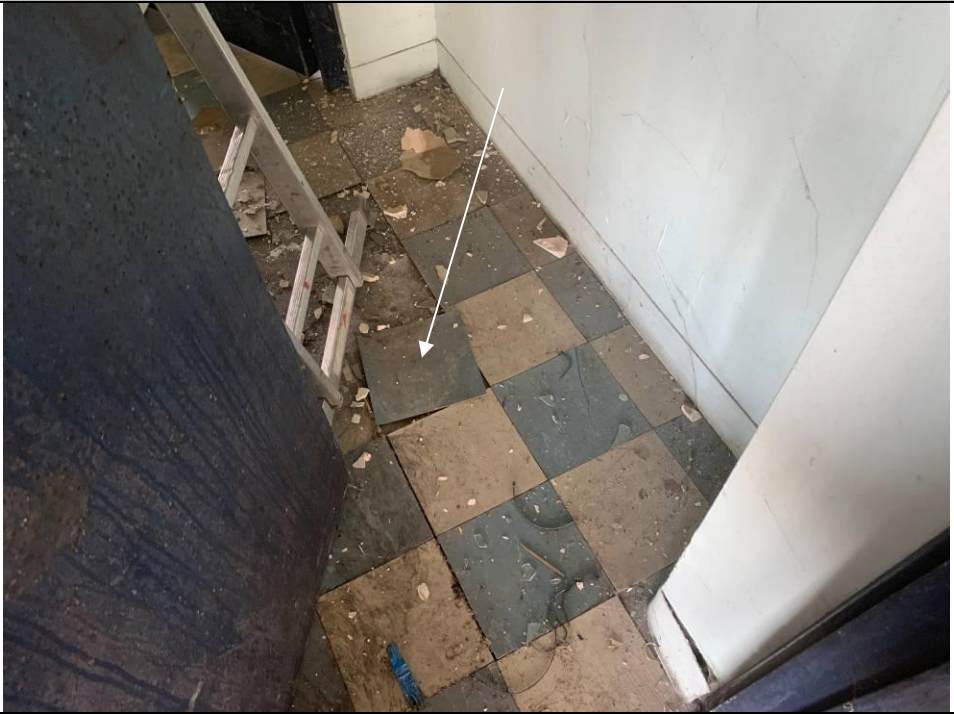
| <b>Loc.</b> | Internal, Second Floor,<br>Rooms 13 & 14 | |

| Sample variable | Score | Examples of scores |
|---|---|---|
| Product type or debris from product | <b>1</b><br>2<br>3 | Asbestos – reinforced composites (plastics, resins, mastics, roofing felts, vinyl floor tiles, semi rigid paints, or decorative finishes, asbestos cement etc.)<br>Asbestos insulating board, asbestos millboard, other low-density insulation boards, asbestos textiles, gaskets ropes and woven textiles, asbestos paper and felt.<br>Thermal insulation (e.g. Pipe and boiler lagging) loose and sprayed asbestos, asbestos mattresses and packing. |
| Extent of damage or deterioration | 0<br>1<br><b>2</b><br>3 | Good condition – no visible damage<br>Low damage – a few scratches or surface marks; broken edges on boards, tiles etc.<br>Medium damage; significant breakage of materials or several small areas where material has been damaged revealing loose asbestos fibres.<br>High damage or delamination of materials, sprays and thermal insulation. Visible asbestos debris. |

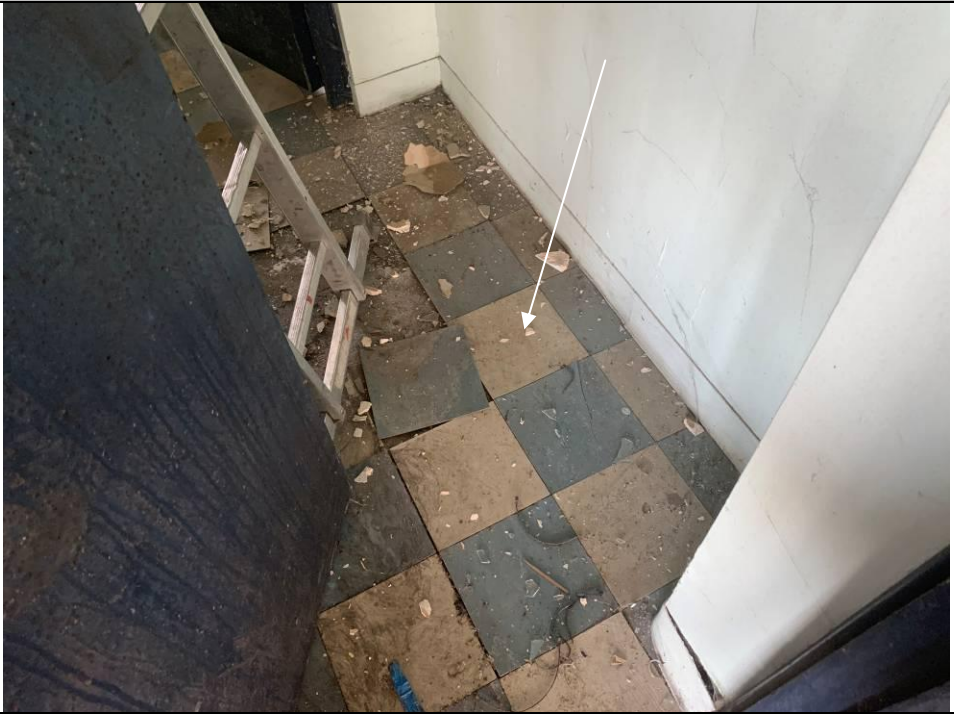
| Sample No. | PS1/13/02 | |

| Result | <b>CHRYSTILE</b> | |

| Sample variable | Score | Examples of scores |
|---|---|---|
| Product type or debris from product | <b>1</b><br>2<br>3 | Asbestos – reinforced composites (plastics, resins, mastics, roofing felts, vinyl floor tiles, semi rigid paints, or decorative finishes, asbestos cement etc.)<br>Asbestos insulating board, asbestos millboard, other low-density insulation boards, asbestos textiles, gaskets ropes and woven textiles, asbestos paper and felt.<br>Thermal insulation (e.g. Pipe and boiler lagging) loose and sprayed asbestos, asbestos mattresses and packing. |

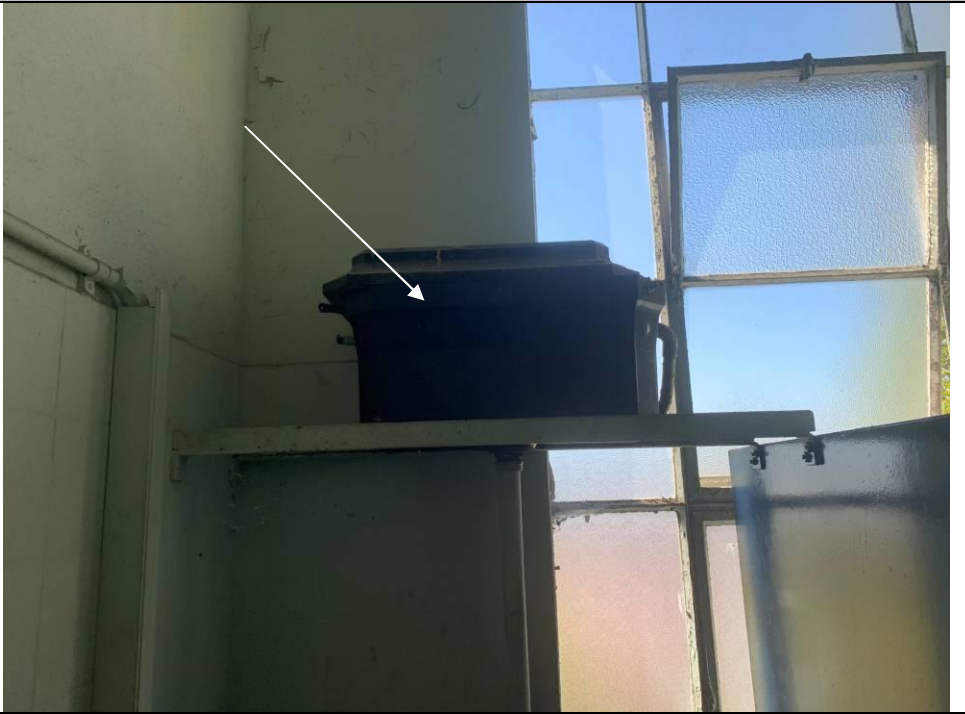
| Sample No. | PS1/14/01 | |

| Result | <b>AMOSITE</b> | |

| Sample variable | Score | Examples of scores |
|---|---|---|
| Product type or debris from product | <b>1</b><br>2<br>3 | Asbestos – reinforced composites (plastics, resins, mastics, roofing felts, vinyl floor tiles, semi rigid paints, or decorative finishes, asbestos cement etc.)<br>Asbestos insulating board, asbestos millboard, other low-density insulation boards, asbestos textiles, gaskets ropes and woven textiles, asbestos paper and felt.<br>Thermal insulation (e.g. Pipe and boiler lagging) loose and sprayed asbestos, asbestos mattresses and packing. |

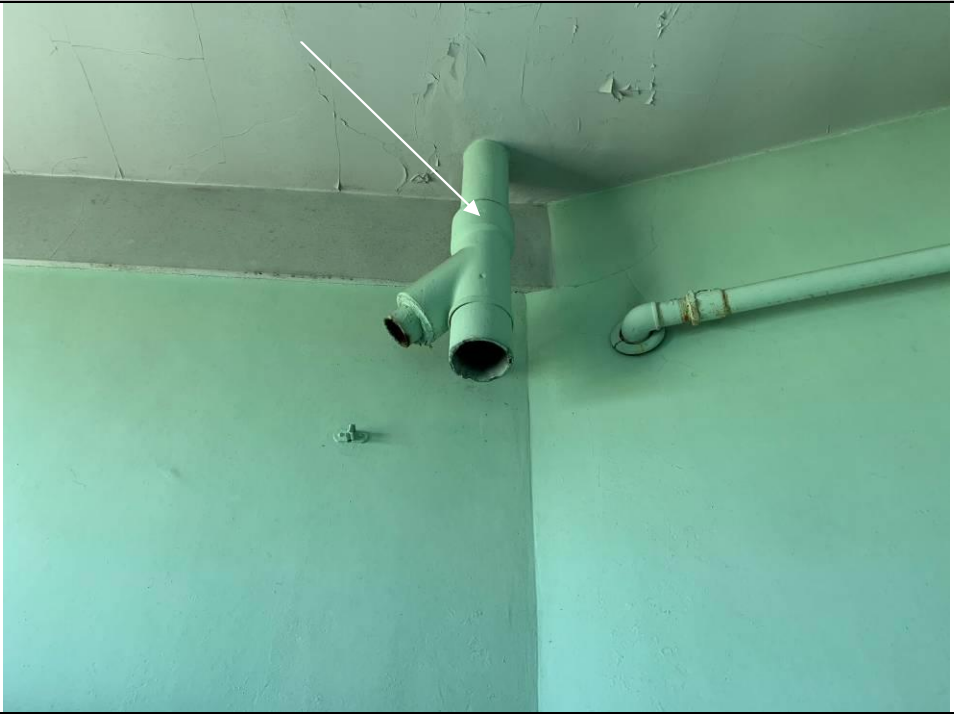
| Sample No. | PS1/16/01 | |

| Result | CHRYSTILE | |

| Sample variable | Score | Examples of scores |
|---|---|---|
| Product type or debris from product | <b>1</b><br>2<br>3 | Asbestos – reinforced composites (plastics, resins, mastics, roofing felts, vinyl floor tiles, semi rigid paints, or decorative finishes, asbestos cement etc.)<br>Asbestos insulating board, asbestos millboard, other low-density insulation boards, asbestos textiles, gaskets ropes and woven textiles, asbestos paper and felt.<br>Thermal insulation (e.g. Pipe and boiler lagging) loose and sprayed asbestos, asbestos mattresses and packing. |

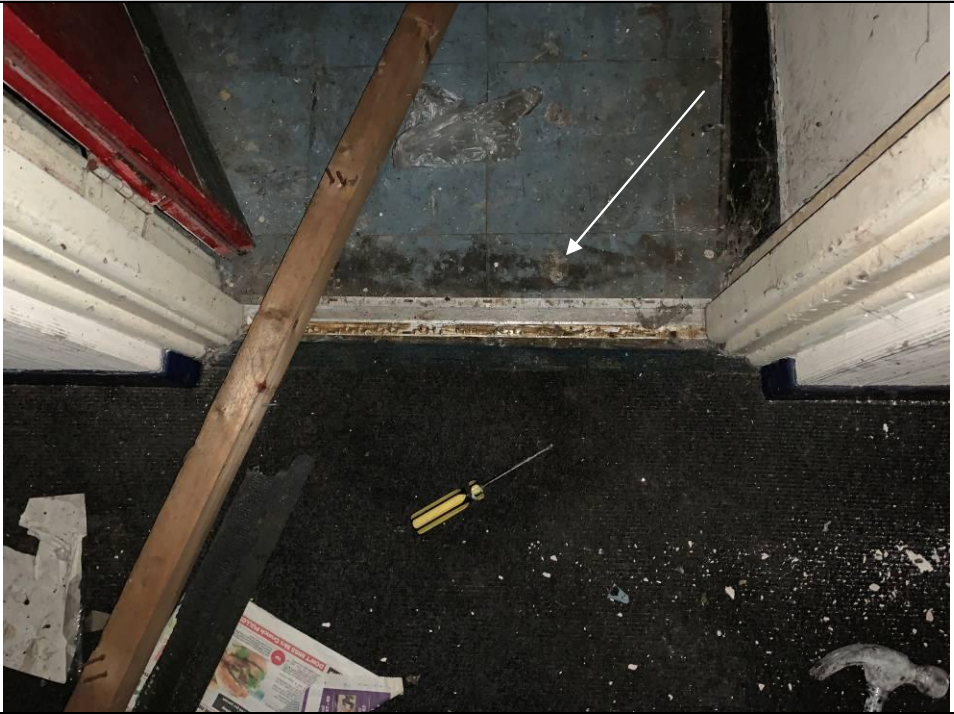
| Sample No. | PS1/17/03 | |

| Result | <b>CHRYSTILE</b> | |

| Sample variable | Score | Examples of scores |
|---|---|---|
| Product type or debris from product | <b>1</b><br>2<br>3 | Asbestos – reinforced composites (plastics, resins, mastics, roofing felts, vinyl floor tiles, semi rigid paints, or decorative finishes, asbestos cement etc.)<br>Asbestos insulating board, asbestos millboard, other low-density insulation boards, asbestos textiles, gaskets ropes and woven textiles, asbestos paper and felt.<br>Thermal insulation (e.g. Pipe and boiler lagging) loose and sprayed asbestos, asbestos mattresses and packing. |

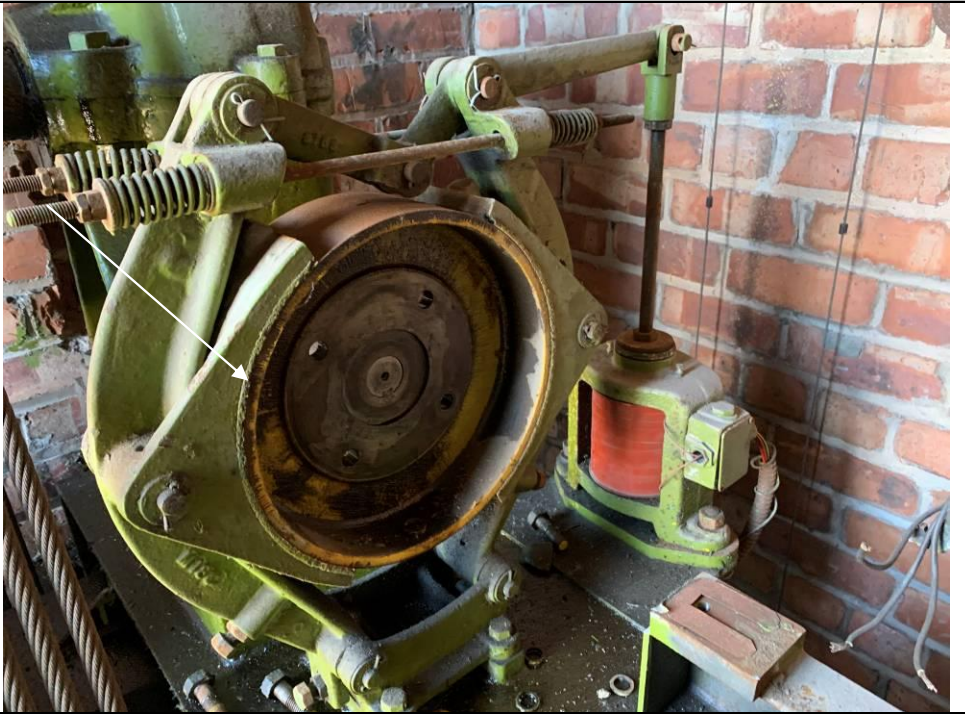
| Sample No. | PS1/19/01 | |

| Result | <b>CHRYSTILE</b> | |

| Sample variable | Score | Examples of scores |
|---|---|---|
| Product type or debris from product | 1<br><b>2</b><br>3 | Asbestos – reinforced composites (plastics, resins, mastics, roofing felts, vinyl floor tiles, semi rigid paints, or decorative finishes, asbestos cement etc.)<br>Asbestos insulating board, asbestos millboard, other low-density insulation boards, asbestos textiles, gaskets ropes and woven textiles, asbestos paper and felt.<br>Thermal insulation (e.g. Pipe and boiler lagging) loose and sprayed asbestos, asbestos mattresses and packing. |

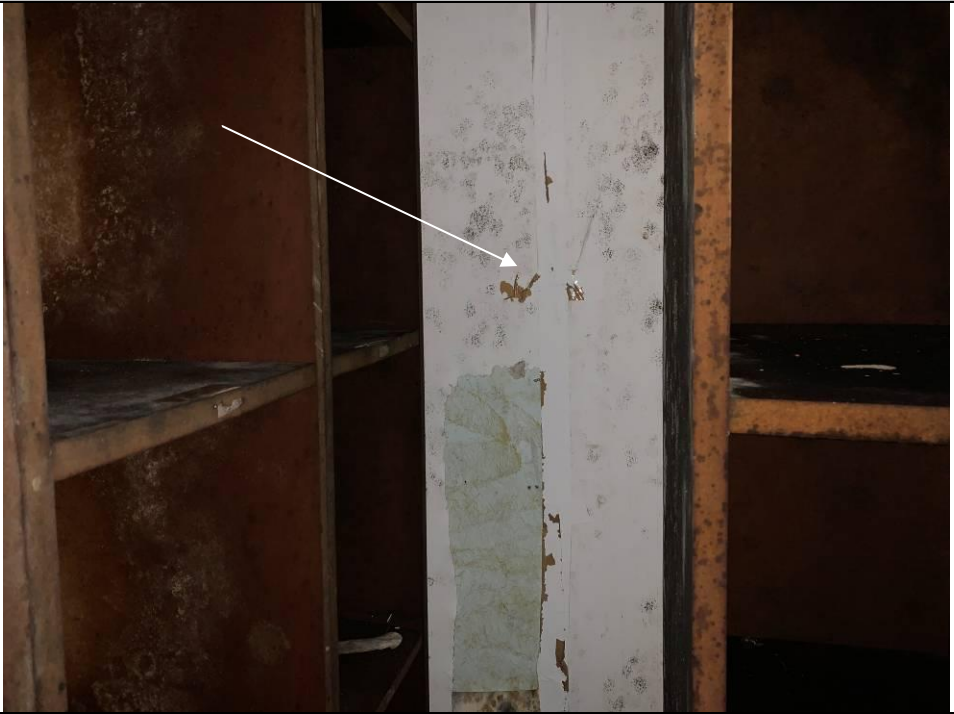
| Sample No. | PS1/30/02 | |

| Result | <b>AMOSITE &amp;<br/>CHRYSTILE</b> | |

| Sample variable | Score | Examples of scores |
|---|---|---|
| Product type or debris from product | 1<br><b>2</b><br>3 | Asbestos – reinforced composites (plastics, resins, mastics, roofing felts, vinyl floor tiles, semi rigid paints, or decorative finishes, asbestos cement etc.)<br>Asbestos insulating board, asbestos millboard, other low-density insulation boards, asbestos textiles, gaskets ropes and woven textiles, asbestos paper and felt.<br>Thermal insulation (e.g. Pipe and boiler lagging) loose and sprayed asbestos, asbestos mattresses and packing. |

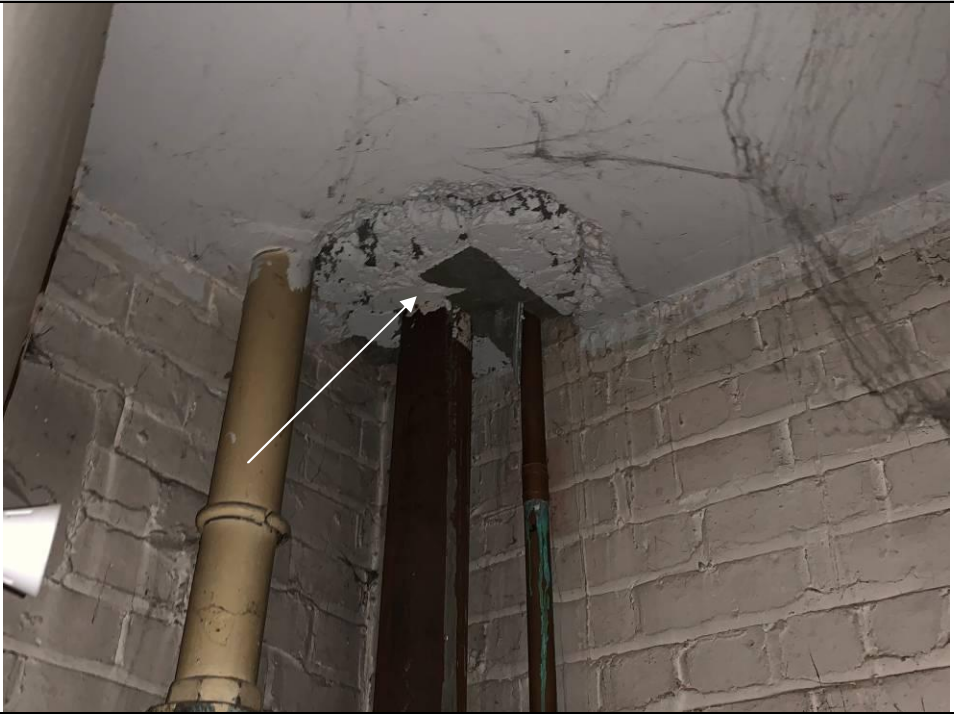
| Sample<br>No. | PS1/51/01 | |

| Result | <b>AMOSITE &amp;<br/>CHRYSTILE</b> | |

| Sample variable | Score | Examples of scores |
|---|---|---|
| Product type or debris<br>from product | 1<br><b>2</b><br>3 | Asbestos – reinforced composites (plastics, resins, mastics, roofing felts, vinyl floor tiles, semi rigid paints, or decorative finishes, asbestos cement etc.)<br>Asbestos insulating board, asbestos millboard, other low-density insulation boards, asbestos textiles, gaskets ropes and woven textiles, asbestos paper and felt.<br>Thermal insulation (e.g. Pipe and boiler lagging) loose and sprayed asbestos, asbestos mattresses and packing. |

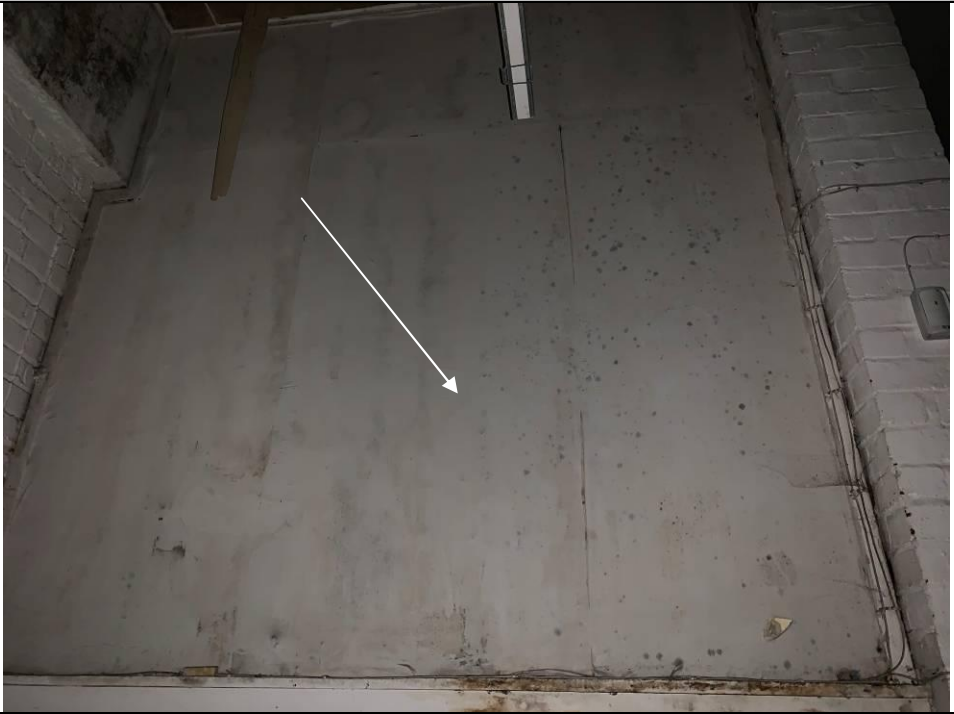
| Sample No. | PS1/67/01 | |

| Result | <b>AMOSITE &amp;<br/>CHRYSOTILE</b> | |

| Sample variable | Score | Examples of scores |
|---|---|---|
| Product type or debris from product | 1<br><b>2</b><br>3 | Asbestos – reinforced composites (plastics, resins, mastics, roofing felts, vinyl floor tiles, semi rigid paints, or decorative finishes, asbestos cement etc.)<br>Asbestos insulating board, asbestos millboard, other low-density insulation boards, asbestos textiles, gaskets ropes and woven textiles, asbestos paper and felt.<br>Thermal insulation (e.g. Pipe and boiler lagging) loose and sprayed asbestos, asbestos mattresses and packing. |
