**Lally Tree Management**

Quote No: LTM0384.LFC.01

This letter has been written to support the application to remove one Scots pine tree from the front of 8 Park Brow CI, Chorlton-cum-Hardy, Manchester, M21 8UL. I do not claim that the risks posed by this tree are not acceptable as I believe that the

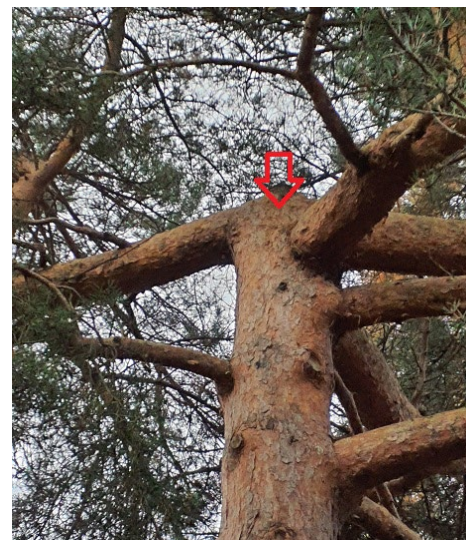
The tree is large for the small garden that it stands within and is causing significant shading to the property even in winter on account that the tree is evergreen. This shading could normally be partially abated through a crown lift, however the tree has been topped in the past at around 6m most likely as a result of someone in the past having the same issues with regards to shading. This has resulted in a stout tree with multiple low branches causing

more shading than would normally be expected for a similar tree of this species at this age.

Figure 1. Previously topped (red arrow) resulting in an unnatural form

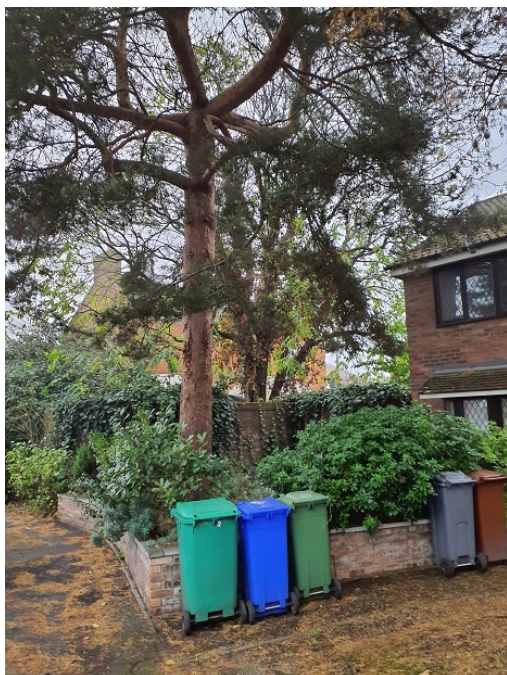
This topping has given the tree an unnatural form with awkward branch unions.

Figure 2 Awkward branch unions present as a result of previous topping works.

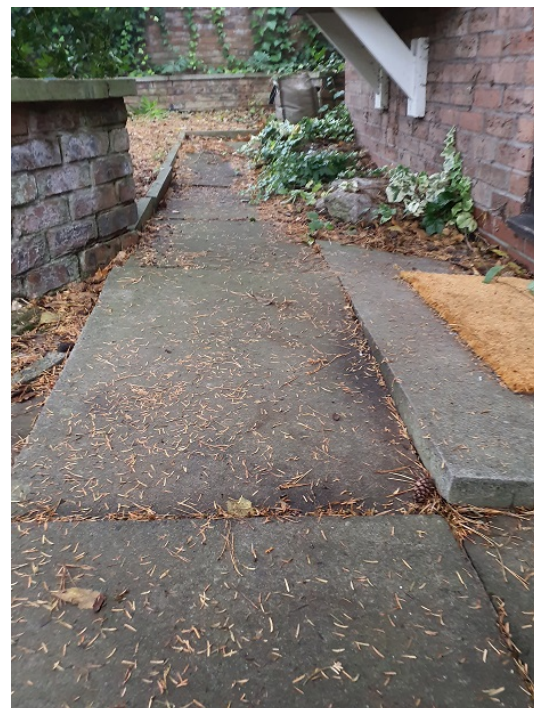
The paving around the property is uneven and appears to be being lifted by surface roots from the Pine and possibly the adjacent Dawn Redwood.

Figure 3. Paving appears to be affected by roots

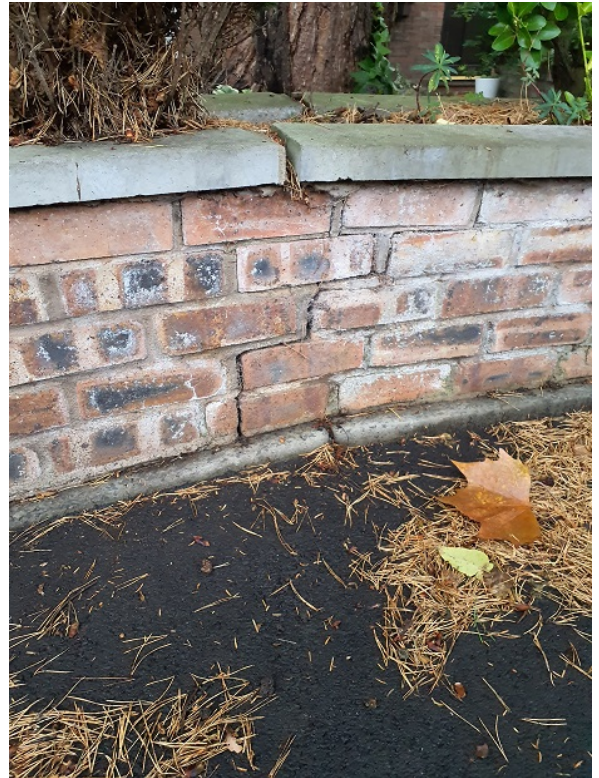
Finally, there is a small crack appearing in the front wall, although we have no evidence at this time linking this crack with the Pine tree it is my opinion that the crack is likely to be due to incremental growth from a large root adjacent to this wall.

*Figure 4. Crack forming in front wall*
