**Project Name:** BELLE VUE DOG TRACK

**Project Description:** CCTV

**Project Date:** 14/10/2021

**Inspection Standard:** MSCC5 Sewers & Drainage GB (SRM5 Scoring)

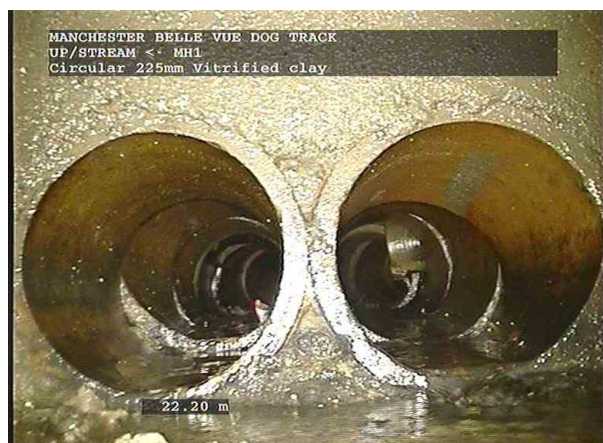
| Scale: | 1:194 | Position [m] | Code | Observation | Grade |
|---|---|---|---|---|---|
| | 22.20 | REM | General remark: SPLITS INTO TWO 150MM PIPES | | |

UP\_STREAMX\_353912d8-0d2d-4ea4-b3c5-a4e89d10e7c9\_2  
0211014\_095353\_969.jpg, 00:08:12, 22.20 m  
General remark, SPLITS INTO TWO 150MM PIPES

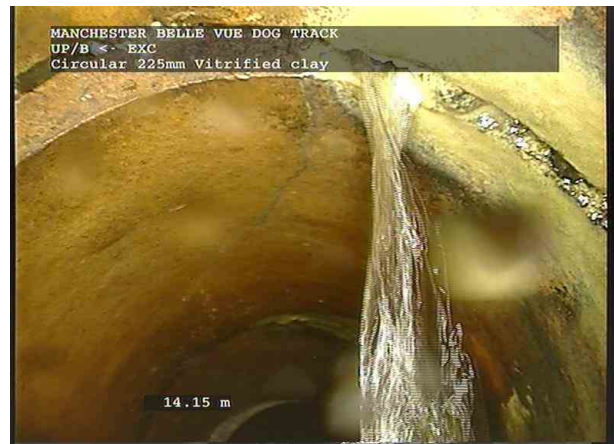
| No. | m+ | Code | Observation |
|---|---|---|---|
| 6 | 14.15 | IRJ | Infiltration, running at joint at 1 o'clock |

UP\_BX\_f80be6bf-109d-46c3-9c52-611f2be35c0d\_20211115\_102636\_062.jpg, 00:02:54, 14.15 m  
Infiltration, running at joint at 1 o'clock

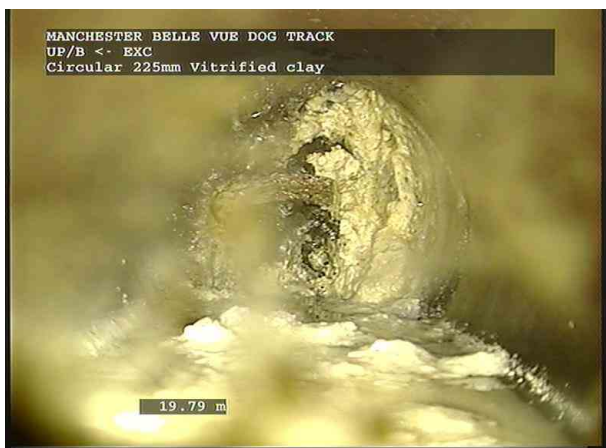
| No. | m+ | Code | Observation |
|---|---|---|---|
| 7 | 19.78 | DEX | Settled deposits, other, 100% cross-sectional area loss |
| 8 | 19.79 | DEX | Settled deposits, other, 95% cross-sectional area loss, start |

| Pipe No. | Insp. No. | Upstream Node | Downstream Node | Dir. | Operator | Insp. Date | Insp. Time | Str | Ser | Final Observation | Length |
|---|---|---|---|---|---|---|---|---|---|---|---|
| 4 | 1 | UP/B | EXC | US | L Meredith | 15/11/2021 | 10:22 | 5 | 1 | SA, COLLAPSED | 19.09 m |

UP\_BX\_6a5f76b5-5bea-4fbb-9ef3-7b1d99de9668\_20211115\_103042\_596.jpg, 00:05:45, 19.79 m  
Survey abandoned, COLLAPSED
