**Project Name:** John Southworth - Mayton Street - PJ00417102  
**Project Status:** Complete  
**Project Date:** 17/08/2021  
**Lanes Division:** Manchester

As requested, we have recently carried out a drainage CCTV survey at the site location and our full and detailed findings are contained in the attached CCTV report which you can review at your leisure.

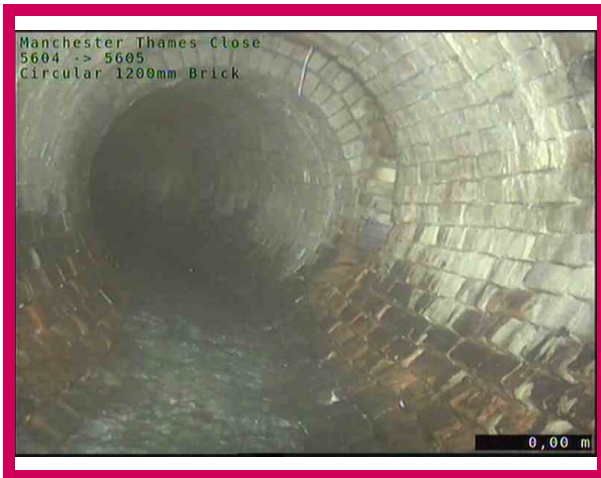
1, 00:00:04, 0.00 m  
Mortar missing, from 15 to 50 mm mortar loss from 04 o'clock to 07 o'clock, start

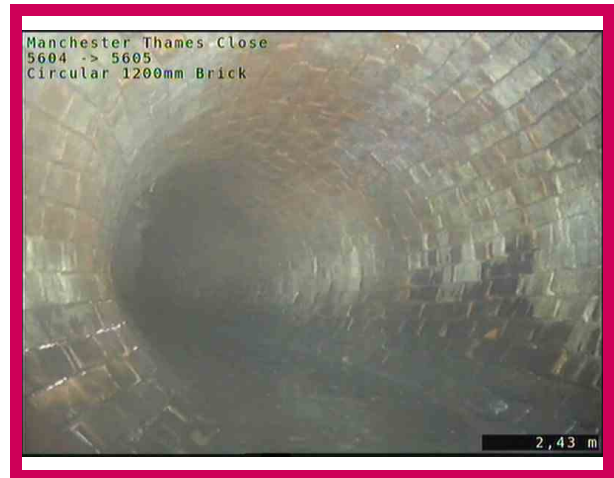
2, 00:00:31, 2.43 m  
Mortar missing, from 15 to 50 mm mortar loss from 4 o'clock to 7 o'clock, finish

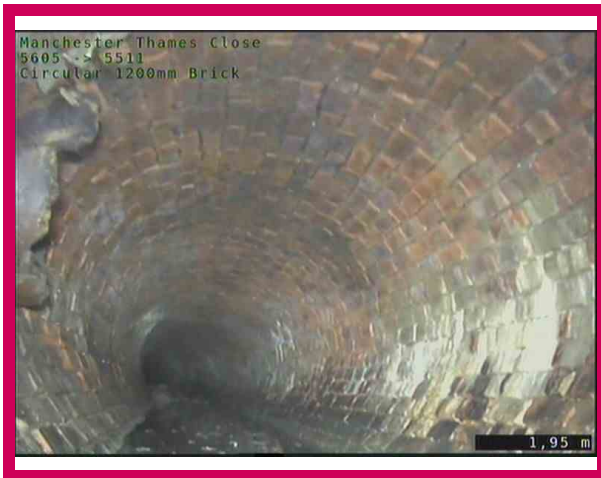
1, 00:00:16, 1.95 m  
Connection defective, connecting pipe is intruding at 10 o'clock, diameter: 675mm, intrusion: 10%

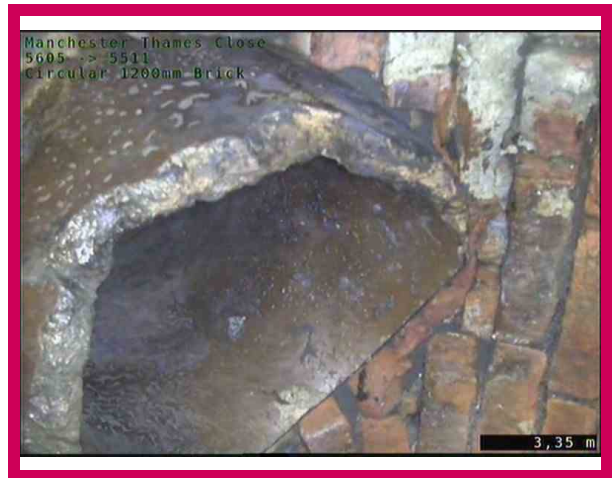
2, 00:00:29, 3.35 m  
Connection defective, connecting pipe is intruding at 9 o'clock, diameter: 300mm, intrusion: 10%

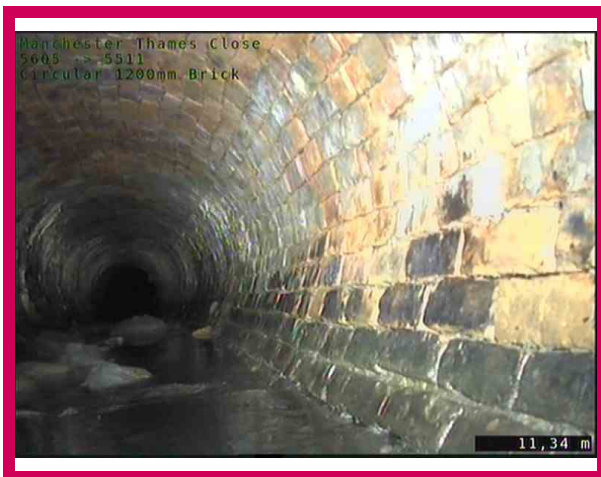
Section 2: Debris coarse 15%

3, 00:02:11, 9.95 m  
Settled deposits, coarse, 15% cross-sectional area loss

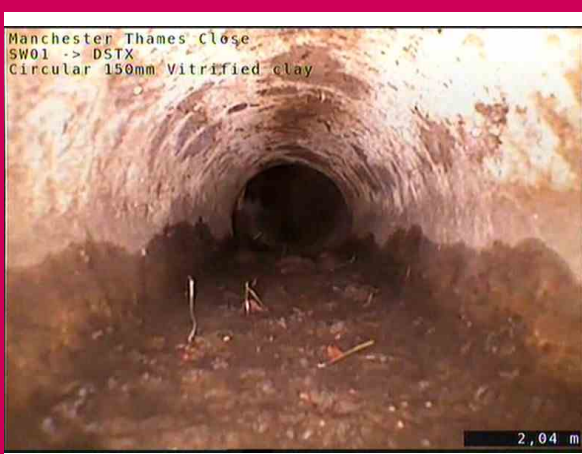
1, 00:00:23, 1.78 m  
Settled deposits, fine, 10% cross-sectional area loss

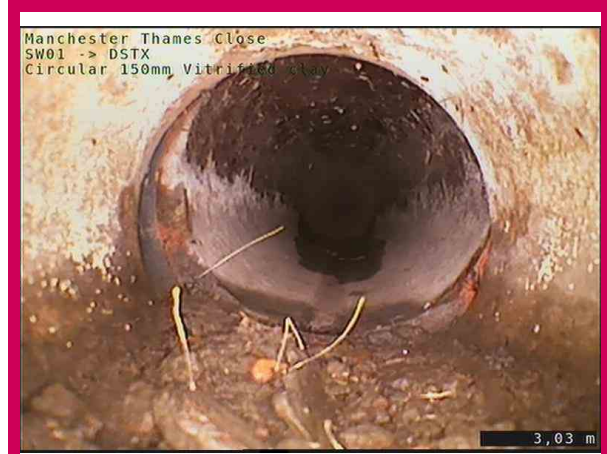
2, 00:01:08, 3.03 m  
Joint displaced, medium

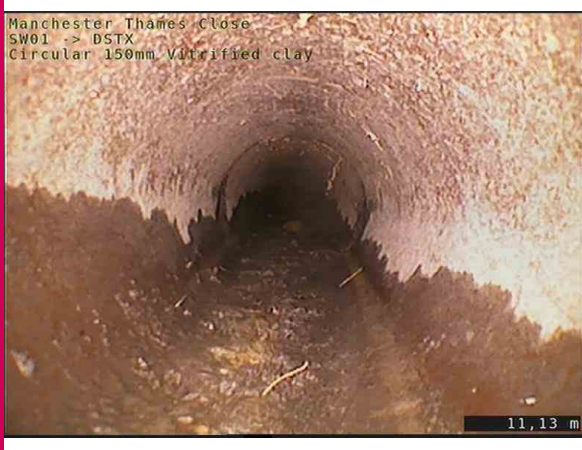
3, 00:03:56, 11.13 m  
Settled deposits, fine, 10% cross-sectional area loss

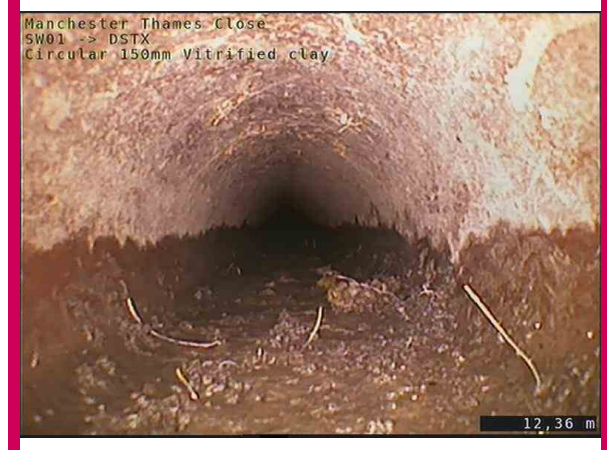
4, 00:04:03, 11.94 m  
Settled deposits, fine, 15% cross-sectional area loss

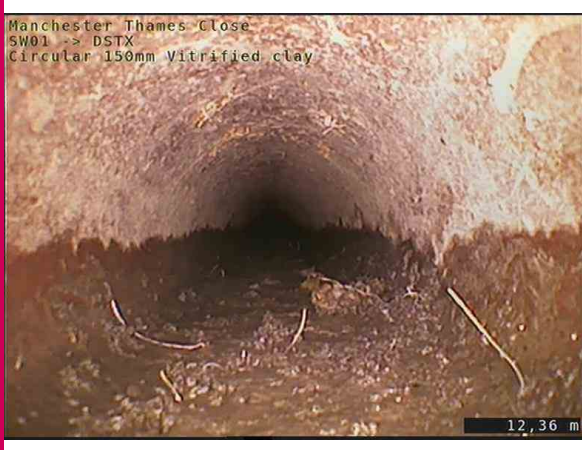
5, 00:04:11, 12.36 m  
Survey abandoned, Debris silt 15%
