# BS 5837:2012 Arboricultural Survey

Scotland Hall Road Recreation Ground, Manchester

Presented to **Manchester City F.C. City in the Community Foundation**

Delta-Simons Project No. 18-1673.04

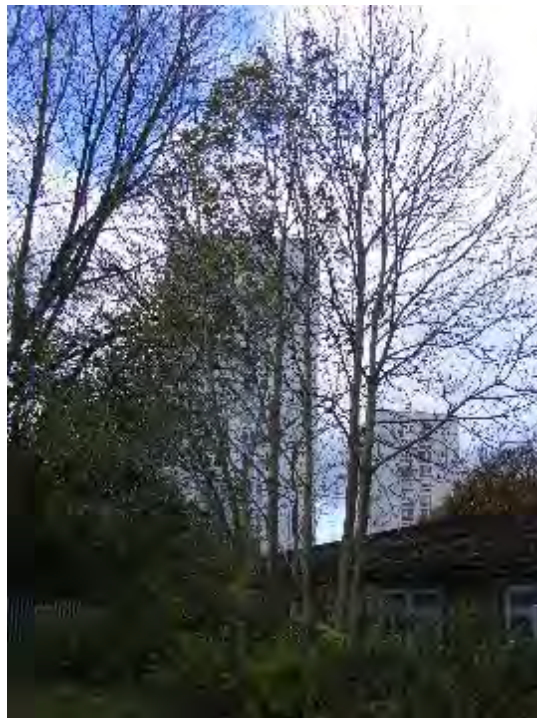
**Photograph 2 – TG2**

| Tree Number | Tree Species | | Measurements | | | Crown (m) | | | | Tree Condition | | | | | | | | | | Management |
|---|---|---|---|---|---|---|---|---|---|---|---|---|---|---|---|---|---|---|---|---|
| TG2 | Ash | <i>Fraxinus excelsior</i> | Y | 10 | SM | Av<br>175 | 2 | 4 | 4 | 4 | 4 | No obvious damage | Multiple stems from base, vertical. | Canopies read as one. | | F | >40 | C | 2.1 | |

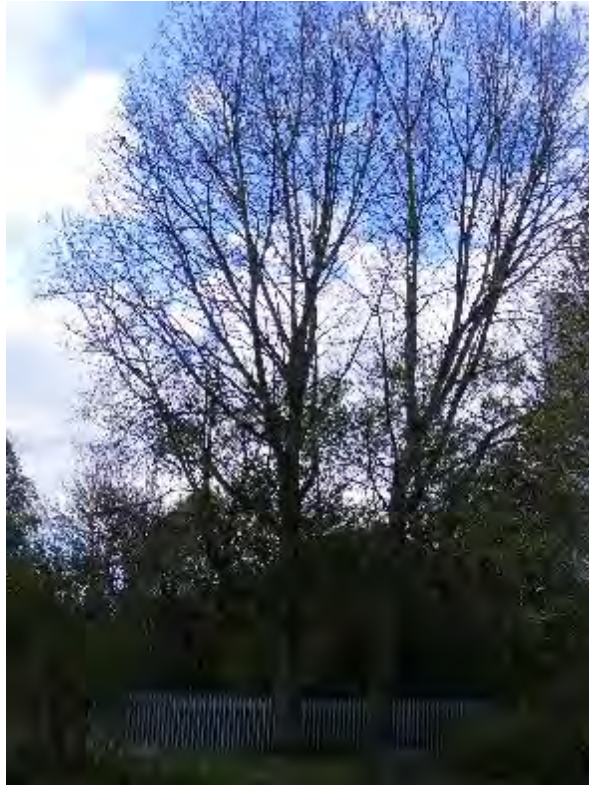
**Photograph 3 – TG3 and TG4**

| Tree Number | Tree Species | | Measurements | | | Crown (m) | | | | Tree Condition | | | | | | | | | | Management |
|---|---|---|---|---|---|---|---|---|---|---|---|---|---|---|---|---|---|---|---|---|
| TG3 | Hybrid black poplar | <i>Populus x canadensis</i> | SM | 18 | S | Av<br>800 | 4 | 8 | 10 | 8 | 6 | No obvious damage | Single stems, vertical. | Open canopy. Scattered deadwood present | | F | >40 | B | 9.6 | |
| TG4 | Crack willow | <i>Salix fragilis</i> | SM | 16 | S | Est<br>550 | 4 | 8 | 8 | 8 | 8 | Unable to access | Single and multiple stems, vertical. | Open canopies. Minor deadwood | Scattered group on embankment with canopies that extend into the park | F | >40 | B | 6.6 | |

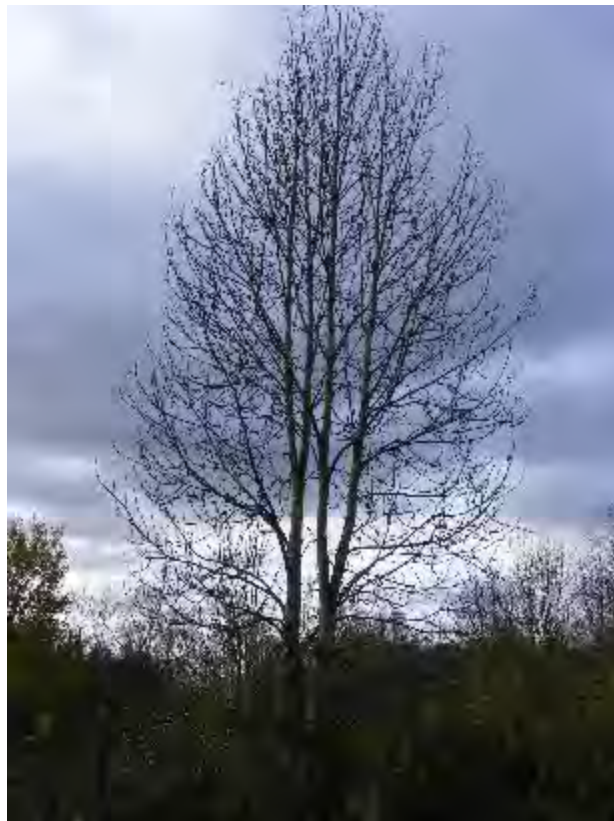
**Photograph 4 – Tree (T)5**

| Tree Number | Tree Species | | Measurements | | | Crown (m) | | | | Tree Condition | | | | | | | | | | Management |
|---|---|---|---|---|---|---|---|---|---|---|---|---|---|---|---|---|---|---|---|---|
| T5 | Ash | <i>Fraxinus excelsior</i> | Y | 7 | 2 | Est 2<br>x<br>200 | 2 | 2 | 2 | 2 | 2 | No obvious damage | Bifurcated at 1 m. Vertical. Included bark present. | Open and balanced | | F | >40 | B | 3.3 | |

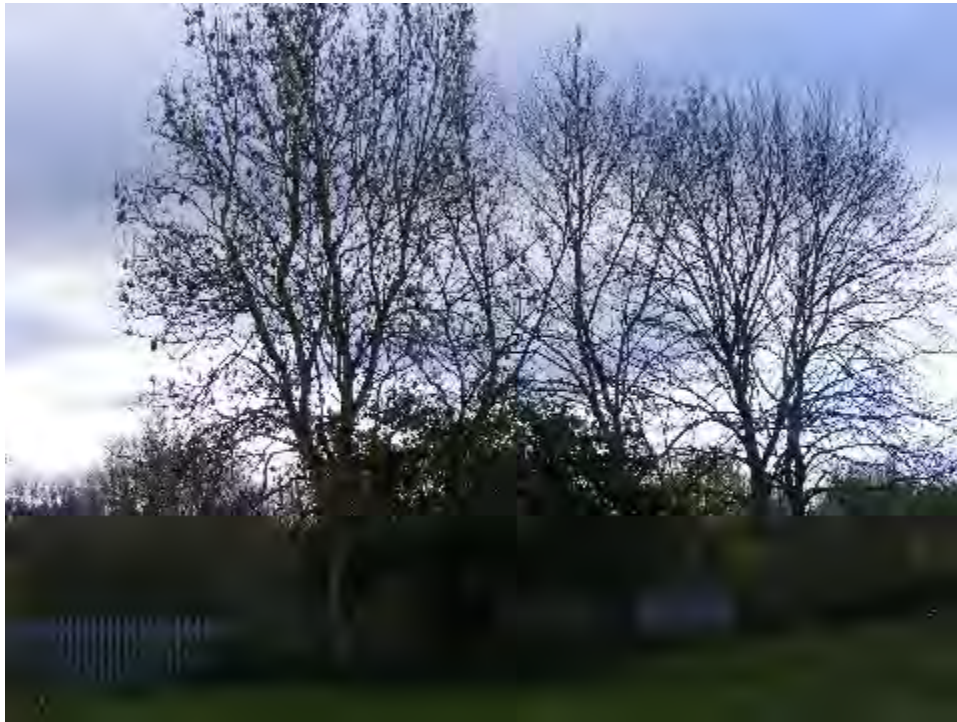
**Photograph 5 – TG6**

| Tree Number | Tree Species | | Measurements | | | Crown (m) | | | | Tree Condition | | | | | | | | | | Management |
|---|---|---|---|---|---|---|---|---|---|---|---|---|---|---|---|---|---|---|---|---|
| TG6 | Ash | <i>Fraxinus excelsior</i> | SM | 12 | S | Av<br>500 | 2 | 8 | 8 | 8 | 8 | No obvious damage | Single stems, vertical. Two trees with extensive bark damage | Canopies read as one. Scattered deadwood present. | | F | >40 | C | 6.0 | |

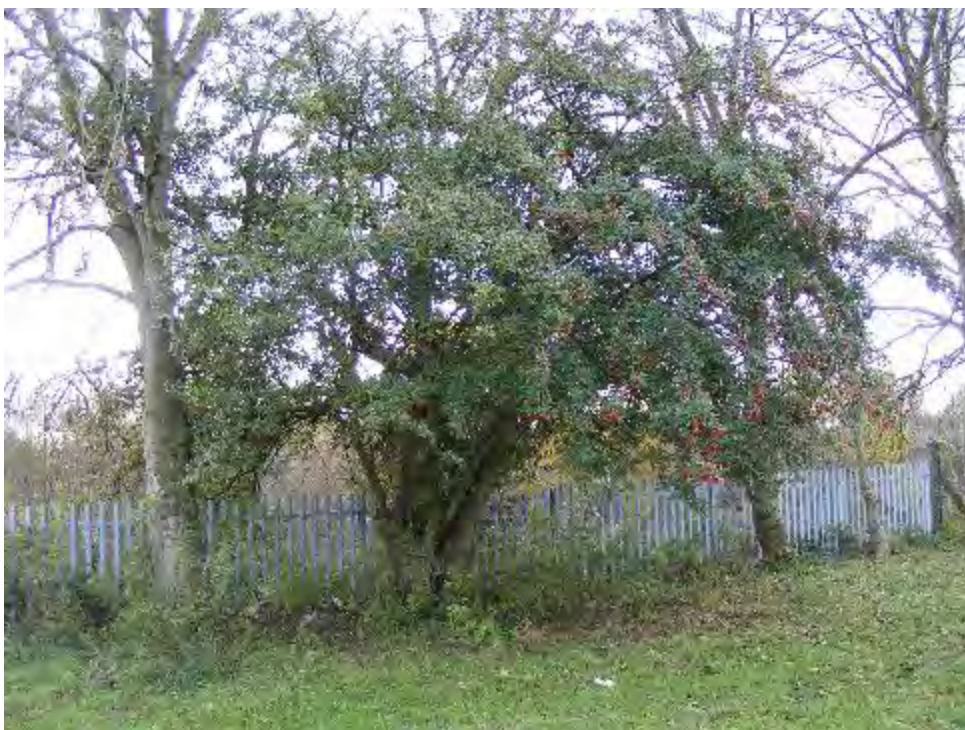
**Photograph 6 – T7**

| Tree Number | Tree Species | | Measurements | | | Crown (m) | | | | Tree Condition | | | | | | | | | | Management |
|---|---|---|---|---|---|---|---|---|---|---|---|---|---|---|---|---|---|---|---|---|
| T7 | Midland hawthorn | <i>Crataegus laevigata</i> | M | 6 | MS | 3 x<br>175 | 1 | 5 | 5 | 5 | 5 | No obvious damage | Multi stemmed from base, vertical. | Dense rounded canopy. Pruning wounds from crown lift present. | | F | 20 - 40 | B | 3.6 | |

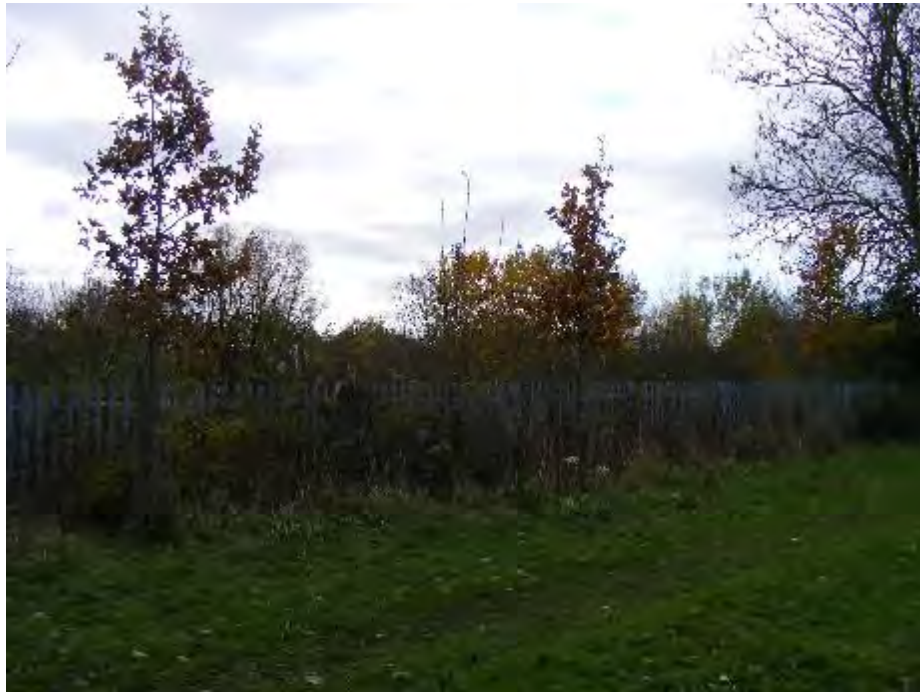
**Photograph 7 – TG8**

| Tree Number | Tree Species | | Measurements | | | Crown (m) | | | | Tree Condition | | | | | | | | | | Management |
|---|---|---|---|---|---|---|---|---|---|---|---|---|---|---|---|---|---|---|---|---|
| TG8 | Pedunculate oak | <i>Quercus robur</i> | Y | 4 | 5 | 75 | 1.5 | .5 | .5 | .5 | .5 | No obvious damage | Single stems, vertical | Open and balanced | Tree supports present | F | >40 | C | 0.9 | |

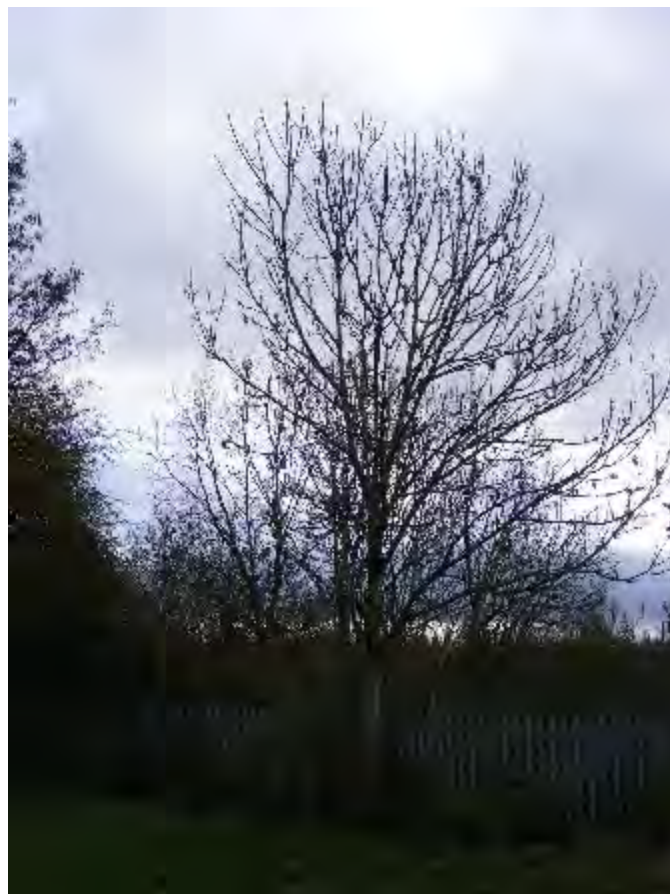
**Photograph 8 – T9**

| Tree Number | Tree Species | | Measurements | | | Crown (m) | | | | Tree Condition | | | | | | | | | | Management |
|---|---|---|---|---|---|---|---|---|---|---|---|---|---|---|---|---|---|---|---|---|
| T9 | Sycamore | <i>Acer pseudoplatanus</i> | Y | 7 | S | 20 | 3 | 3 | 3 | 3 | 3 | No obvious damage | Single stem, vertical | Rounded canopy. | Suckered growth from base | F | >40 | C | 2.4 | |

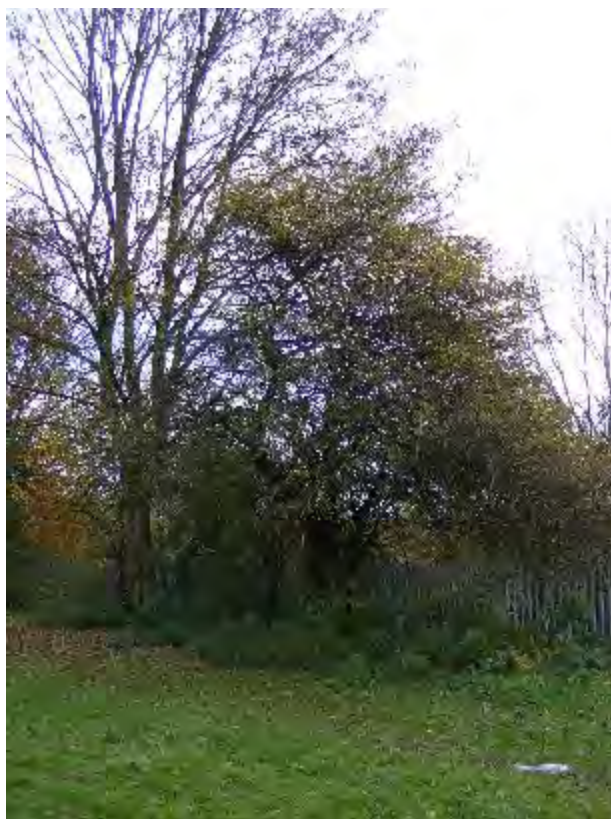
**Photograph 9 – TG10**

| TG10 | Common hawthorn | <i>Cataegus monogyna</i> | Y/ SM | 5 | SM | Av 15 | 1 | 4 | 4 | 4 | 4 | No obvious damage | Single and multiple stems, vertical | Canopies read as one. Minor deadwood | | F | 20-40 | C | 1.8 | |

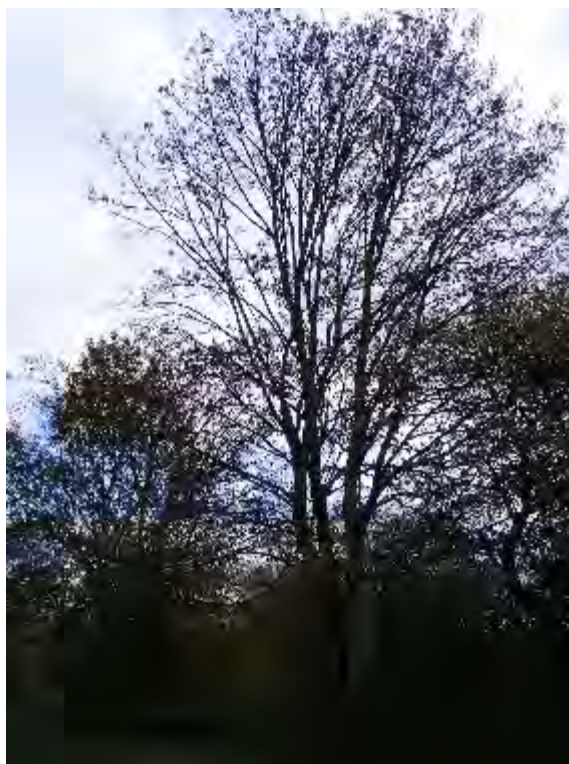
**Photograph 10 – T11**

| T11 | Sycamore | <i>Acer pseudoplatanus</i> | SM | 6 | S | 600 | 4 | 8 | 8 | 8 | 8 | No obvious damage | Single stem, vertical. | Rounded canopy. Scattered deadwood present. | | F | >40 | B | 7.2 | |

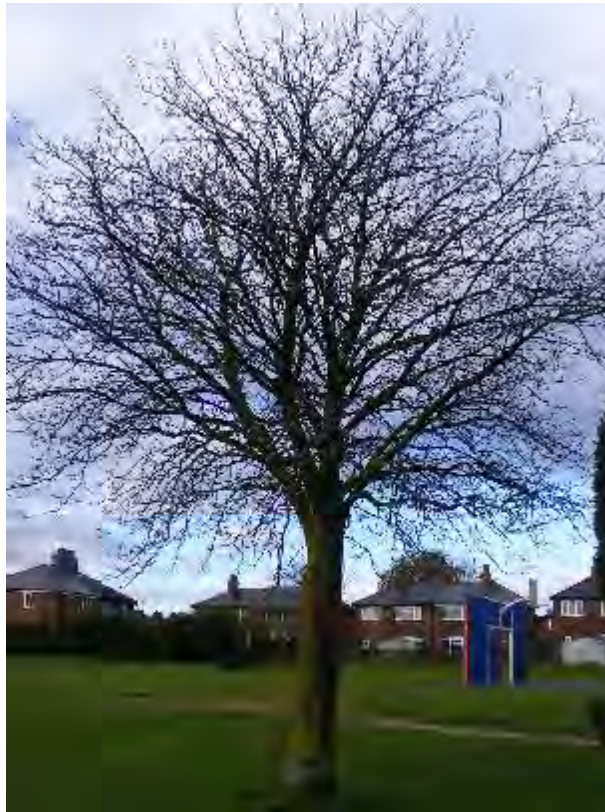
**Photograph 11 – T12**

| T12 | Whitebeam | <i>Sorbus aria</i> | SM | 6 | S | 425 | 2 | 4 | 4 | 4 | 4 | No obvious damage | Single stem, vertical. Occluded wound on trunk at 1 m. | Balanced, rounded canopy. | | F | 20-40 | B | 5.1 | |

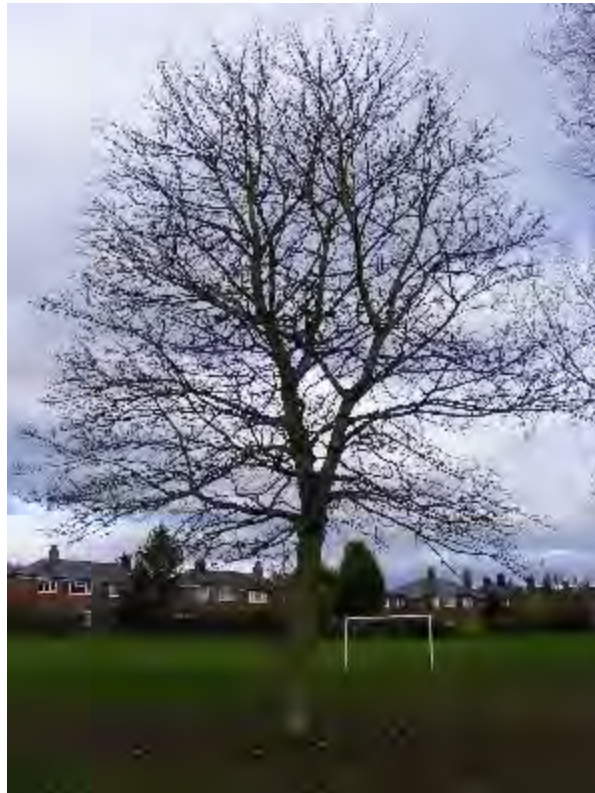
**Photograph 12 – T13**

| T13 | Silver maple | <i>Acer saccharinum</i> | SM | 6 | S | 450 | 2 | 4 | 4 | 4 | 4 | No obvious damage | Single stem, vertical. | Rounded canopy | | G | >40 | B | 5.4 | |

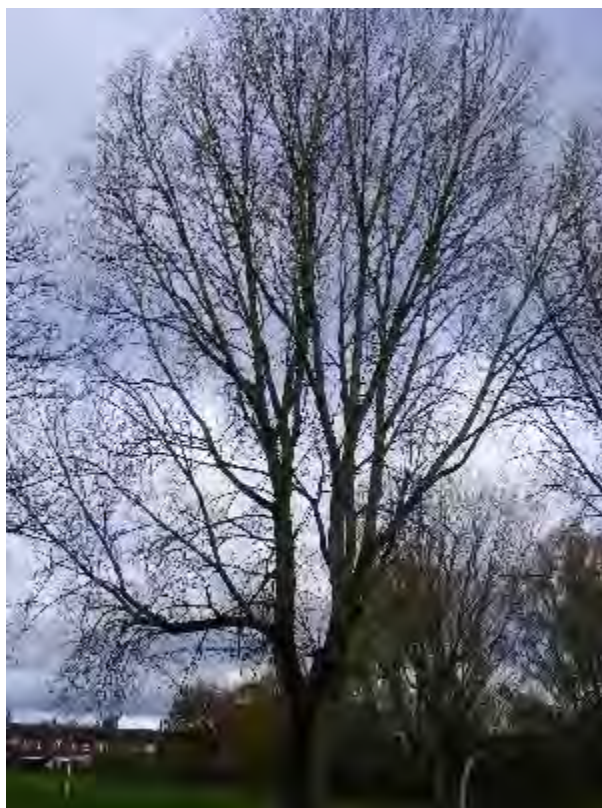
**Photograph 13 – T14**

| T14 | Hybrid black poplar | <i>Populus x canadensis</i> | SM | 22 | S | 1100 | 4 | 10 | 10 | 8 | 8 | No obvious damage | Single stem, vertical. | Open canopy. Minor deadwood | | G | >40 | A | 13.2 | |

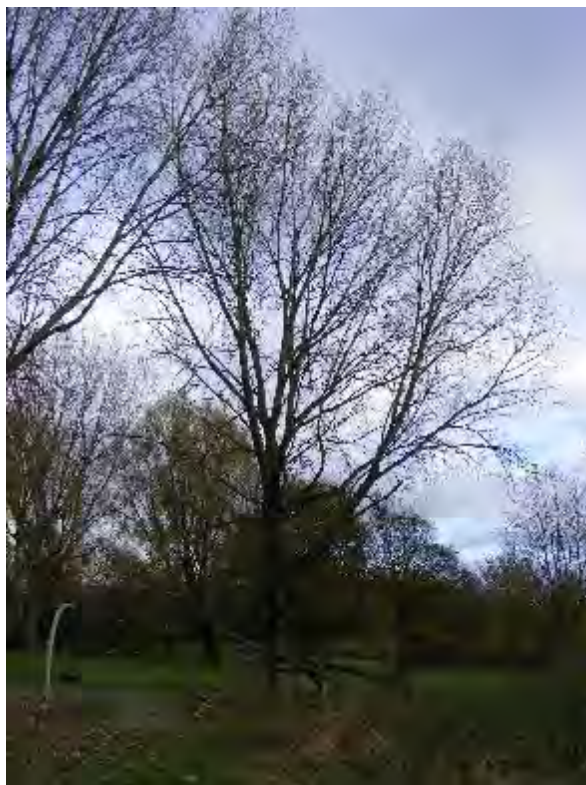
**Photograph 14 – T15**

| T15 | Hybrid black poplar | <i>Populus x canadensis</i> | SM | 21 | S | 1000 | 3 | 8 | 10 | 10 | 8 | No obvious damage | Single stem, vertical. Wound from base to 1 m, occluding | Open canopy. Minor deadwood | | F | >40 | A | 12.0 | |

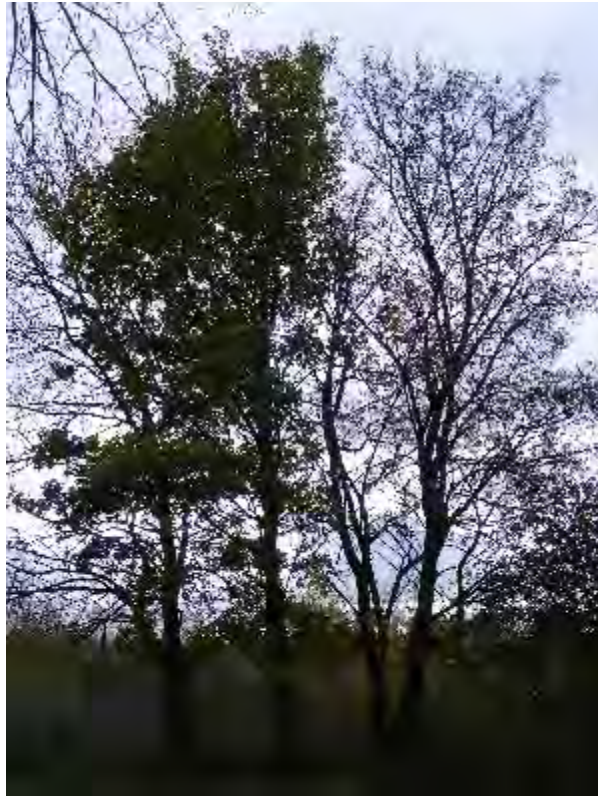
**Photograph 15 – TG16**

| TG16 | Sycamore Common hawthorn | <i>Acer pseudoplatanus</i><br><i>Cataegus monogyna</i> | SM | 15 | S/ MS | Av 425 | 2 | 8 | 8 | 8 | 8 | No obvious damage | Single and multiple stems, vertical | Canopies read as one. Scattered deadwood. Vertical wound on one stem, occluding. | | F | 20-40 | B | 5.10 | |

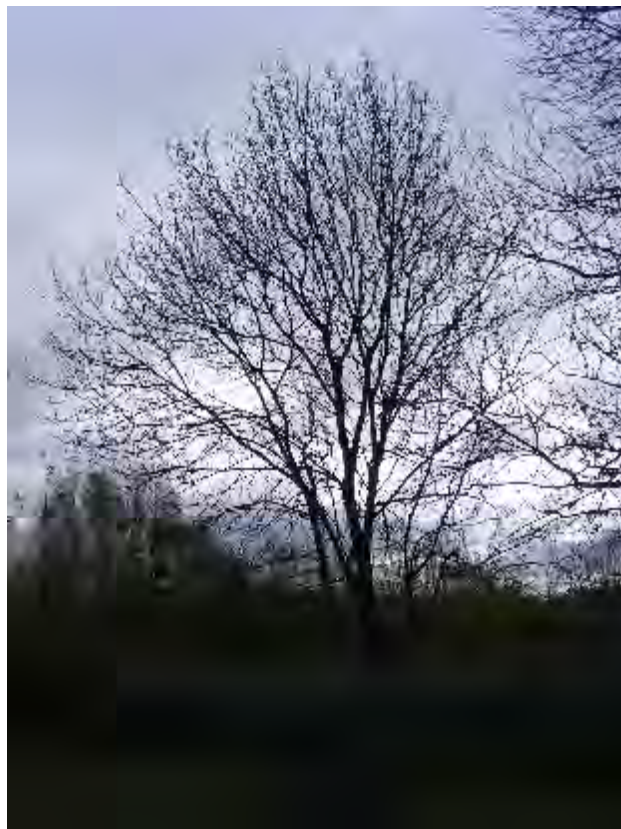
**Photograph 16 – T17**

| T17 | Sycamore | <i>Acer pseudoplatanus</i> | SM | 14 | S | Est 500 | 1 | 6 | 6 | 6 | 4 | No obvious damage | Single stem, vertical. | Rounded canopy | Fencing impacting stem at base. | F | 20-40 | B | 6.0 | |

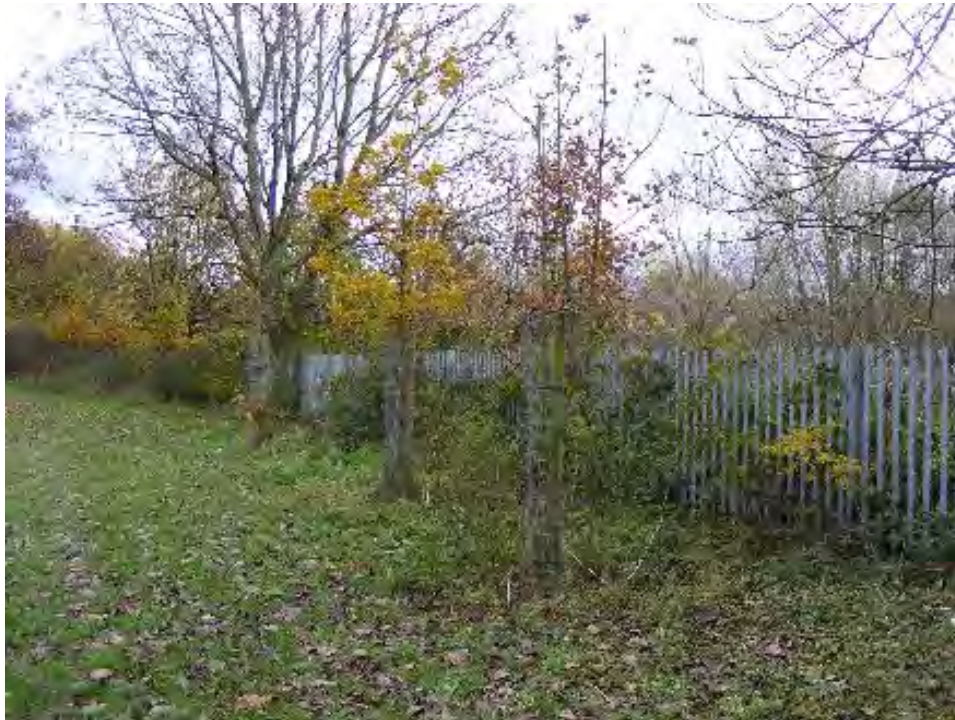
**Photograph 17 – TG18**

| TG18 | Pedunculate oak | <i>Quercus robur</i> | Y | 4 | S | 75 | 1 | .5 | .5 | .5 | .5 | No obvious damage | Single stems, vertical | Open and balanced | Tree supports present | F | >40 | C | 0.9 | |

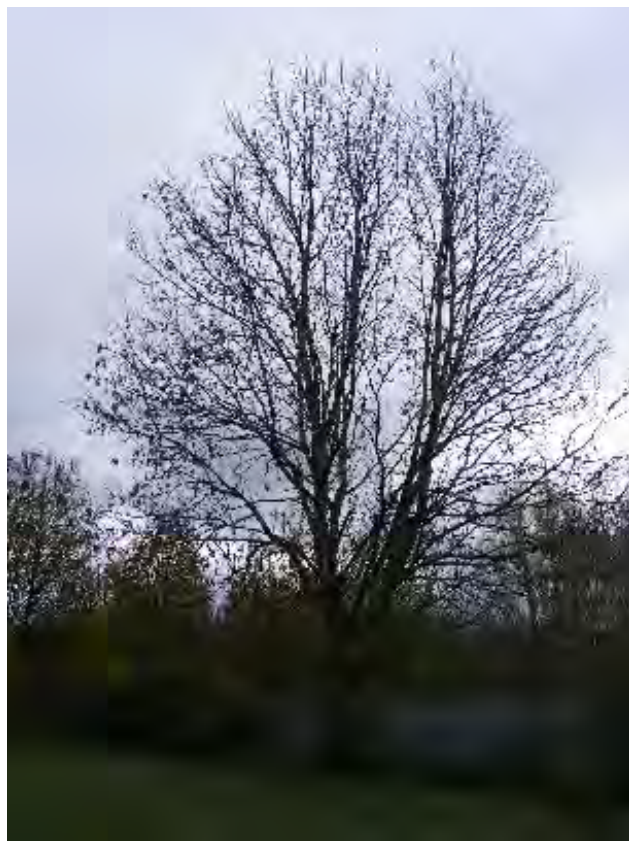
**Photograph 18 – T19**

| T19 | Ash | <i>Fraxinus excelsior</i> | SM | 16 | 4 | 275<br>300<br>350<br>475 | 2 | 5 | 5 | 5 | 5 | No obvious damage | Multi stemmed from base. Vertical. Bark damage at 1 m, occluding | Rounded and balanced | | F | >40 | B | 8.4 | |

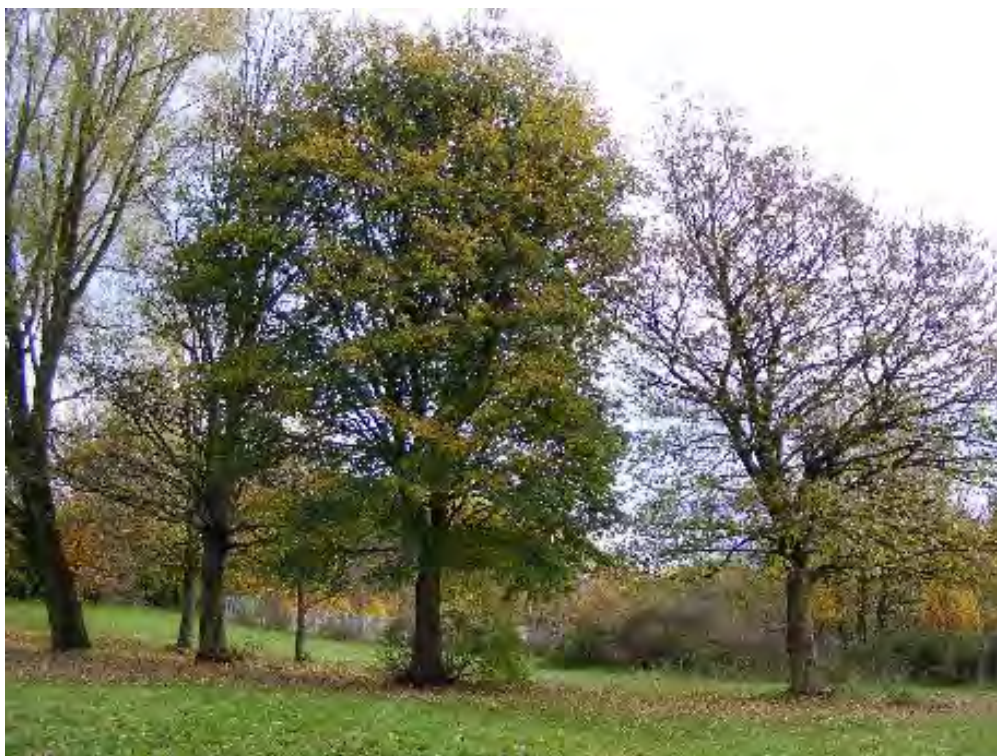
**Photograph 19 – TG20**

| TG20 | Sycamore | <i>Acer pseudoplatanus</i> | SM | Av 16 | S | Av 600 | 2 | 7 | 7 | 7 | 7 | No obvious damage | Single stem, vertical. | Rounded and balanced | | F | >40 | B | 7.2 | |

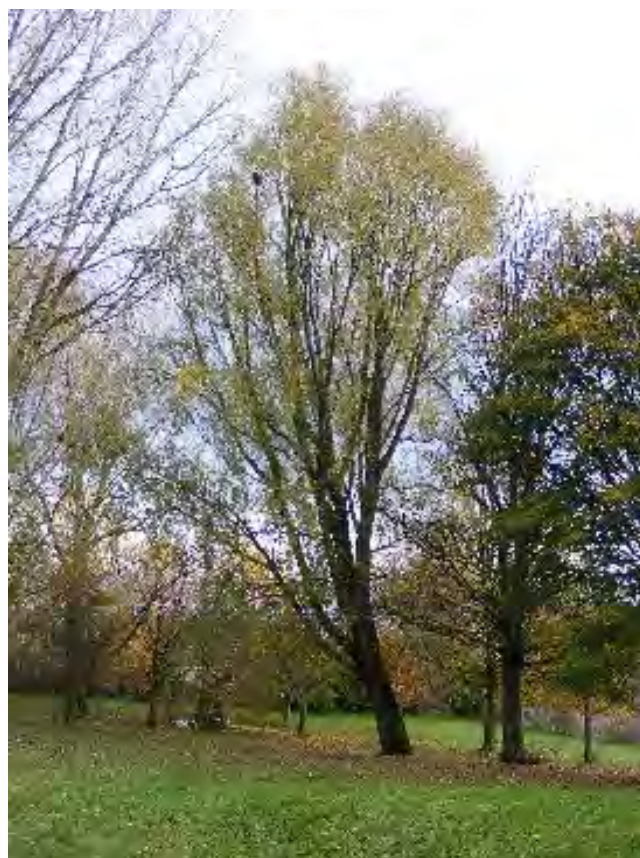
**Photograph 20 – T21**

| T21 | Crack willow | <i>Salix fragilis</i> | M | 22 | S | 975 | 3 | 12 | 8 | 5 | 8 | No obvious damage | Single stem, Leaning to the north. | Open, suppressed by surrounding trees. Scattered deadwood. | | F | >40 | A | 11.7 | |

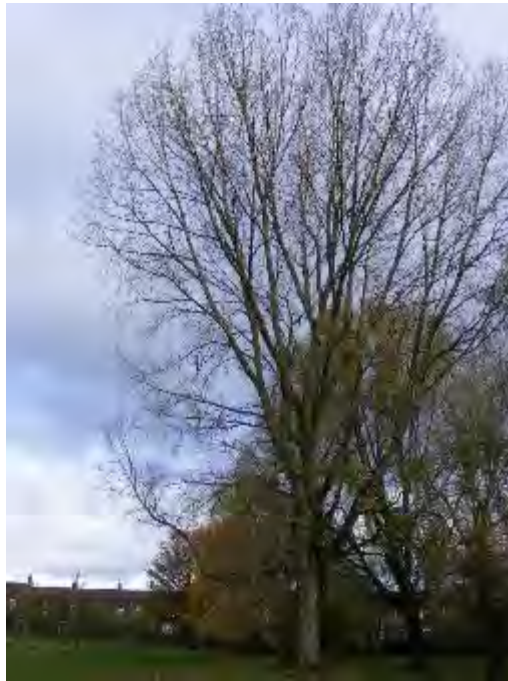
**Photograph 21 – T22**

| T22 | Hybrid black poplar | <i>Populus x canadensis</i> | M | 22 | S | 1100 | 3 | 12 | 10 | 8 | 10 | No obvious damage | Single stem, vertical. | Open and balanced. Minor | | F | >40 | A | 13.2 | |

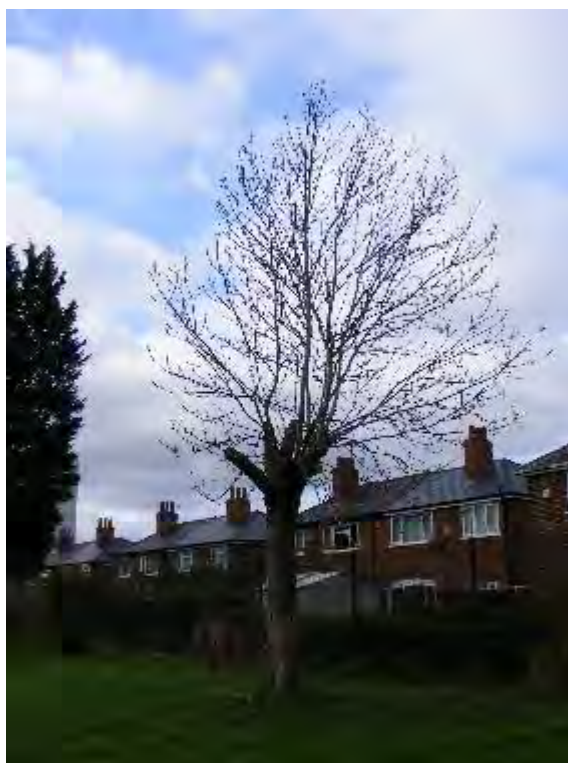
**Photograph 27 – T28**

The greater proportion of the trees surveyed are mature and semi-mature with a several young oak trees present on the southern boundary and a community orchard of young apple trees. With the exception of T28 that has been pollarded, the remainder of the trees show limited signs of past management with the occasional hawthorn crown lifted. All trees appear to be in fair to good condition apart from T28 that was in a poor condition due to fungal growth and extensive bark damage.

It appears limited management has taken place to the trees off-Site. However, the majority of trees are in fair to good health, apart from T28 that was in poor health due to fungal disease and significant bark damage.
