## Science & Industry Museum, Manchester

### Power Hall: Drainage Engineering Note

180426/K Clark

17 Oct 2021

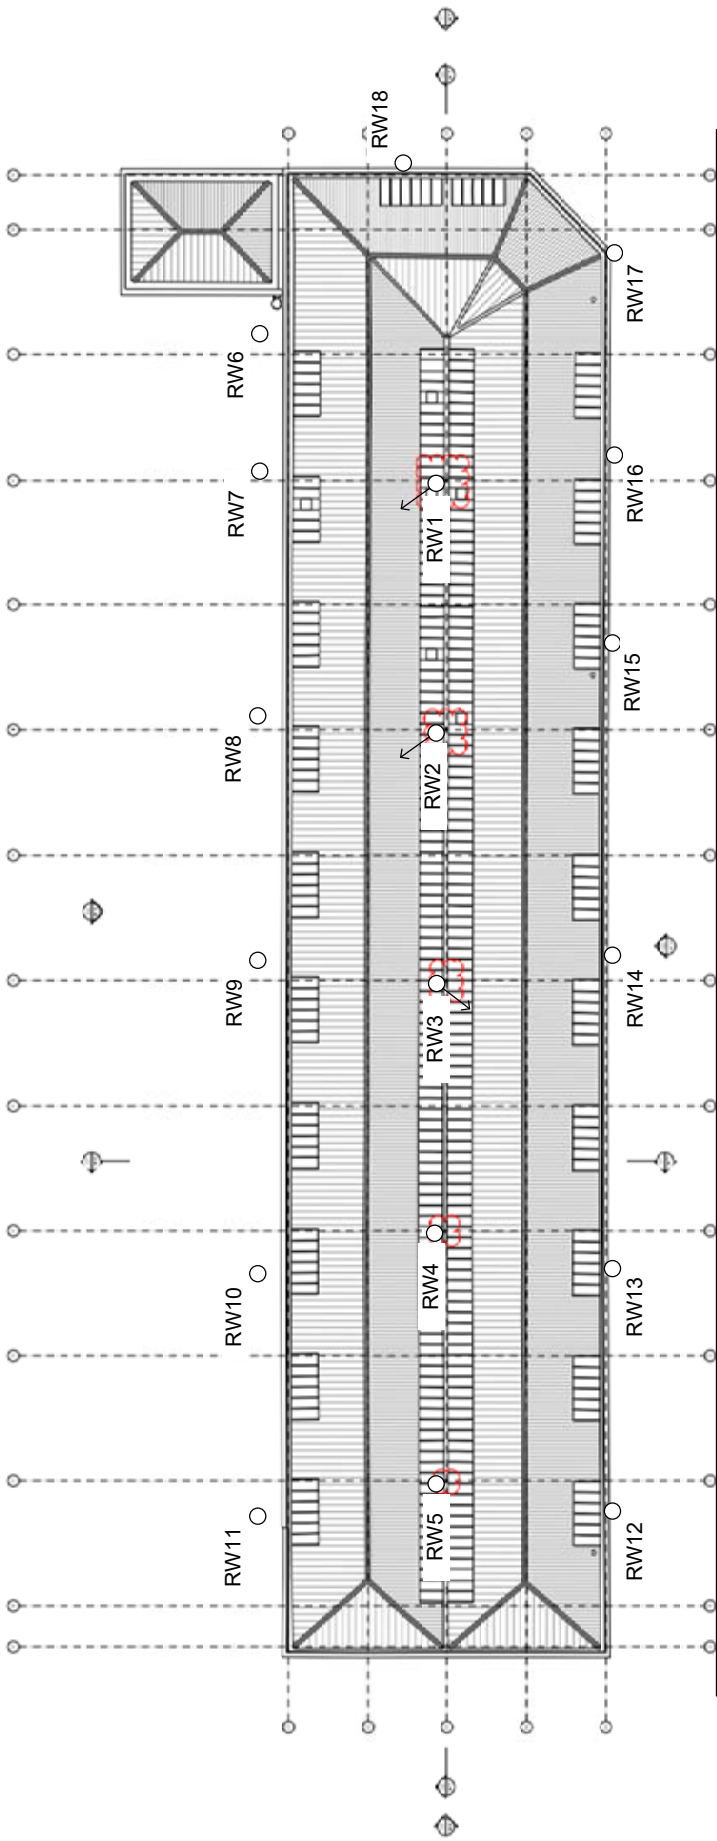
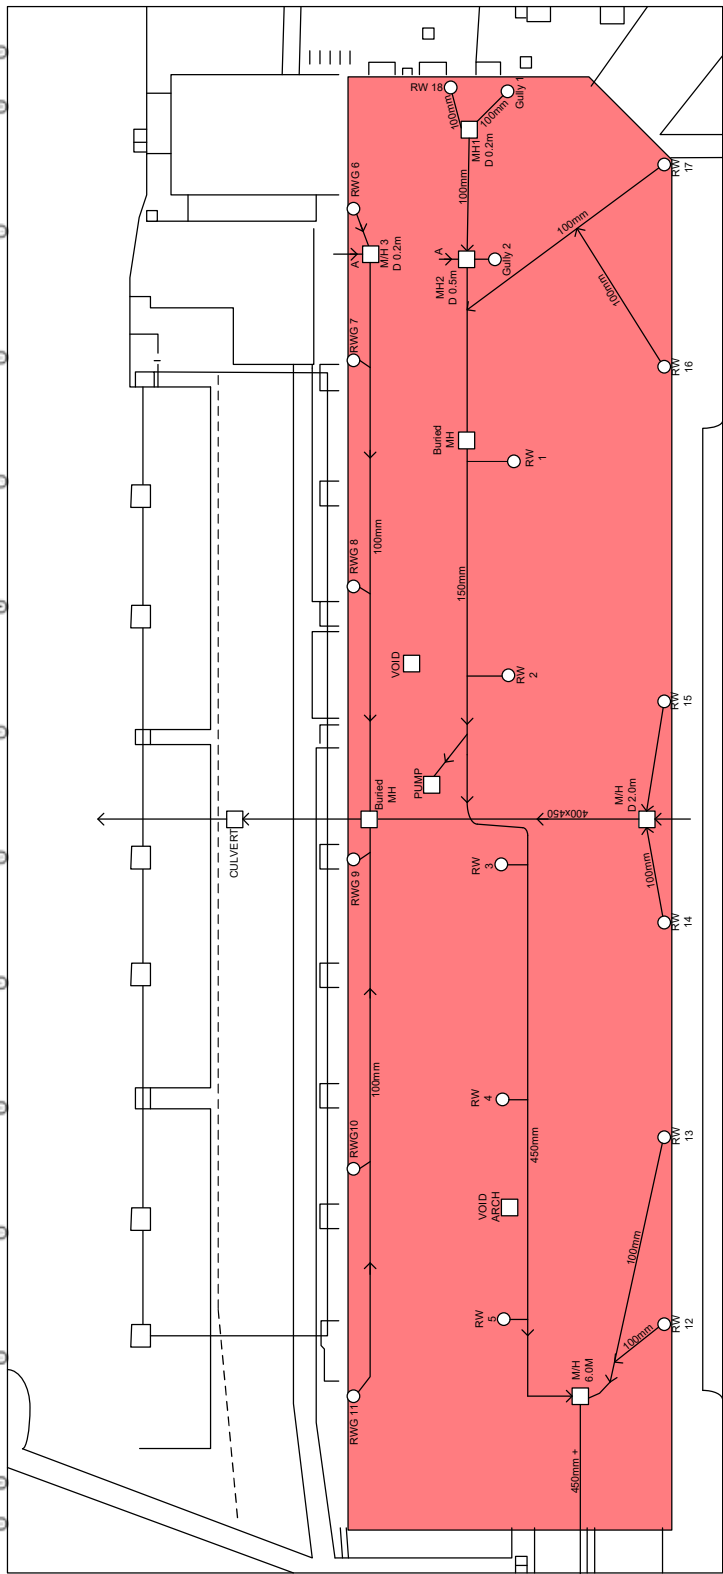
Surveyed 17m  
Suspect runs to main culvert that  
runs through the centre of the site

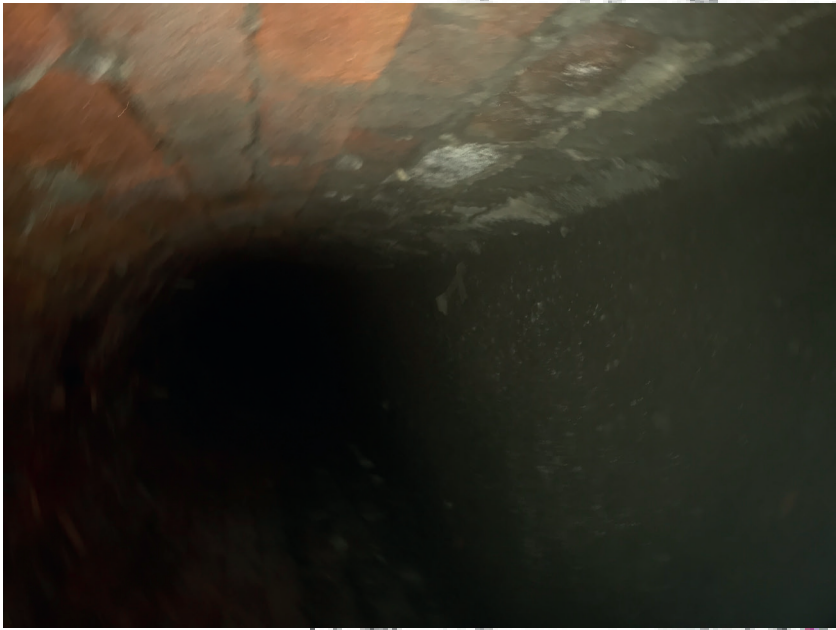
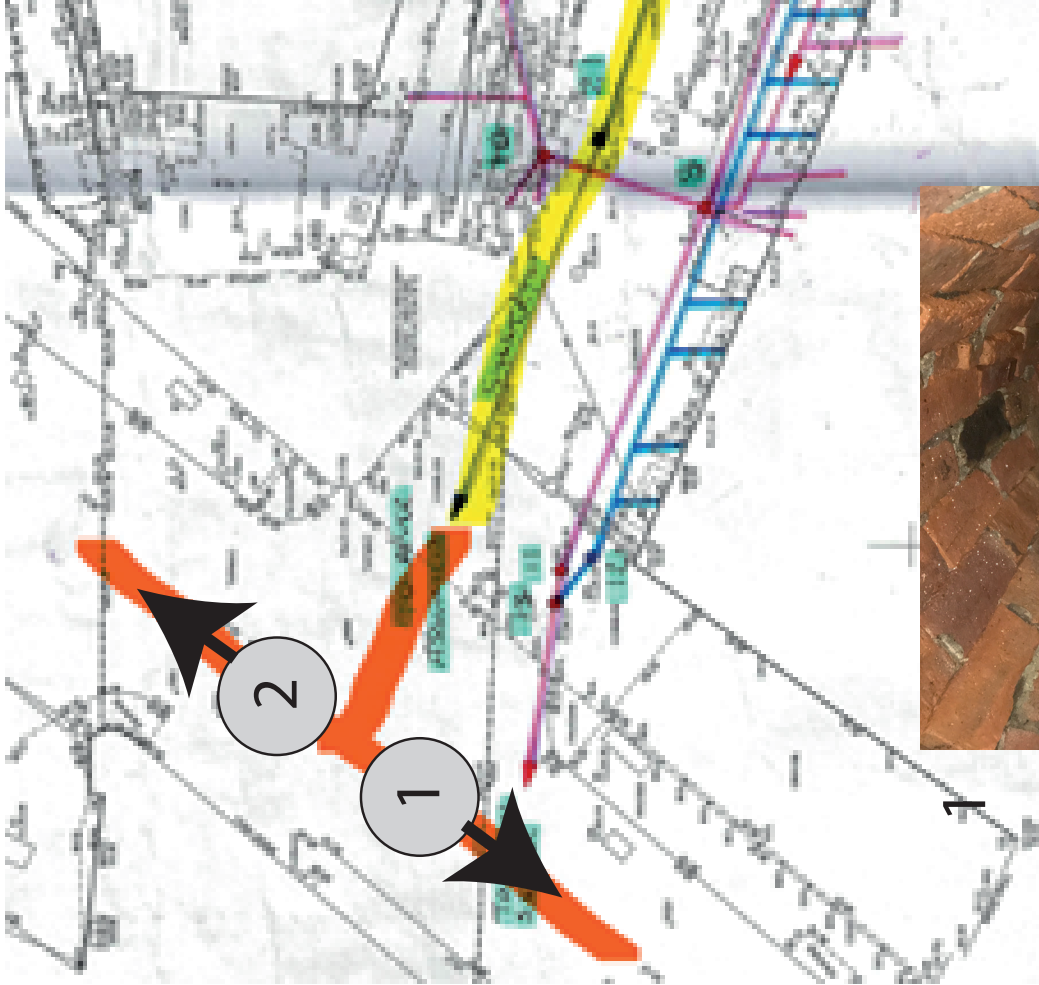
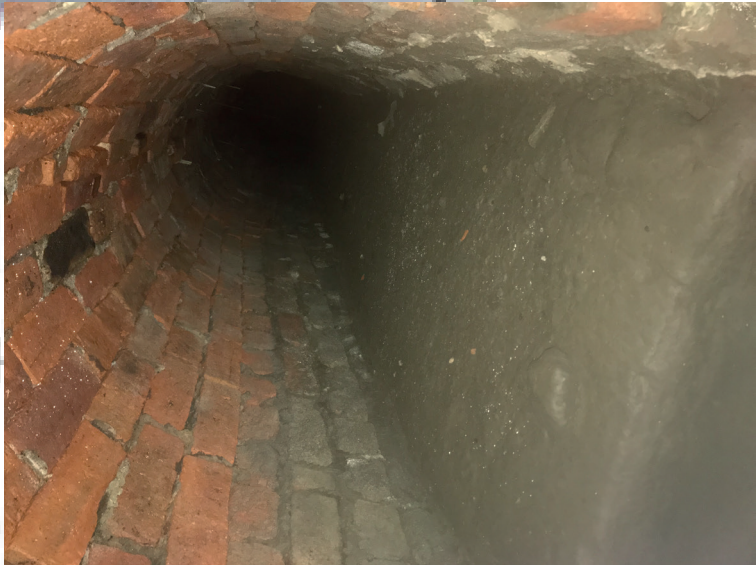
## Culvert Downstream

Clear downstream from Lower Yard manhole to T junction in Water street. Both upstream and downstream from T junction in Water street both clear.

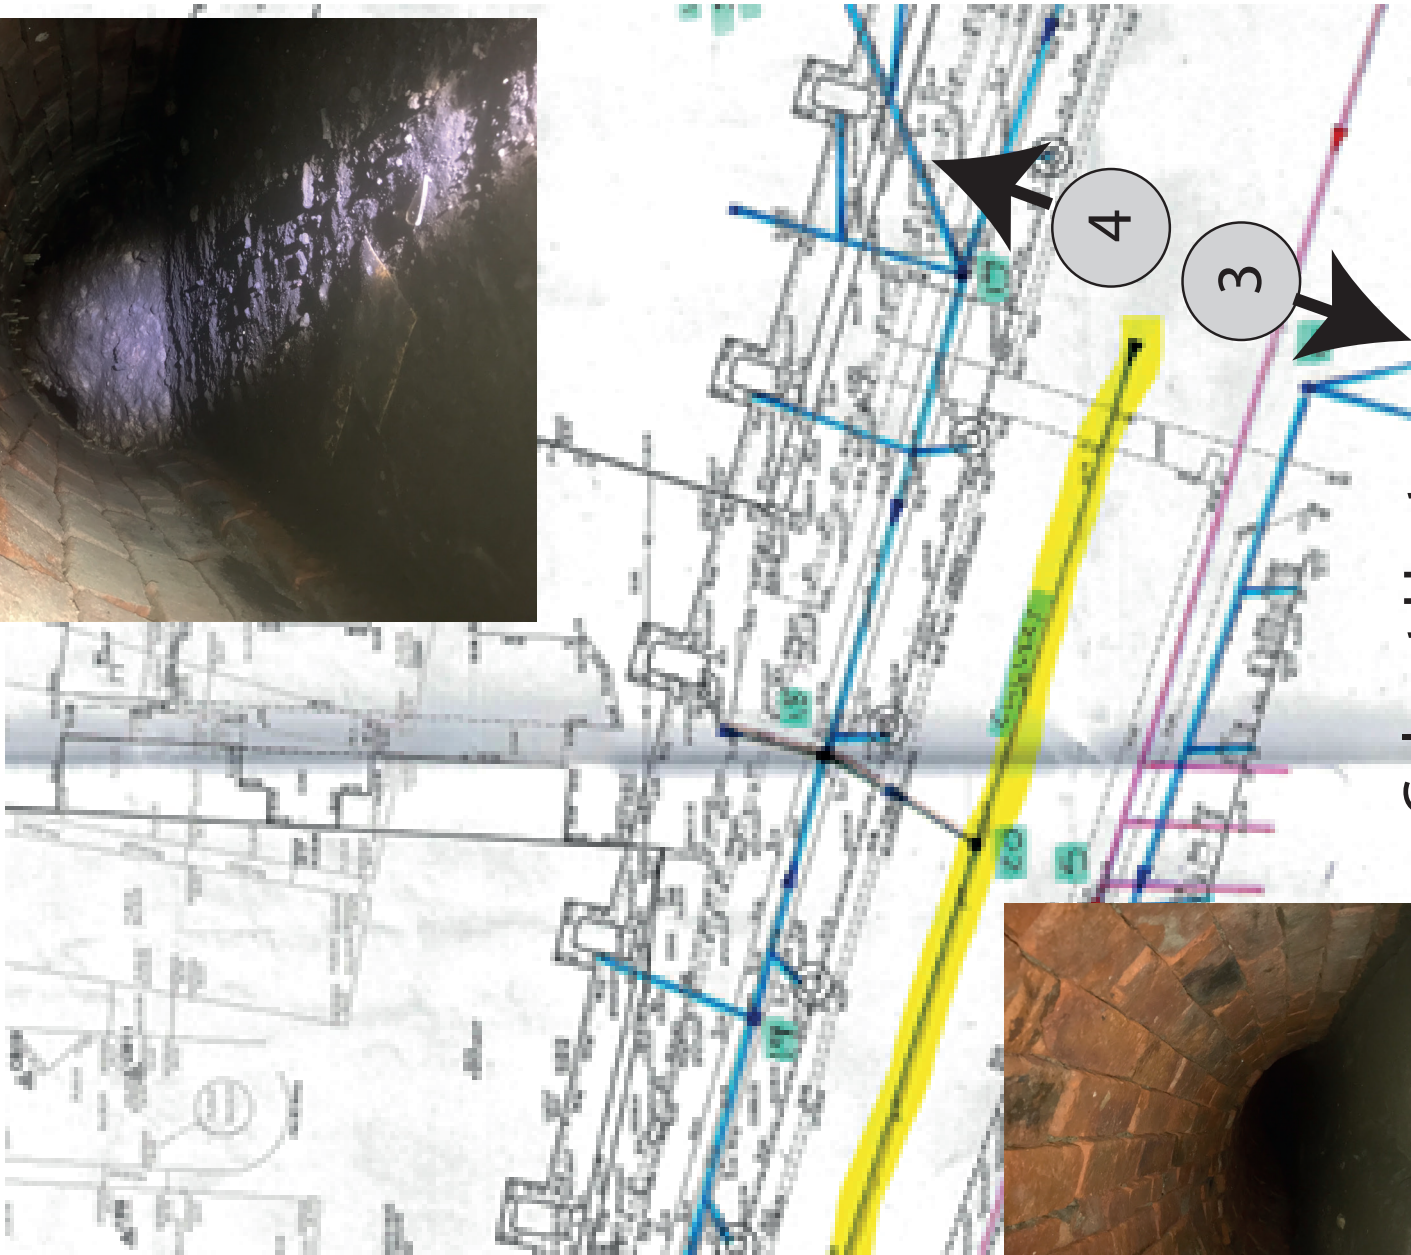
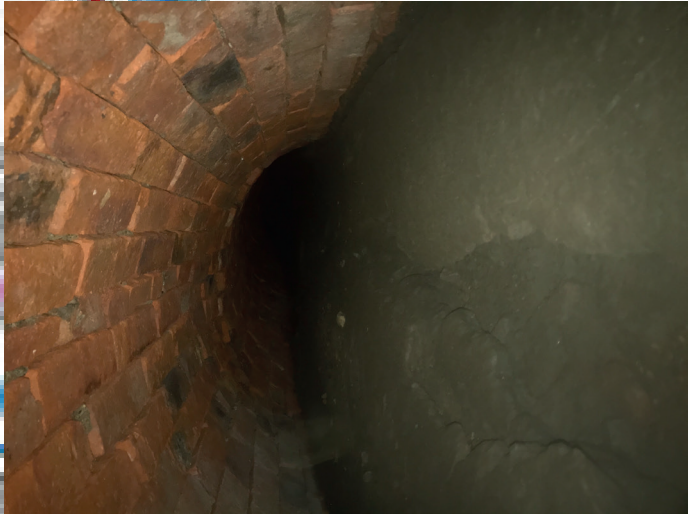
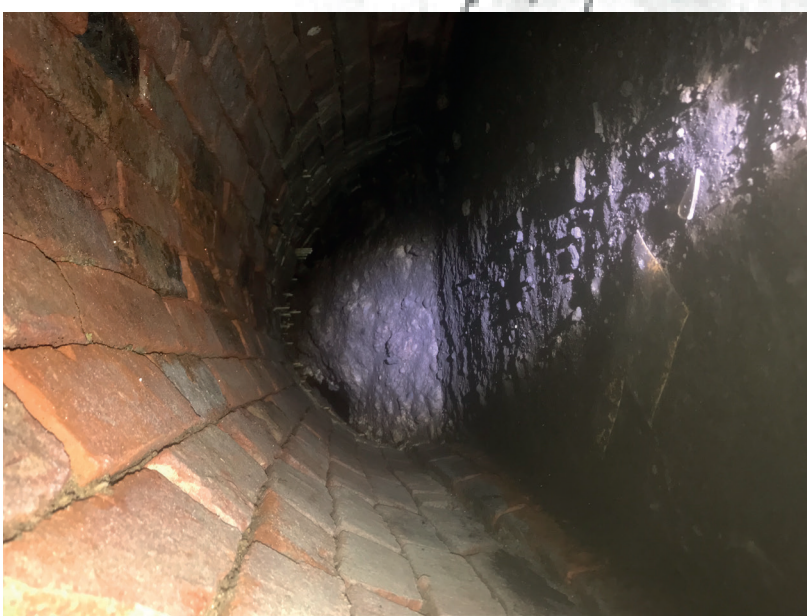
## Culvert Upstream

Culvert runs in a straight line for approximately 22m with various inlets on both sides. At 22m the culvert reaches a junction going both left and right. To the left is a full collapse or 100% full of silt, to the left is 90% full of silt. Unable to carry on, this would need an excavation on the T junction to gain access to clear both jways and a manhole constructed.
