Site Location:  
MAG building 401

Compiled Photo Log: Site Reconnaissance for MAG Building 401  
(08/09/2021)

Project No. 60663052

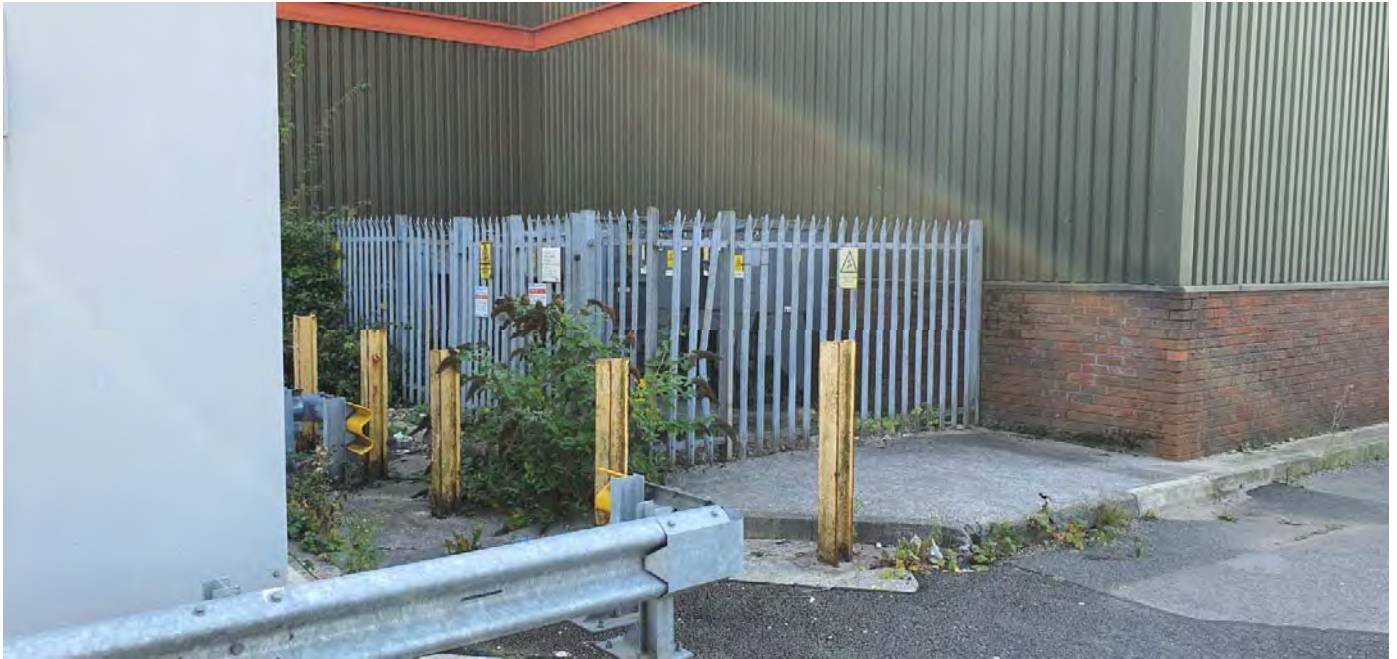
PHOTO No. 1 Substation 'Z' on northern side of the Building 401

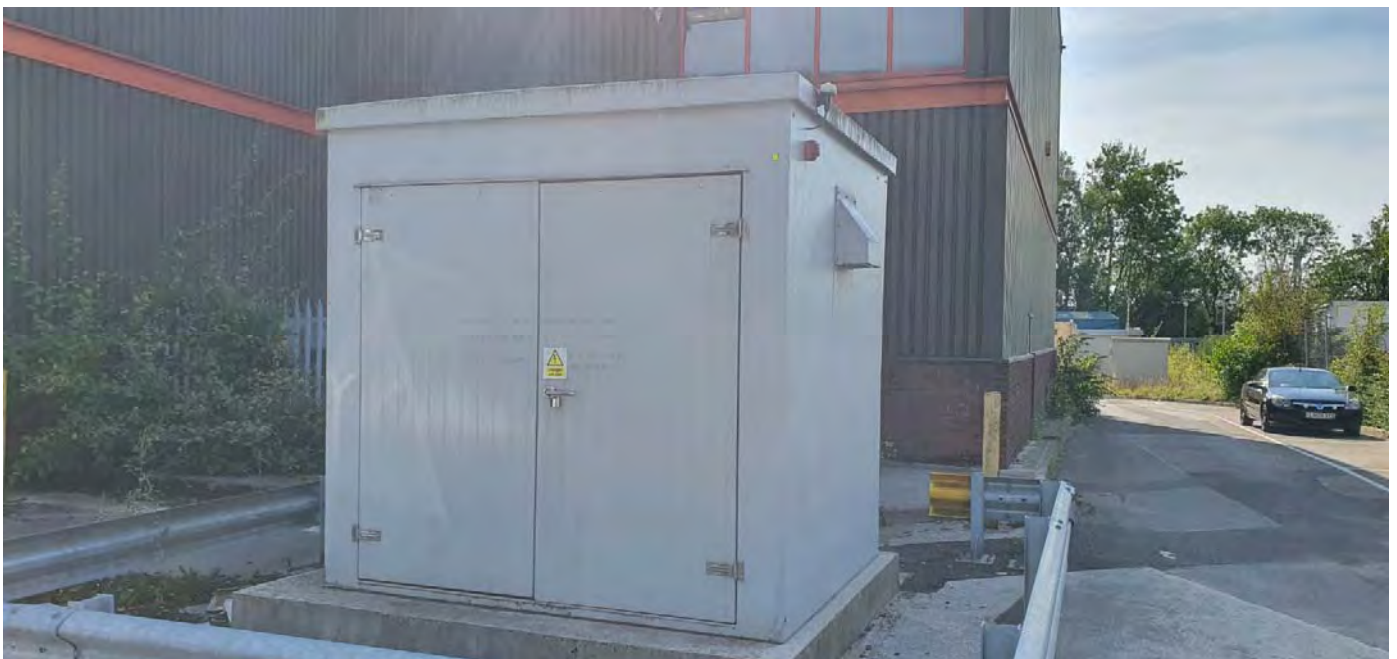
PHOTO No. 2 Electrical housing adjacent to substation 'Z'

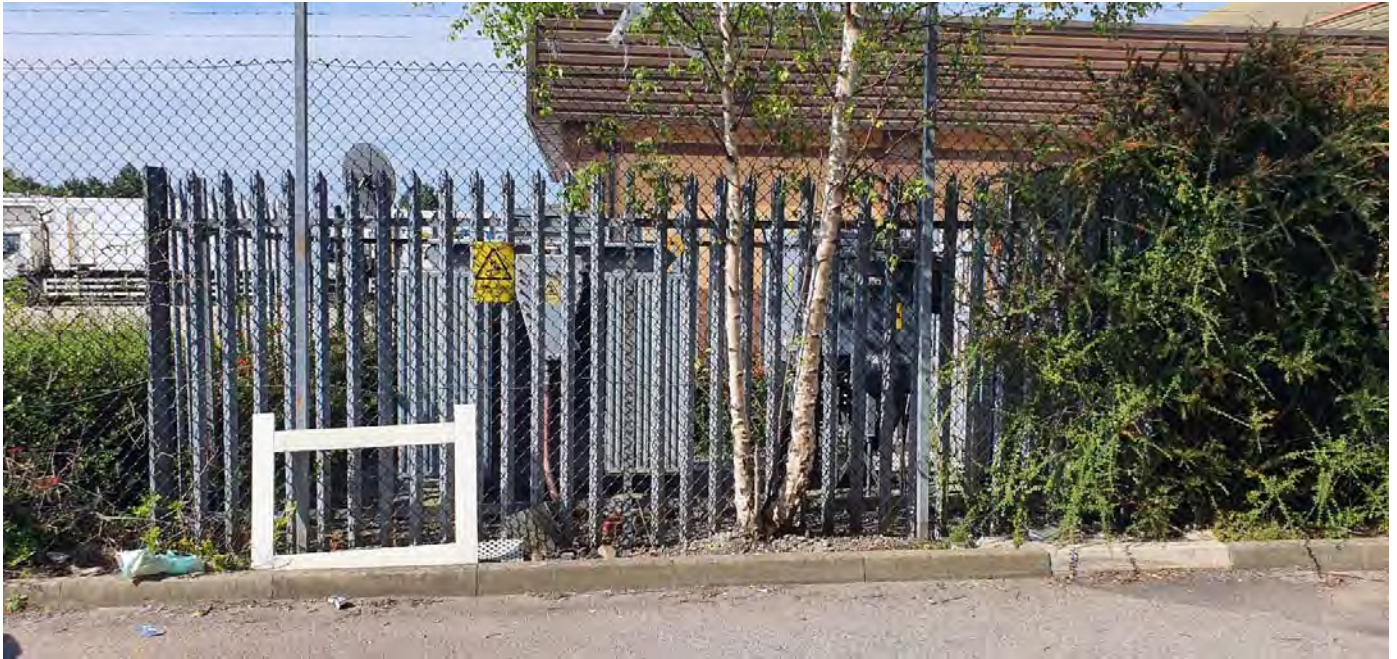
PHOTO No. 3 Small substation on northern boundary of site within Building 402 site.

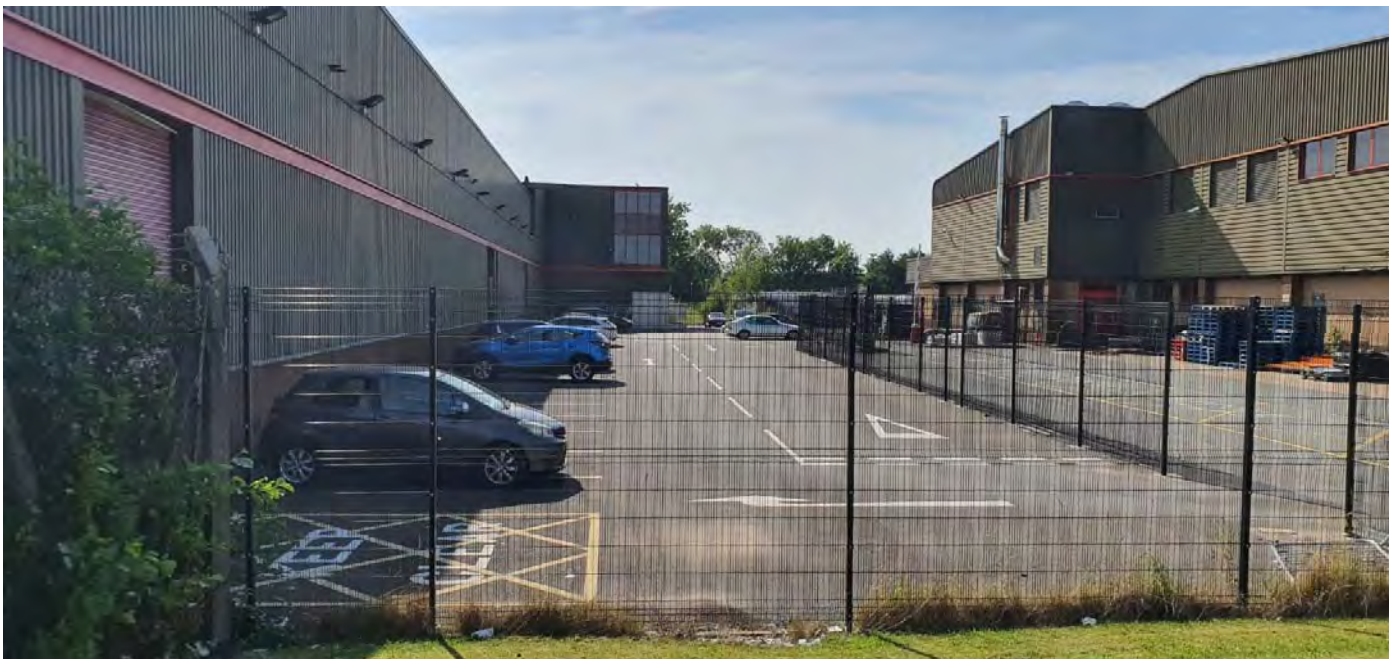
PHOTO No. 4 View west from north east corner of site showing rear of Building 401 and Building 402 on the right of frame.

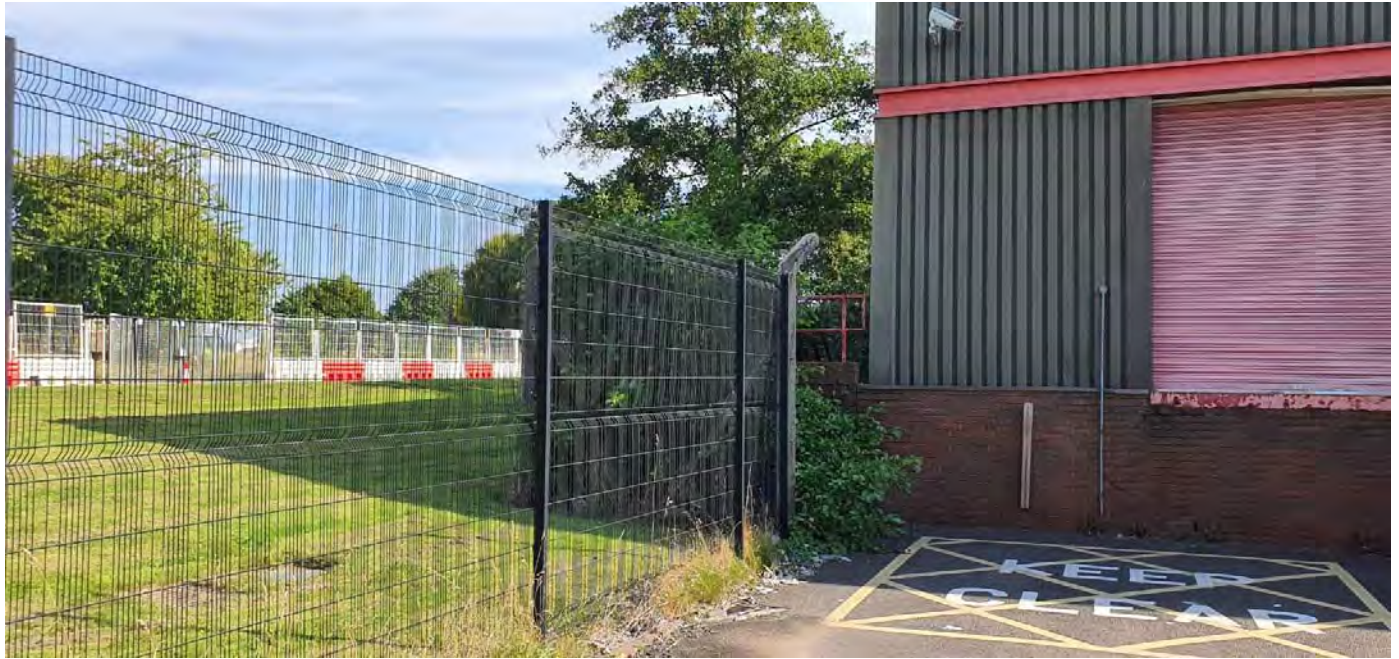
PHOTO No. 5 View north east of site showing slight landscaped rise to Avro Way from site and part brick part corrugated metal construction of Building 401.

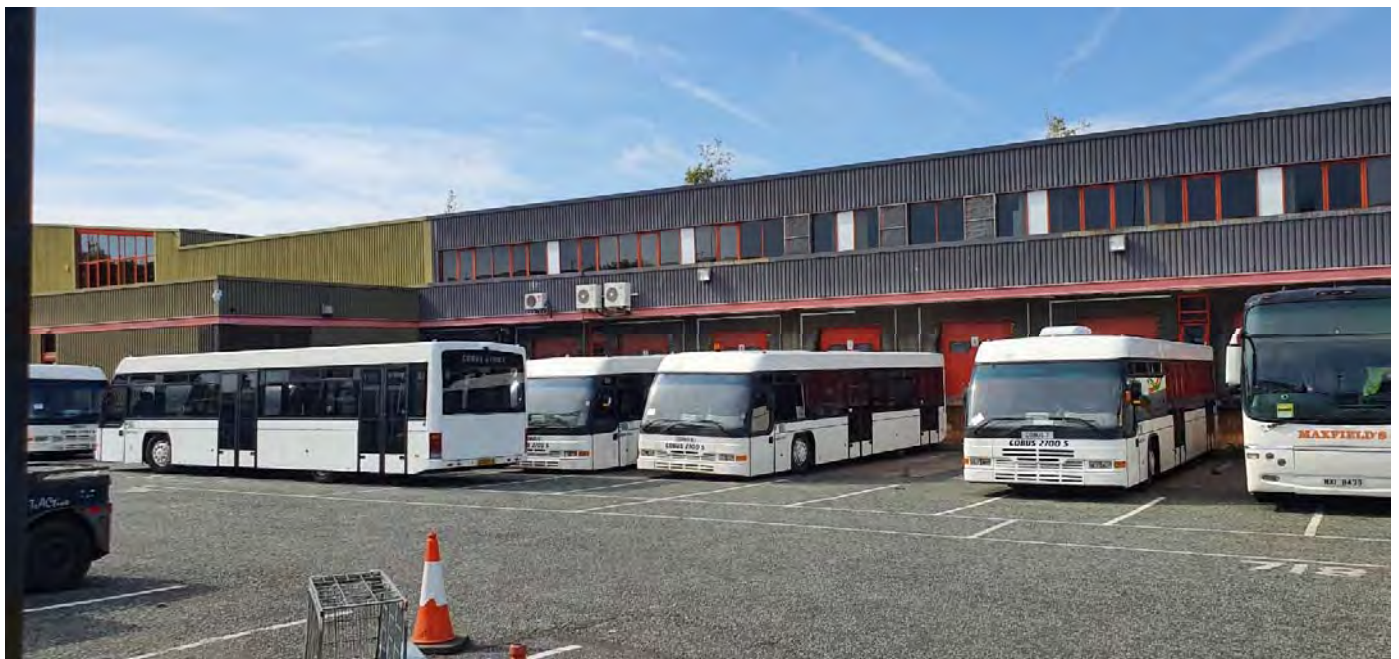
PHOTO No. 6 view north from south east site boundary of Building 401 showing lorry access points and part tiled brick half floor with two story warehouse above with apparent office windows. Also shown MAG busses in various state of repair.

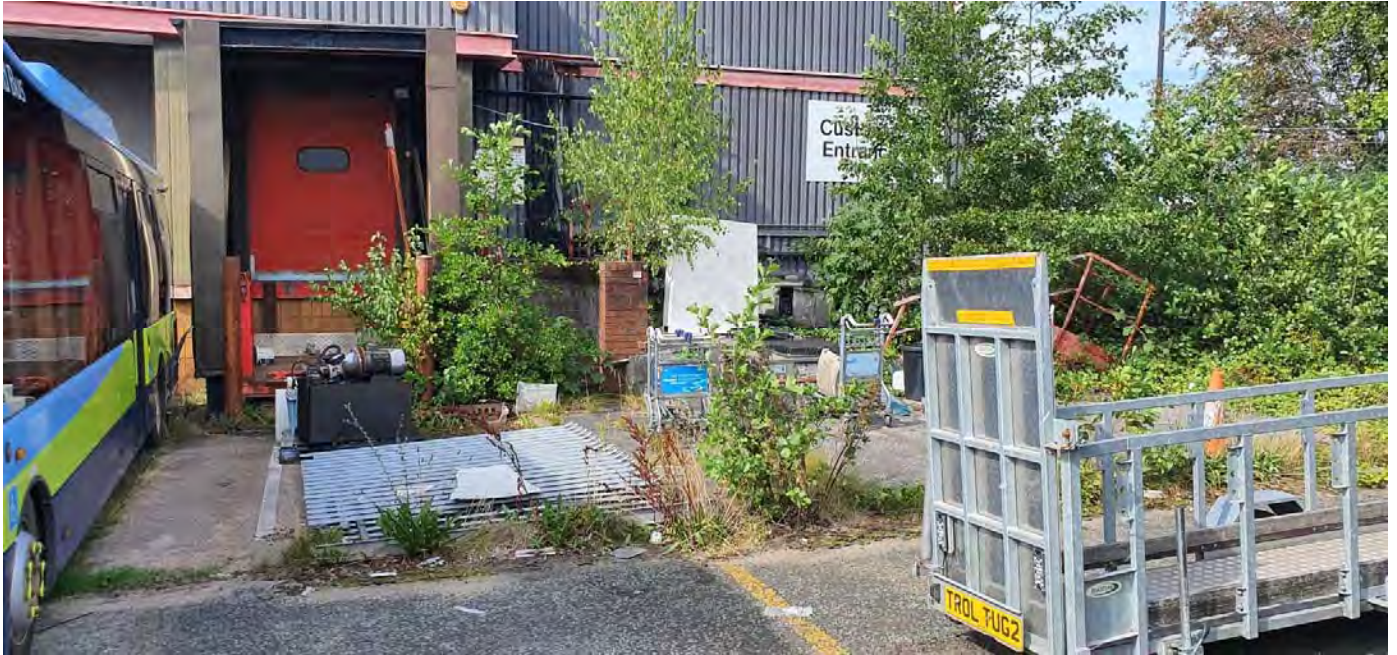
| PHOTO No. 7 South eastern end of site showing customer entrance to Building 401 and hydraulic lift. Including storage area with aircon and refrigeration units and an empty oil tank stored on pallets | | |

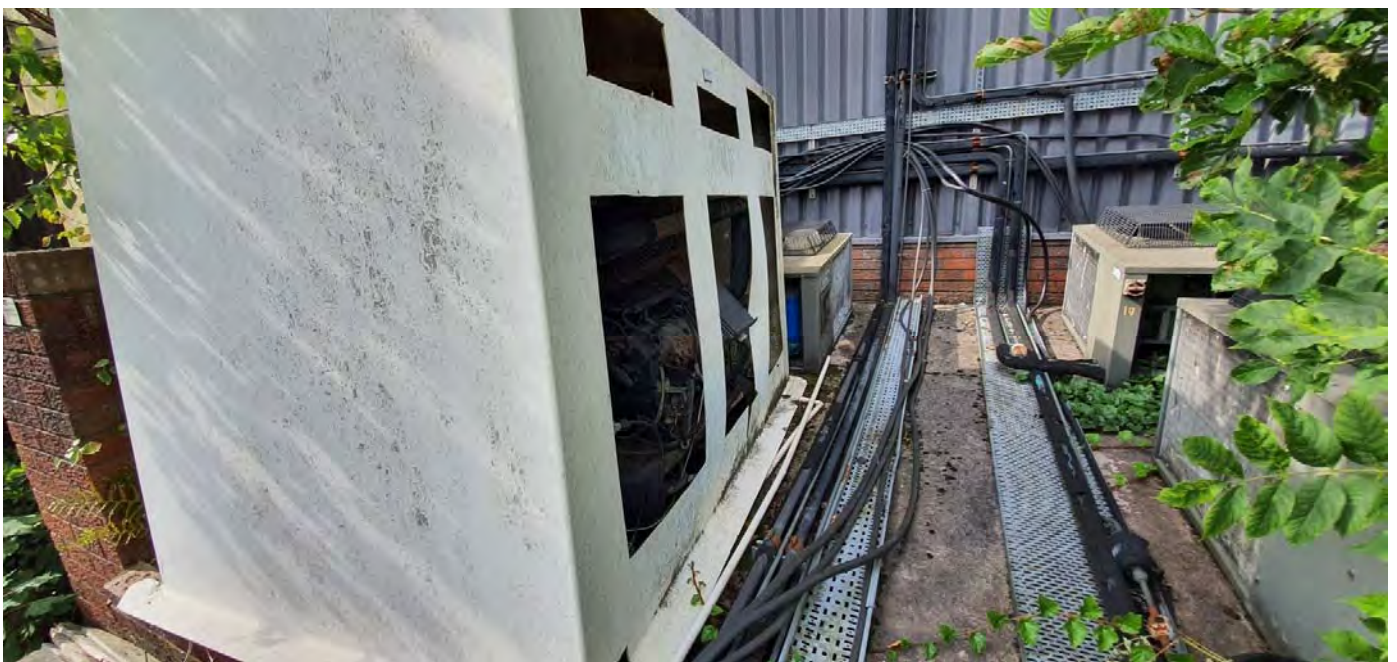
PHOTO No. 8 Closer image of storage area showing partial brick and concrete cover service duct area.

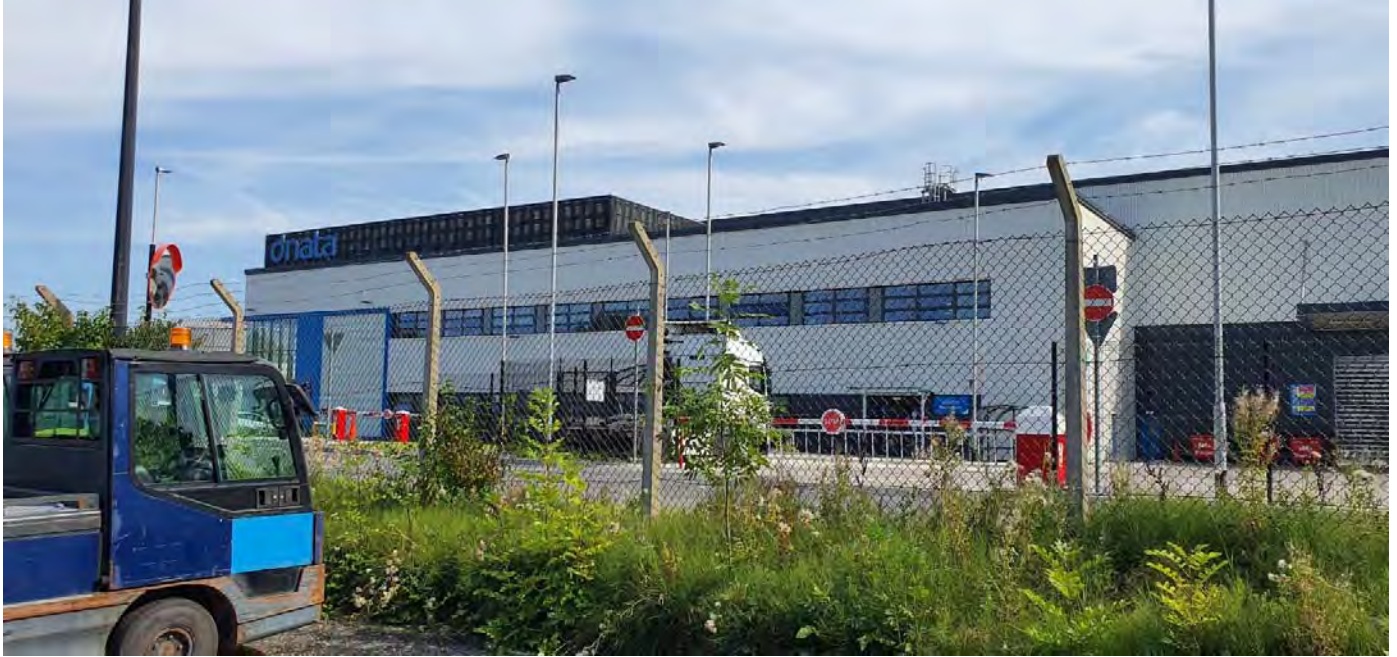
PHOTO No. 9 view south east of site showing DNATA warehouse and chainlink fencing

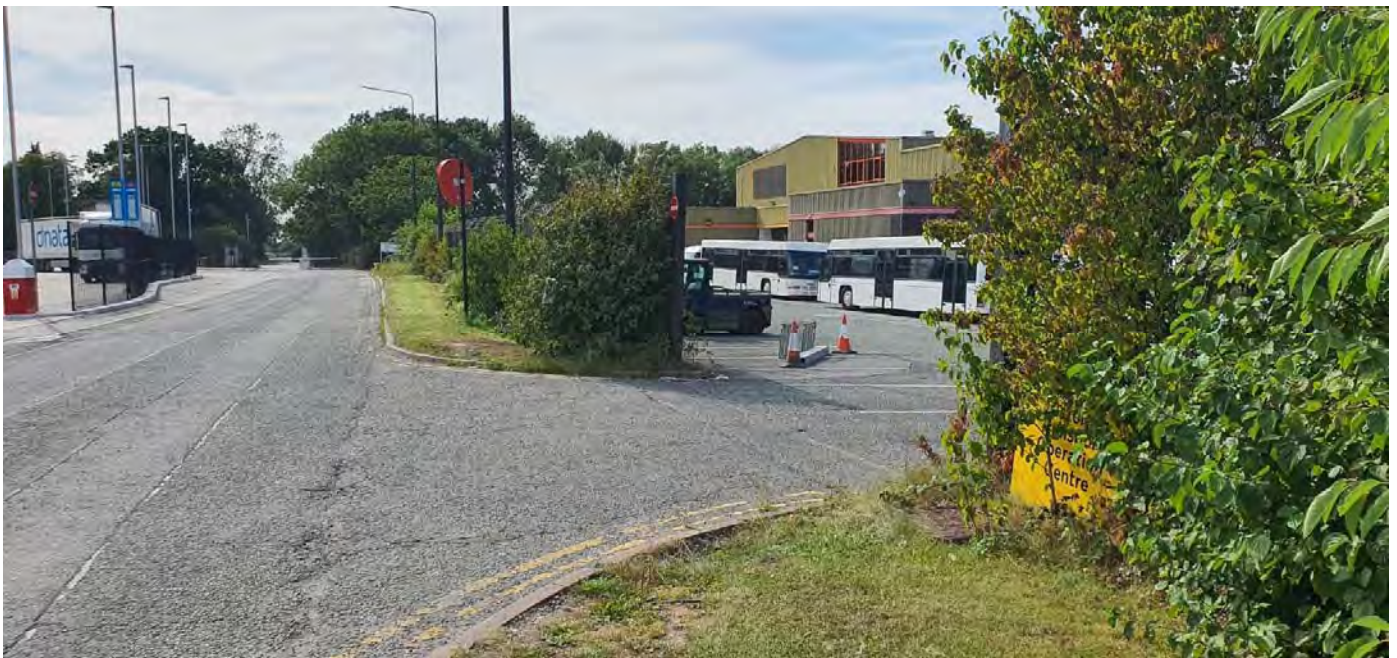
PHOTO No. 10 View of south east entrance to site from Pinfold Lane

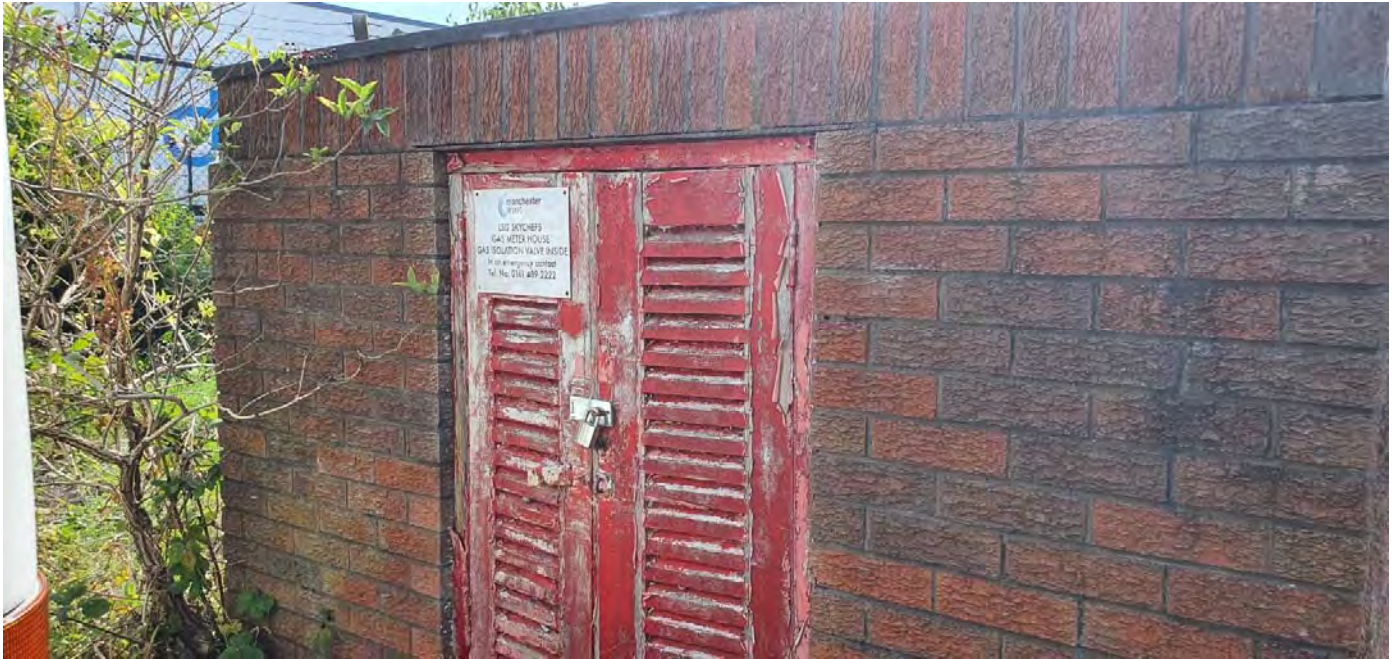
**PHOTO No. 11 Gas housing building on eastern side of main entrance from Pinfold Lane**

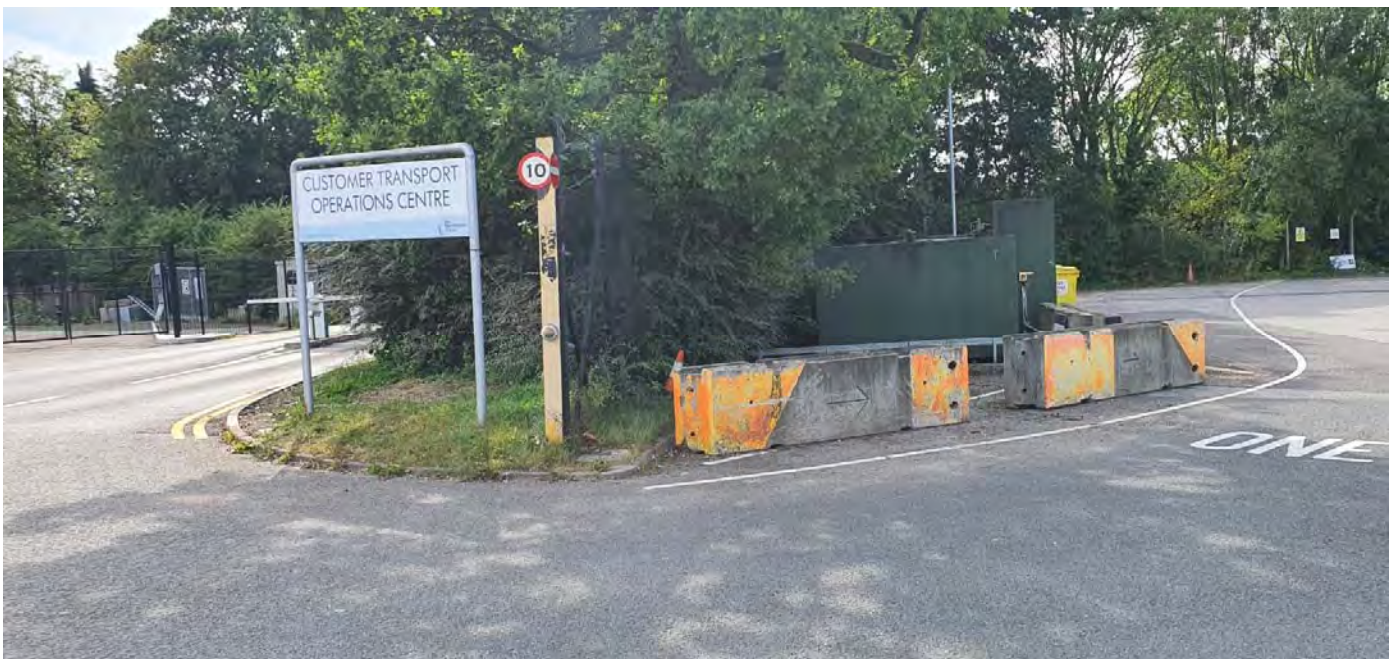
**PHOTO No. 12 View west across main south entrance to site showing bollards and diesel fueling tank**

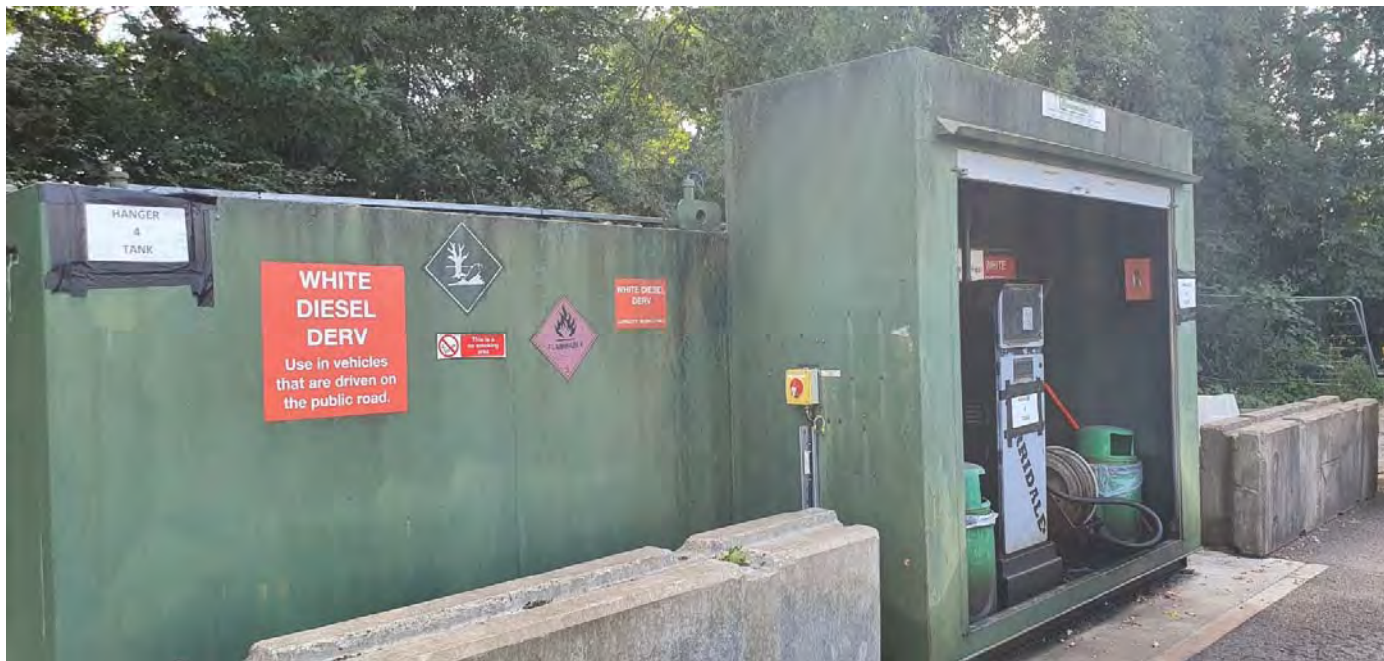
PHOTO No. 13 View of southern diesel tank with internal pump

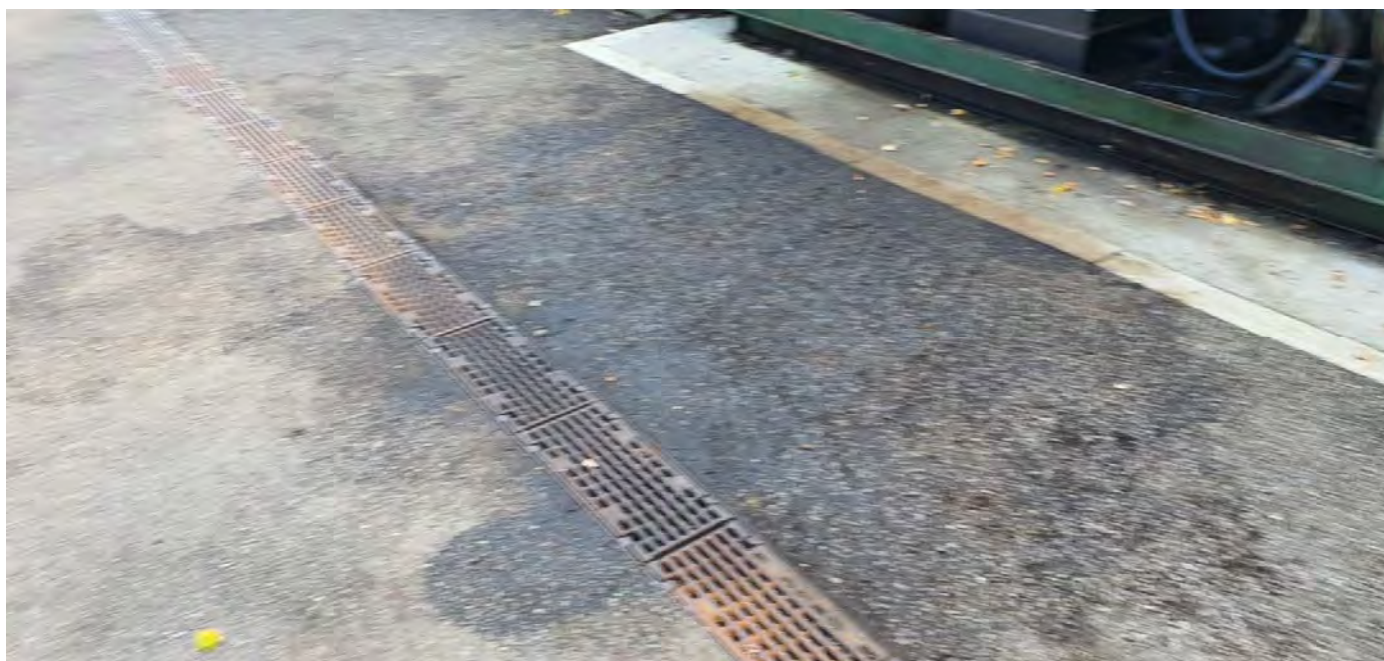
PHOTO No. 14 view of interceptor for southern diesel tank with some spillage noted

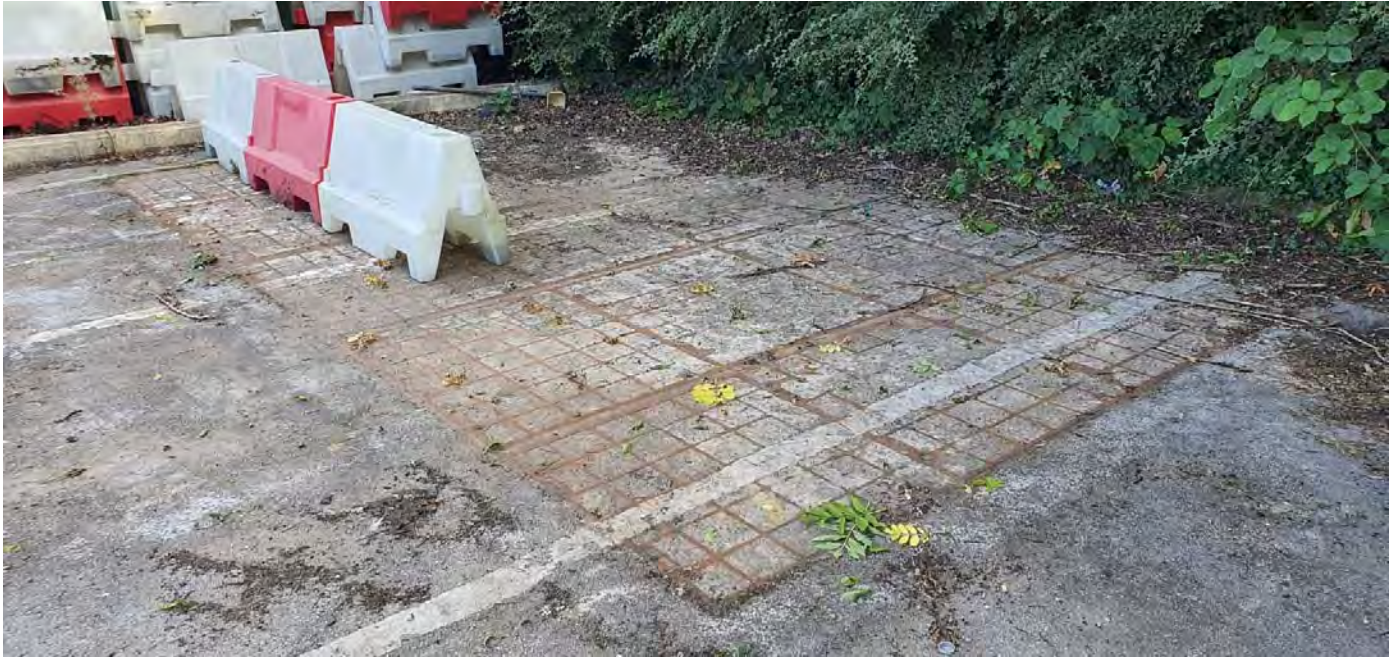
PHOTO No. 15 view in south west corner of site, metal and concrete manholes potentially associated with interceptor.

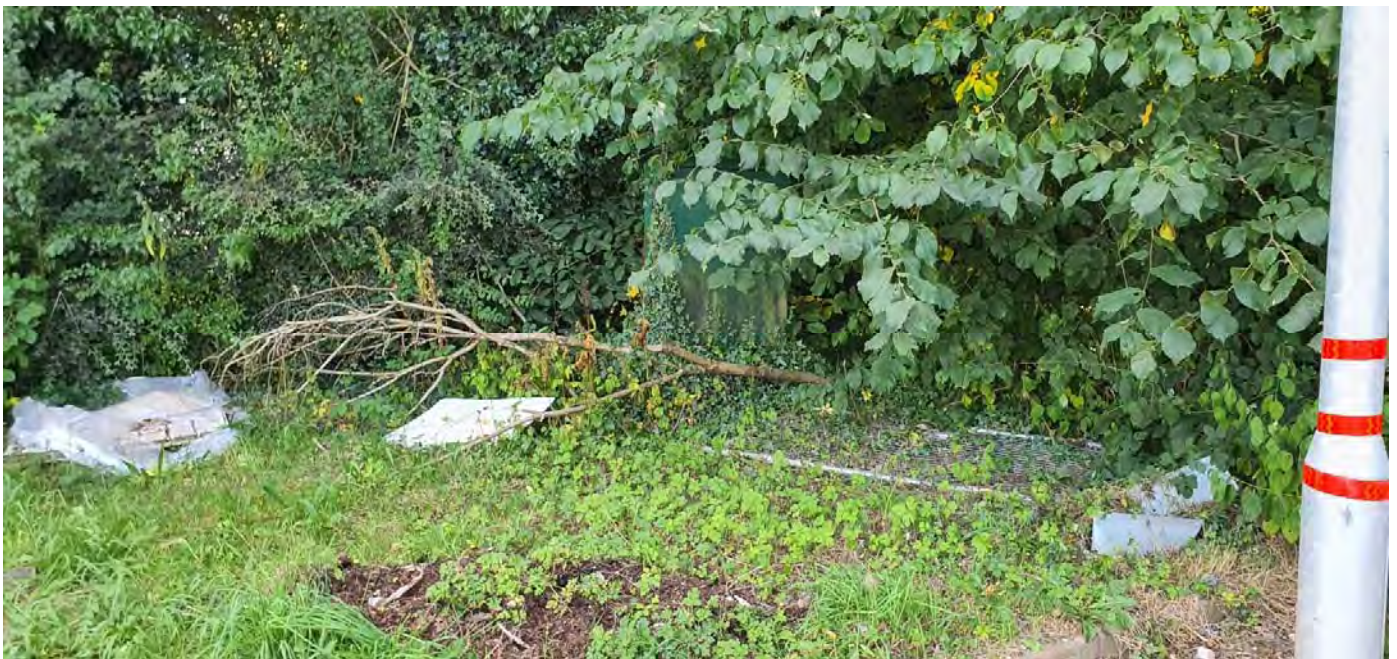
PHOTO No. 16 Electrical box south western corner of site

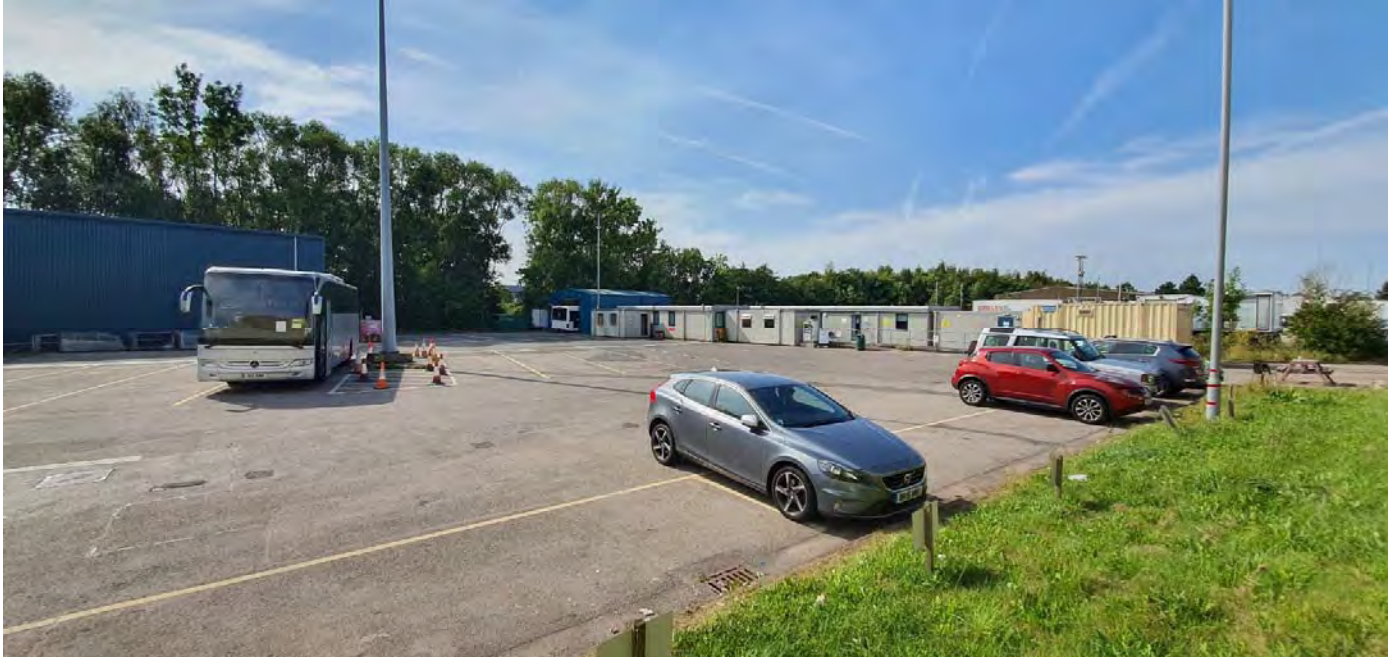
PHOTO No. 17 View north west across MAG Bus Depot showing porta-cabin type offices and bus wash on left of image

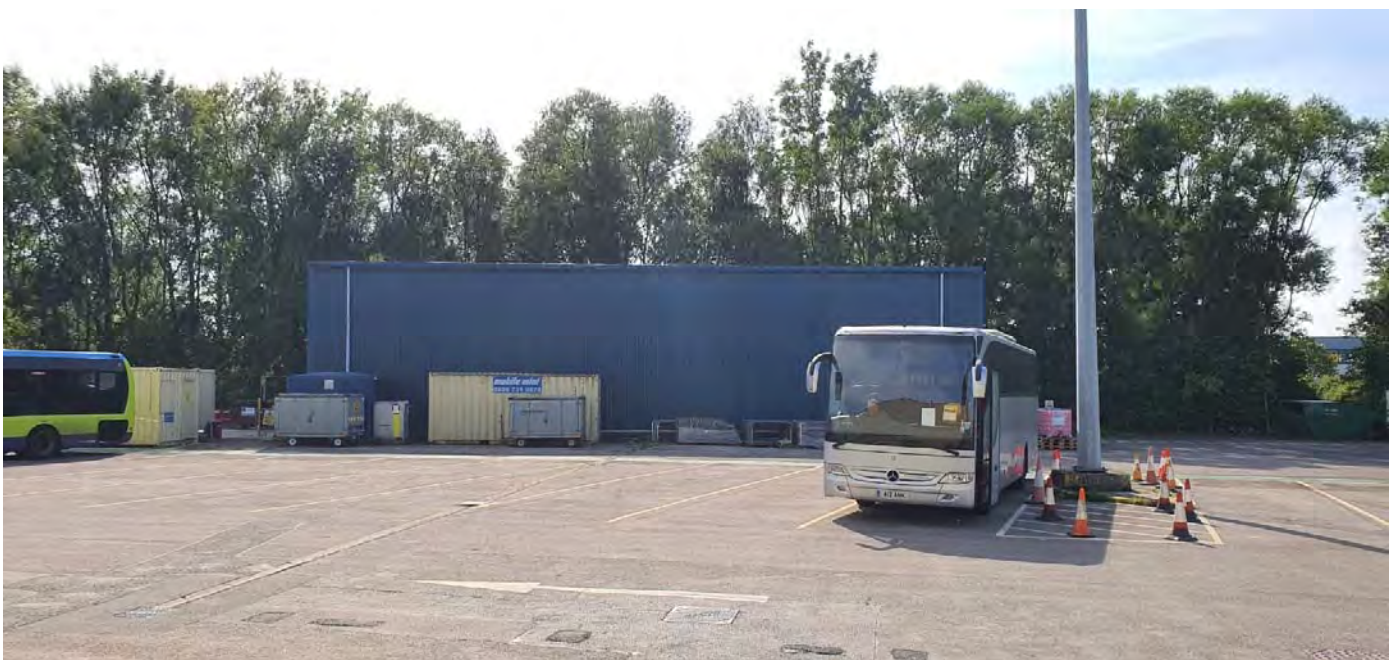
PHOTO No. 18 View west of bus wash including storage of cleaning chemicals and light pole

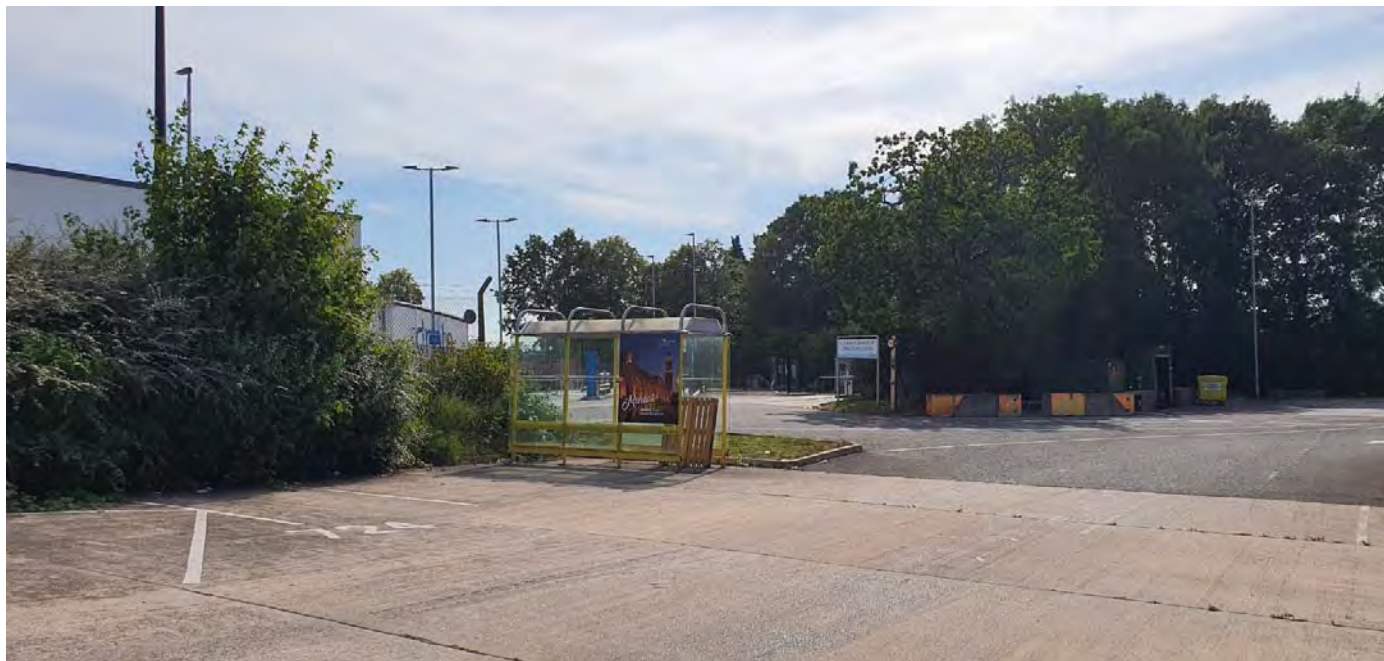
PHOTO No. 19 View south towards main entrance from Pinfold Lane

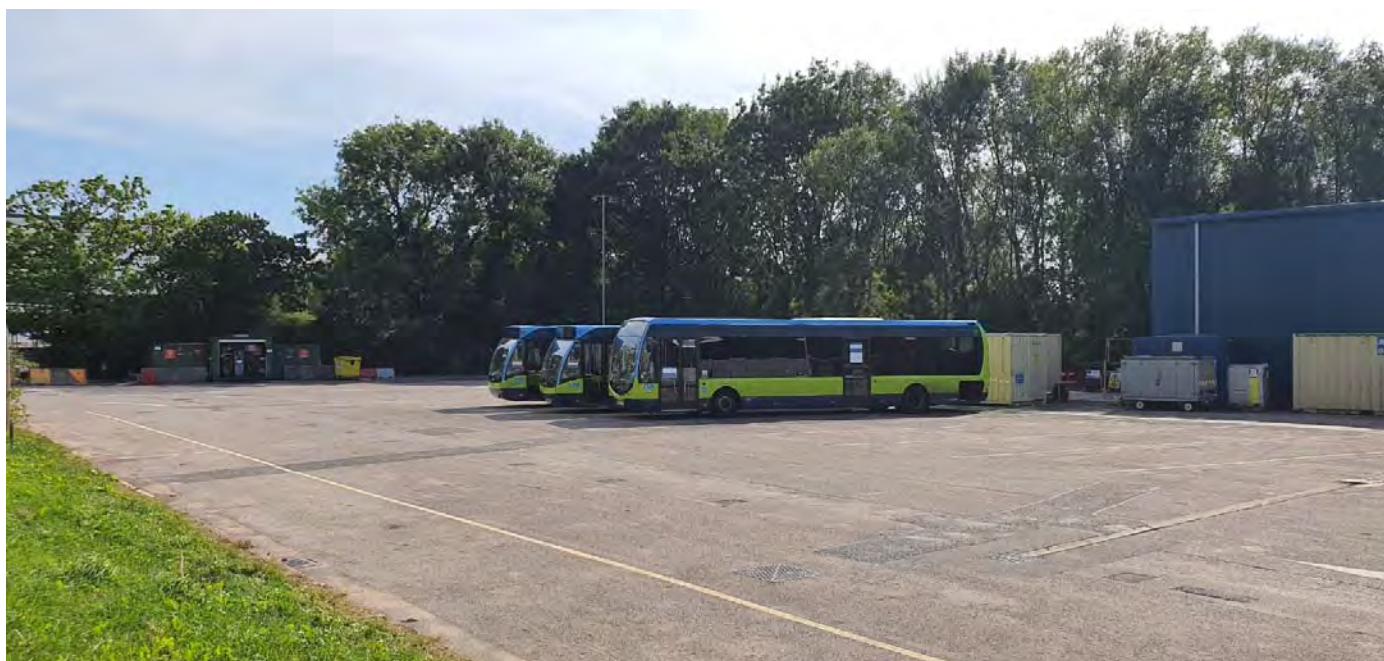
PHOTO No. 20 view south across MAG Bus Depot

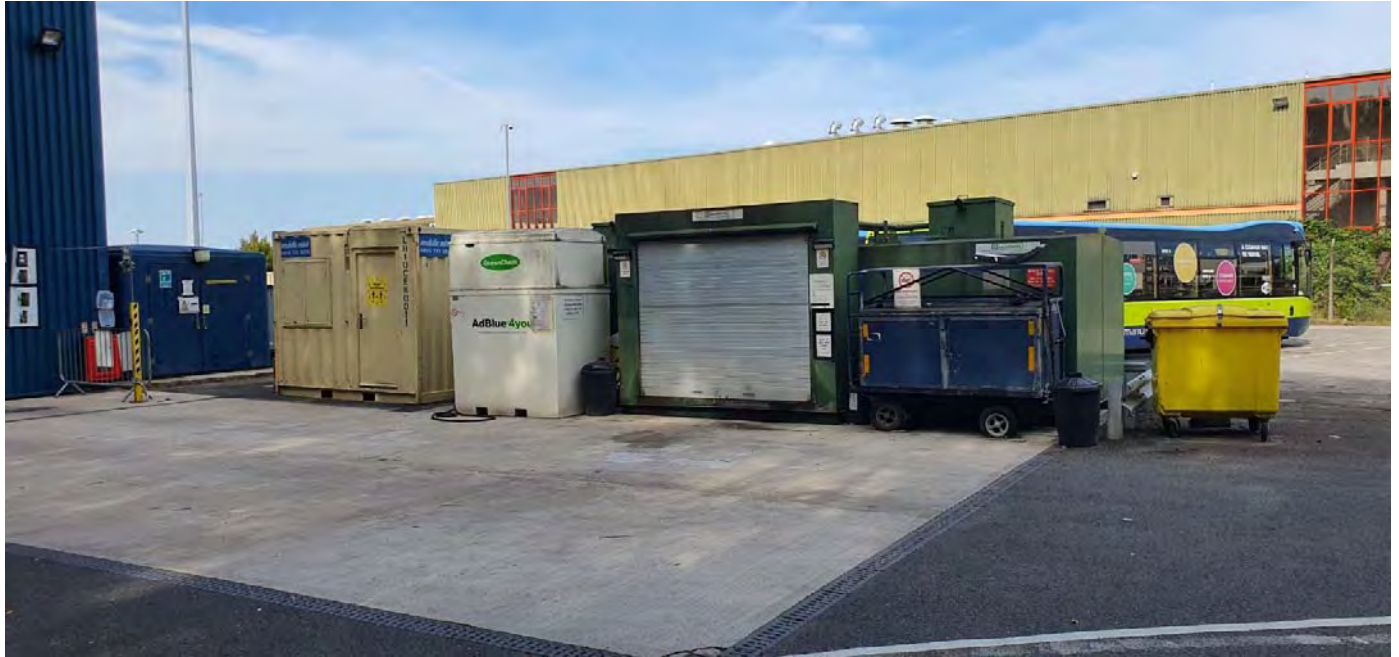
PHOTO No. 21 View east from western side of site with bus wash on left of frame showing diesel storage, adblue storage and cleaning equipment

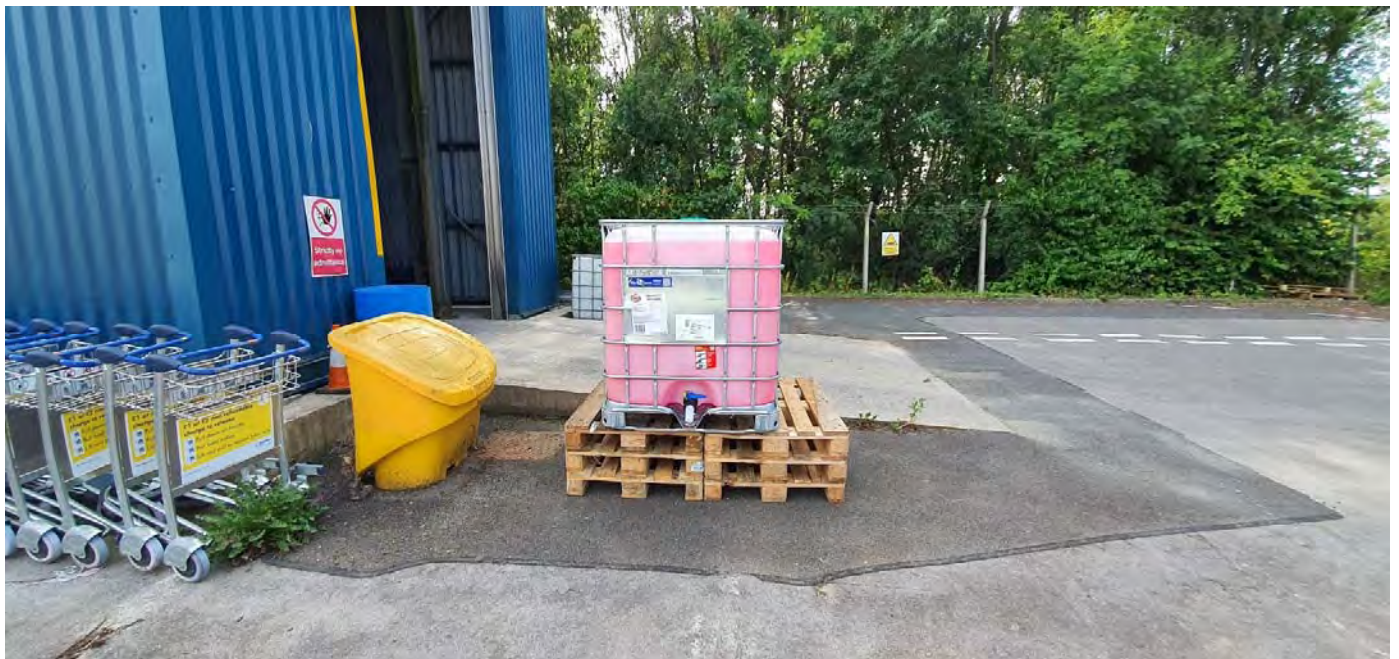
PHOTO No. 22 View of cleaning chemical storage at bus wash also showing raised concrete foundations to was house.

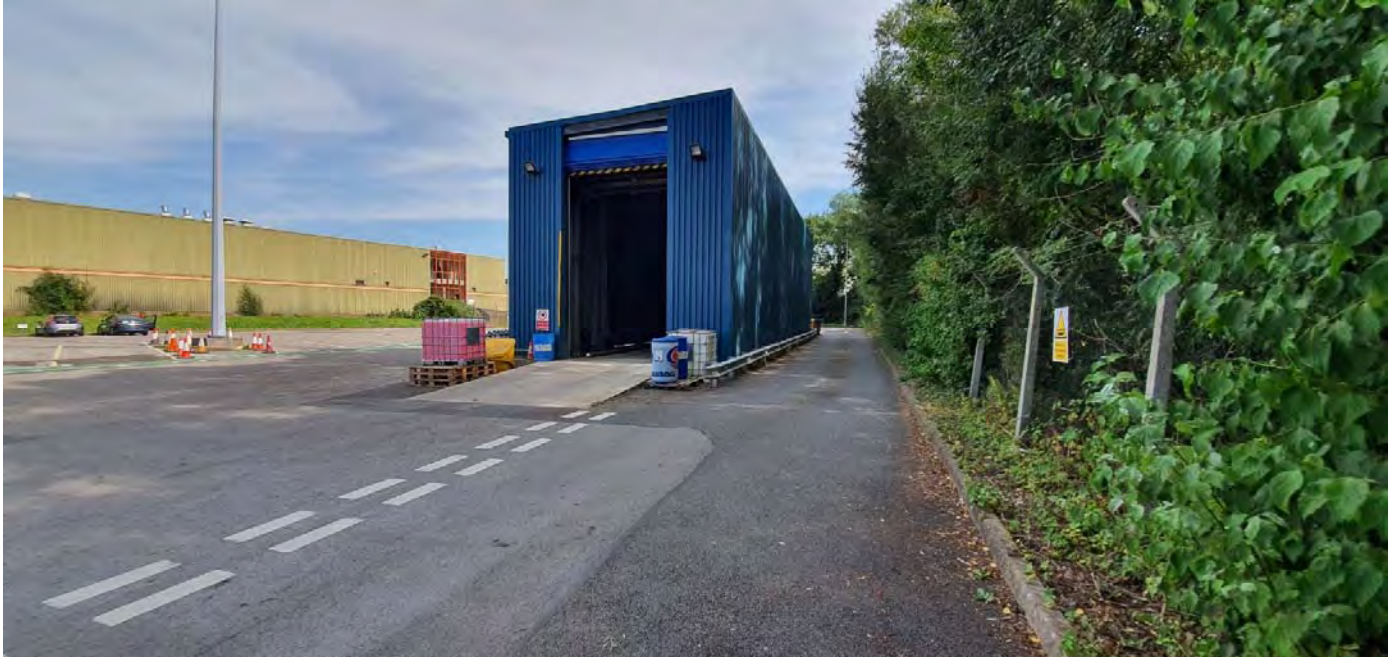
PHOTO No. 23 View south showing western side of bus wash and chainlink fence between the depot and wooded area (far west end of site)

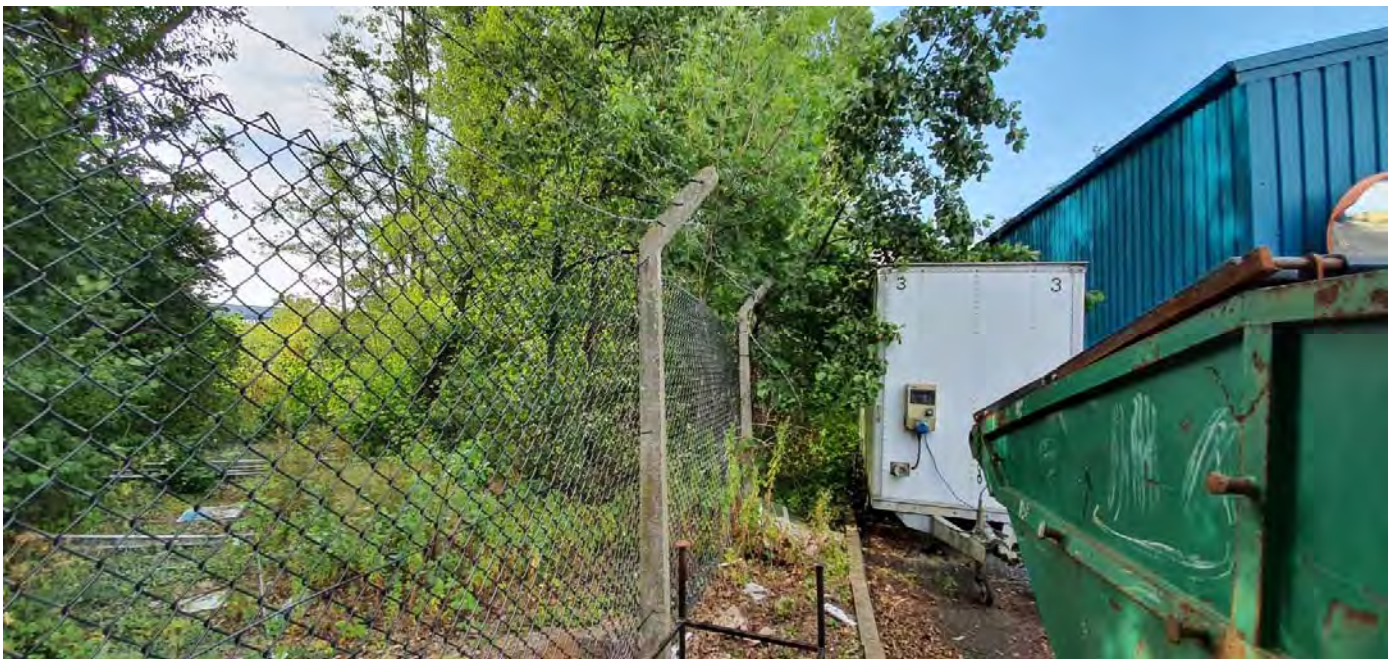
PHOTO No. 24 view north into wooded area on north western corner of depot area with bus store on right including skip and trailer storage
