Site Location:  
MAG building 401

Compiled Photo Log: Site Reconnaissance for MAG Building 401  
(08/09/2021)

Project No. 60663052

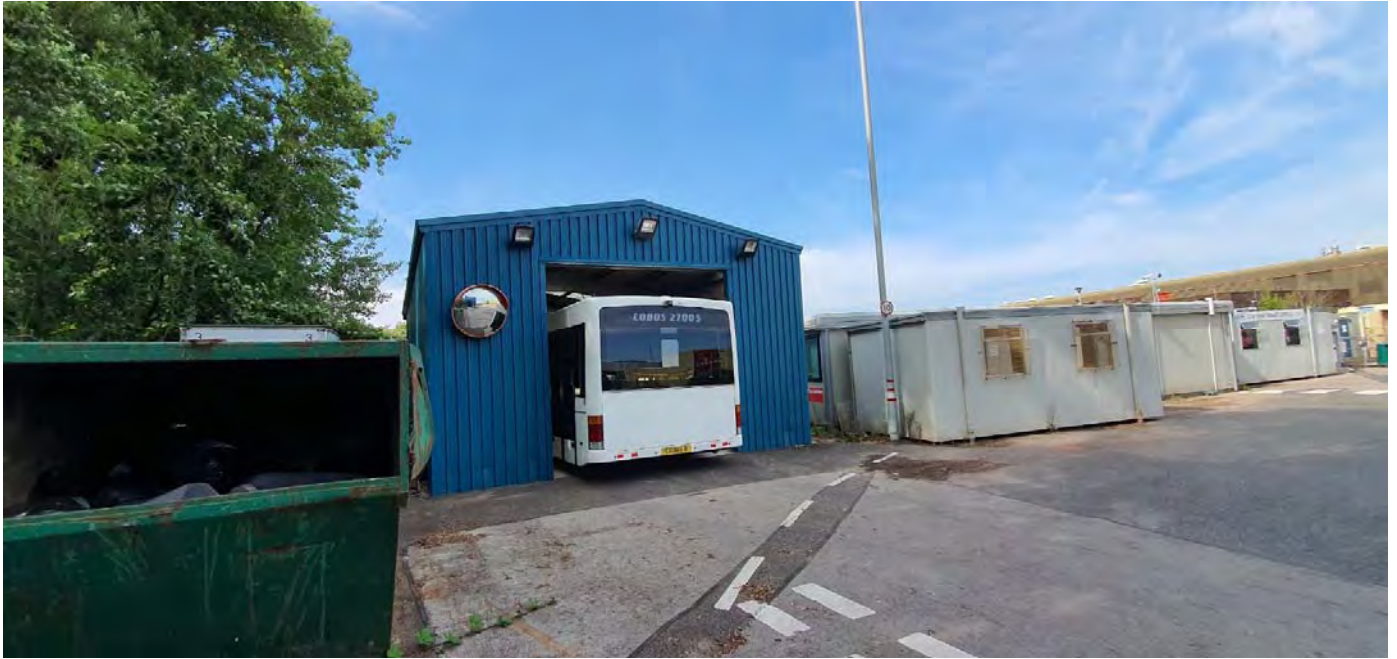
PHOTO No. 25 view north of bus storage and potential maintenance building in north western corner of site

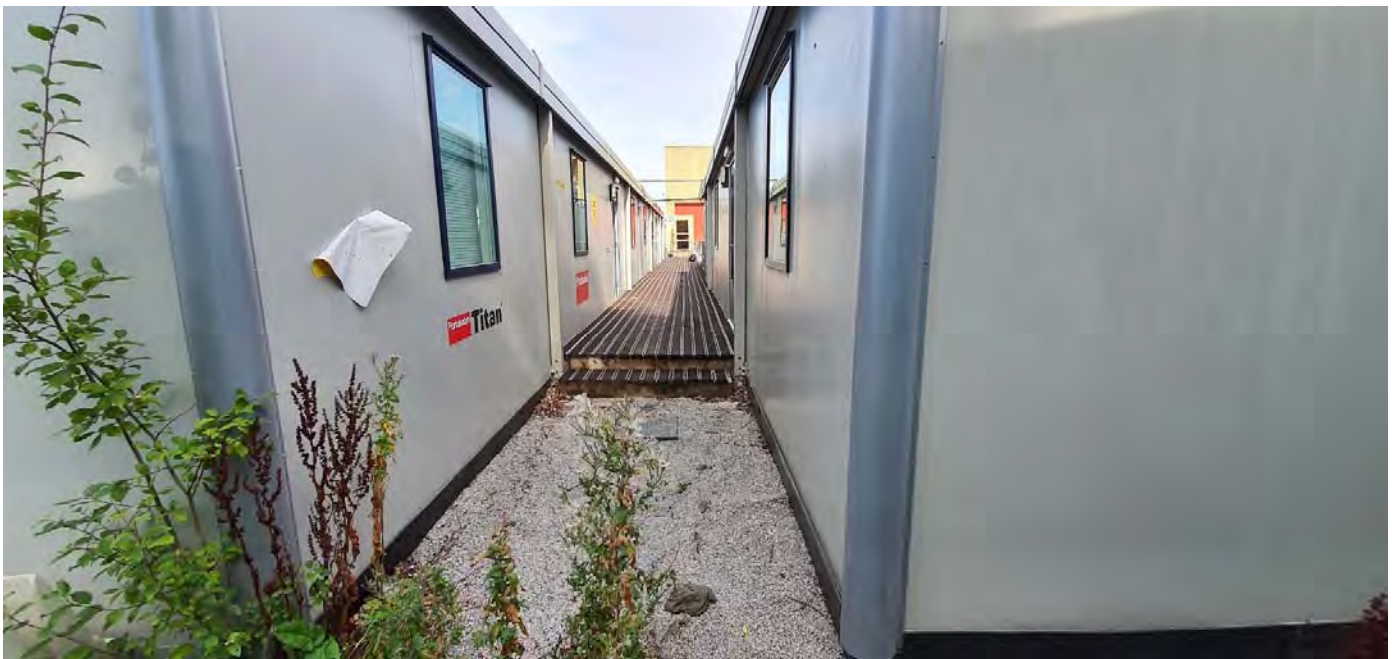
PHOTO No. 26 View east through temporary offices showing raised concrete foundation pads

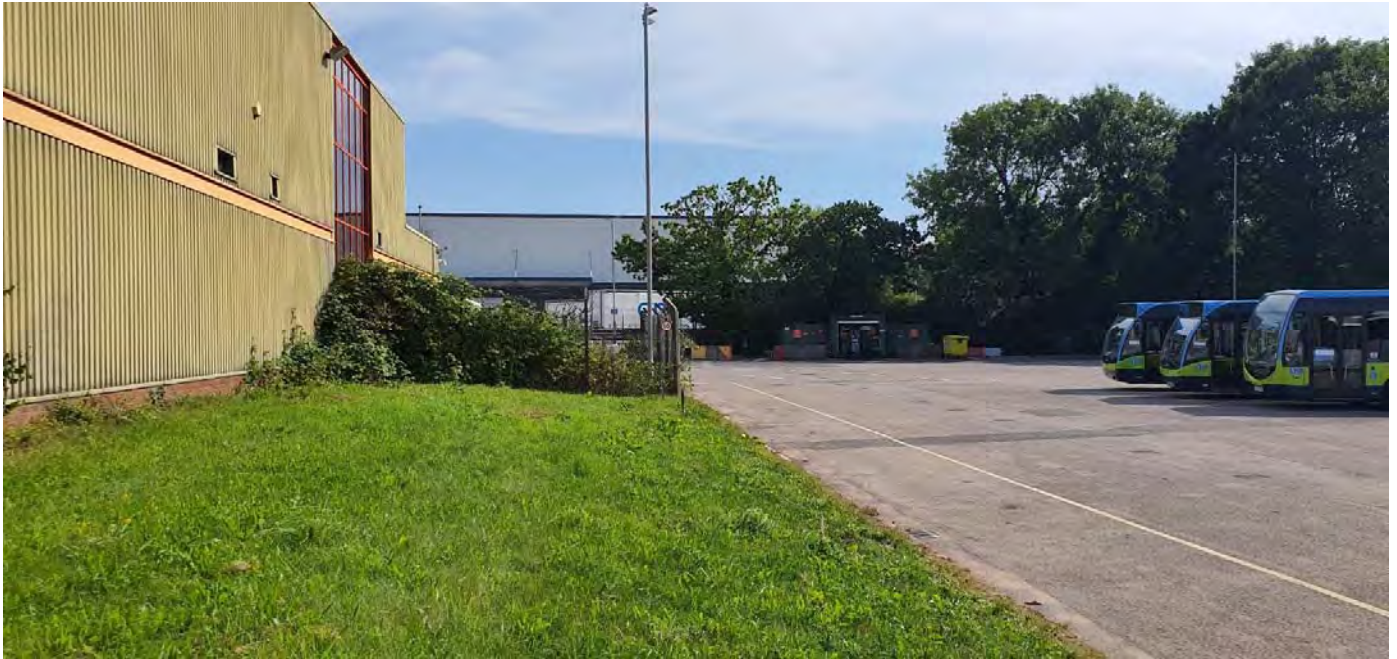
PHOTO No. 27 View south along western side of Building 401 showing slight raise in grass embankment

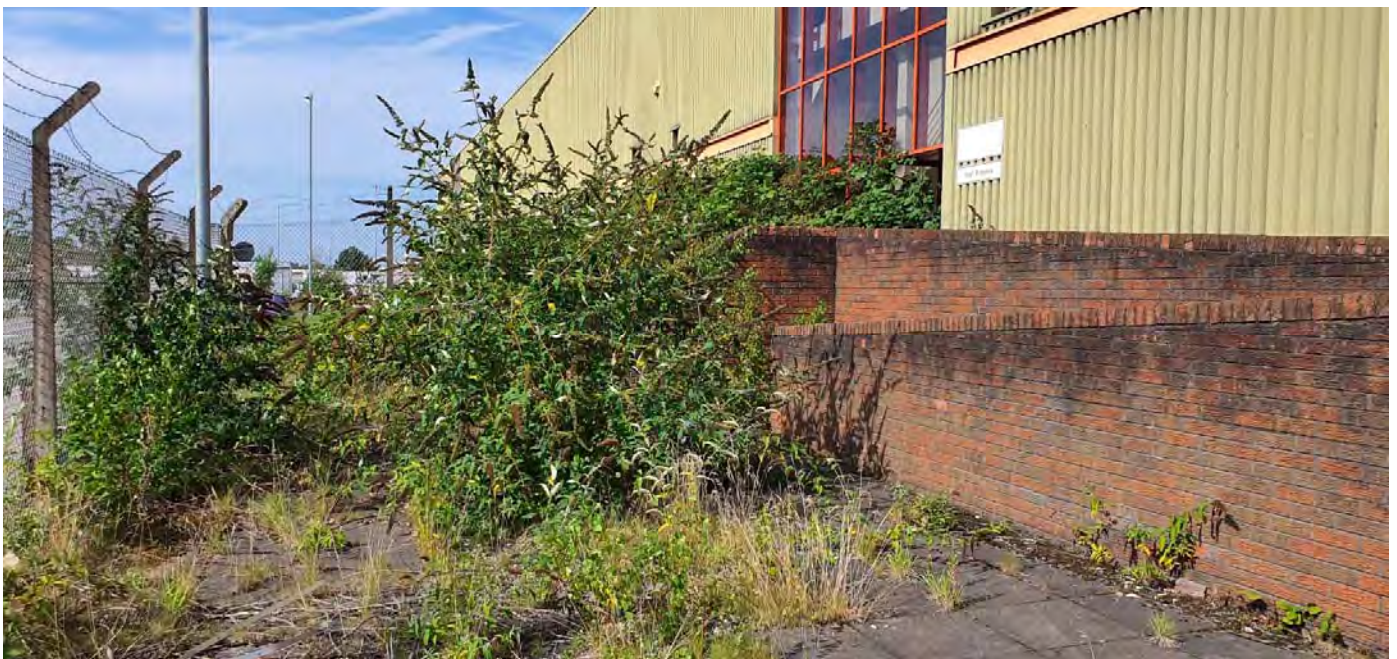
PHOTO No. 28 Main entrance to Building 401 in central south of site showing raised walkway to main doors
