Our Ref: 3041/AM  
Date: 21<sup>st</sup> September 2021

**Re: The Sedge Lynn, Chorlton Building Inspection**

Following our visit to site on 15<sup>th</sup> September 2021, we are pleased to provide our structural Inspection report for your consideration.

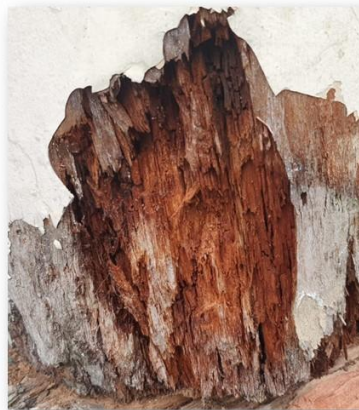
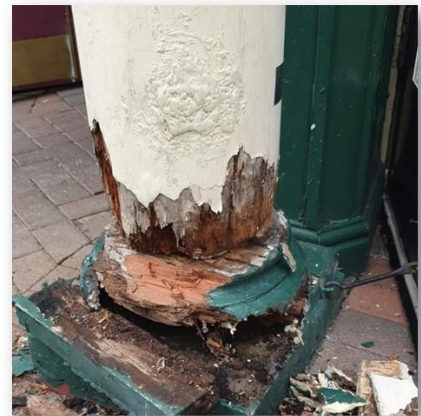
OSE Consulting were requested to inspect damage to the base of a timber column on the front elevation of the domed entrance pavilion (Fig.2 and Fig.3), following concerns raised by the unit manager.

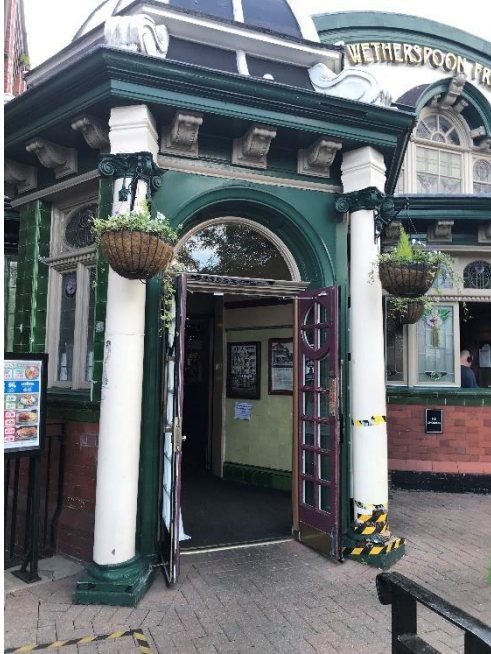
(1)

1. Extensive damage and timber rot to the base of the timber column located to the right of the main entrance door (1,2,3,4).
2. Minor damage and timber rot to the base of the timber column located to the right of the side entrance door on the pavilion (6).
3. Minor damage from corrosion to the cast iron gutter at eaves level over the main entrance door (1).

1. A hole was present in section of the timber casing to the gutter over the main entrance door (1).

It is considered that the hole in the timber casing to the gutter has probably occurred due to expansion of the cast iron gutter from corrosion. We recommend that a high-level inspection is carried out to determine the cause and extent of the damage before recommending remedial repairs.

1. Column to RHS of main door – The eaves at either side of the column should be propped using suitable acrow props. The remains of the damaged timber footing should be removed and replaced with new treated timber sections to match the existing architectural design. The damaged section at the base of the column should be cut away to a height above the rotten timber. A specialist carpenter/ timber expert should be employed to identify the type of timber rot present, determine the extent of the rot and to specify a suitable chemical treatment to halt the rot and prevent further damage [e.g., Smith's Clear Penetrating Epoxy Sealer CPES and Epoxy Filler – or similar approved] . The exposed timber should be treated before splicing with a new treated column section to match the existing. The column should be repainted with suitable protective paint following the repairs and treatment.

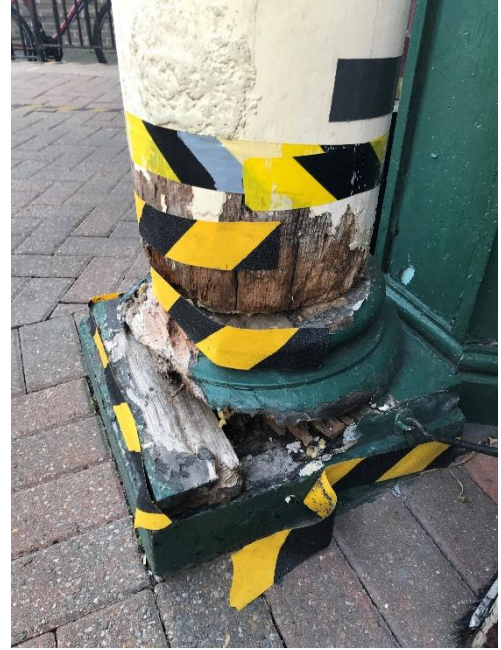
(2)

1. Column to RHS of main door - The timber footing that sits on the concrete plinth was extensively damaged due to timber rot, with under half of the timber footing remaining intact. A section measuring approximately 300mm in height at the base of the column above the footing was also rotten, around the full circumference of the column base (2,3,4).
2. Column to RHS of side door – Minor damage from rot to the base of the column. Protective paintwork had peeled from the timber footing which revealed cracking (6).

We consider that the damage to the base of the columns has occurred due to moisture ingress. Moisture has soaked into the timber at the bases of the columns over time probably through cracks in the protective paintwork. The moisture has caused rot in the timber footings and the bases of the columns. The source of the moisture is probably due to one or more of the following;
