# Drainage Report

**MMI 105**  
**99 OXFORD ROAD**  
**MANCHESTER**

**AQUASPEED DRAIN SERVICES**

## 99 OXFORD ROAD MANCHESTER - CCTV Survey Report : 30/09/21

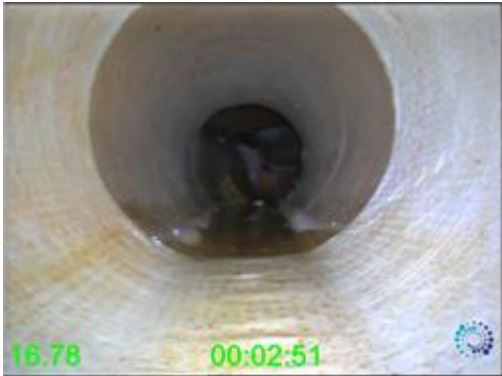
| Pos | Video Ref | Code | Description | Image |
|---|---|---|---|---|
| 16.78m | 0:02:51 | REM | General remark<br>PATCH LINER FITTED | <p>Image Provided - Ref: 7_4</p> |

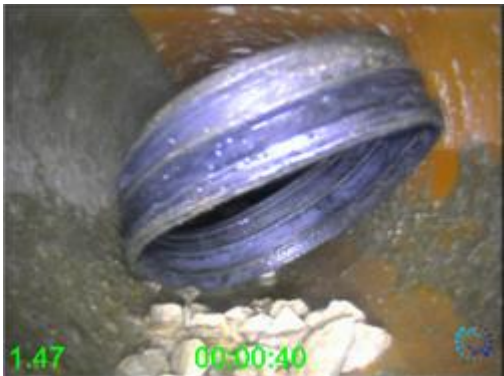
| Pos | Video Ref | Code | Description | Image |
|---|---|---|---|---|
| 01.47m | 0:00:40 | OB | Other obstacles: 0% Cross sectional area loss - Severity 3 RUBBER SEALING RING | Image Provided - Ref: 9_3<br> |

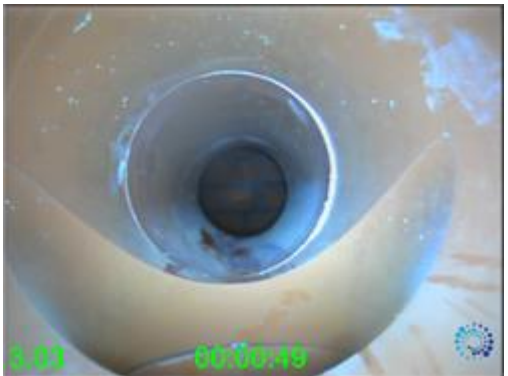
| Pos | Video Ref | Code | Description | Image |
|---|---|---|---|---|
| 03.03m | 0:00:49 | LDF | Line of drain/sewer deviates down [full] BACKDROP | Image Provided - Ref: 14_3<br> |
