## GAS MEMBRANE VALIDATION

**Site: Bowes Street**

Project Number: 11-813

Ground Gas Risk Assessment: **Characteristic Situation 2 / Amber 1**

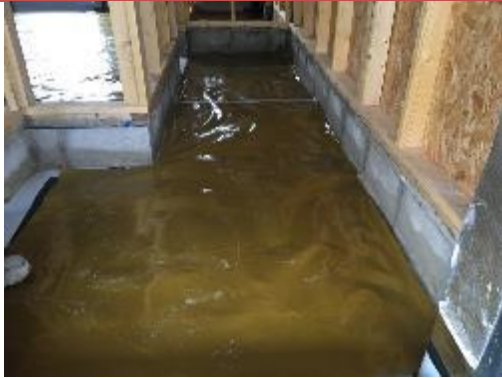
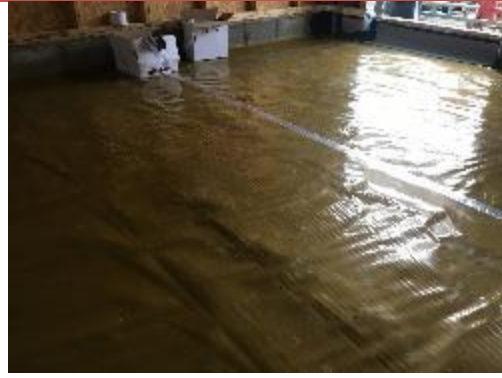
**Plot – 14**

**General Condition of Membrane-Good Condition**

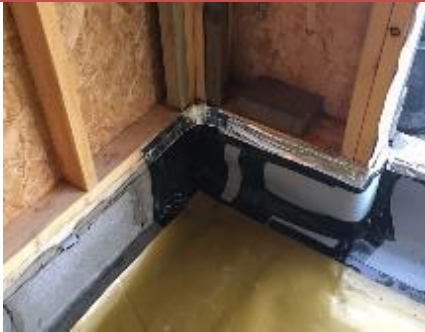
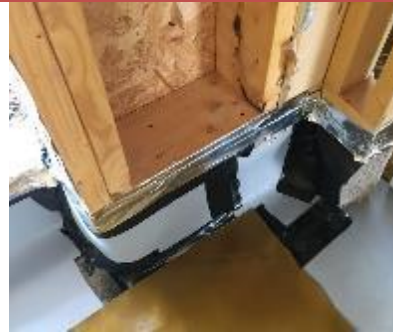
**Verification of Joints and Seals-Good Condition**

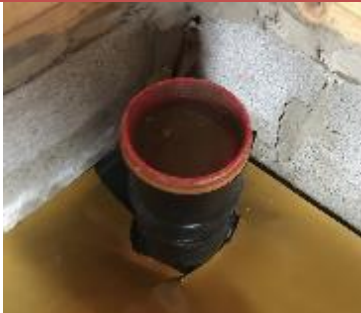
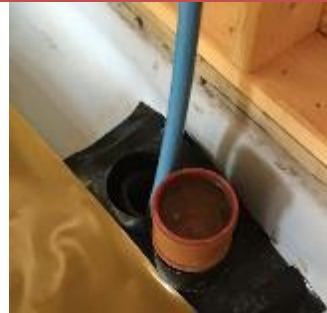
**Verification of Service Penetrations-Good Condition**

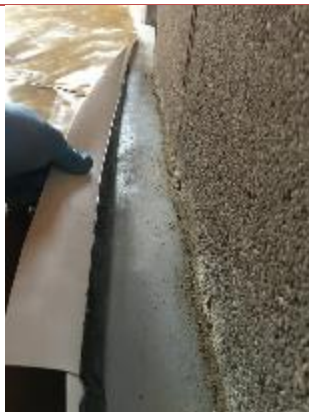
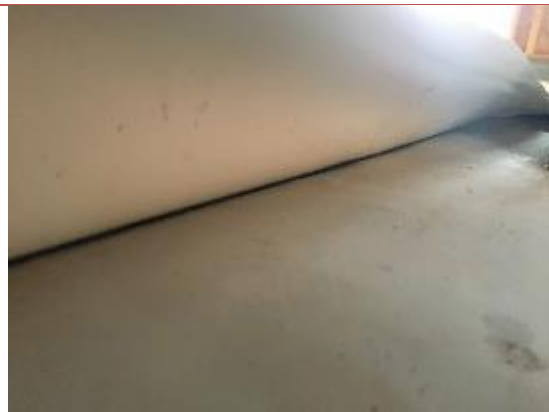
**Verification of Ventilation- Good Condition**

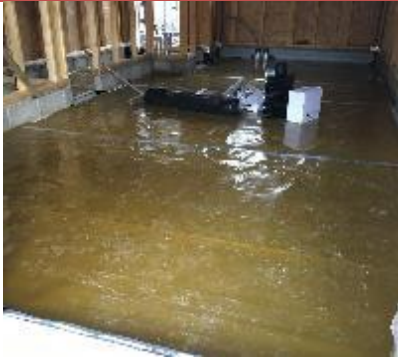
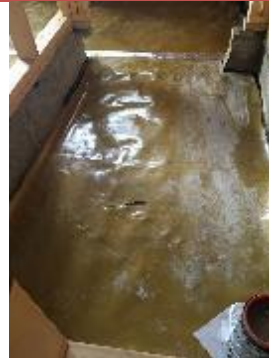
**Plot – 15**

**General Condition of Membrane-Good Condition**

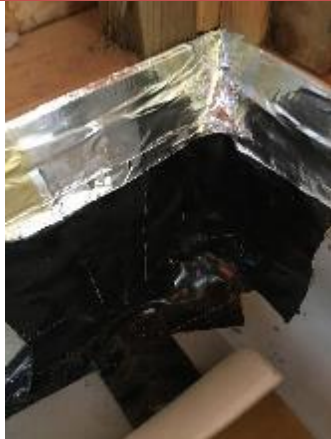
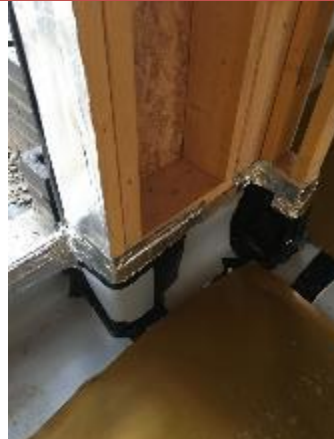
**Verification of Joints and Seals-Good Condition**

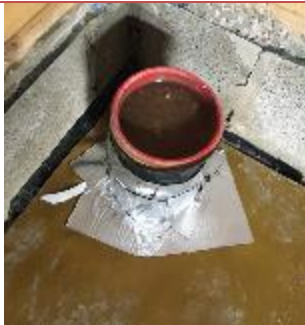
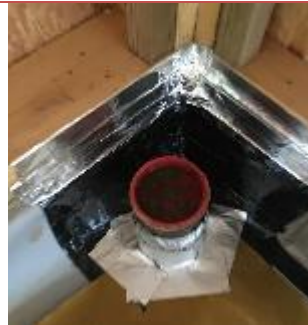
**Verification of Service Penetrations-Good Condition**

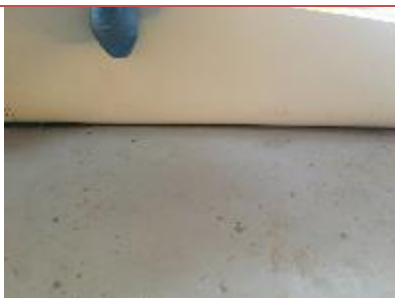
**Verification of Ventilation- Good Condition**

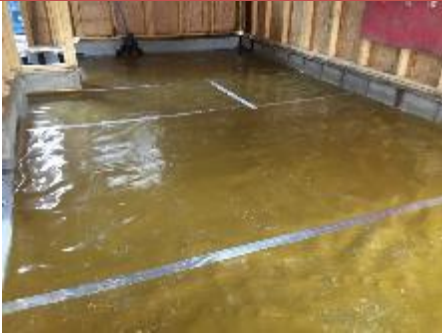
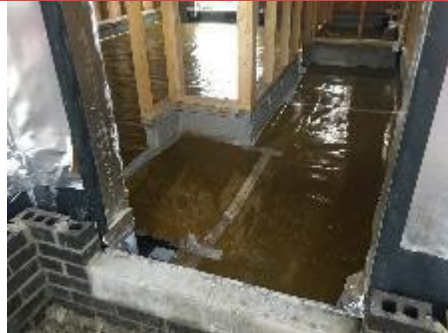
**Plot – 16**

**General Condition of Membrane-Good Condition**

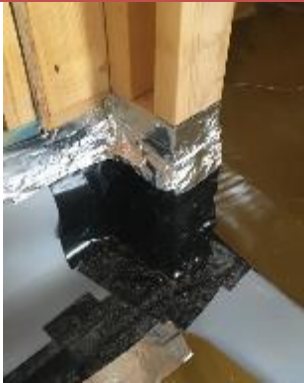
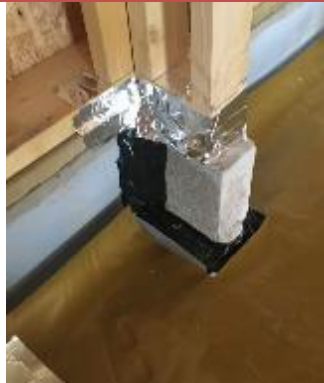
**Verification of Joints and Seals-Good Condition**

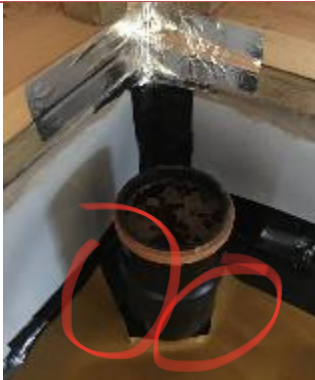
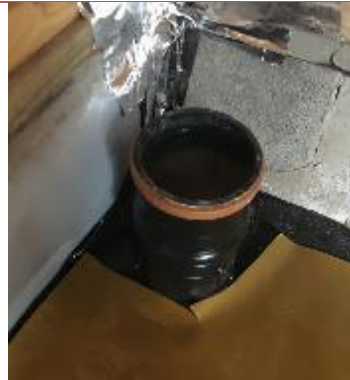
**Verification of Service Penetrations-Good Condition**

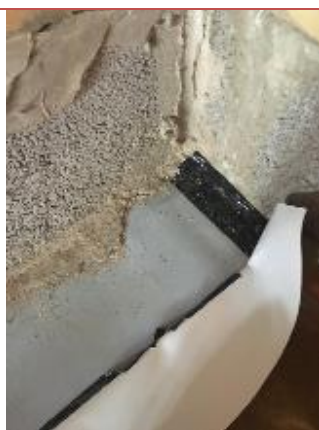
**Verification of Ventilation- Good Condition**
