## GAS MEMBRANE VALIDATION

| <b>Site: Bowes Street</b> | |
| Date: 22 <sup>nd</sup> -24 <sup>th</sup> June 2021 | Project Number: 11-813 |

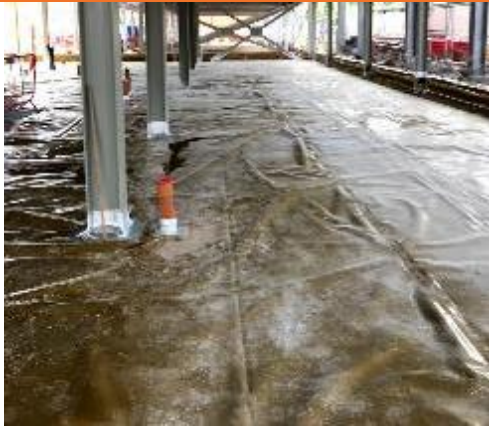
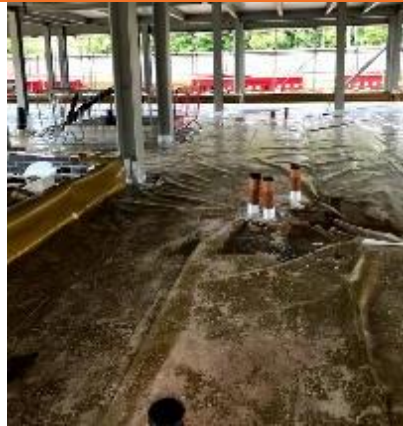
**General Condition of Membrane-Good Condition**

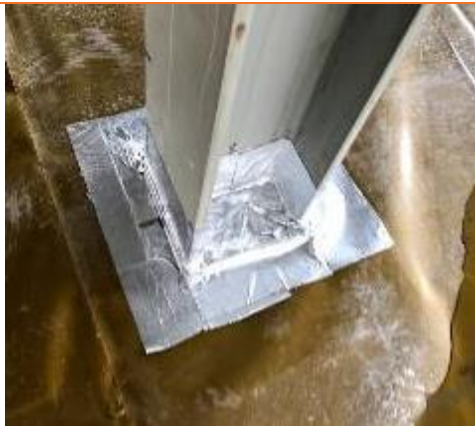
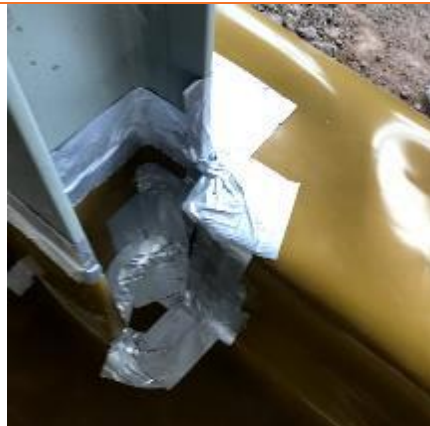
**Verification of Joints and Seals-Good Condition**

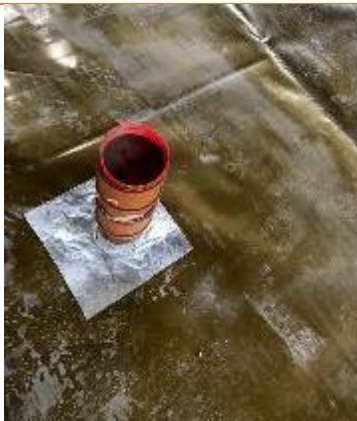
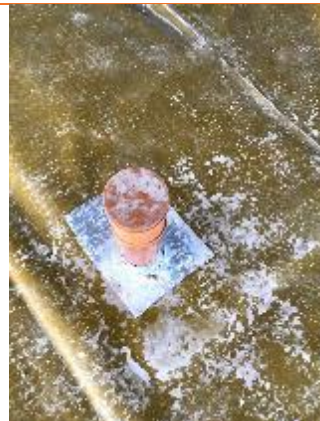
**Verification of Service Penetrations-Good Condition**

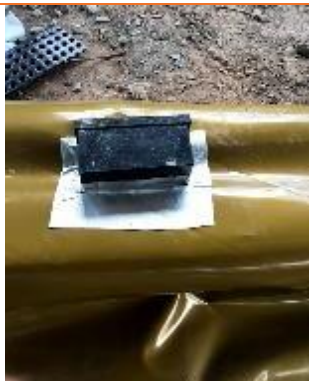
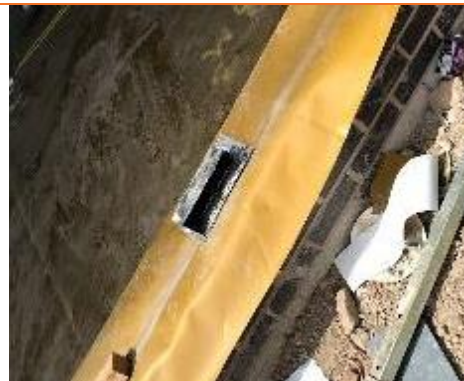
**Verification of Ventilation- Good Condition**

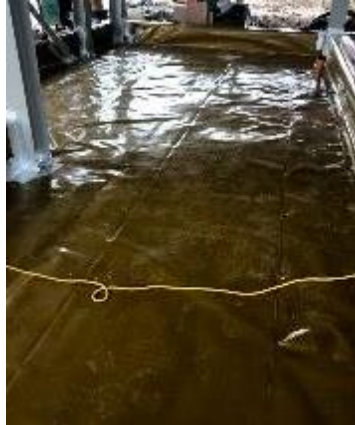
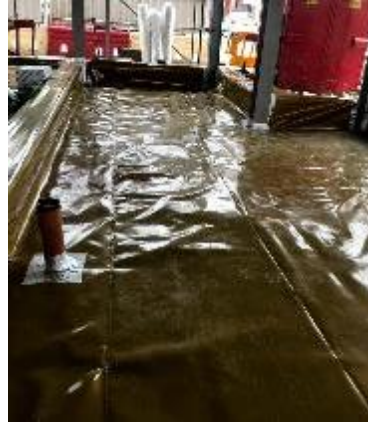
**General Condition of Membrane-Good Condition**

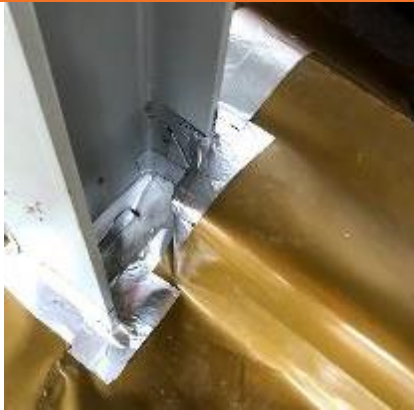
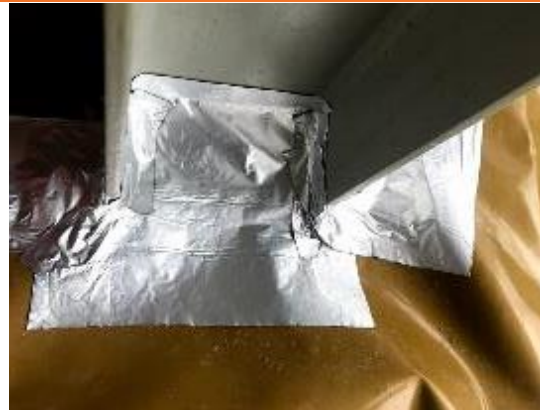
**Verification of Joints and Seals-Good Condition**

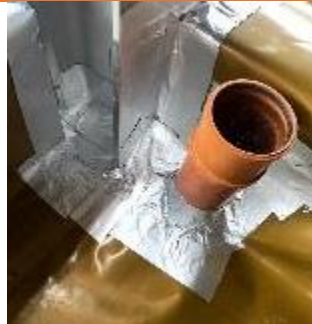
**Verification of Service Penetrations-Good Condition**

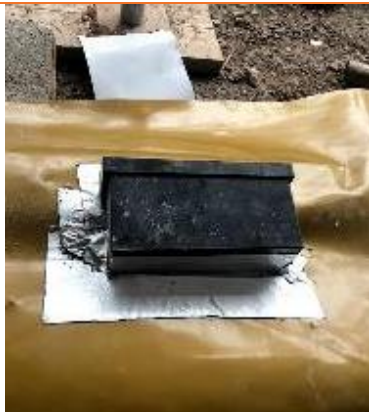
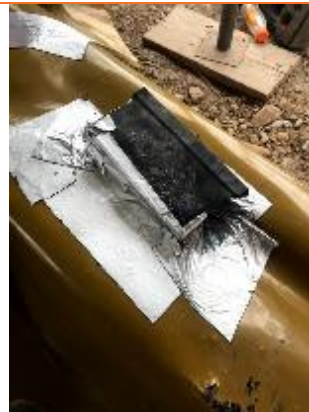
**Verification of Ventilation- Good Condition**

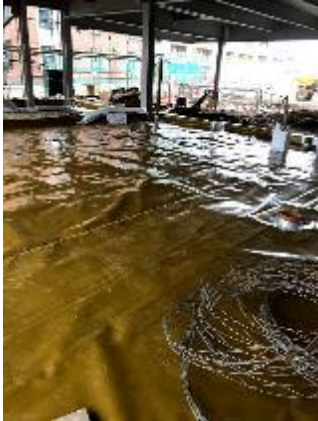
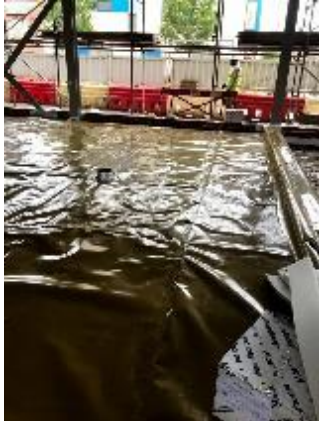
| Block A Visit 3 – 24/06/2021 | |
|---|---|
| General Condition of Membrane-Good Condition | |

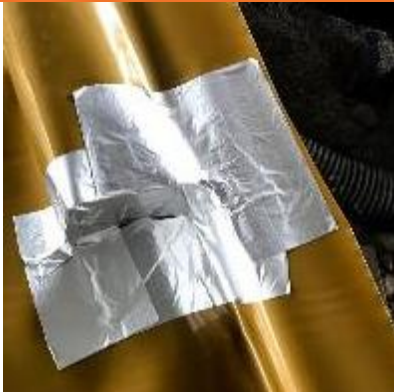
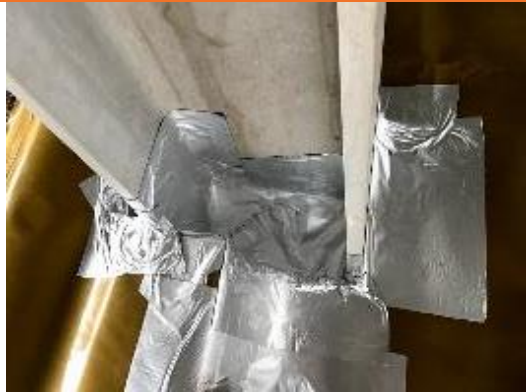
| Block A Visit 3 – 24/06/2021 | |
|---|---|
| Verification of Joints and Seals-Good Condition | |

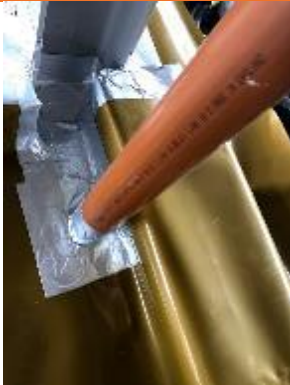
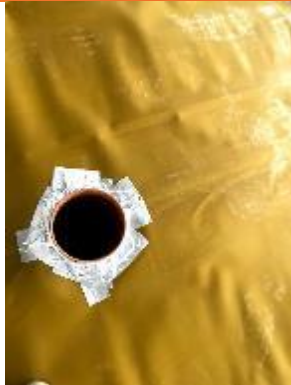
| Block A Visit 3 – 24/06/2021 | |
|---|---|
| Verification of Service Penetrations-Good Condition | |

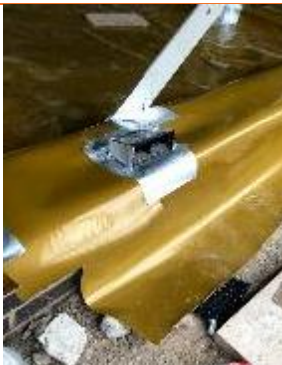
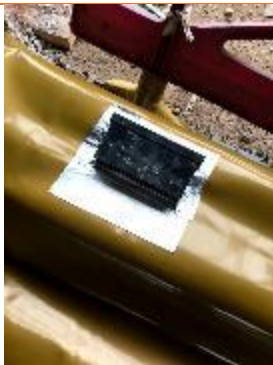
| Block A Visit 3 – 24/06/2021 | |
|---|---|
| Verification of Ventilation- Good Condition | |
