# Castlefield Viaduct

Arup Report – 3 September 2021

# Executive Summary

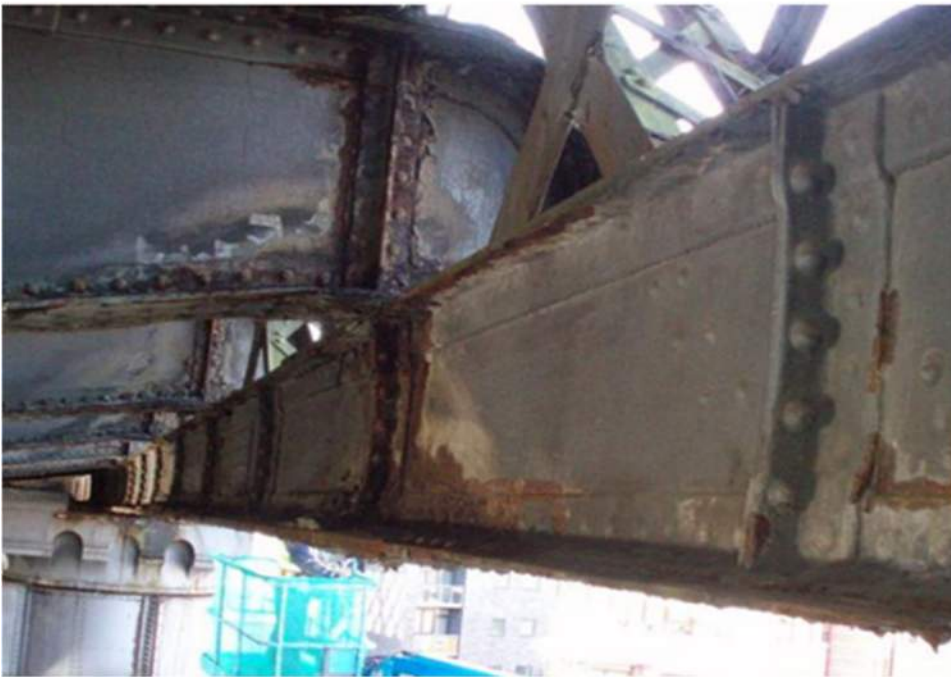
**Typical Transvers Girder End Stiffener**

The key mode of potential failure identified is in the transverse girders at the support. These are typically provided with an end stiffener to resist web buckling, but it was noted that this has been entirely lost in places due to corrosion, particularly on the exposed north side of the structure.

The stiffener is the vertical plate, riveted to the web

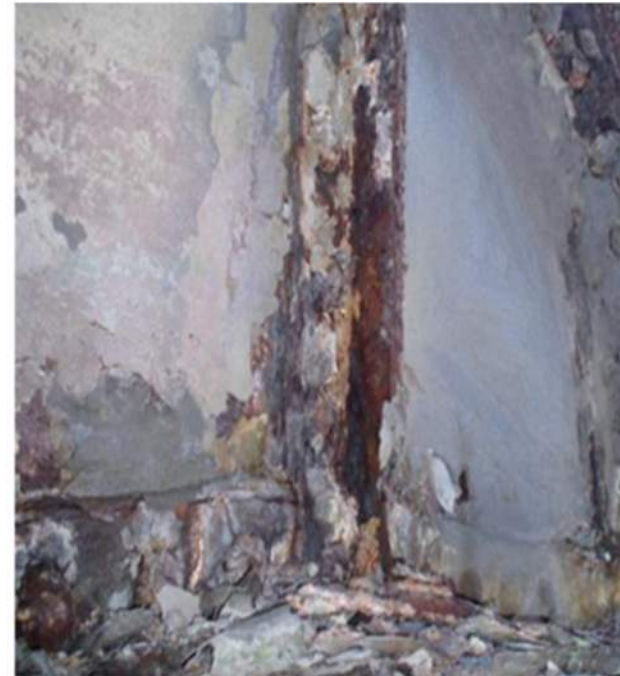
**Close up of Stiffener**

Shows corrosion and loss of section

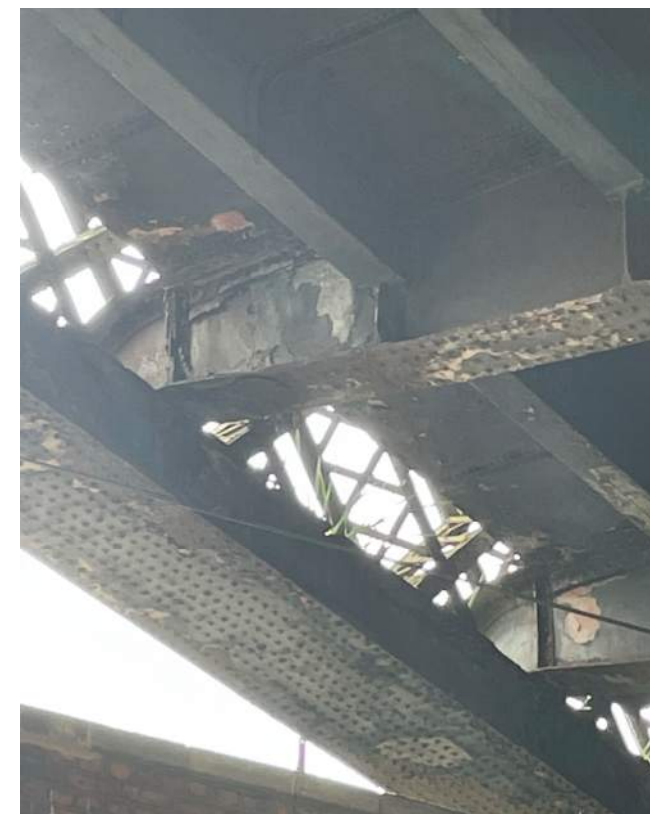
## Underside of the viaduct

Image shows transverse fish belly girder and corroded stiffener

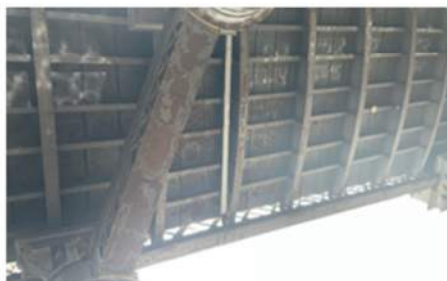
Overall, the condition is 'satisfactory' with some discrete elements in 'poor' condition. Failure of the corrosion protection system is commonplace – refer to *Figure 3*. Surface corrosion is present across the structure, commonly in localised patches in the following five typical locations:

- Patches of the deck plate.
- The underside of each end of the fish-belly beams.
- The web stiffeners at each end of the fish-belly beams.
- Patches on any soffit element, including the transfer trusses between piers.
- Patches on the surface of, and seams between, structural panels of the main piers.

Figure 3 - General condition of the viaduct soffit

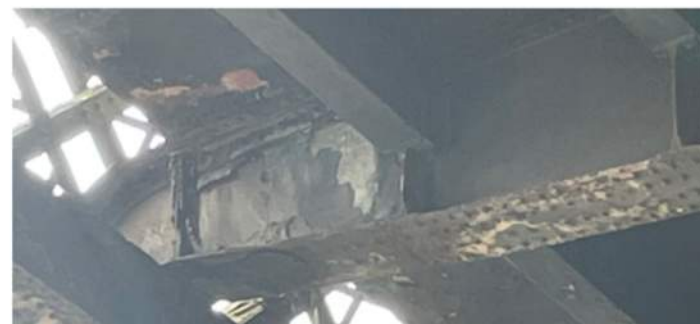
The end web stiffeners, which align with the bearing point of the fish-belly beams onto the main trusses, are more exposed to the elements than others which is evident from the levels of corrosion. A proportion of end web stiffeners are significantly corroded and probable delamination of the section – refer to *Figure 4*.

Figure 4 - Example of significant corrosion and possible delamination of the end web stiffener on the fish-belly beams

**It is recommended that a detailed measurement inventory of each stiffener is made to allow further assessment to determine the likely structural capacity of the beams at these locations.**

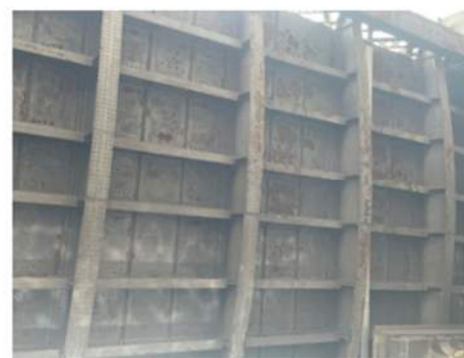
The deck plate appears to be in reasonable condition. Surface corrosion is commonplace but from a distance, there does not appear to be any evidence of significant corrosion or section loss from the soffit.

Figure 5 - Typical condition of the deck plate

**It is recommended that the detailed structural examination of the viaduct includes trial pits in the ballast to observe the top side of the deck plate at several locations and at the positions of drainage points.**

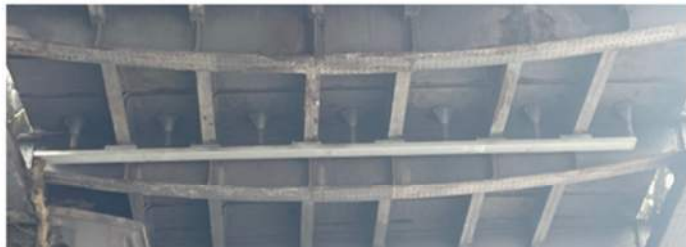
Three locations were observed between the metrolink surface carpark and the canal basin where new drainage channels had been installed since the 2015 Jacobs report – refer to Figure 8. At one location the down-pipe was leaking – refer to Figure 9 – the last rainfall appears to have been approx. 6.4mm 24hrs prior but followed a hot sunny day (21 degrees C).

Figure 8 - Example of new drainage channel

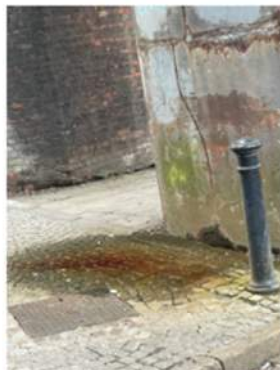
Figure 9 - Example of constant drip patch under downpipe joint.

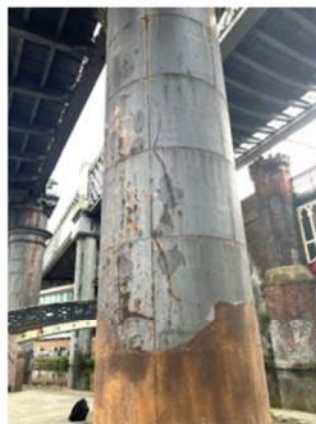
Several cracks were observed in main structural piers that appeared to be more than simple surface paint cracks – refer to Figure 10 and Figure 11. It is understood that these columns have been infilled with mortared aggregate, which is likely to be the main structural element.

Figure 10 – Location 1 - example of main pier crack

Further investigation e.g. NDT would be beneficial to understanding the significance and further work for these cracks.

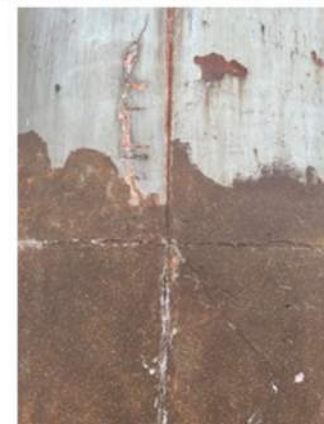
Figure 11 - Location 2 - example of main pier crack
