# Glazing Options Matrix Report

## **Non-Intrusive Condition Survey into the Glazed Façade Elements Report**

07055/HB/RS/54314/WL/02

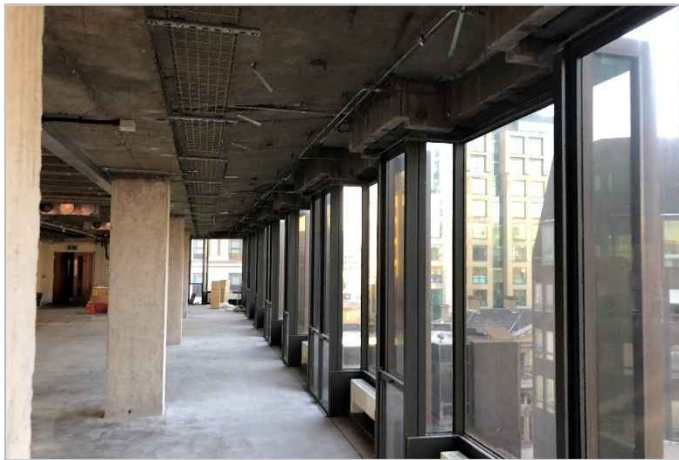
*Photograph No. 7 – Underside of slab exposed revealing the installation methodology of aluminium shopfront system*

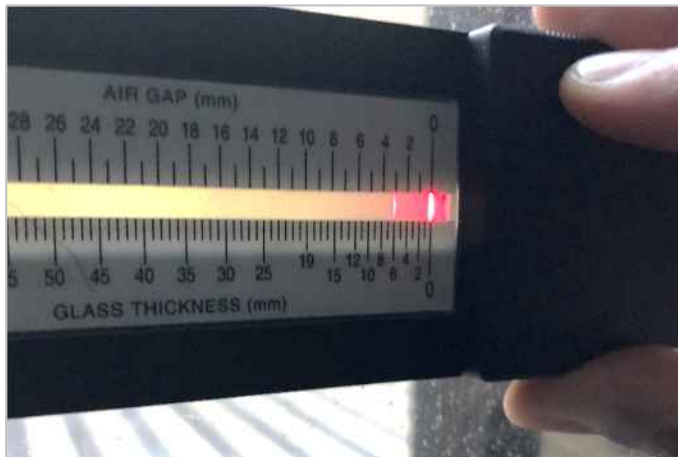
- 4.5 The façade is single glazed, and using the Merlin glazing equipment, measured approximately 6mm. An engraving or sticker was also observed to the corner of the glazed pane which displayed (Madico Film – BS 6206 CLASS B).

Photograph No. 12 – 6mm glazed pane measured

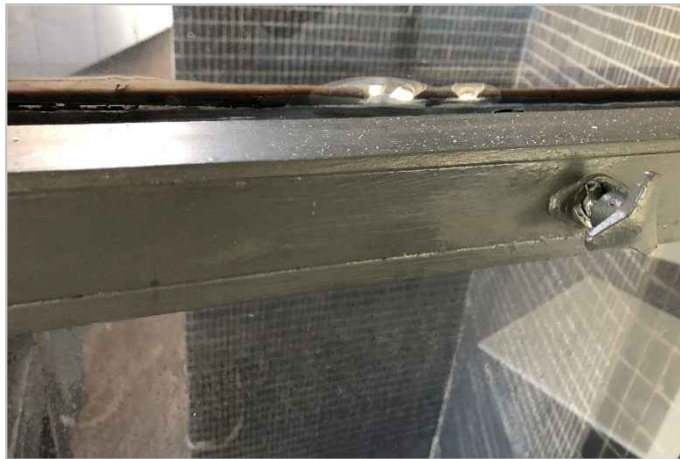
- 4.6 The 6mm single glazed pane installed has a film applied to the inside face which has been applied as a separate element. The 6mm glazing panes installed are annealed glass. In some locations, the film was observed to be peeling away at the edge of the glazed pane. With this being said, the film does not appear to be glazed into the system.

Photograph No. 13 – Film application bubble at window edge

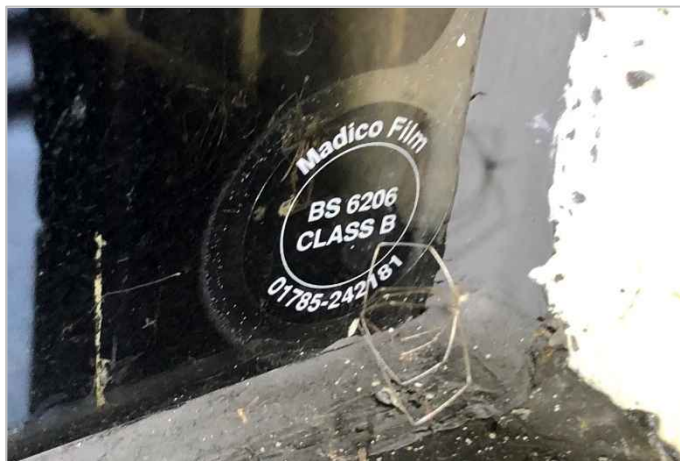
- 4.7 The corners of the glazing installed bared a small print illustrating the glazing performance, 'Madico BS 6206 Class B'. A phone number was also present on the sticker, believed to be the manufacturer of the film applied. The film appears to have been applied in an effort to help see that the glass panes installed are a Class B safety glass. With the small print and film applied the author believes the film to be a safety film for the glazed pane rather than a solar control film.
- 4.8 However, the film application does not appear to be rebated into the glazed system but applied and cut short around the edge of the opening. It also appears that the logo was applied before the film application as an air bubble around the sticker is evidently behind the film.

Photograph No. 14 – Madico Film BS6206 Class B

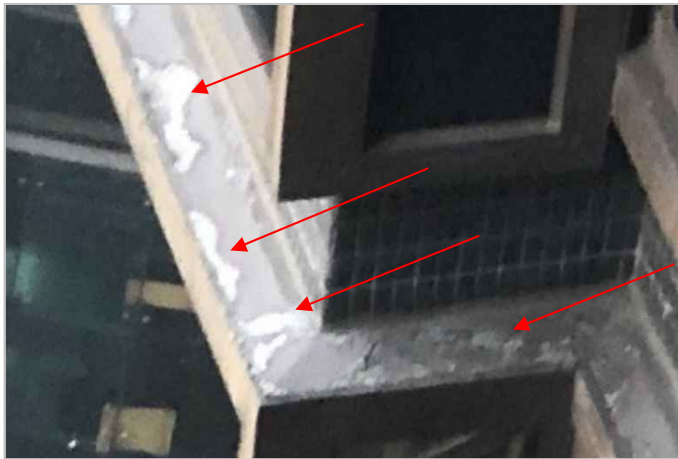
- 5.1.1 The surface finish to the framework appears to be a bronze PPC. The black PPC applied to the top surface of the framework was found peeling/flaking away from the edges. The cause of this is unknown. However, the system installed is 50+ years and has reached the end of its service life, which includes the PPC illustrated in Photograph No. 15. Wintech believe that moisture has seeped in between the paint application and the surface and over time, has begun to flake near the edges.

*Photograph No. 15 – Paintwork deteriorated on top of framework  
(Level 6 – West elevation – Pall Mall Court)*

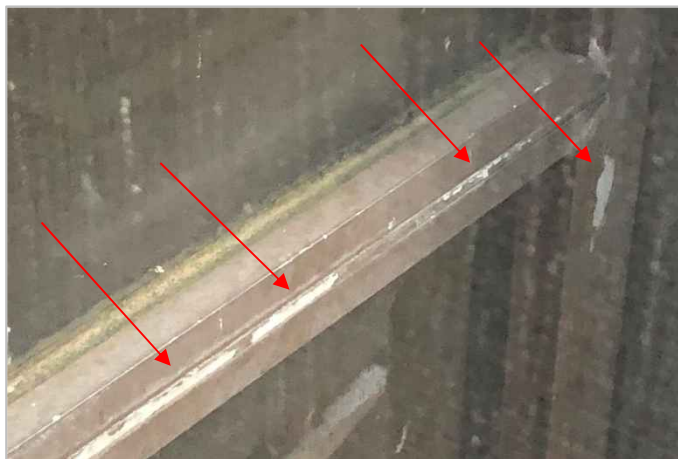
- 5.1.2 The image below illustrates a number of areas which display signs of flaking. The flaking, of what appears to be the original paintwork application, was found predominately to the edges highlighted red in Photograph No. 16.

*Photograph No. 16 – Paintwork applied to framework observed  
peeling from edges on framework (Level 3 – East elevation – Pall Mall  
Court)*

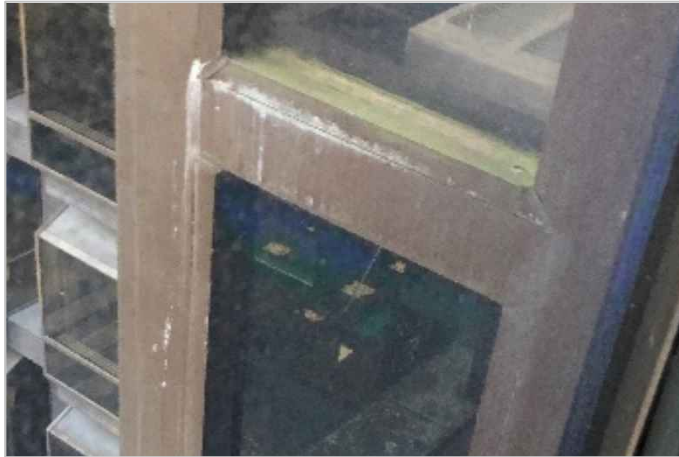
- 5.1.3 The author was unable to get a closer view of the cloudy white staining to the framework observed on the external side of the building. However, the author believes that adverse weather conditions over time have affected the framework throughout the years, allowing hard residue to build up and leaving heavy staining to the horizontal joint between the framework and the mitred corner joints of the framework.

*Photograph No. 17 – Water staining observed to framework (Level 4 – South elevation – Marsden Block)*

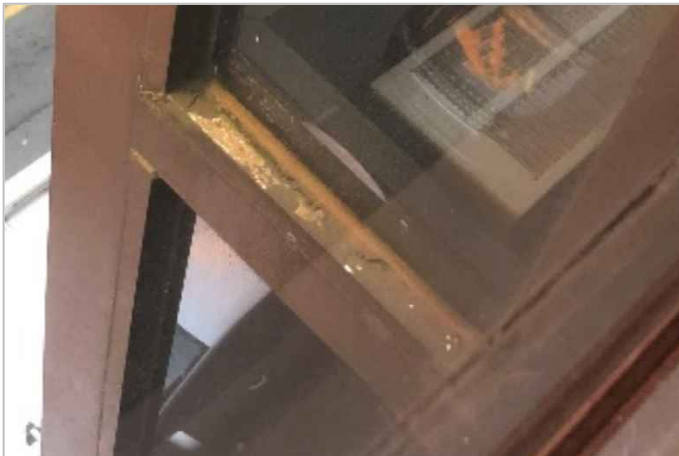
*Photograph No. 18 – Water damage to framework (Level 2 – North elevation – Marsden Block)*

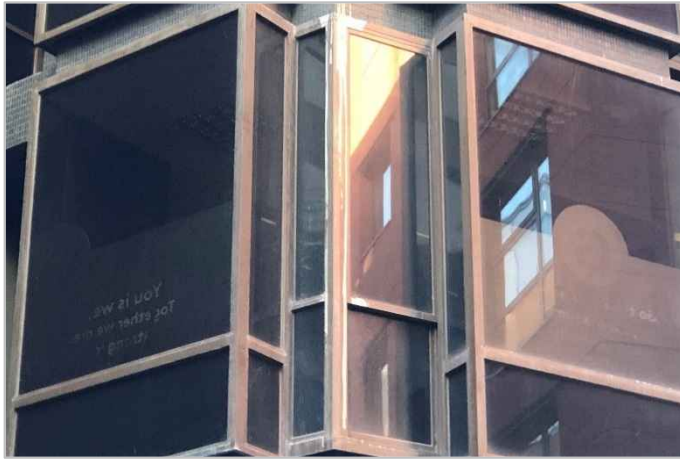
*Photograph No. 19 – Excess water staining observed to corner bay  
(Level 3 – West elevation – Marsden Block)*

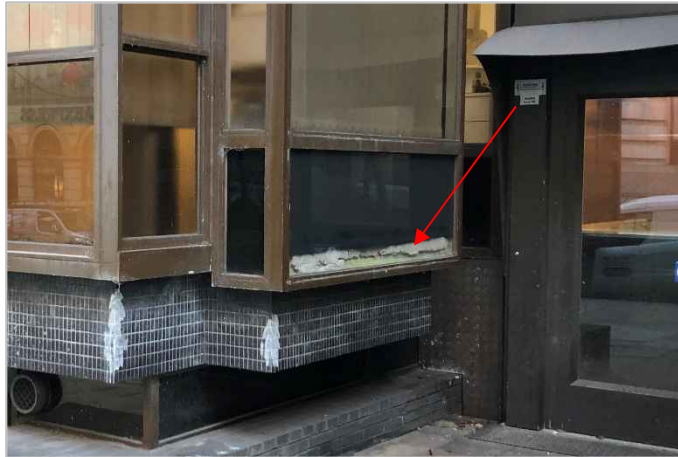
- 5.2.2 The ground floor level presented a spandrel unit with the bottom edge clear, exposing the materials behind, i.e. the internal plasterboards, insulation and the materials behind it. The cause for the black coating failing is unknown without a full intrusive investigation; however, due to the glass installed being a single glazed pane, there is a high risk of condensation forming on the inside face. The author believes that condensation occurring on the glass pane could have impacted the degradation of the black coating applied.

*Photograph No. 20 – Spandrel panel on the ground floor (Ground floor – South elevation – King Street)*

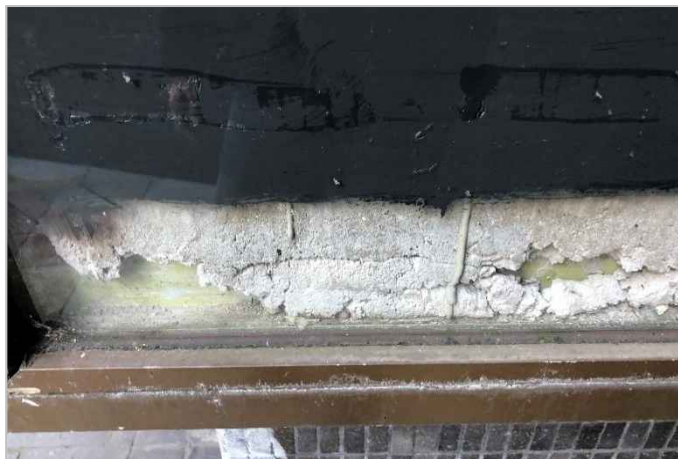
- 5.2.3 Another factor in the degradation process of the black coating could be that the application is not UV stable. Meaning the applied coating as applied may not have been long term resistant to the presence of ultraviolet light from the sun's rays. Thermal cycle is another factor where differential temperatures have an effect on the application and cause it to degrade through heating and cooling (the expanding and contracting causes small cracks in the black coating which will slowly break away).

*Photograph No. 21 – Black coating to spandrel panel degraded, exposed materials behind it (Ground floor – South elevation – King Street)*

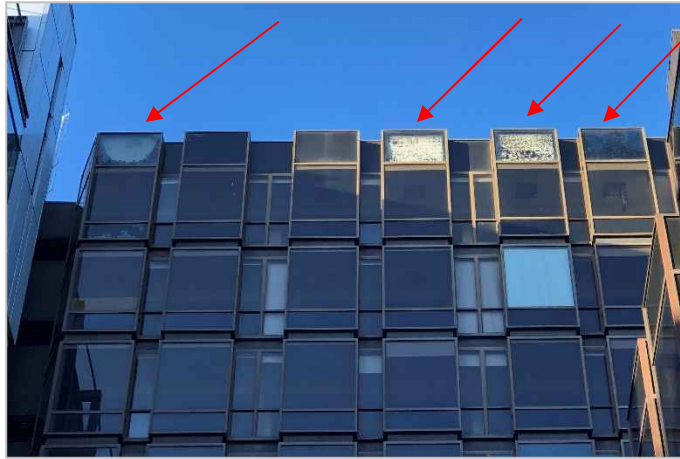
- 5.2.4 The black coating to the glazed pane (spandrel panel) was observed from the outside of Pall Mall Court. There were a number of panels which displayed a large amount of degradation to the black coating applied to the inside face. A number were observed from the ground floor level, with the majority observed on Level 10, East elevation, facing Brown Street.

*Photograph No. 22 – Spandrel panels at roof level exposed due to degradation of black coating on inside face (Level 10 – East elevation – Pall Mall Court facing Brown Street)*

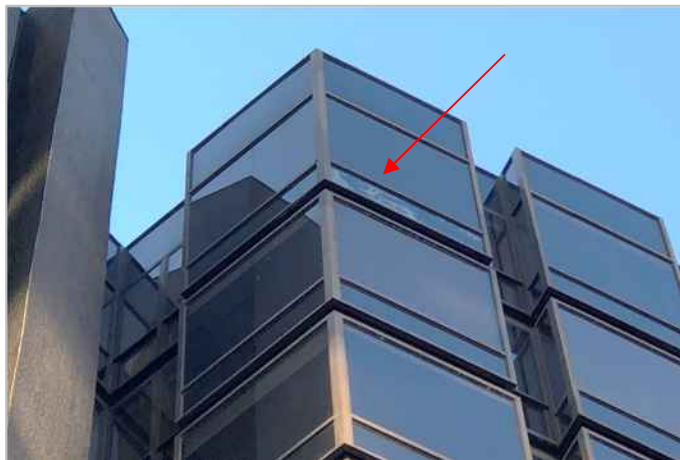
- 5.2.5 Another was located on the North elevation, Marsden Block, Level 5, facing Marsden Street. Without an intrusive survey and testing, the author believes that the condensation forming on the inside face of the glazed pane has over time degraded the black coating. It is not common for one to degrade whilst others have remained intact. Therefore, the author believes that the application of the black coating may not have been applied correctly, meaning the surface it was applied to was not clean and free of debris or grease.

*Photograph No. 23 – Black coating to spandrel panel deteriorated over time (Level 5 – North elevation – Marsden Block)*

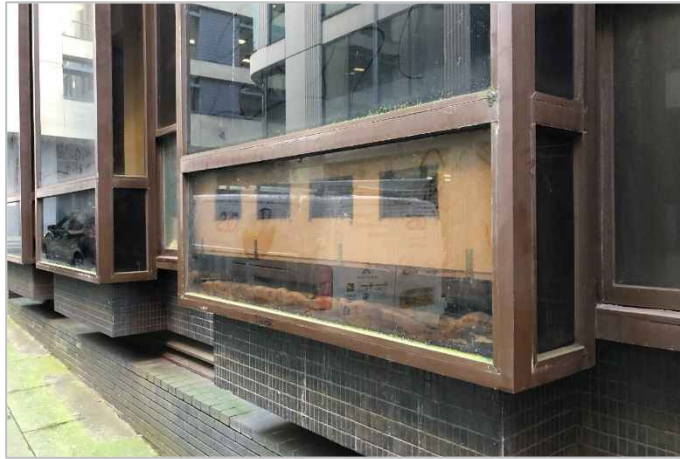
- 5.2.6 On the ground floor level, one glazed pane was found to be without any black coating. This happened to be the only glazed pane with the black coating entirely diminished, rendering the area completely exposed. The reason for this could be due to the application quality of the black coating, i.e, the application was not as specified, or the surface was not clear of debris and grease. This could also be condensation related, as mentioned within Section 4.2.

*Photograph No. 24 – Ground floor exposed spandrel glass panel with black coating diminished – (Ground floor – North elevation – Marsden Block)*

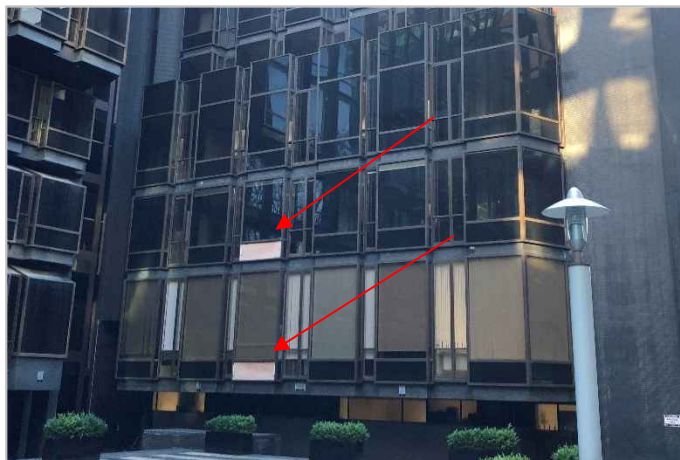
- 5.3.1 Two 6mm glazed panels were missing from the glazed façade system. The missing glazed panes acting as spandrel panels were replaced with timber boards. The timber boards were installed within the framework and secured via fasteners and timber boards, as well as silicone sealant, to the edges.

*Photograph No. 25 – Glazed spandrel panels replaced with timber boards (Levels 1 & 2 – North elevation – King Street Block)*

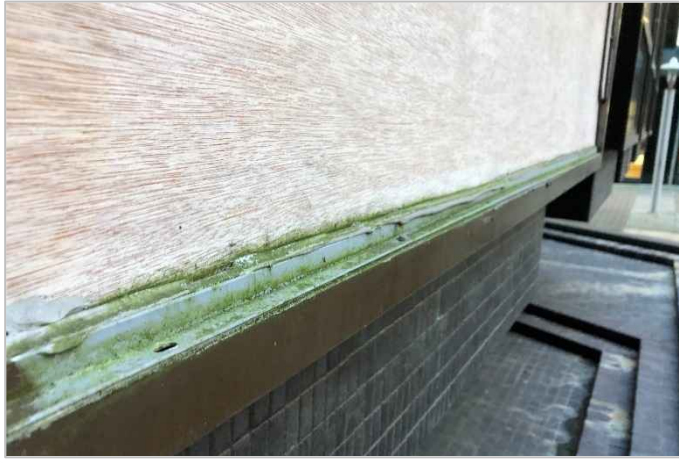
- 5.3.2 The bottom edge of the replacement timber board was installed behind the horizontal framework and then silicone sealed along the span.

*Photograph No. 26 – Timber board installed behind framework and silicone sealed (Level 1 – North elevation – King Street Block)*

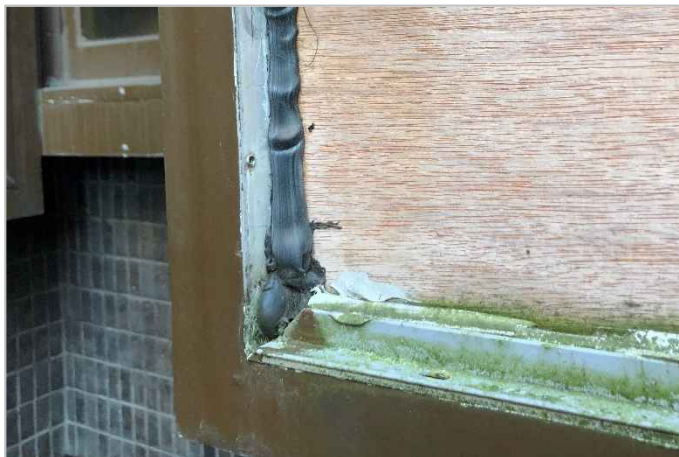
*Photograph No. 27 – Timber panel installed, and silicone sealed around the jamb edges (Level 1 – North elevation – King Street Block)*

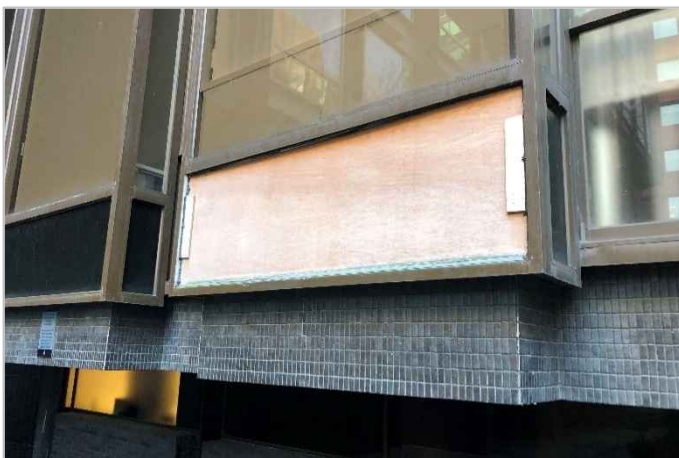
*Photograph No. 28 – Timber spandrel panel (Level 1 – North elevation – King Street Block)*

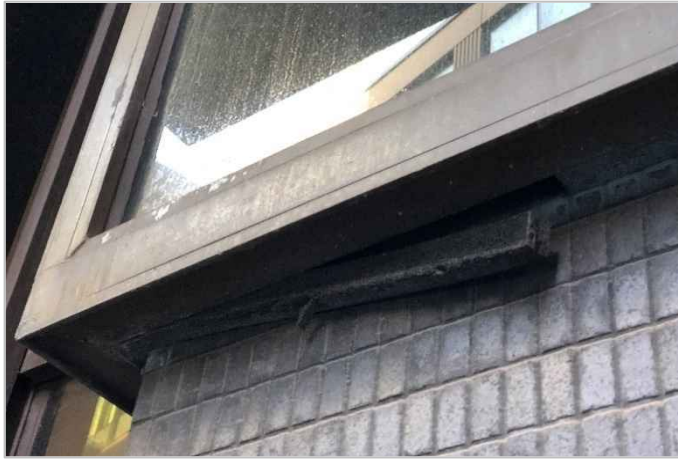
- 5.4.1 An impregnated foam material which measured a depth of approximately 15mm was found dislodged from the underside of the projected pod. With this gap present, heat will escape and affect the thermal performance of the building.

*Photograph No. 29 – Impregnated foam found loose between façade and glazing system (Level 1 – West elevation – Marsden Block)*

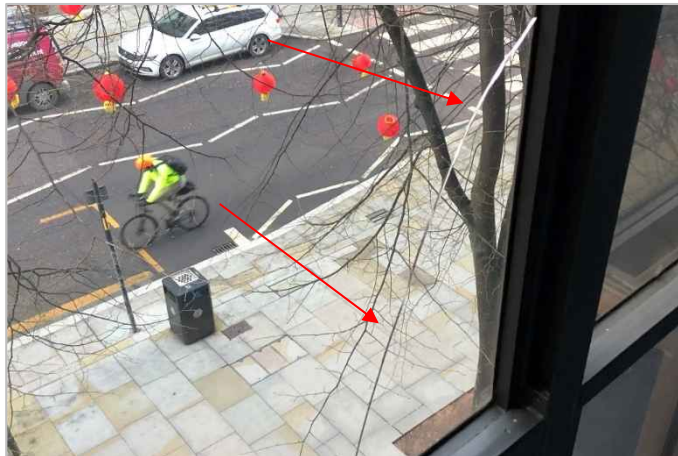
- 5.5.1 On Level 1, a fracture in the glazing pane was observed. The fracture appears to be thermal related due to the location; the fracture extends from the left jamb towards the middle of the cill.

*Photograph No. 30 – Internal view of cracked glazed pane (Level 1 – South elevation – King Street Block)*

- 5.5.2 The cause of this fracture is most likely to be a thermal one. The film application introduced to the inside face of the glazed pane is likely to have increased the solar energy absorbance, creating a differential in temperature. Due to the differential temperatures in the glass pane, the glass expands and contracts at different rates and the unexpected temperature change creates a thermal shock on a molecular level and causes certain parts of the glass to contract while other areas are expanding. With this stress occurring within the glass pane, cracks appear. There is a possibility that edge damage to the glass pane may have occurred, causing this fracture.

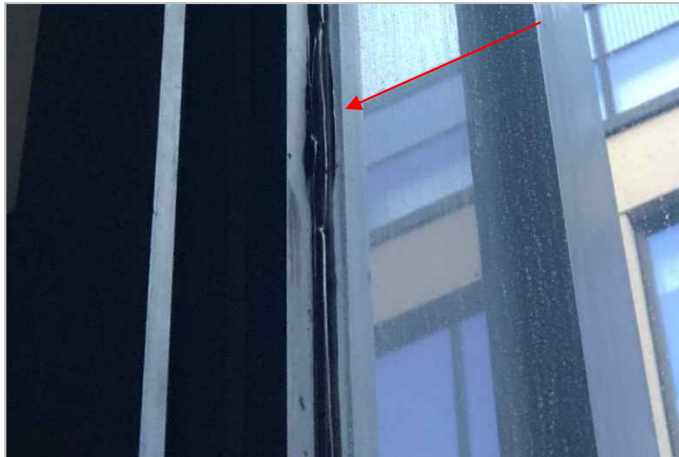
- 6.1.1 The gaskets used between the single glazed pane and the internal framework were found to be deformed in a number of locations. This appears to be a result of age hardening which also indicates that the seals have reached their service life and should be replaced.

*Photograph No. 31 – Deformed seal as a result of age hardening between the glazed pane and framework (Level 2 – South elevation – King Street Block)*

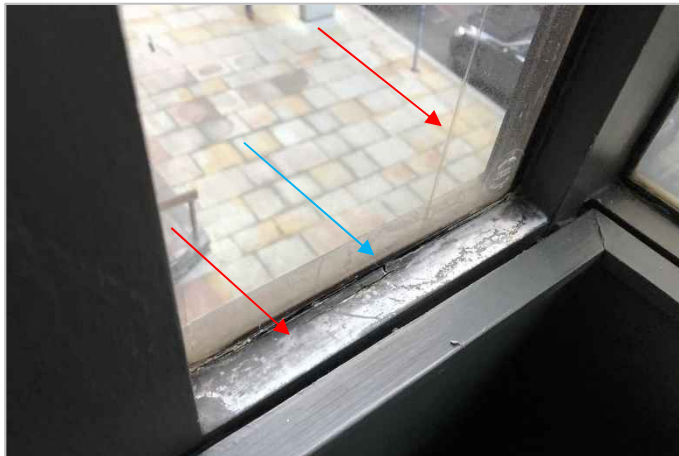
- 6.1.2 In a number of locations within Pall Mall Court, heavy degradation to the paintwork was found to the internal cill framework.

*Photograph No. 32 – Degradation of paint and sealant applied (Level 1 – South elevation – King Street Block)*

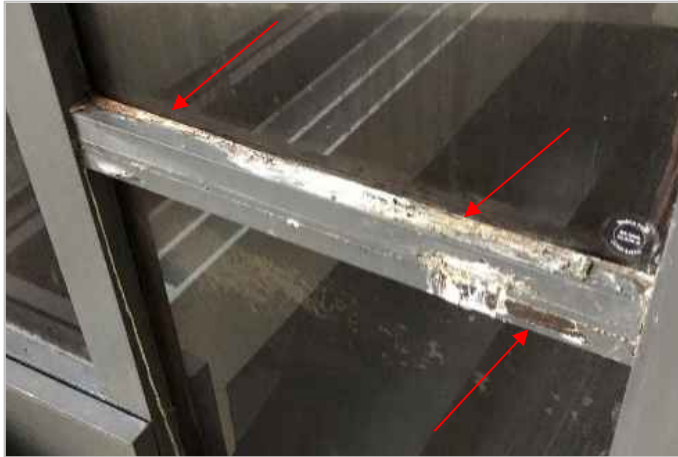
- 6.1.4 Heavy degradation of the paintwork was observed to the entire length of the horizontal aluminium framework on Level 3. This particular window section has been susceptible to a large amount of water ingress, due to the level of corrosion observed to the framework. The author believes that the water pooling on top of the framework has eventually seeped out between the internal paint application and over time degraded, exposing the original bronze coloured PPC.

*Photograph No. 33 – Heavy amount of staining to paintwork application on framework (Level 3 – South elevation – King Street Block)*

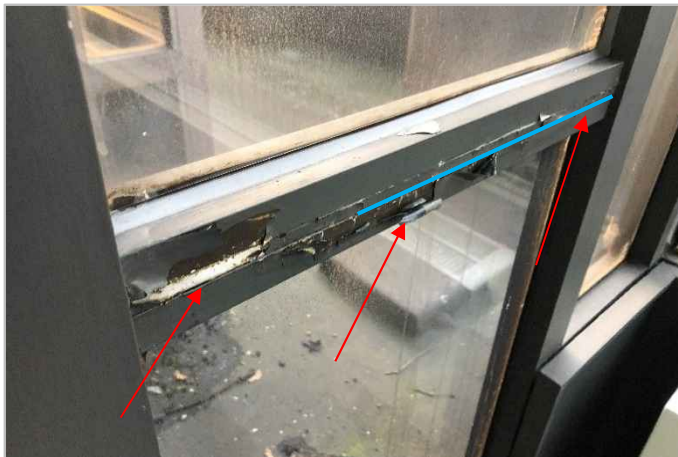
- 6.1.5 Water found sitting on top of the framework has eventually trickled down the front of the horizontal members and has tracked along the connection joint/line (highlighted blue). The water has eventually traversed its way along the joint and has seeped out in between the applied paintwork and the PPC bronze framework, causing the paint to peel away over time.

*Photograph No. 34 – Paint application peeling away from the framework (Level 3 – South elevation – King Street Block)*

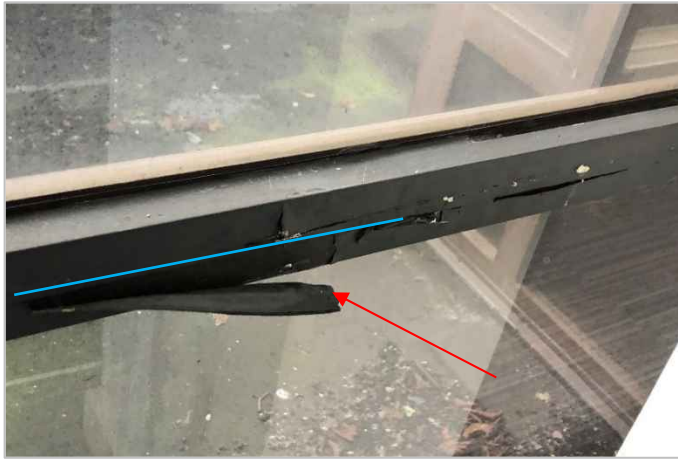
*Photograph No. 35 – Paint peeling away from framework (Level 3 – South elevation – King Street Block)*

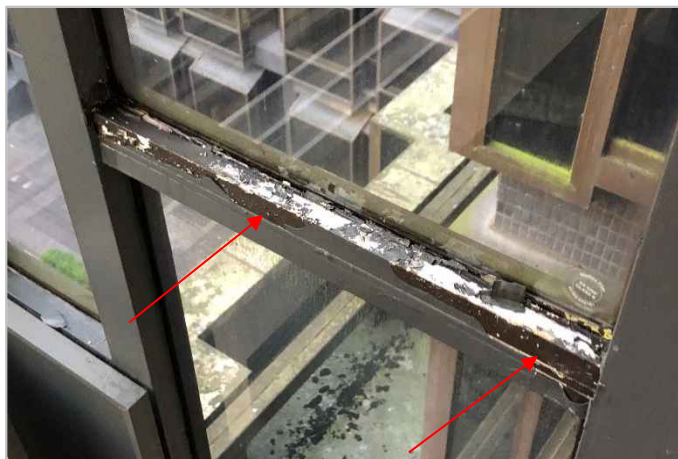
- 6.1.6 In some locations, the degradation was observed to be heavy, exposing the bronze PPC entirely. This is most likely due to the condensation which forms on the inside face of the glazed pane as well as water ingress through the top seals. Water/moisture has pooled on the horizontal frame and over time has degraded the internal paint application, exposing the bronze PPC framework and the aluminium framework.

*Photograph No. 36 – Degradation to internal paint application exposing bronze PPC (Level 4 – North elevation – King Street Block)*

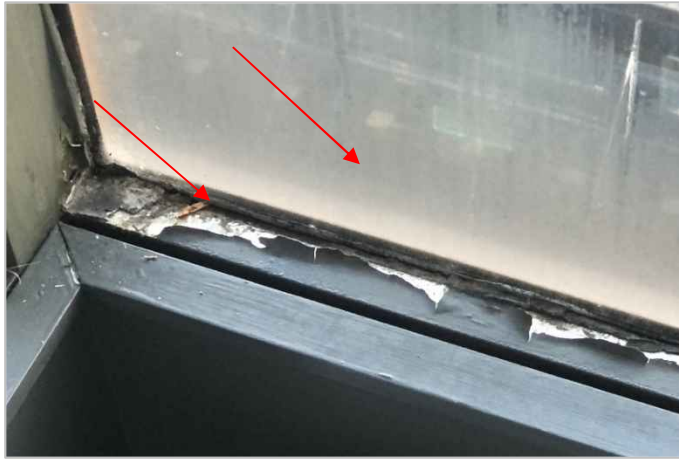
*Photograph No. 37 – Paint application peeled away from edge closest to glazed pane (Level 9 – West elevation – Pall Mall Court)*

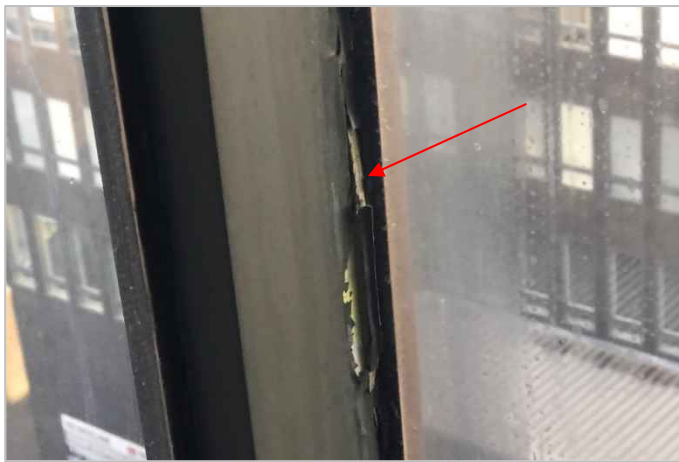
*Photograph No. 38 – Sealant applied degraded with paint work flaking (Level 9 – West elevation – Pall Mall Court)*

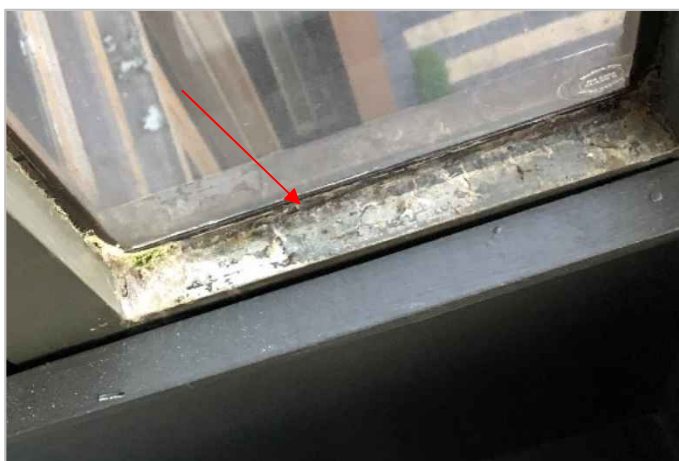
*Photograph No. 39 – Heavy degradation to framework (Level 9 – West elevation – Pall Mall Court)*

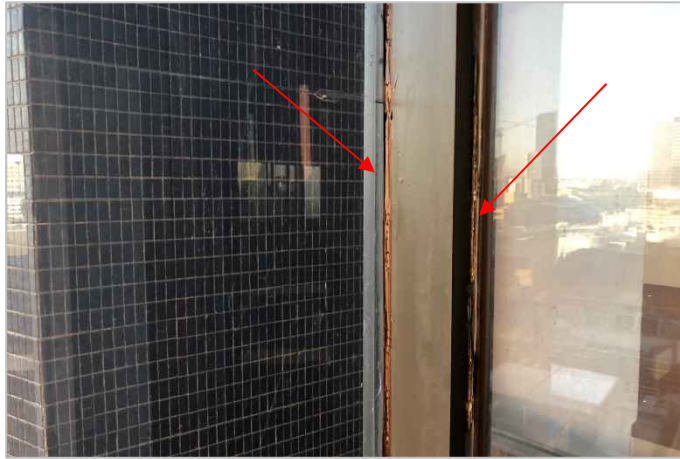
*Photograph No. 40 – Sealant degraded between the glazed pane and framework – (Level 10 – West elevation – Pall Mall Court)*

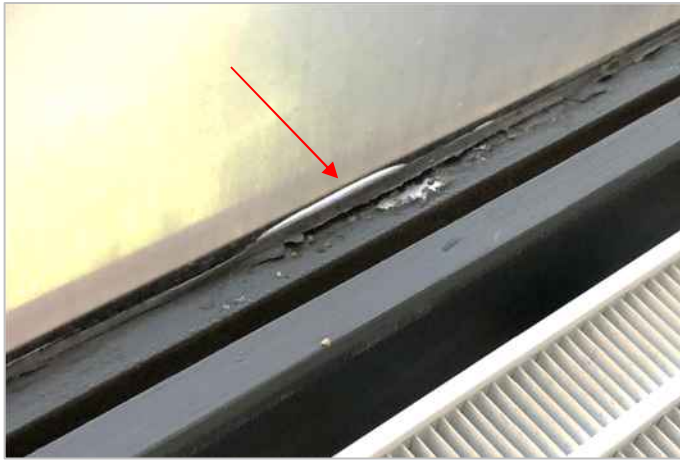
*Photograph No. 41 – Adhesion failure of sealant applied to framework and glazed pane (Level 10 – East elevation – Pall Mall Court)*

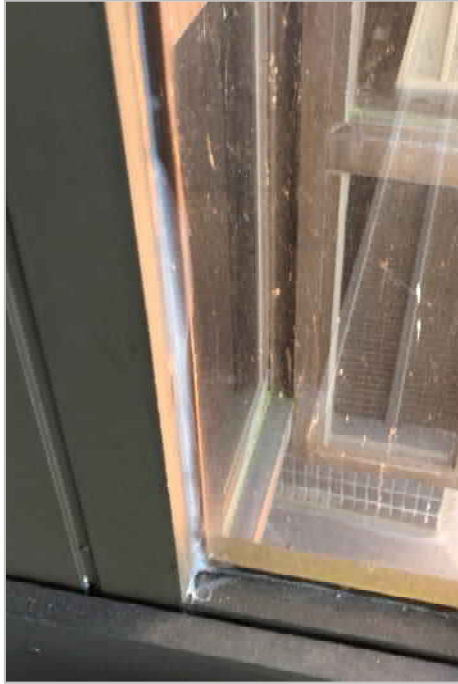
- 6.1.8 On Level 10, a clear sealant was observed to the edge of the framework in an attempt to seal any gaps between the glazed pane to the framework. This is likely to be a remediation attempt to seal the glazed pane to prevent any further water ingress. The silicone sealant applied does not appear to be compatible with the frame or the glazed pane as the adhesion has evidently failed in Photograph No. 43.

*Photograph No. 42 – Clear silicone sealant applied (Level 10 – West elevation – Pall Mall Court)*

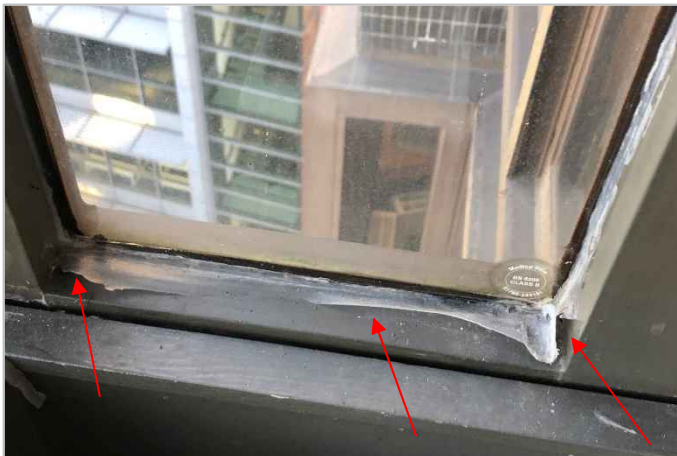
*Photograph No. 43 – Clear silicone sealant showing signs of adhesion failure (Level 10 – West elevation – Pall Mall Court)*

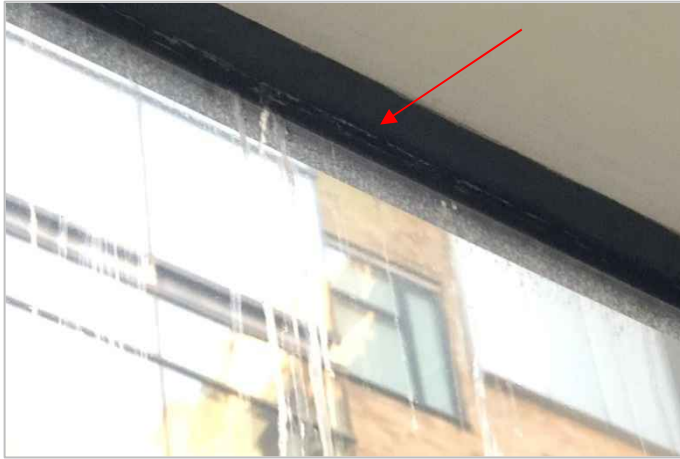
- 6.2.1 Streaks of water stains were found on the inside face of the single glazed pane on various floor levels. A number of these appeared to be through the internal top seal between the glazed pane and the framework.

*Photograph No. 44 – Water streak from under glazing seal (Level 2 – North elevation – Marsden Block)*

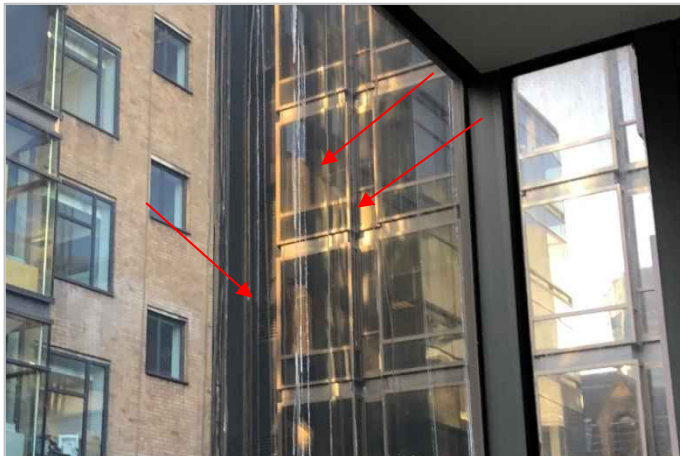
*Photograph No. 45 – Water streak on window unit (Level 2 – North elevation – Marsden Block)*

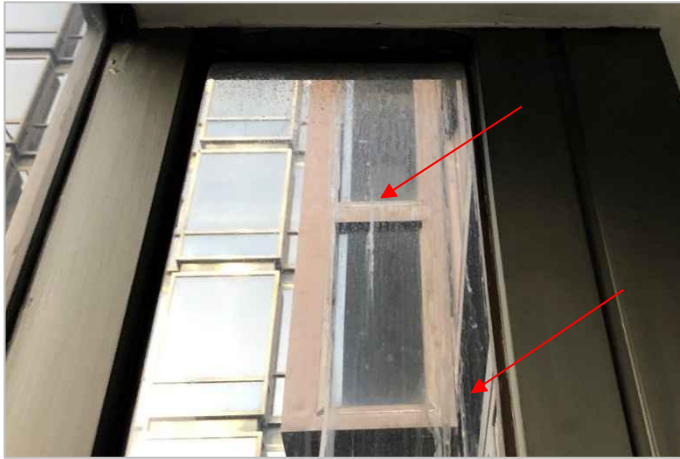
*Photograph No. 46 – Water streaks on glazed pane (Level 2 – North elevation – Marsden Block)*

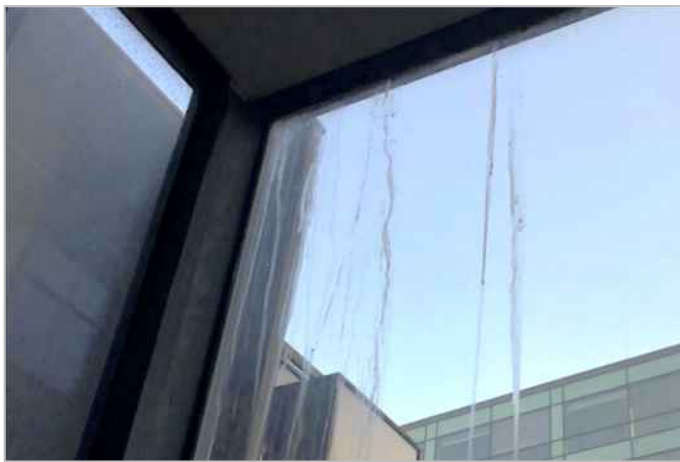
*Photograph No. 47 – A number of water streaks on glazed pane (Level 2 – West elevation – Pall Mall Court)*

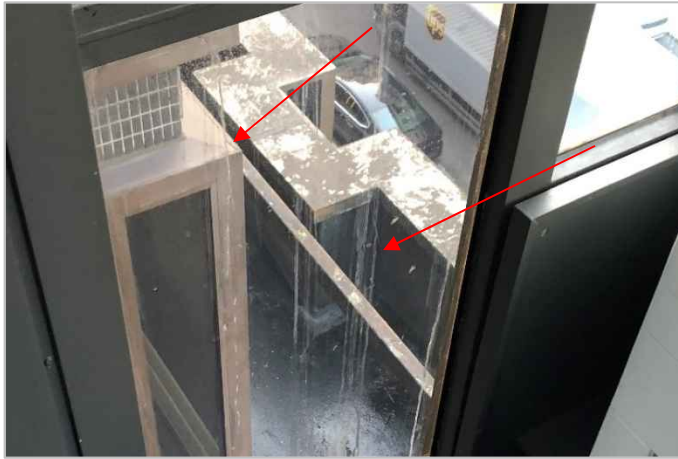
*Photograph No. 48 – Water streaks observed to glazed pane (Level 4 – South elevation – King Street Block)*

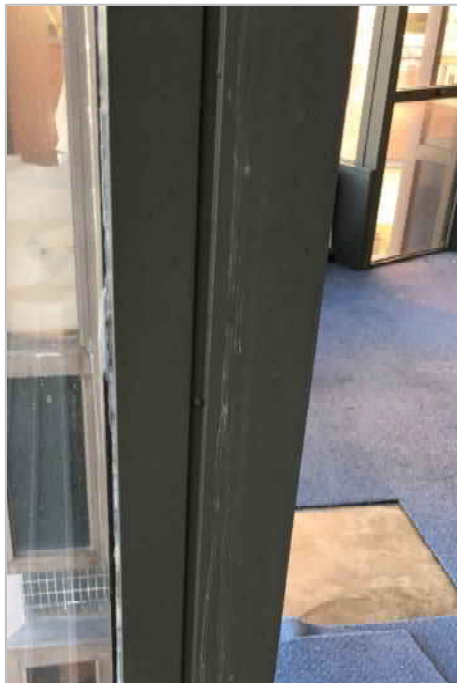
*Photograph No. 49 – Water staining found on the framework (Level 10 – North elevation – Pall Mall Court)*

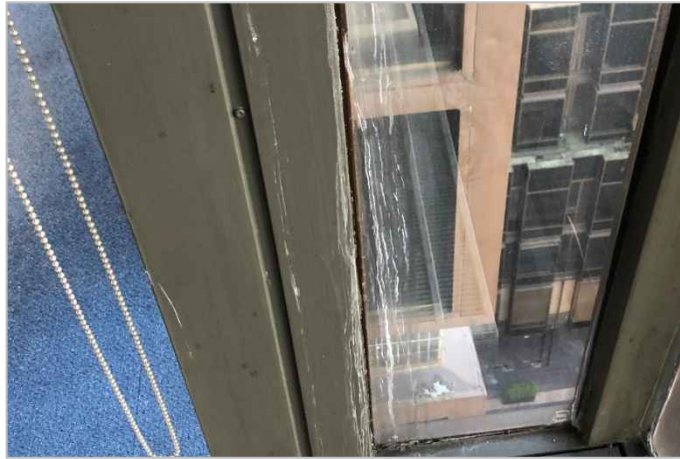
*Photograph No. 50 – Heavy water staining to framework and glazed pane (Level 10 – West elevation – Pall Mall Court)*

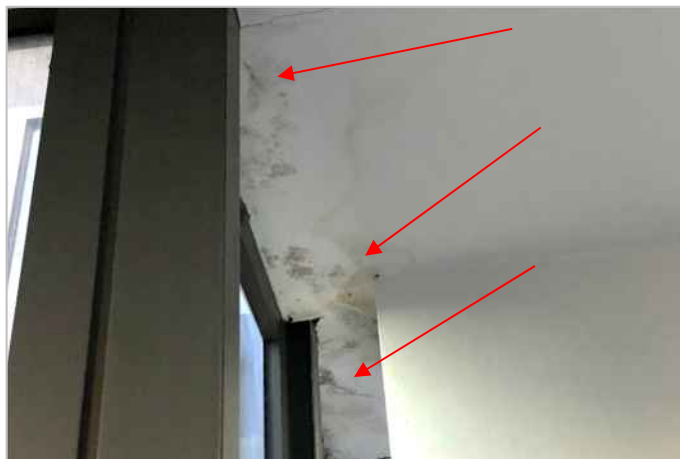
- 6.2.2 Signs of damp were observed to the underside of the ceiling panels. The projected pods are installed floor to ceiling with a glazed infill piece as a spandrel panel in front of the slab. As the floor slab is masked with a single glazed pane with the black coating application to the inside face, it is likely that condensation is forming on the inside face of the glazed pane in front of the slab and over time, pooling onto the ceiling panels, creating stains and mould.

*Photograph No. 51 – Water staining to ceiling (Level 4 – West elevation – Marsden Block)*

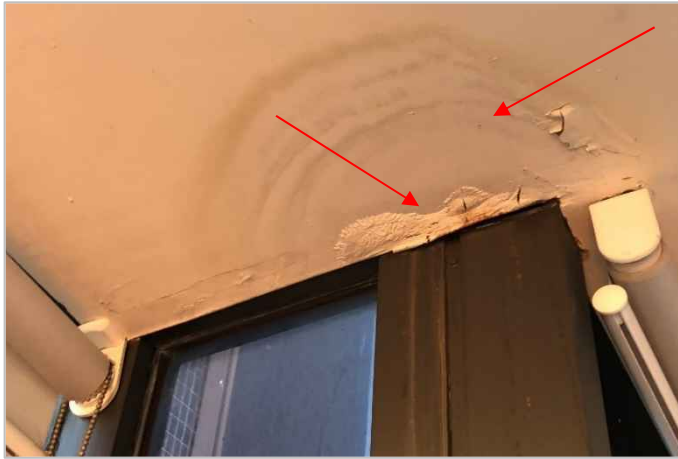
*Photograph No. 52 – Excessive water damage to ceiling (Level 10 – East elevation – Pall Mall Court)*

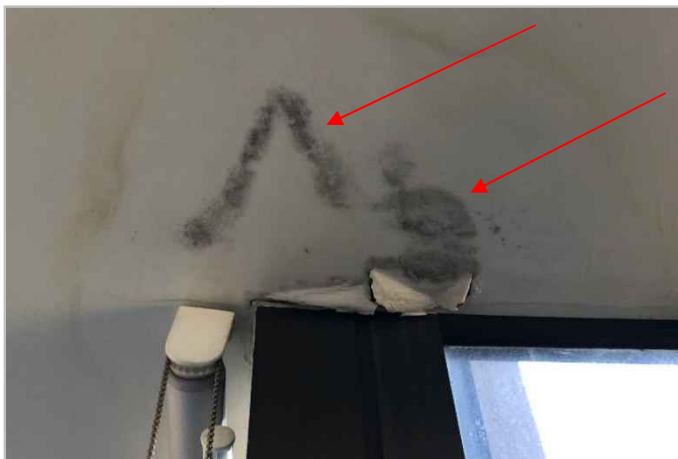
- 6.2.3 Black mould was observed to the ceiling around the glazing system, indicating that the system at the head is no longer watertight as the majority of the staining was observed on Level 10.

*Photograph No. 53 – Black mould observed to ceiling around glazing system (Level 10 – West elevation – Pall Mall Court)*
