# Preliminary Roost Assessment

3 Meadow Bank  
Chorltonville  
Manchester  
M21 8EF

# Gritstone Ecology

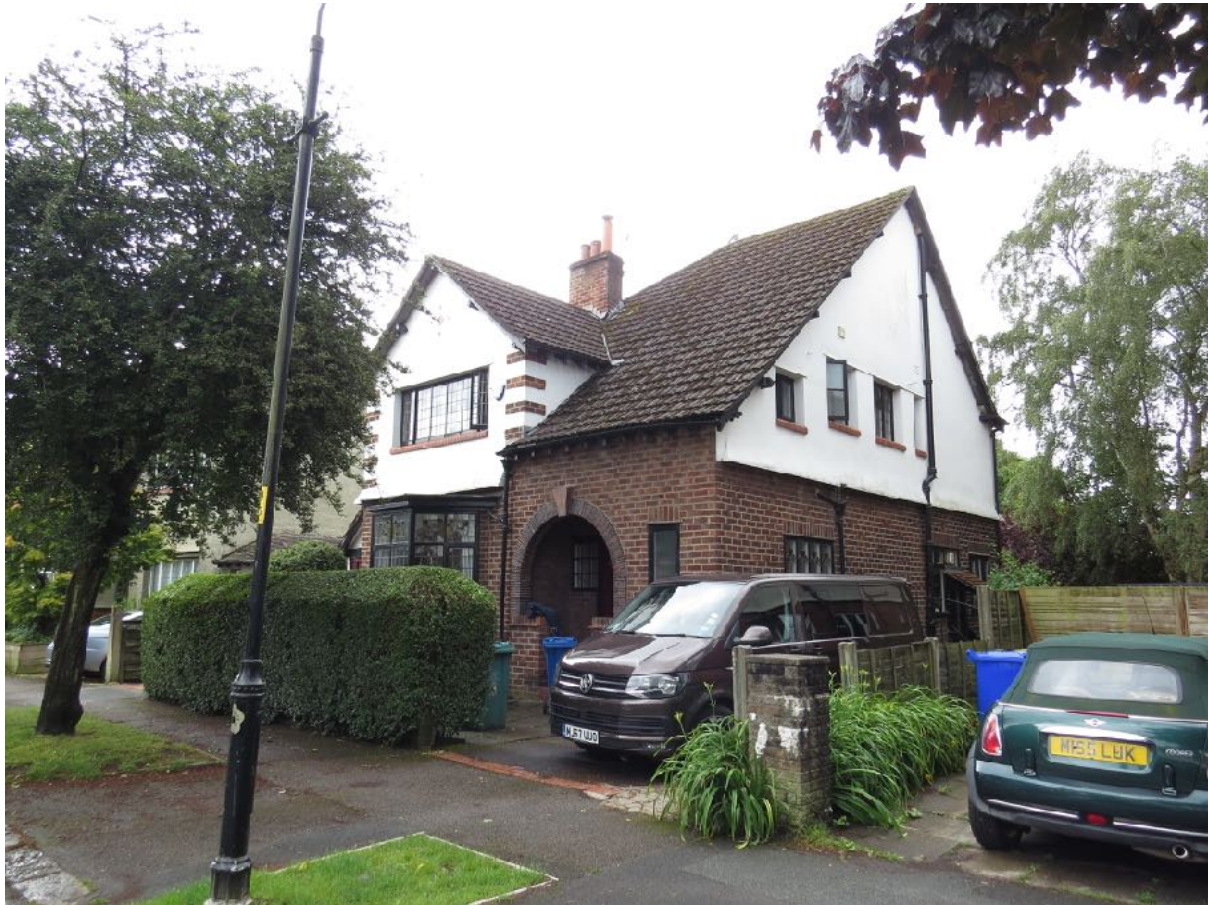
3.1a – The front of the house.

The building is well maintained, and in good condition. Ridge tiles are fixed tightly, there are no damaged or missing ridge tiles. There are no damaged, slipped, or missing roof tiles. Roof tiles are tightly fitted, with no gaps between tiles. Cement beneath tiles is intact with no viable gaps. Fascia boards are fitted tightly with no viable gaps between boards and brickwork. Walls are in good condition, with no missing mortar or cracks.

There are no features externally which are likely be used by roosting bats, and no indications of use by bats were present during the inspection.

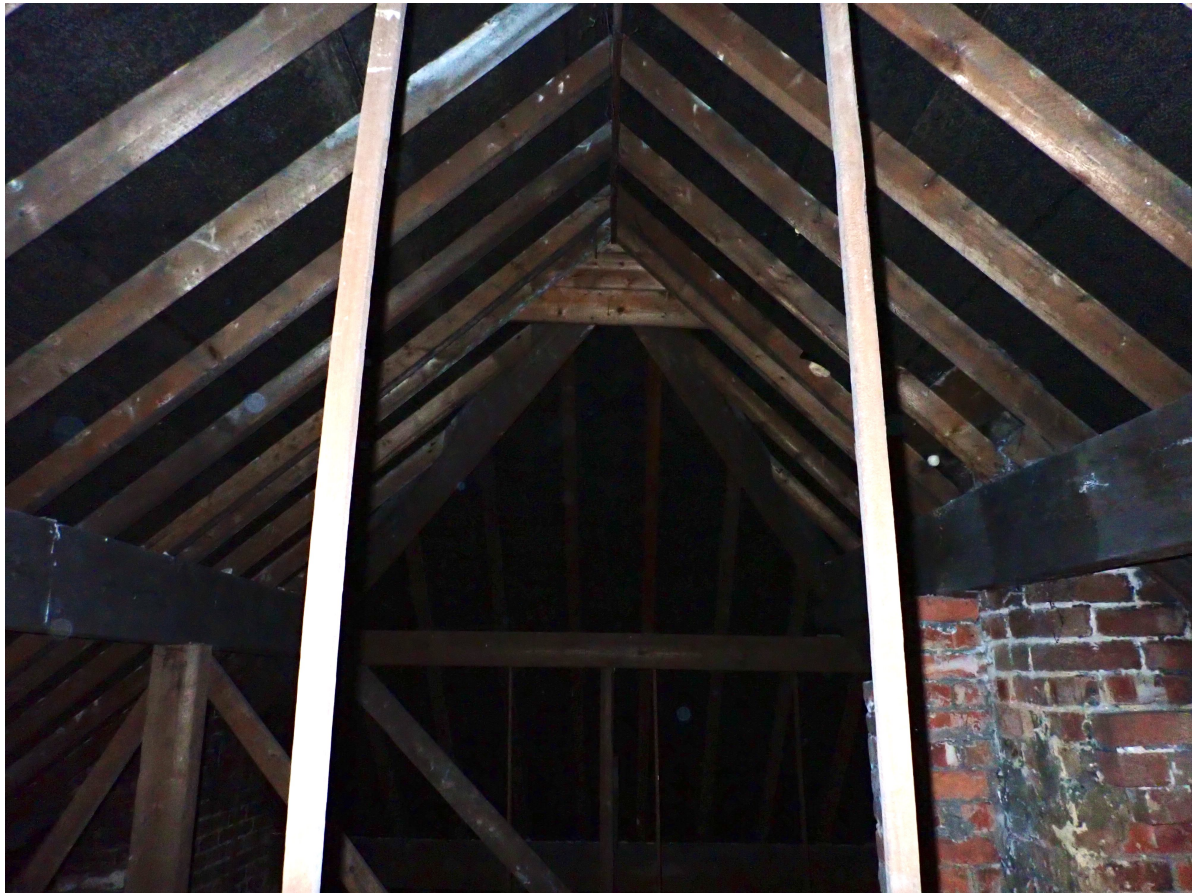
3.2a – The roof void.

The roof has a wooden rafter and purlin structure, lined with bitumen felt, and insulated between ceiling joists with mineral wool. Roof lining is intact with no tears. Roof timbers are covered with dusty cobwebs at the joints.

The eaves and gables were inspected at the wall plate using an endoscope. There are no gaps at the eaves or gables; and there are no gaps which give direct access to the roof void from the outside.

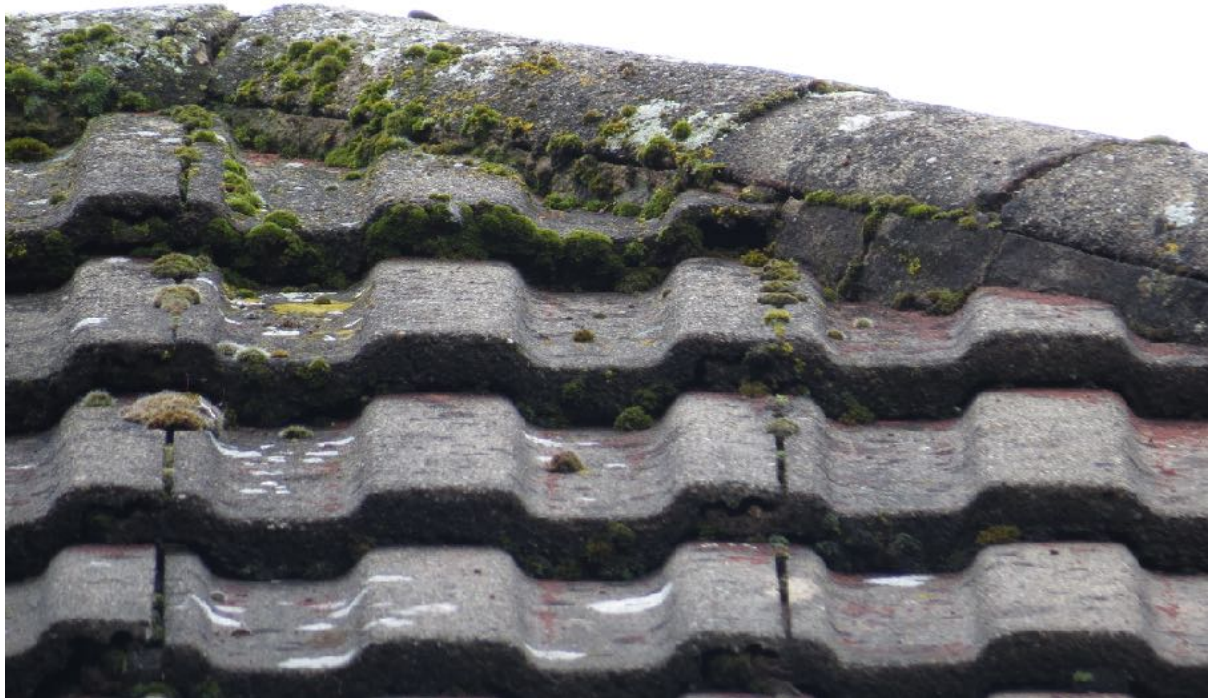
Roof and ridge tiles are in good condition, and ridge tiles are sealed with cement. There are no gaps between roofing materials which could be used by roosting bats.

3– Roof and ridge tiles are in good condition with no suitable gaps.

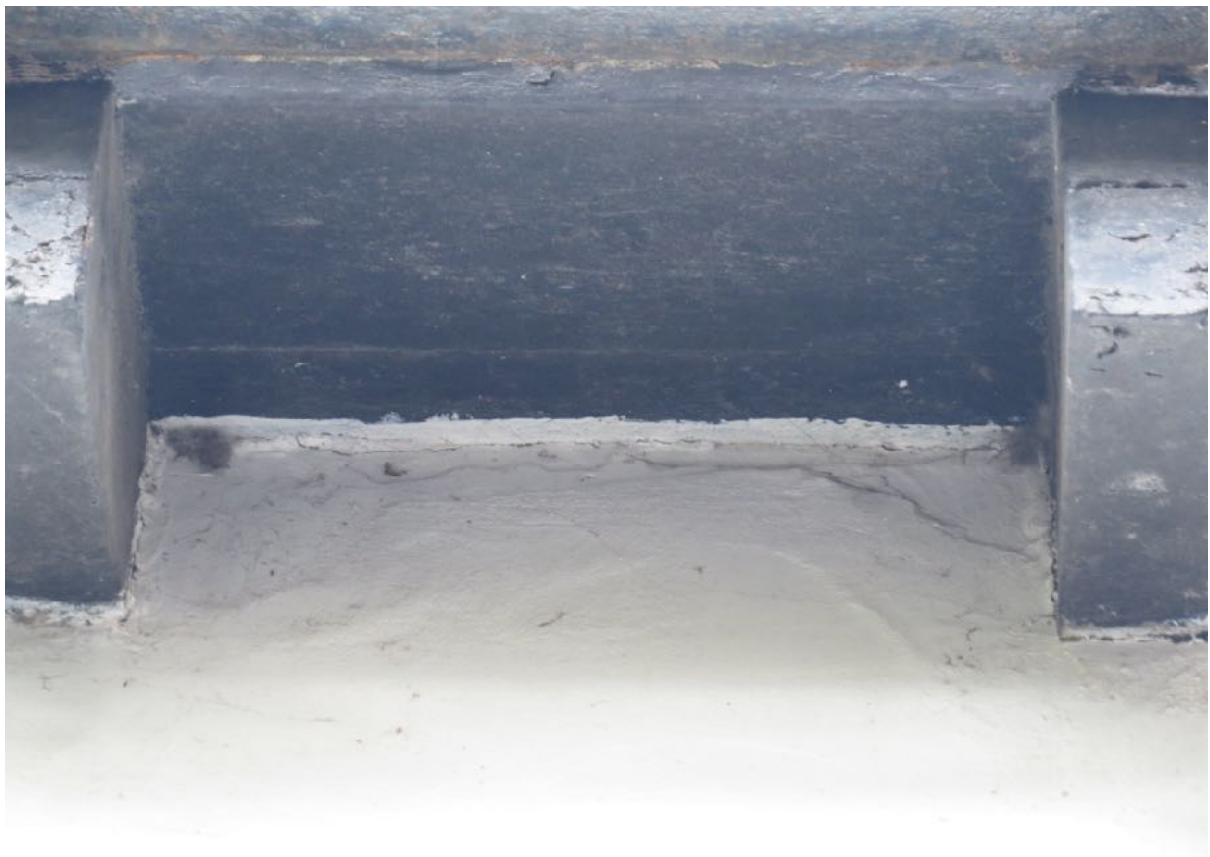
4 – Boards and protruding timbers at the eaves are sealed against brickwork and render.

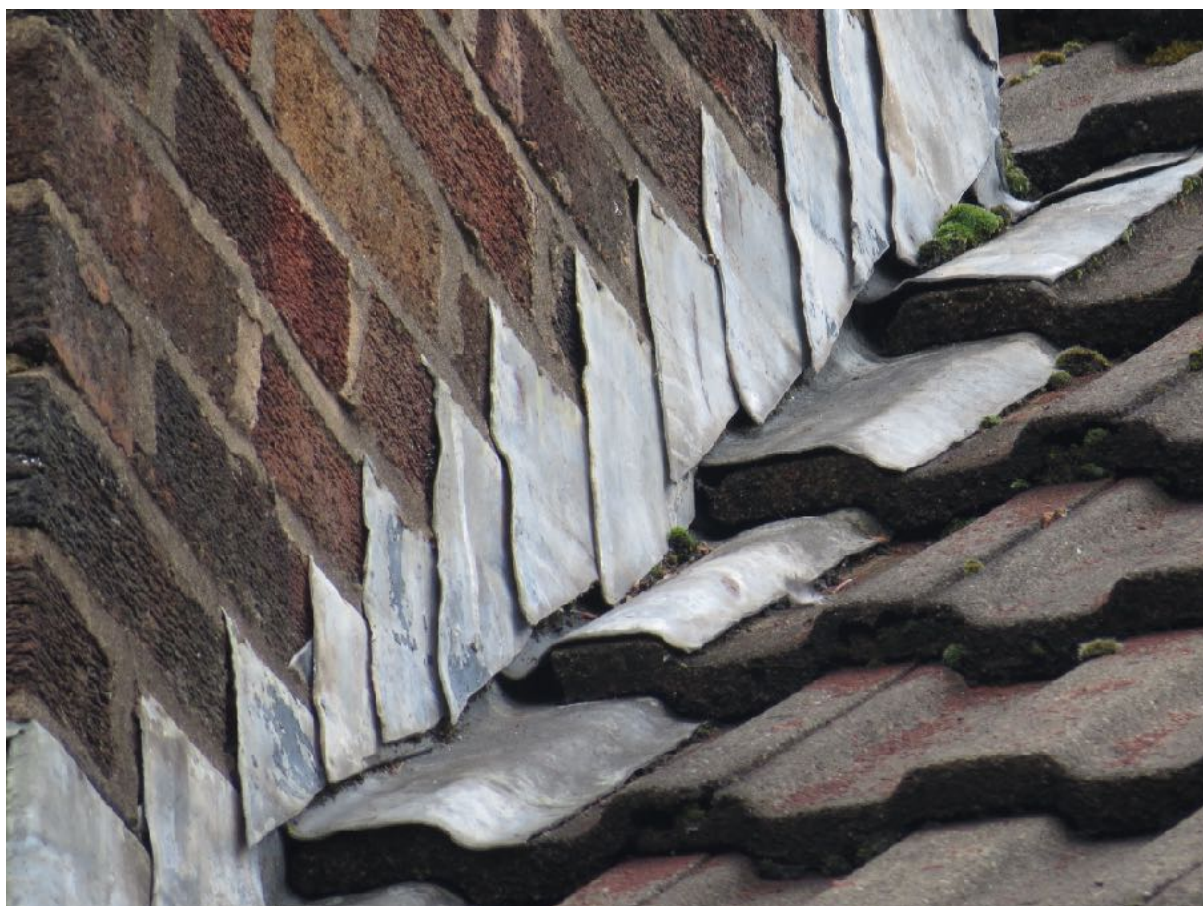
Leadwork is in good condition, and is fixed tightly against brickwork and tiles, with no suitable gaps. End tiles in the roof valleys are filled with cement, with no gaps between tiles and leadwork.

5 – Lead flashing is fitted tightly with no suitable gaps.

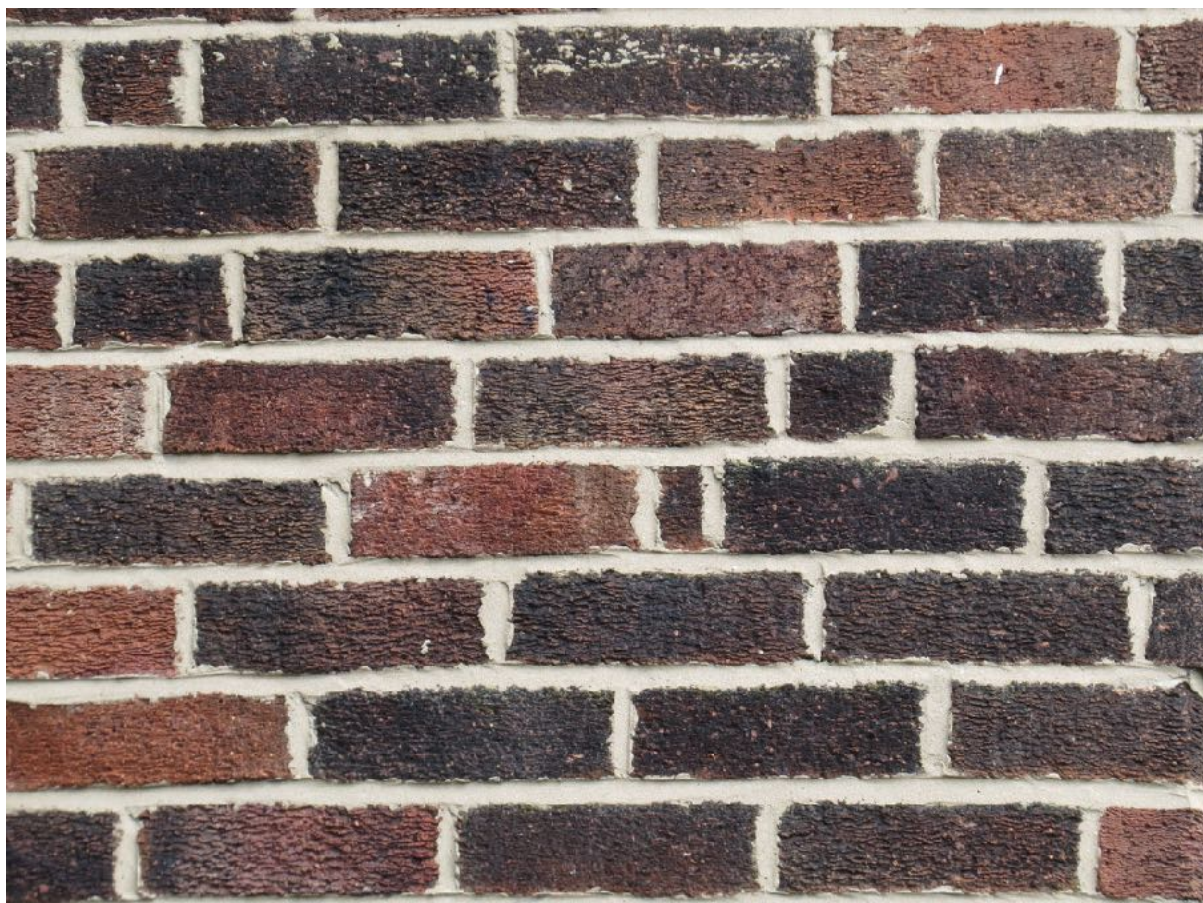
The walls are solid brick with no insulating cavity. Walls are in good condition, with no cracks, or missing mortar which could be used by crevice dwelling bats.

6 – Brickwork and mortar are in good condition with no suitable gaps.

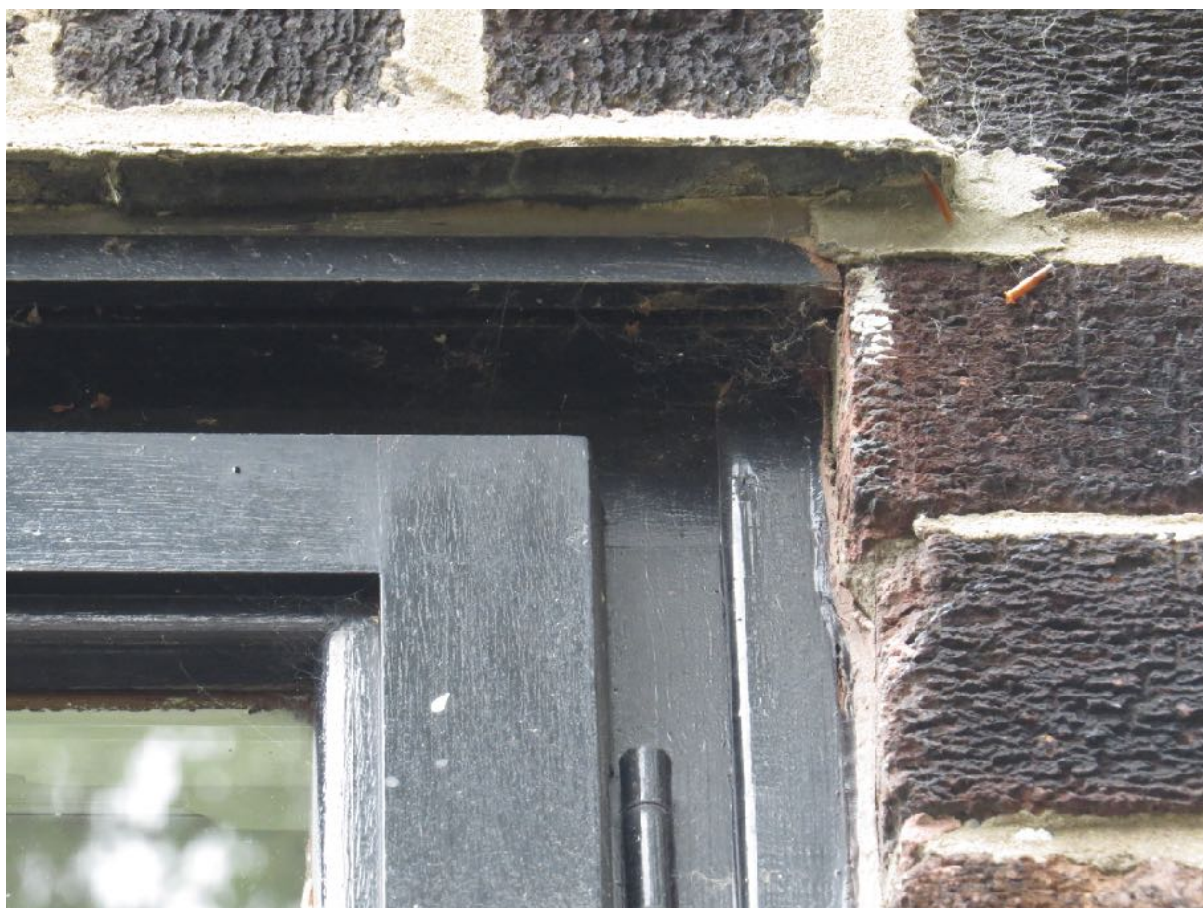
Window and door frames are fixed into the brickwork, gaps are filled with sealant, and offer no suitable roosting opportunities.

7 – Window and door frames are tightly sealed into brickwork with no suitable gaps.

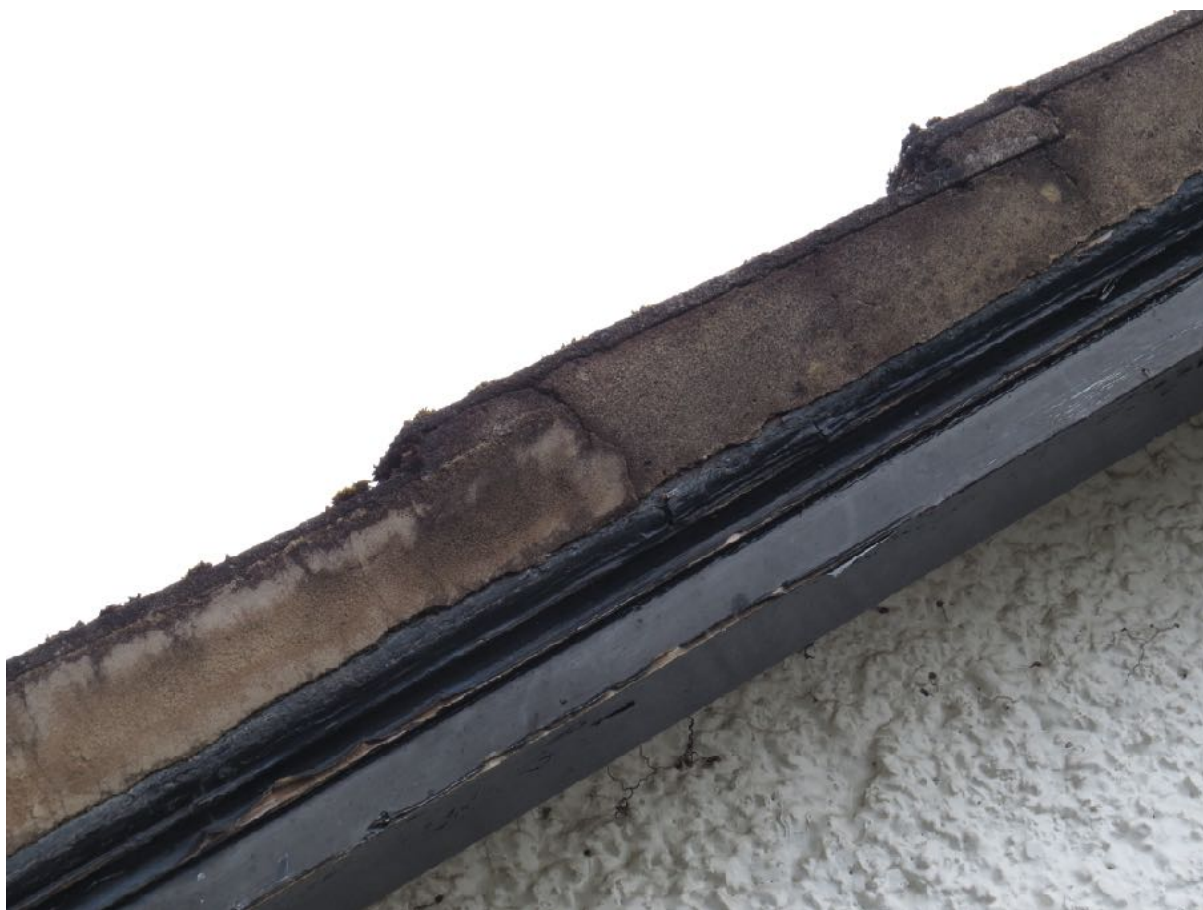
8 – Cement at the verges is in good condition with no suitable gaps.

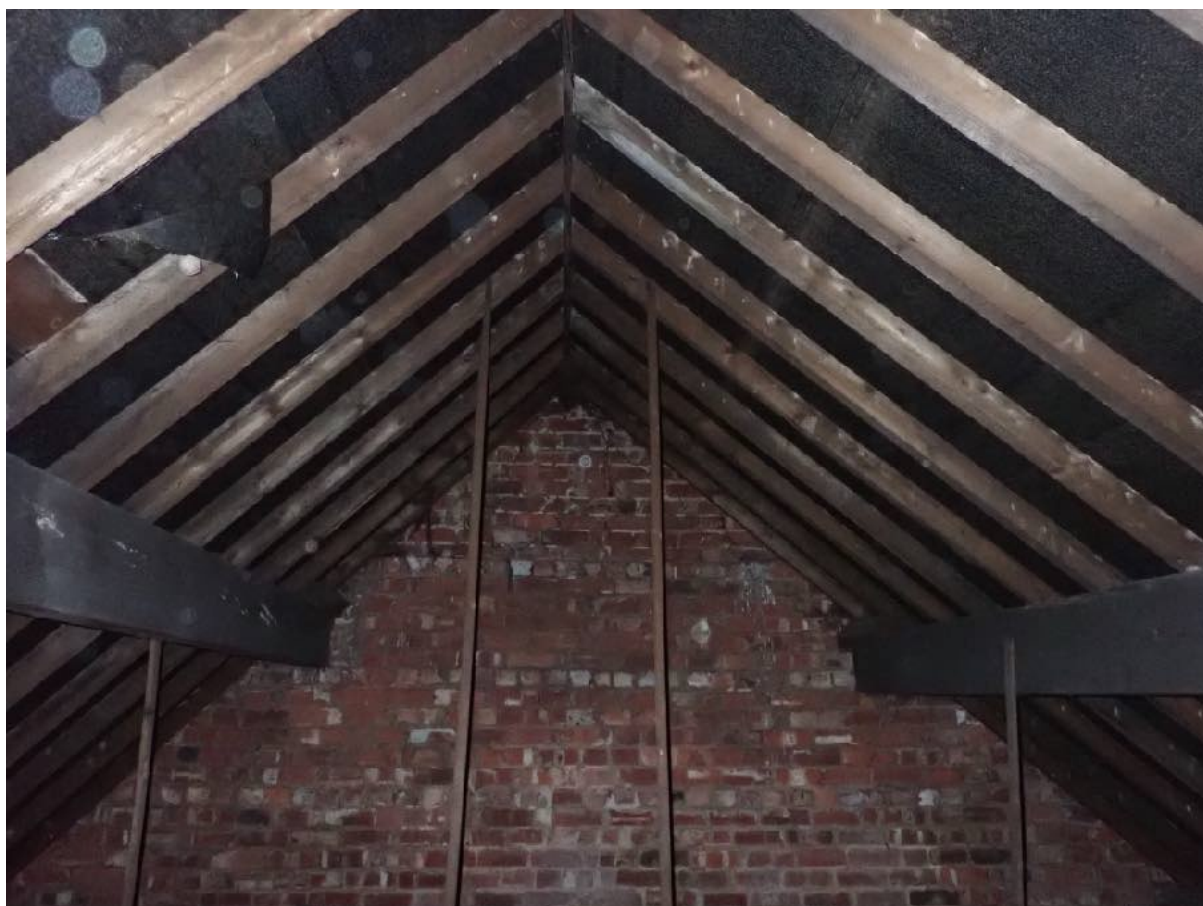
9 – The house has a single roof void which is not used for storage.

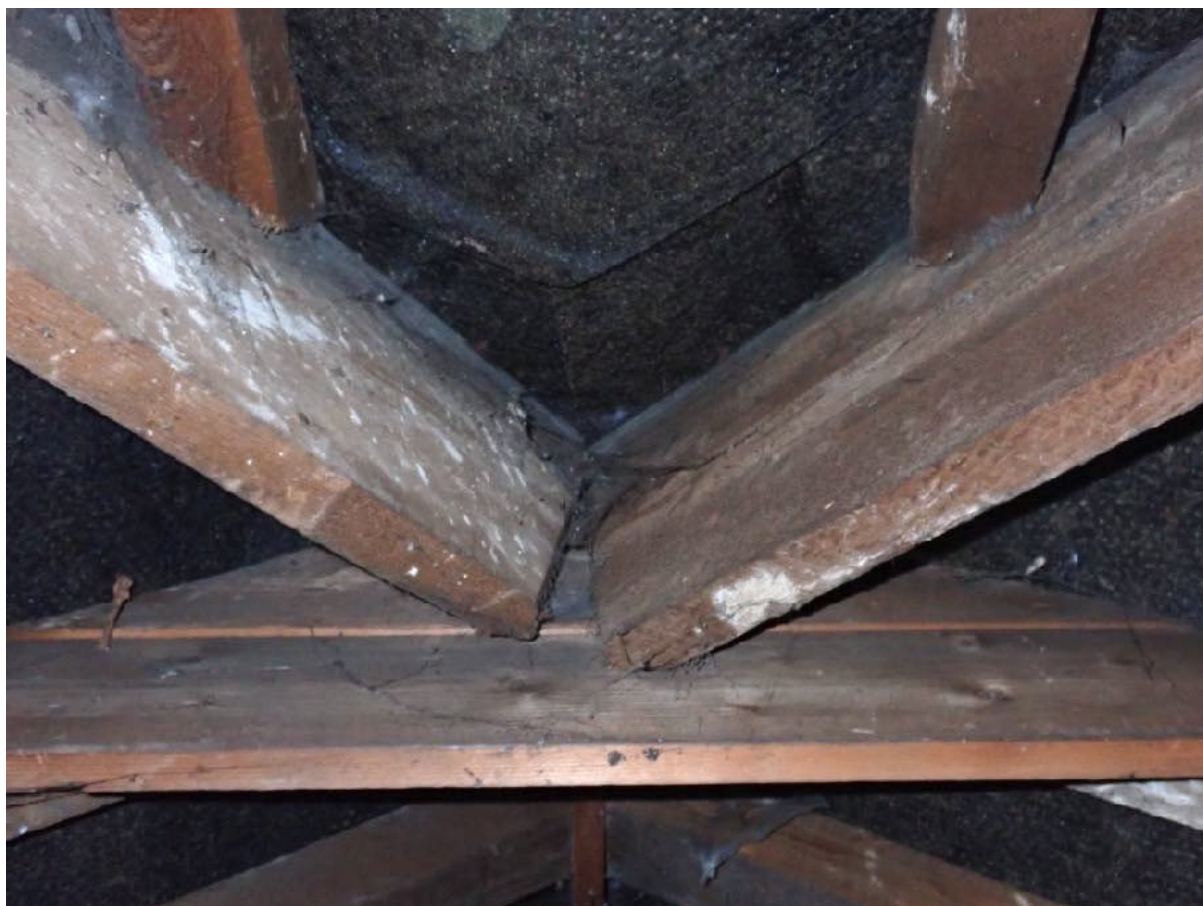
10 – The roof is lined with bitumen felt, joints in timbers are filled with dusty cobwebs.
