## GAS MEMBRANE VALIDATION

| <b>Site: Bowes Street</b> | |
| Date: 06-10-2020 | Project Number: 11-813 |
| Ground Gas Risk Assessment: <b>Characteristic Situation 2 / Amber 1</b> | |

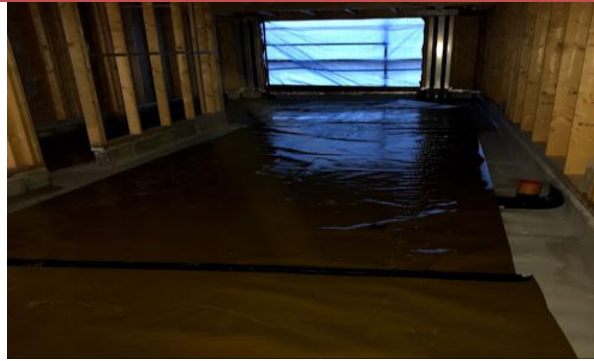
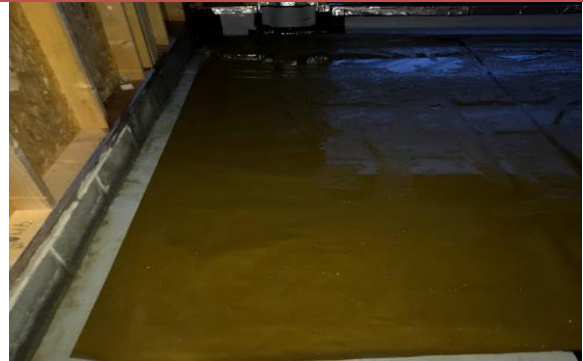
**Plot – 21**

**General Condition of Membrane-Good Condition**

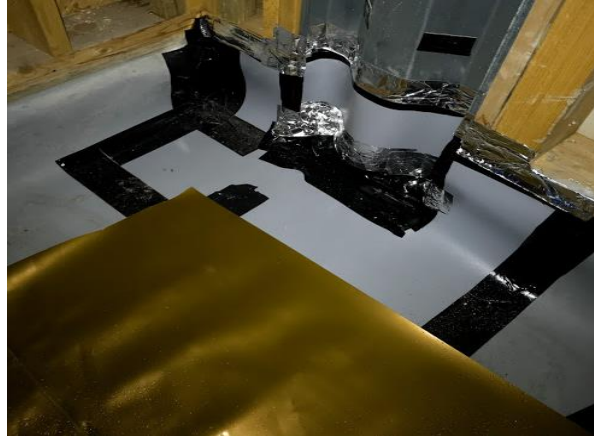
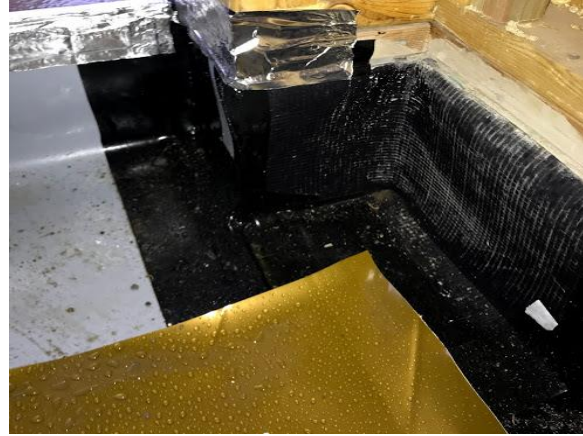
**Verification of Joints and Seals-Good Condition**

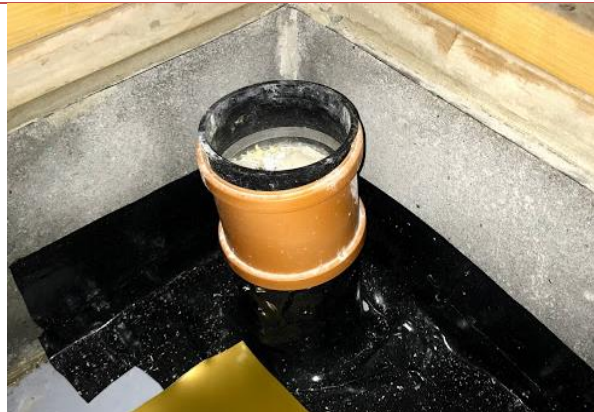
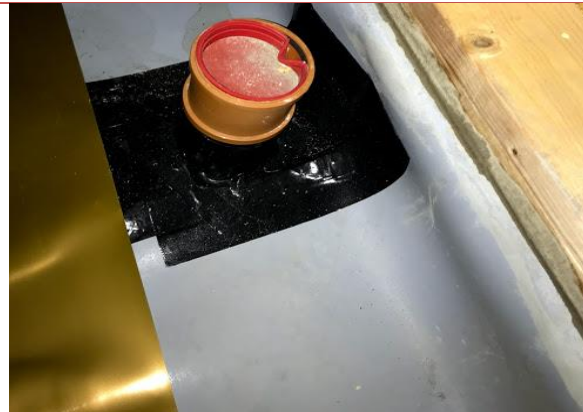
**Verification of Service Penetrations-Good Condition**

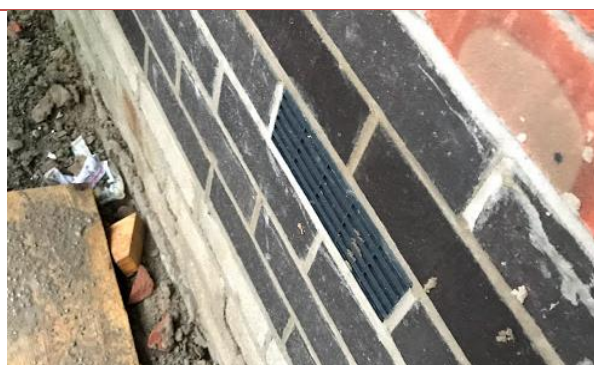
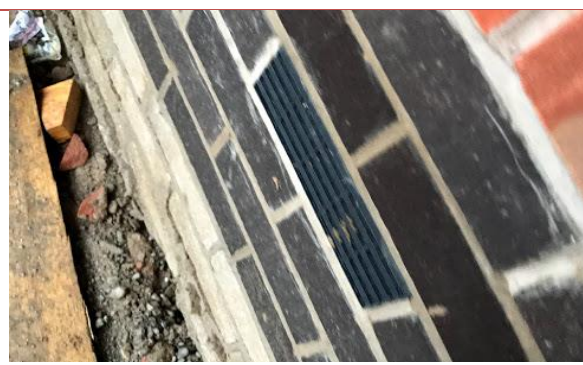
**Verification of Ventilation- Good Condition**

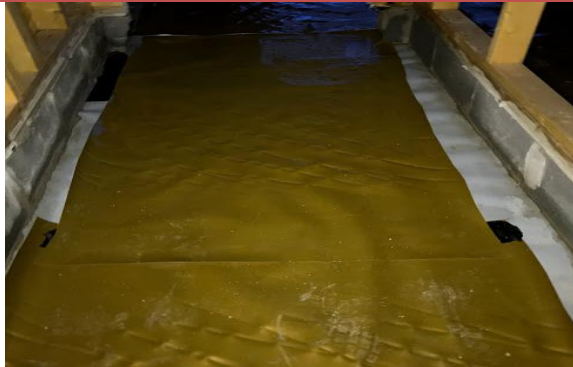
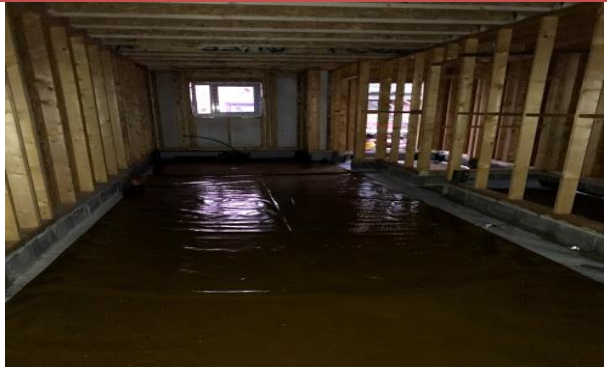
**Plot - 22**

**General Condition of Membrane-Good Condition**

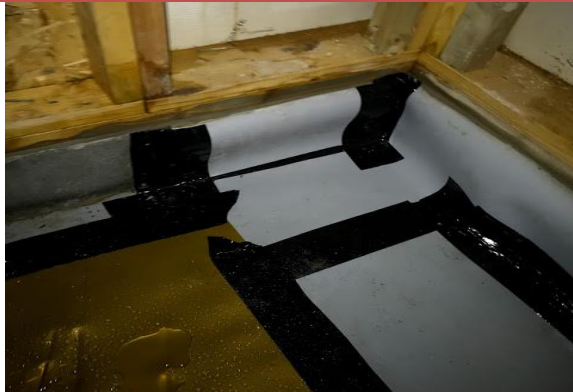
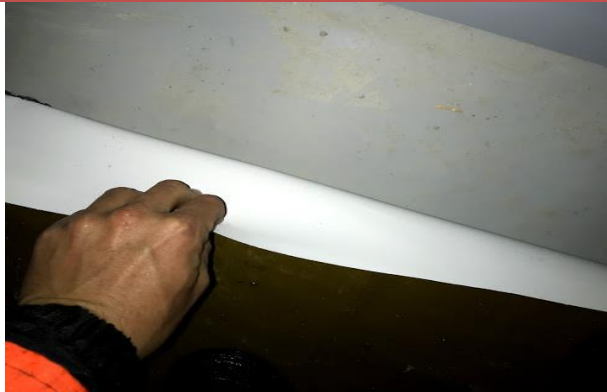
**Verification of Joints and Seals-Good Condition**

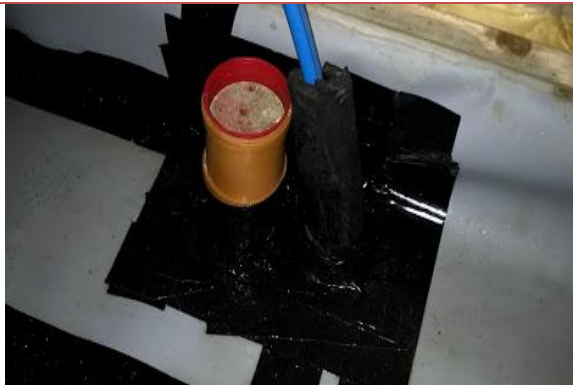
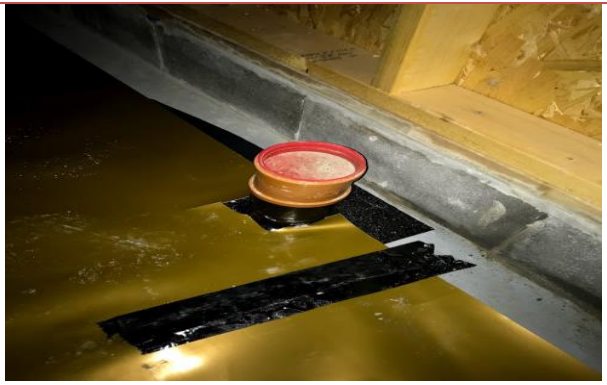
**Verification of Service Penetrations-Good Condition**

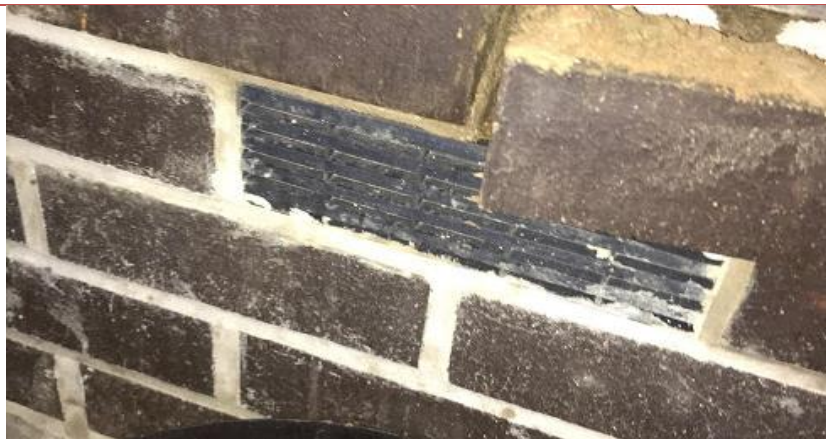
**Verification of ventilation-Good Condition**

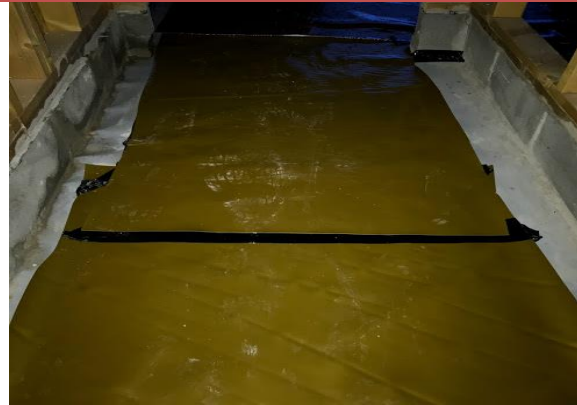
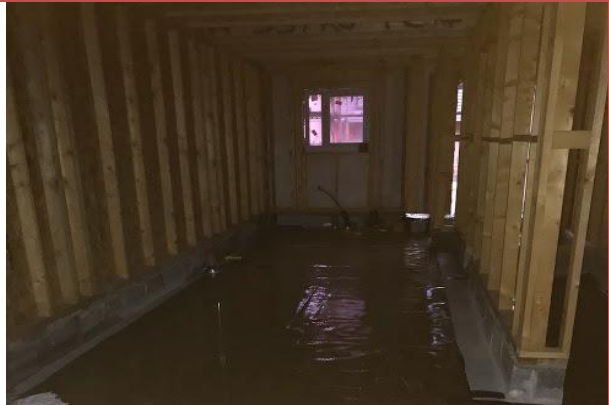
**Plot -23**

**General Condition of Membrane-Good Condition**

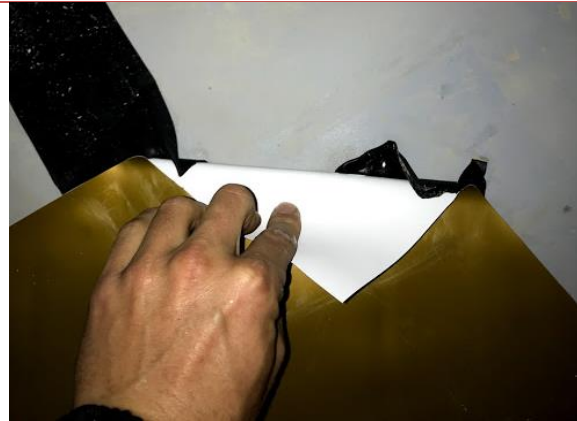
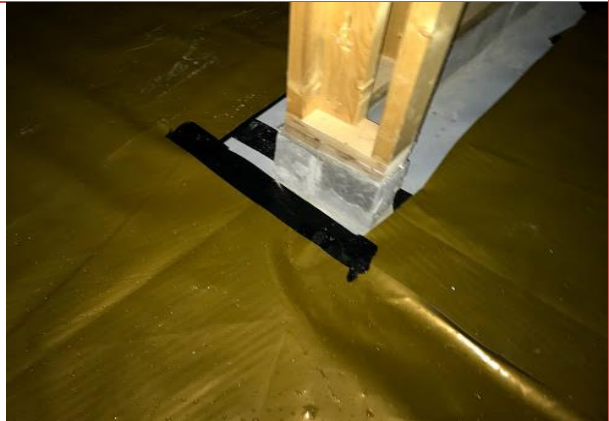
**Verification of Joints and Seals-Good Condition**

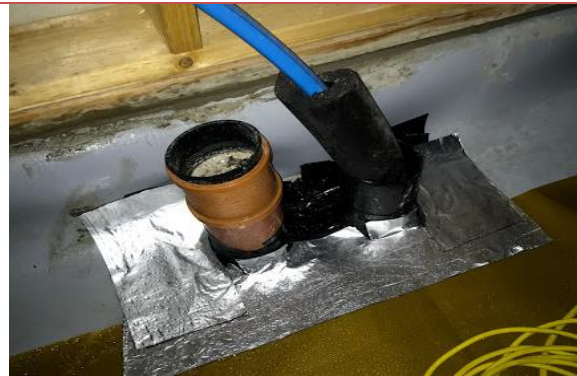
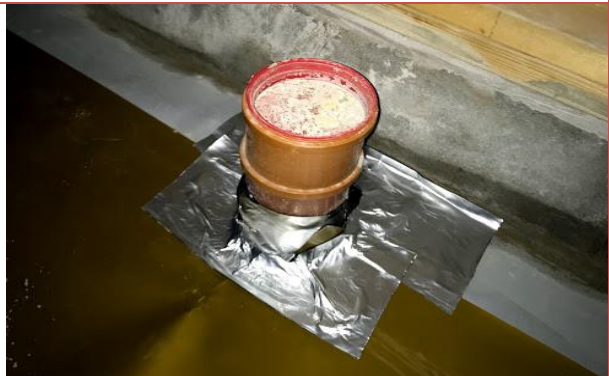
**Verification of Service Penetrations-Good Condition**

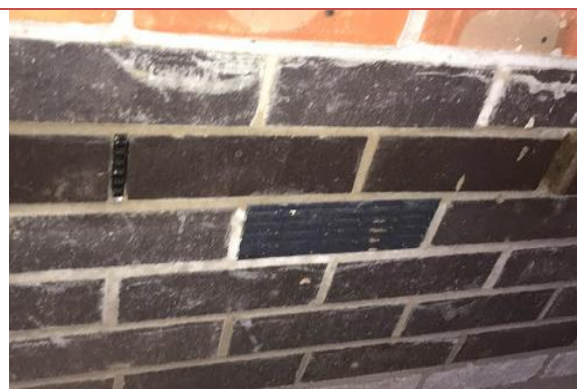
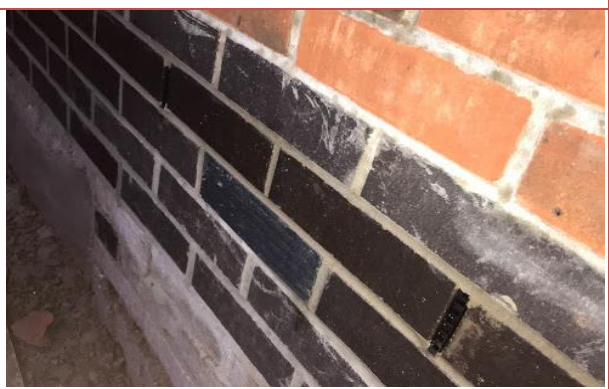
**Verification of ventilation-Good Condition**

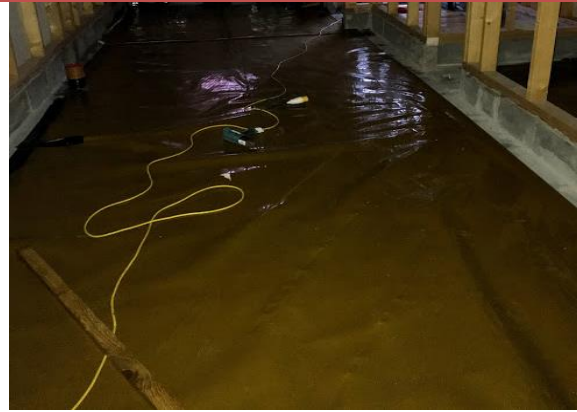
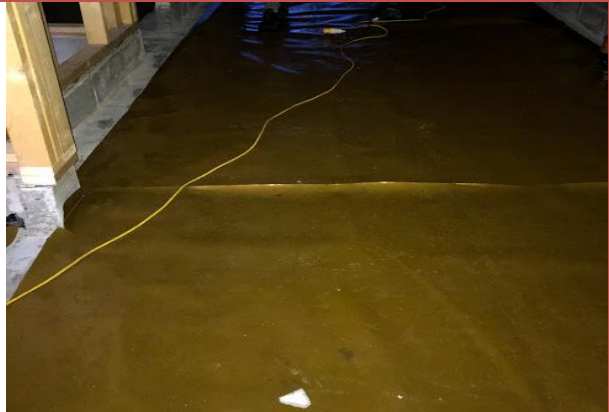
**Plot - 24**

**General Condition of Membrane-Good Condition**

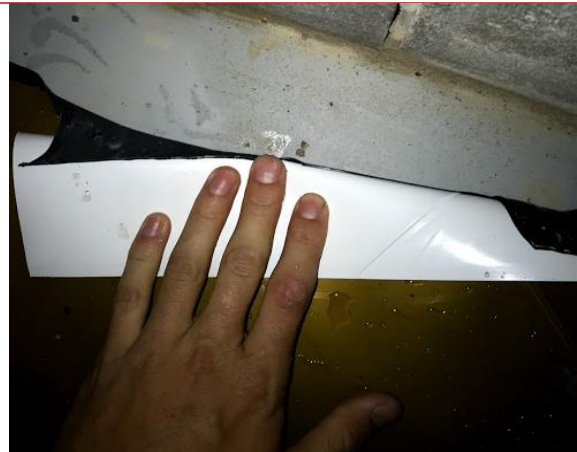
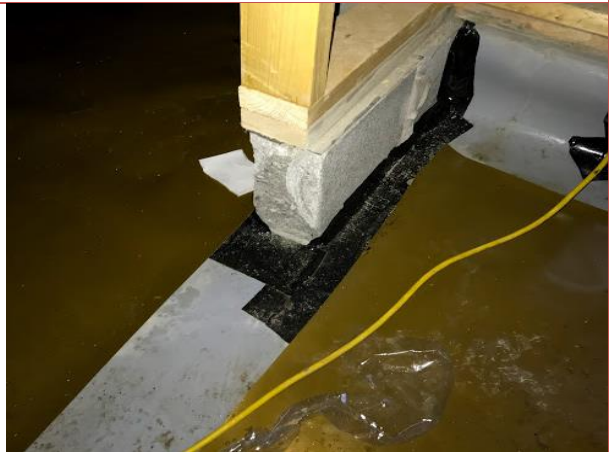
**Verification of Joints and Seals-Good Condition**

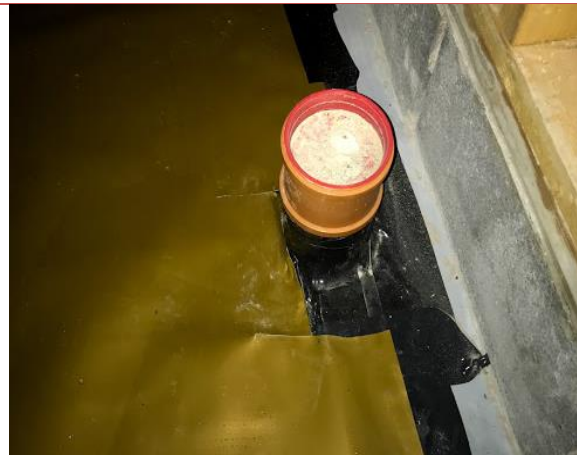
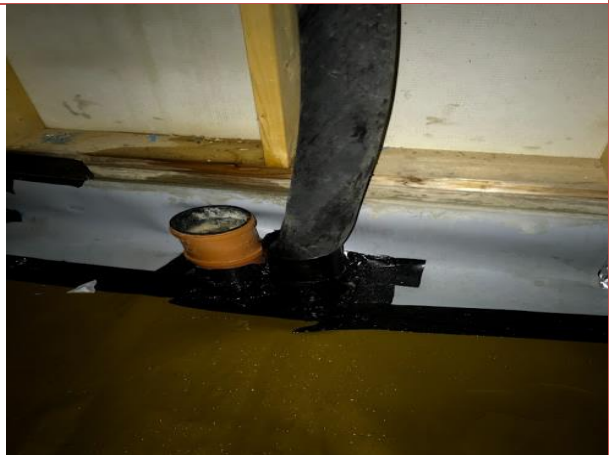
**Verification of Service Penetrations-Good Condition**
