## VALIDATION COMPLETION REPORT

Former Withington Hospital  
Cavendish Road  
Manchester  
M20 1LB

Prepared for:  
Bellway Homes Manchester

**Report Ref: 10-933-R4-1**  
**Date Issued: 30/07/2020**

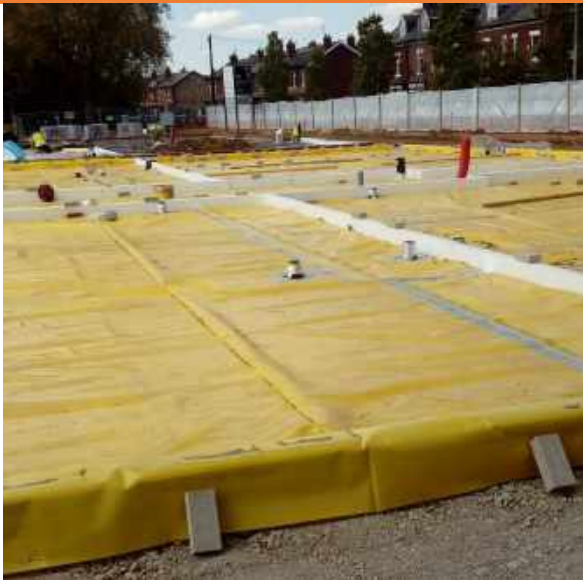
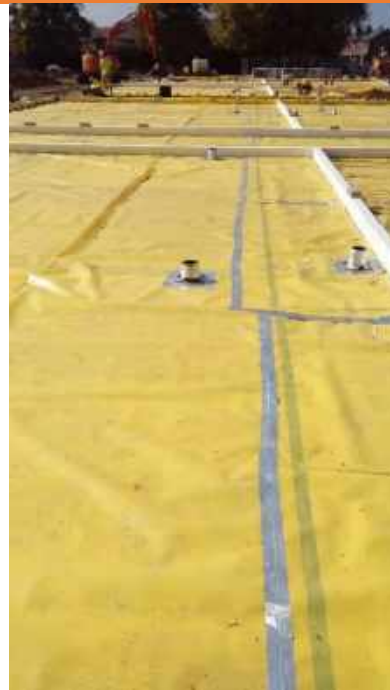
## Apartment Plots 1-24

### General Condition of Membrane-Good Condition

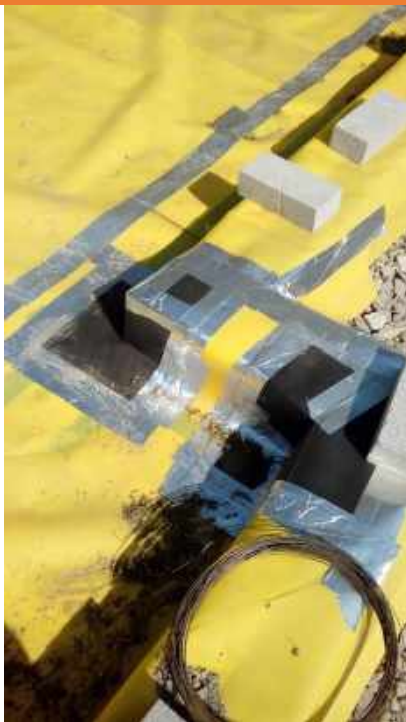
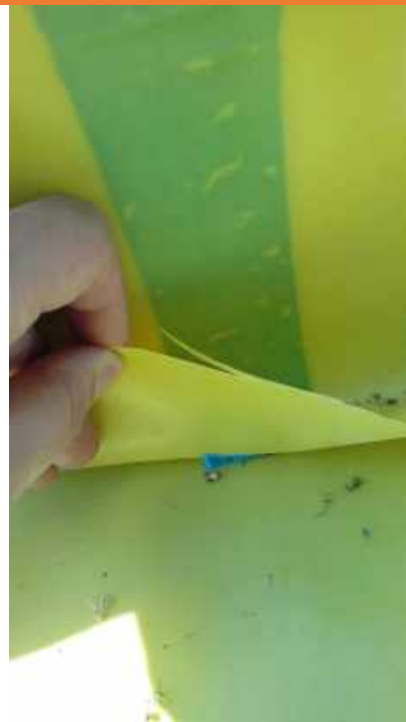
### Verification of Joints and Seals-Good Condition

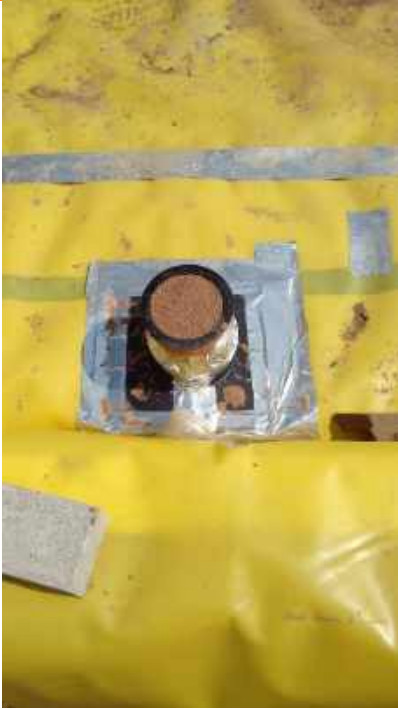
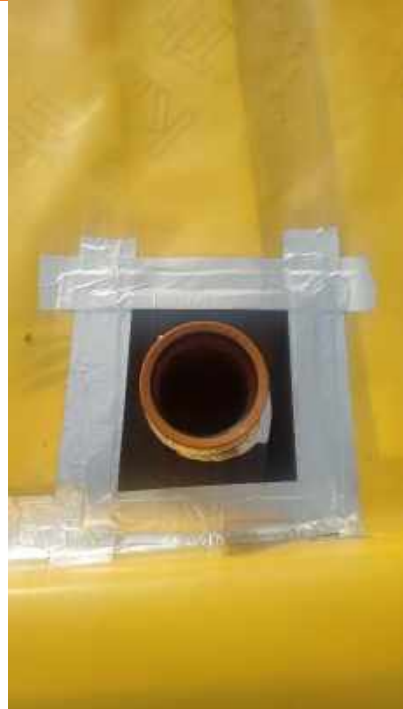
### Verification of Service Penetrations-Good Condition

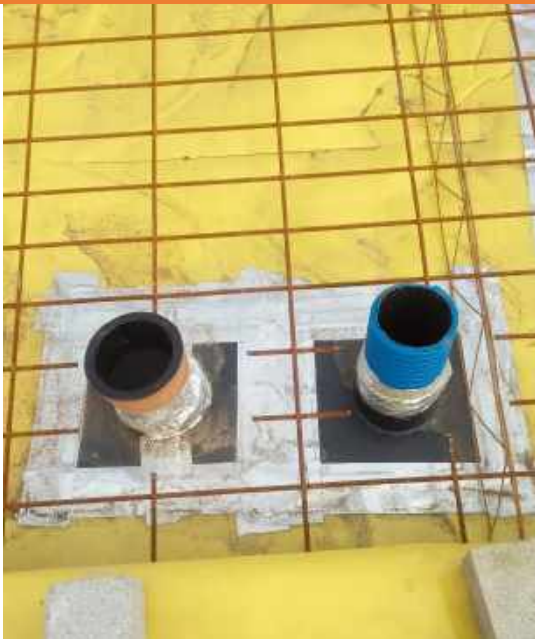
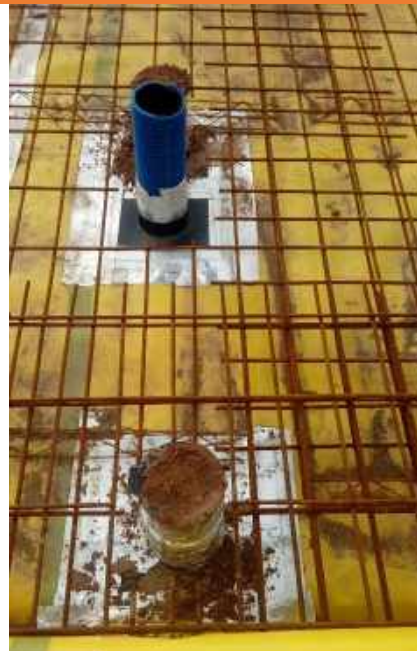
**Verification of Service Penetrations-Good Condition**

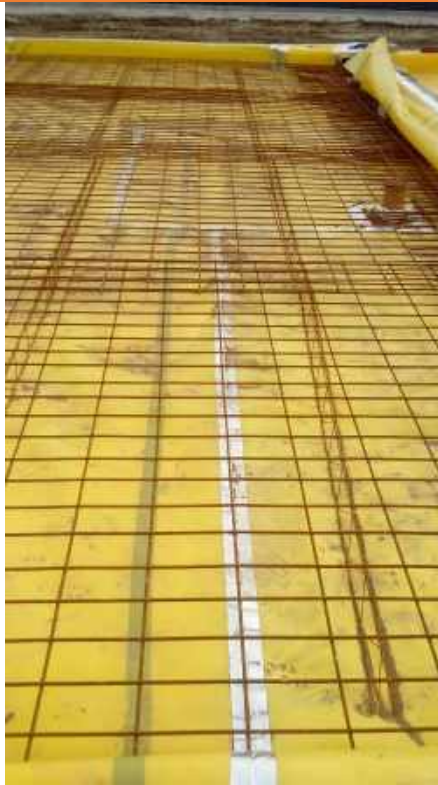
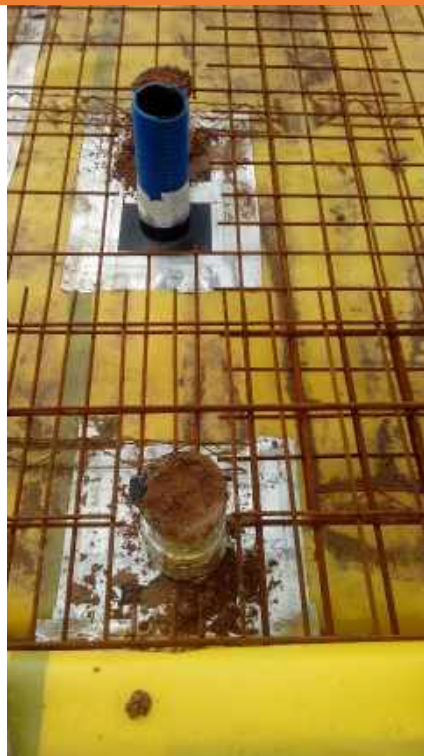
**Plots – 31 & 32**

**General Condition of Membrane-Good Condition**

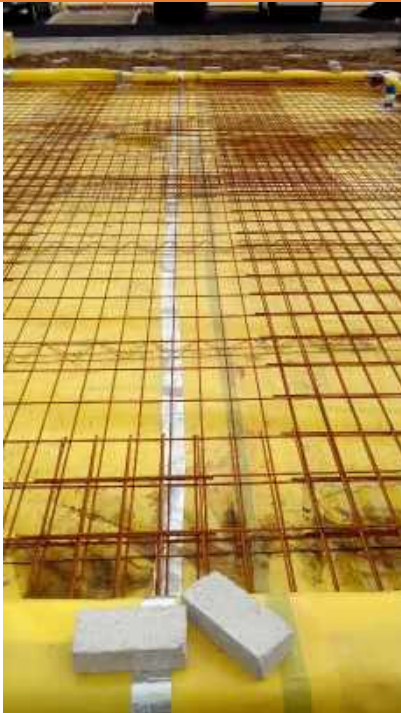
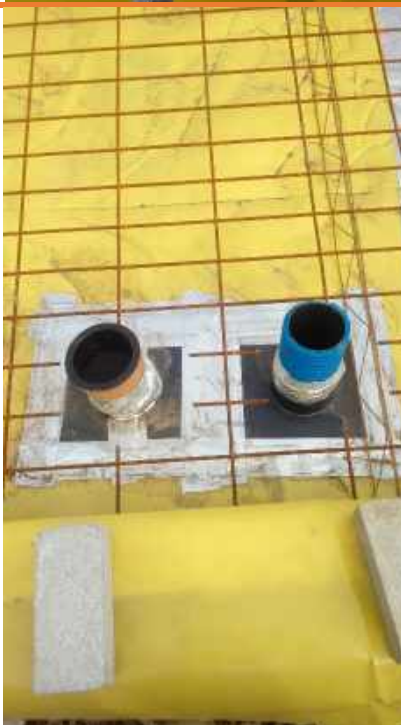
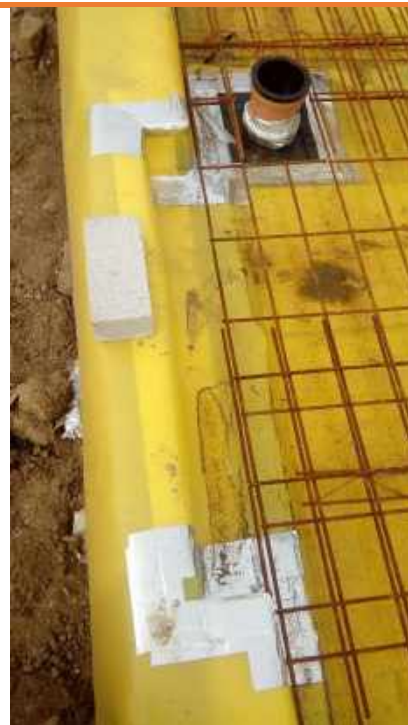
**Plot – 33**

**General Condition of Membrane-Good Condition**

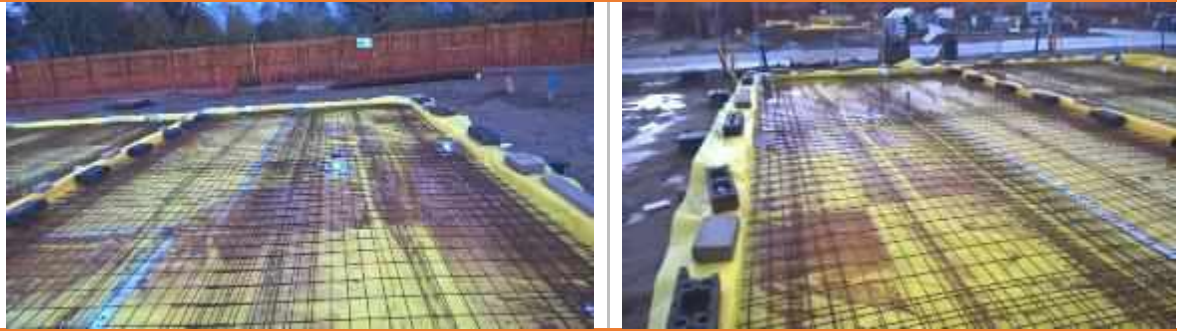
**Plot - 42**

**General Condition of Membrane-Good Condition**

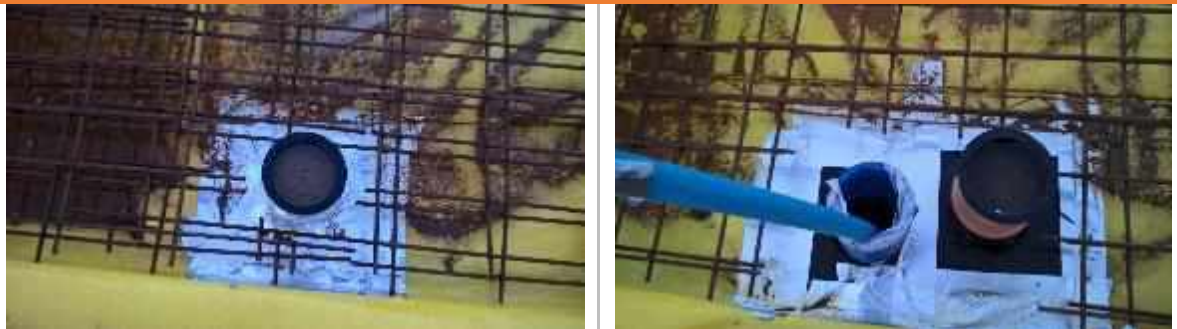
**Verification of Service Penetrations-Good Condition**

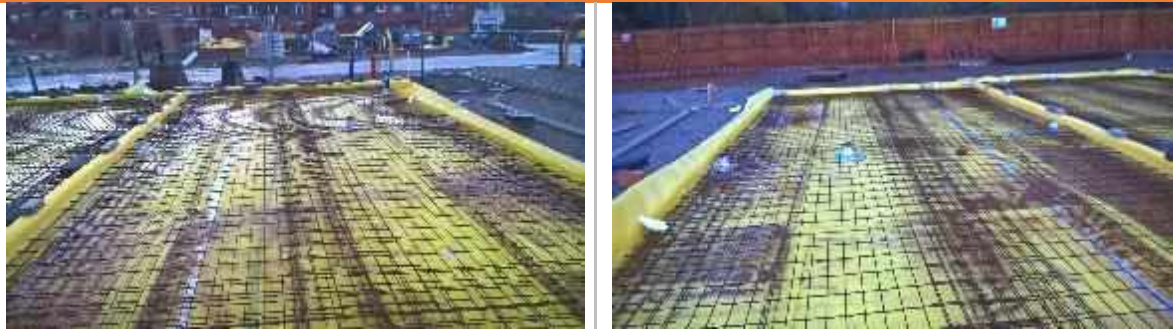
**Plot - 43**

**General Condition of Membrane-Good Condition**

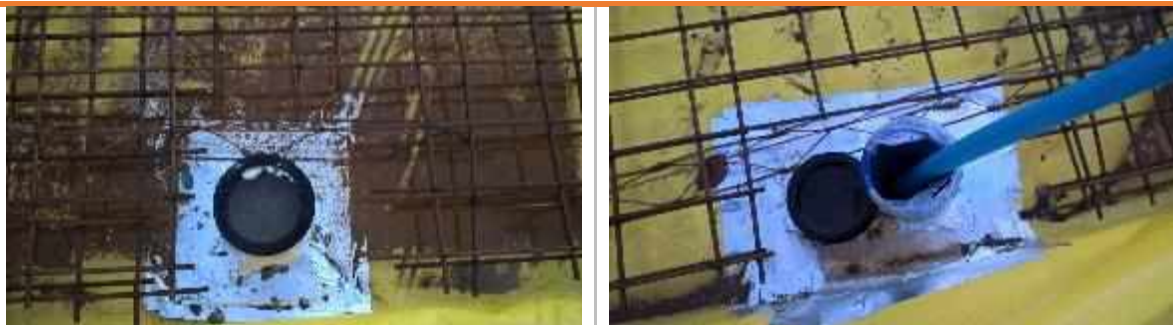
**Verification of Service Penetrations-Good Condition**

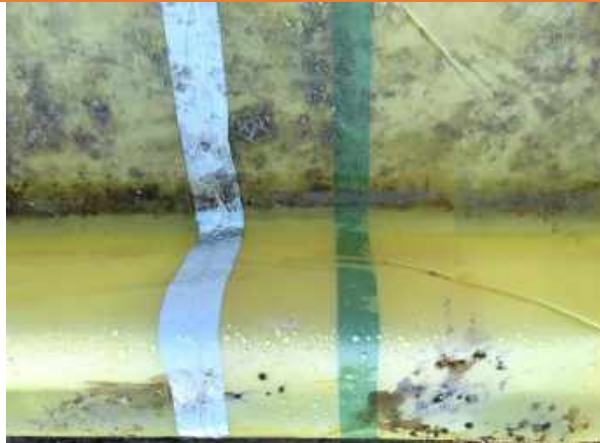
**Verification of Joints and Seals-Good Condition**

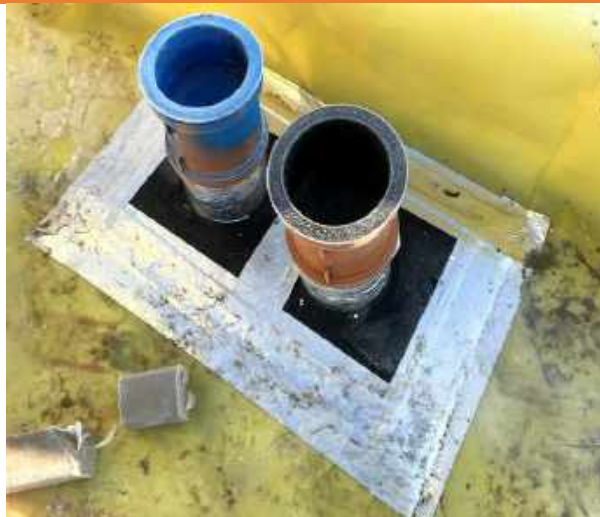
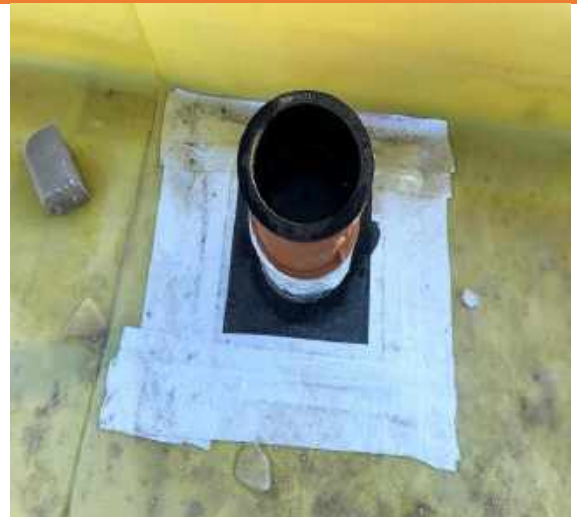
**Verification of Service Penetrations- Good Condition**

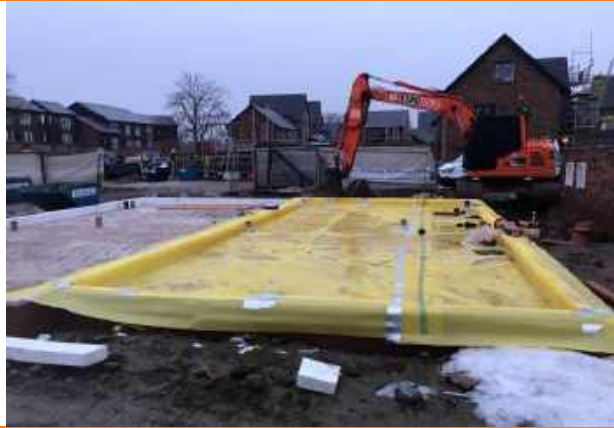
**Plot 53**

**General Condition of Membrane-Good Condition**

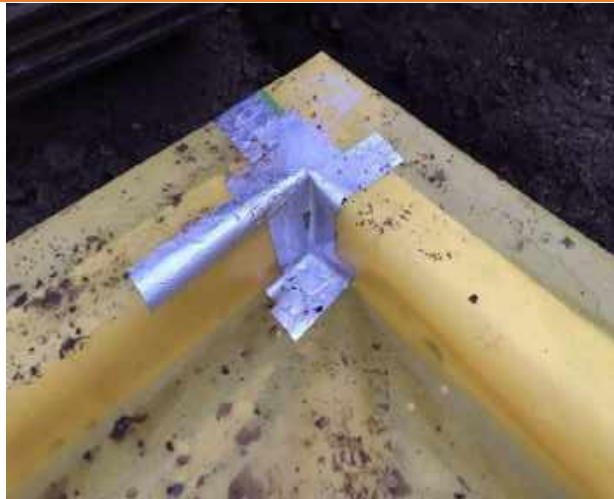
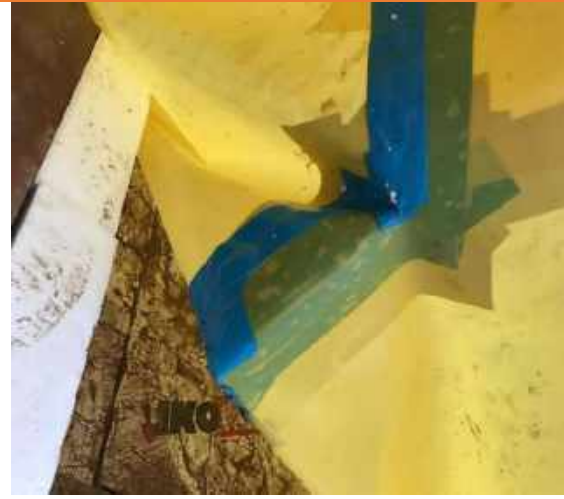
**Verification of Joints and Seals-Good Condition**

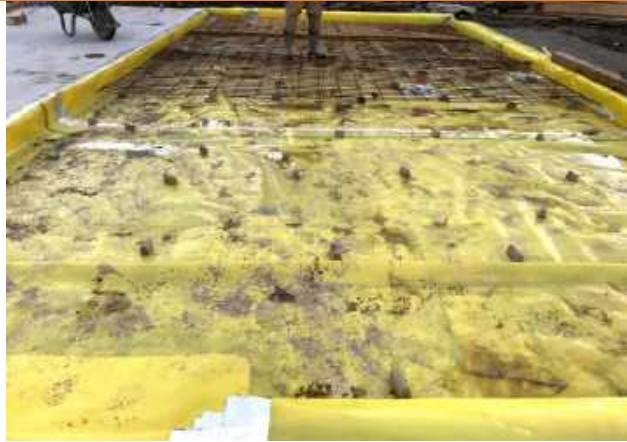
**Plot 54**

**General Condition of Membrane-Good Condition**

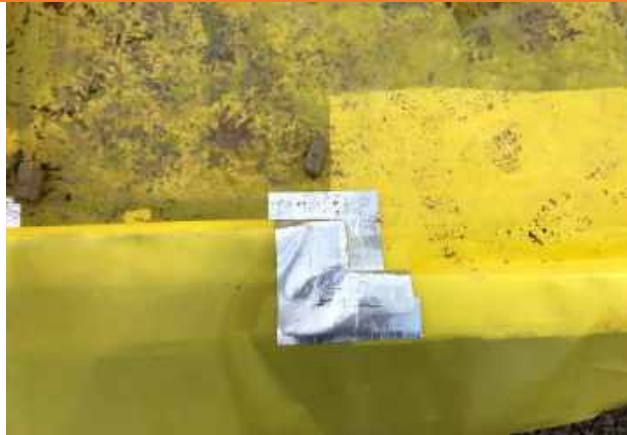
**Verification of Joints and Seals-Good Condition**

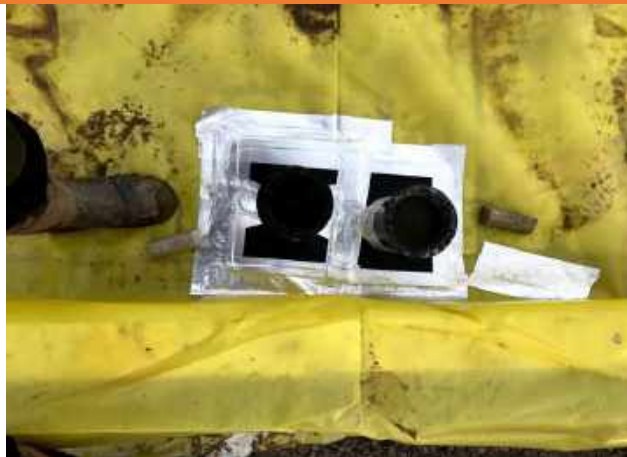
**Verification of Service Penetrations- Good Condition**

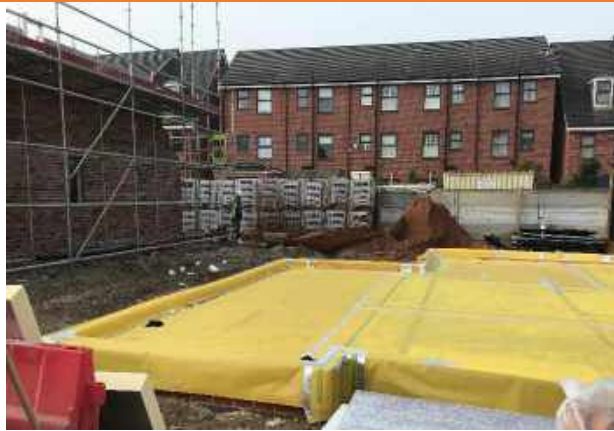
**Plot 55**

**General Condition of Membrane-Good Condition**

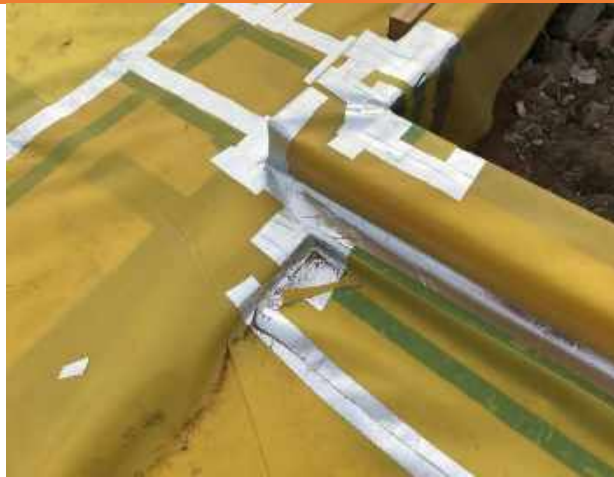
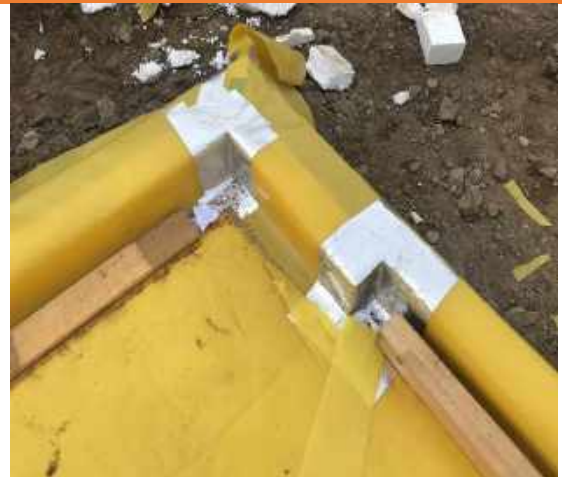
**Verification of Joints and Seals-Good Condition**

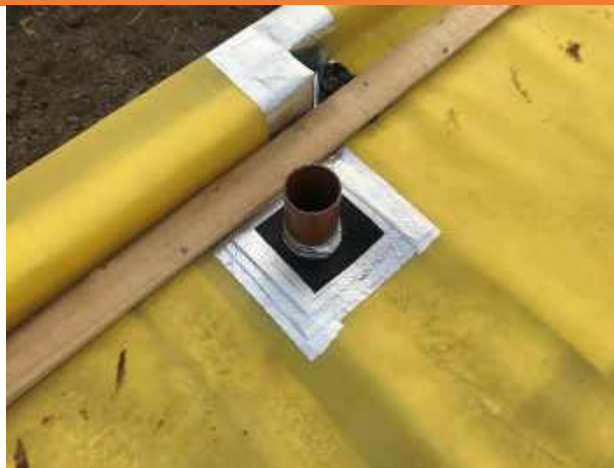
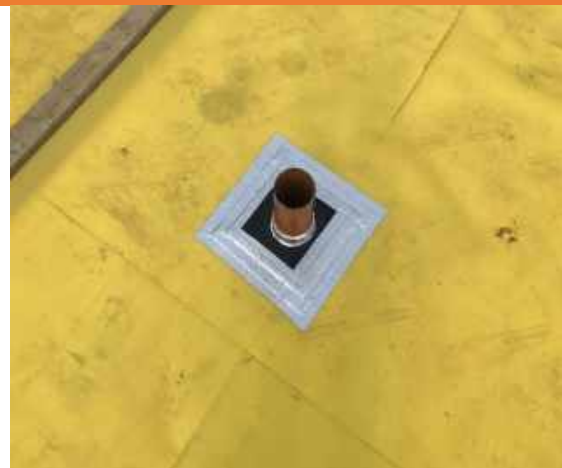
**Verification of Service Penetrations- Good Condition**

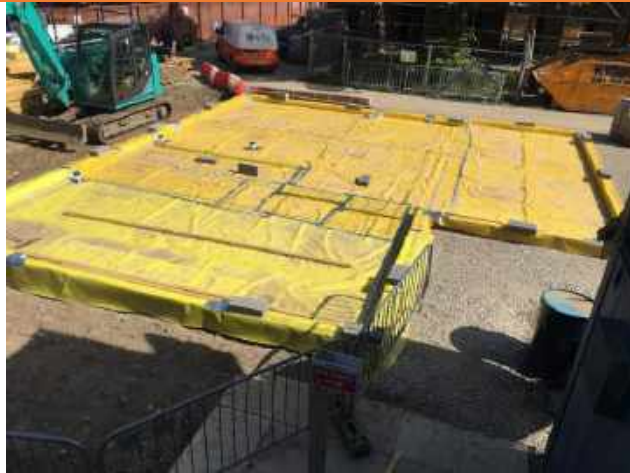
**Plot 56**

**General Condition of Membrane-Good Condition**

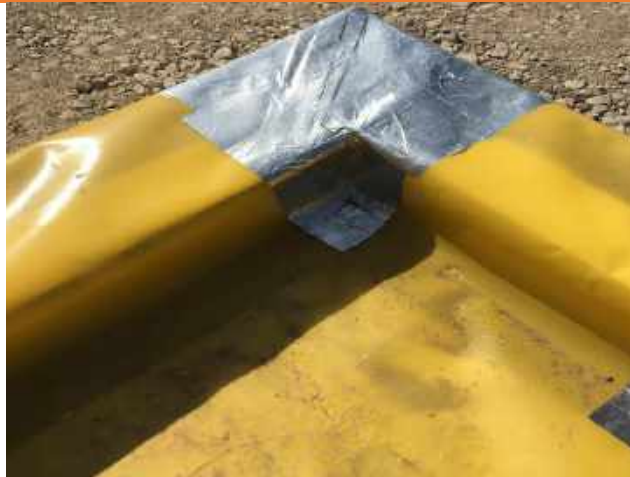
**Verification of Joints and Seals-Good Condition**

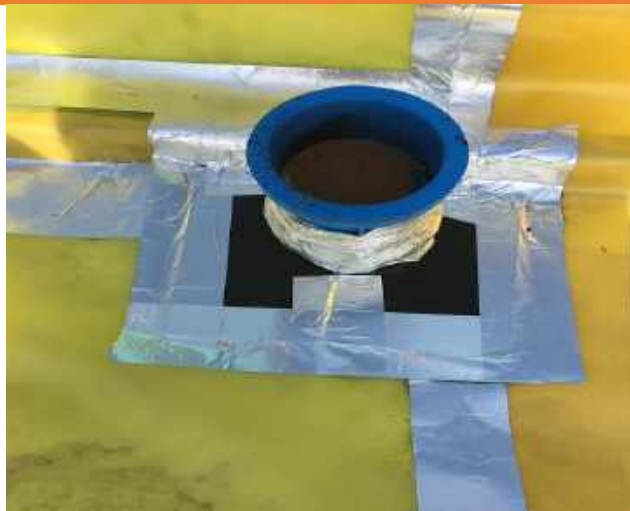
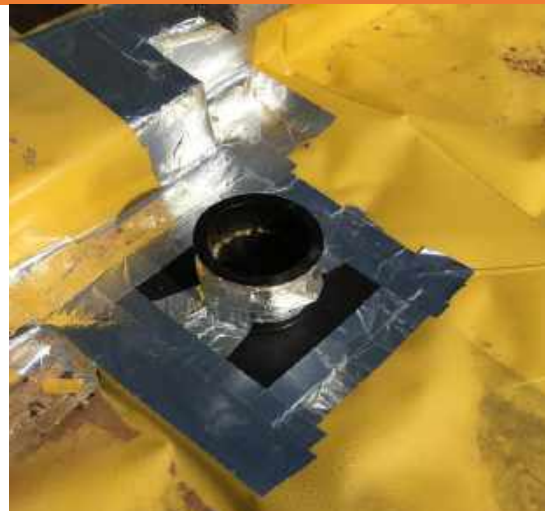
**Verification of Service Penetrations- Good Condition**

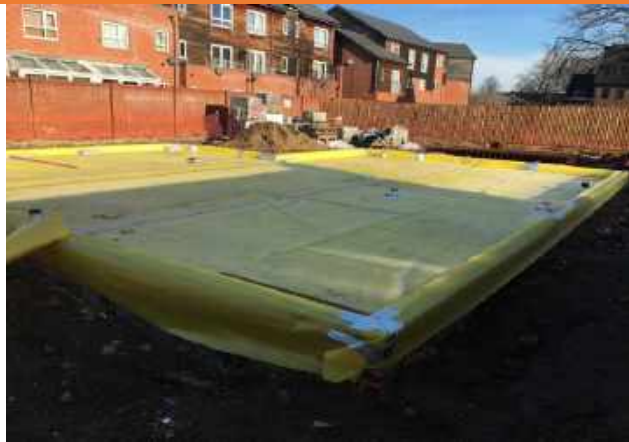
**Plot 57**

**General Condition of Membrane-Good Condition**

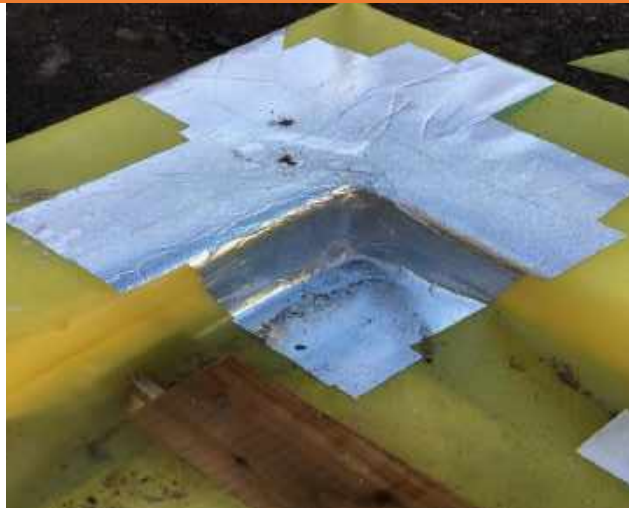
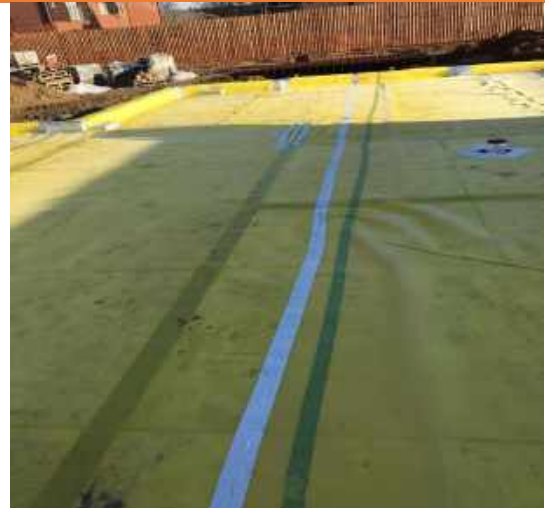
**Verification of Joints and Seals-Good Condition**

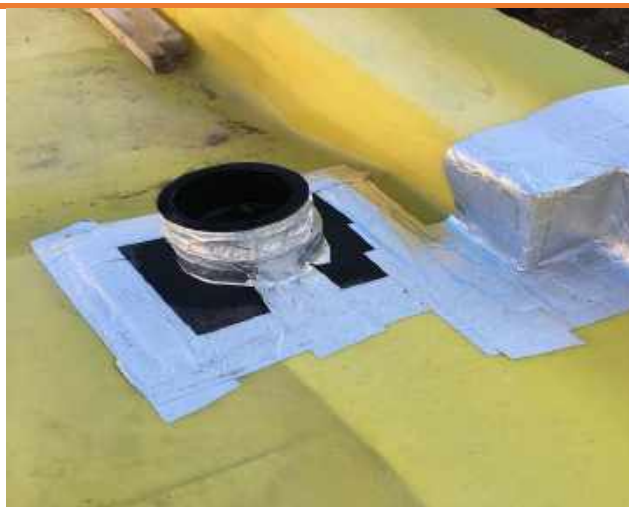
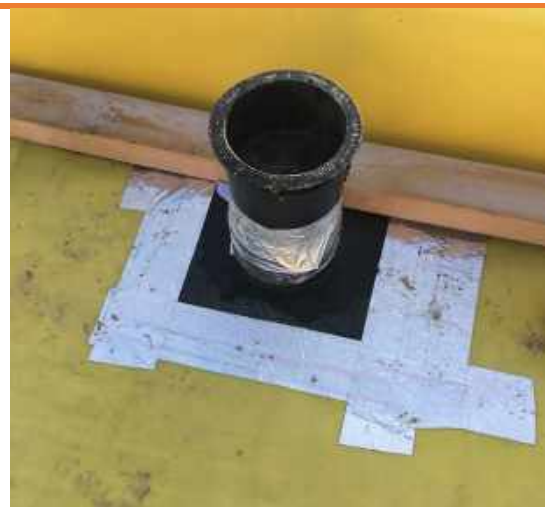
**Verification of Service Penetrations- Good Condition**

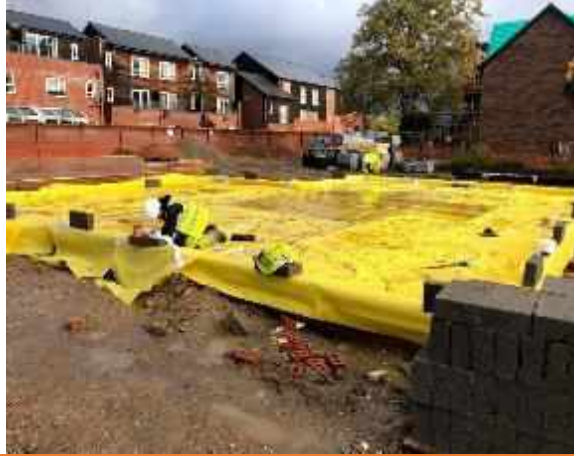
**Plot 58**

**General Condition of Membrane-Good Condition**

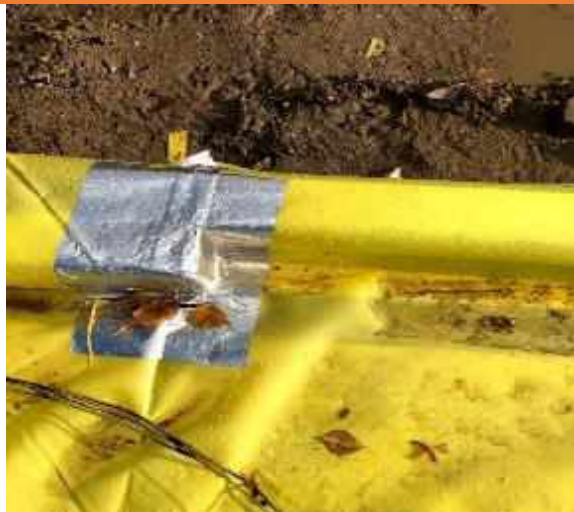
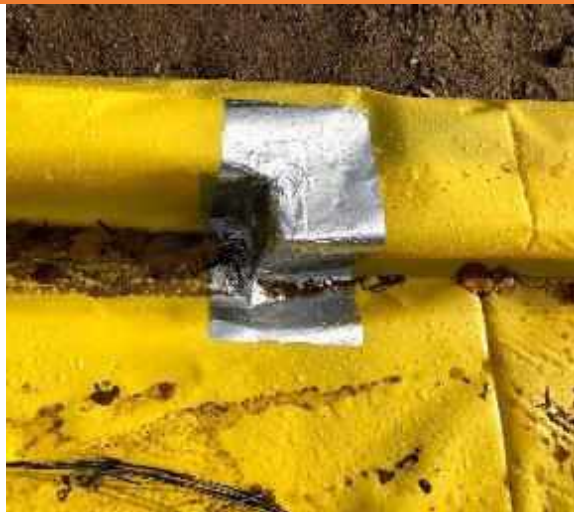
**Verification of Joints and Seals-Good Condition**

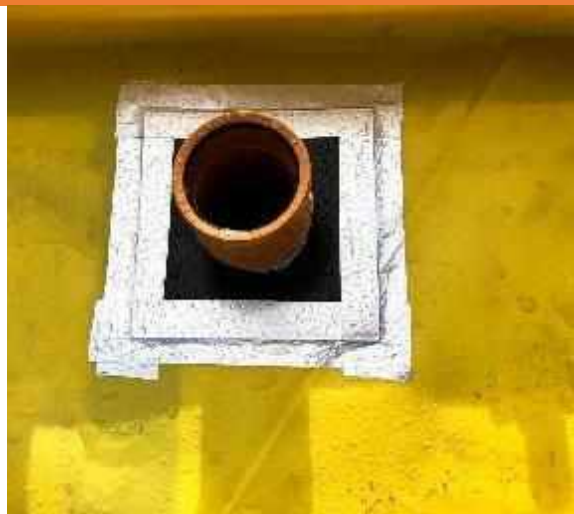
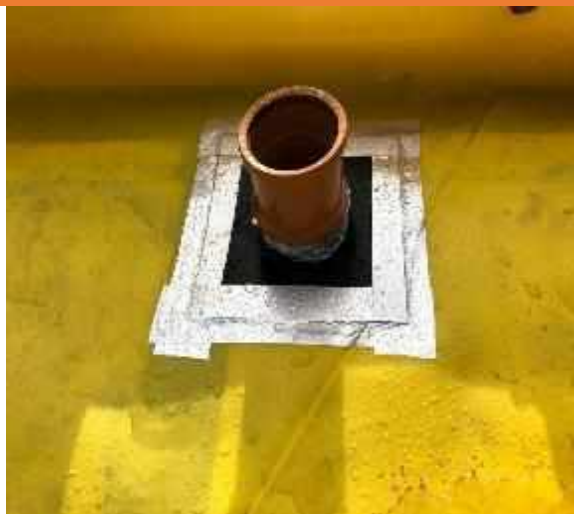
**Verification of Service Penetrations- Good Condition**

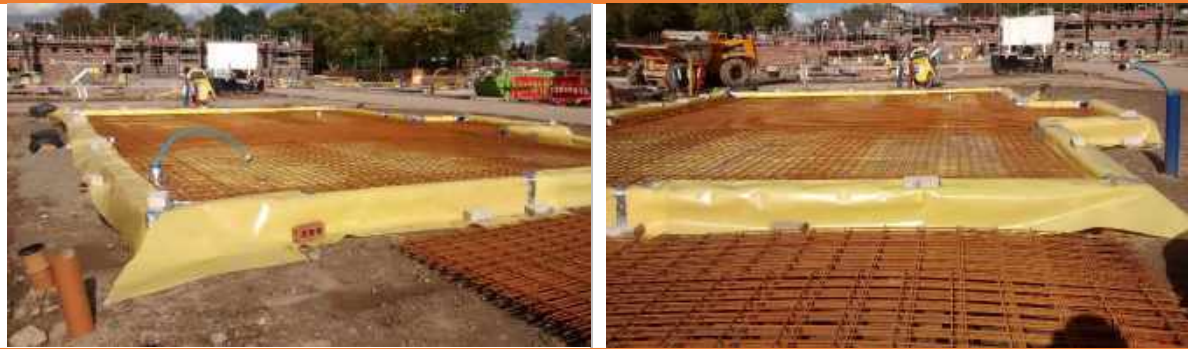
**Plot - 61**

**General Condition of Membrane-Good Condition**

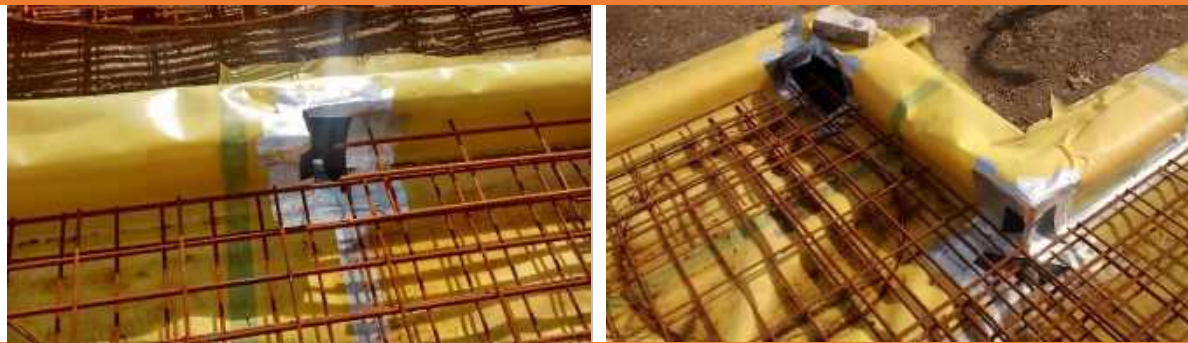
**Verification of Joints and Seals-Good Condition**

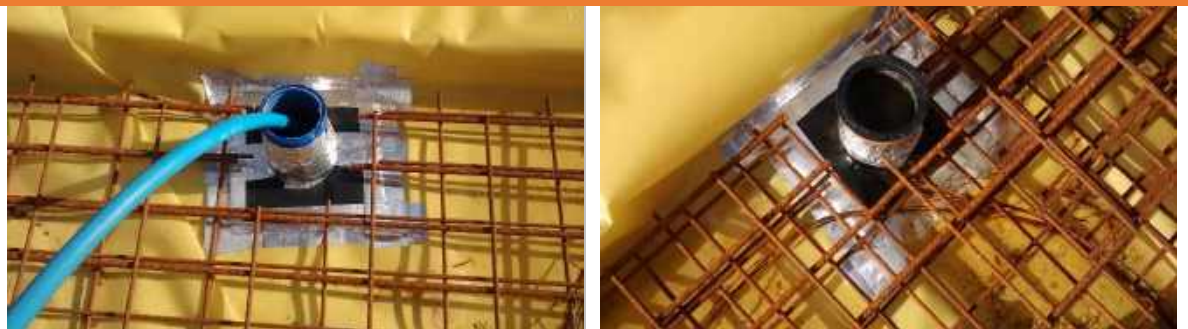
**Verification of Service Penetrations-Good Condition**

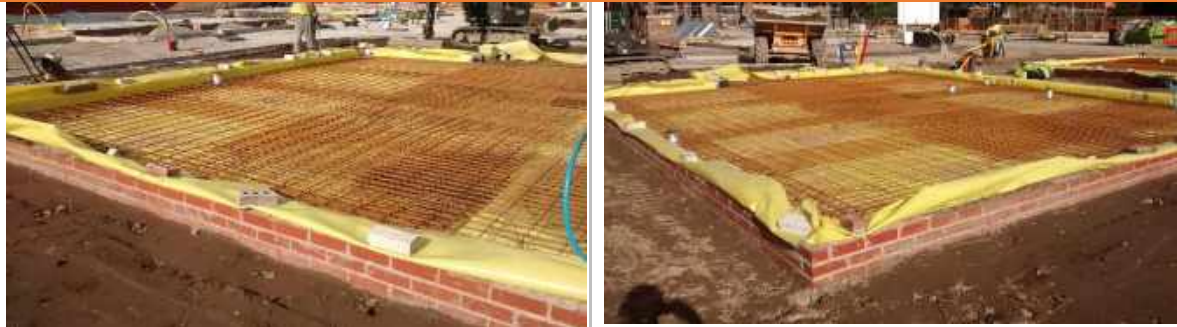
**Plot - 62**

**General Condition of Membrane-Good Condition**

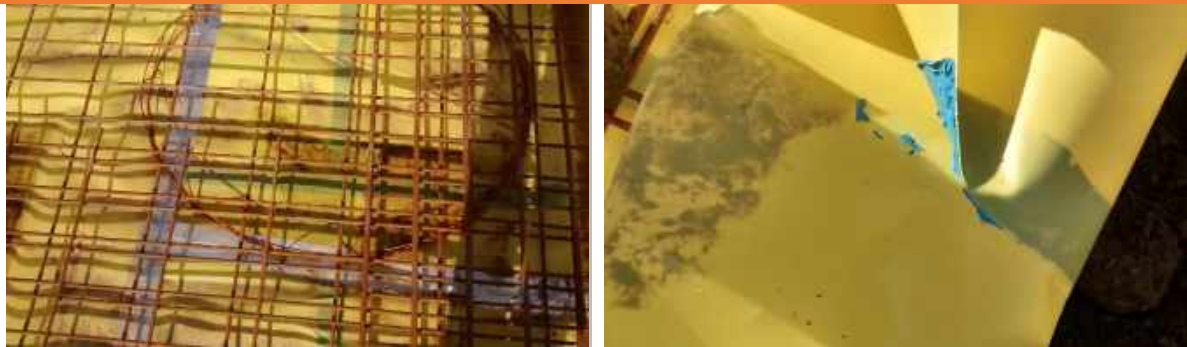
**Verification of Joints and Seals-Good Condition**

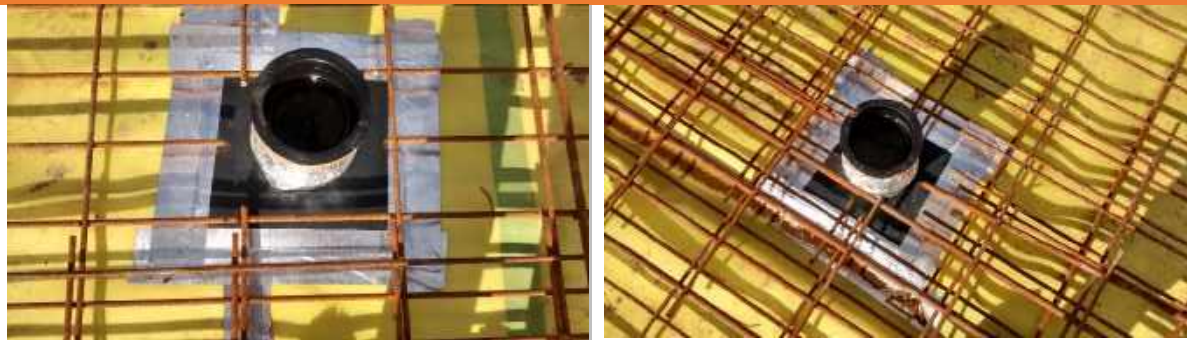
**Verification of Service Penetrations-Good Condition**

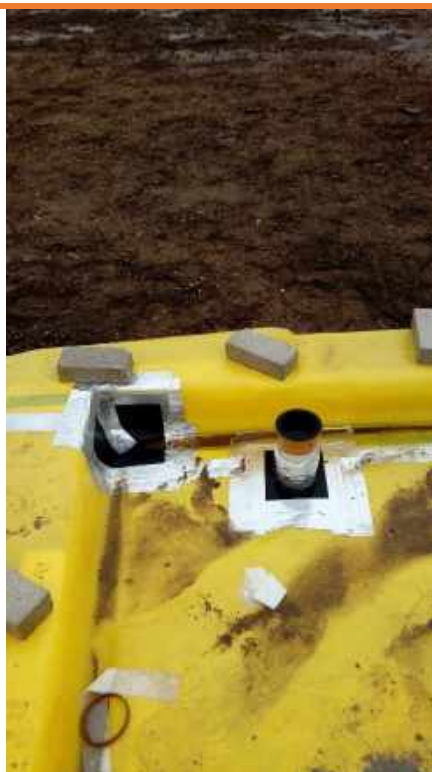
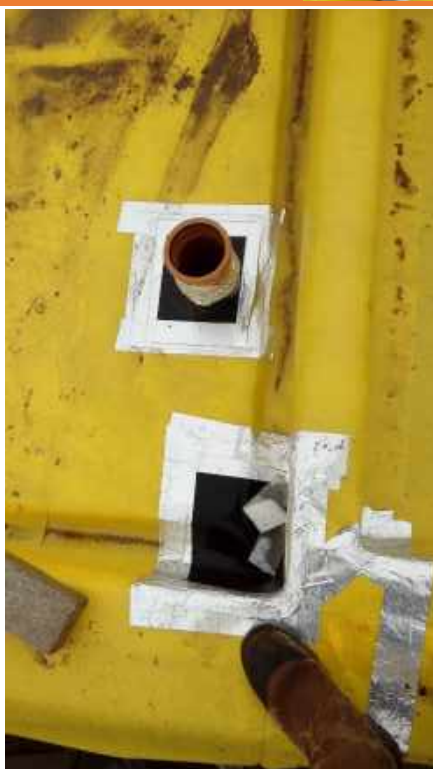
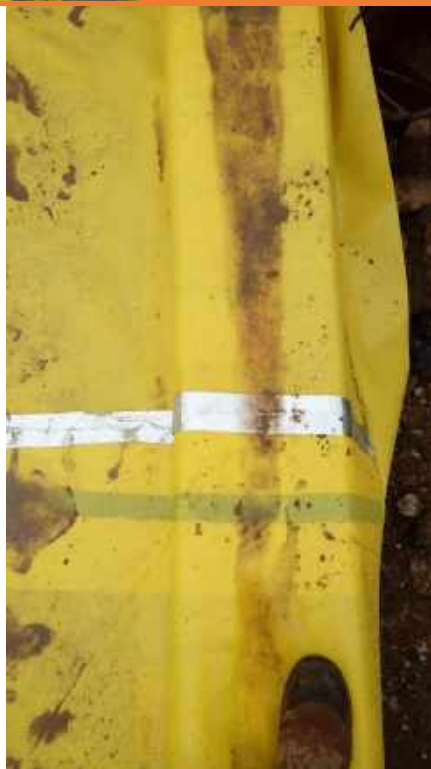
**Plot – 68**

**General Condition of Membrane-Good Condition**

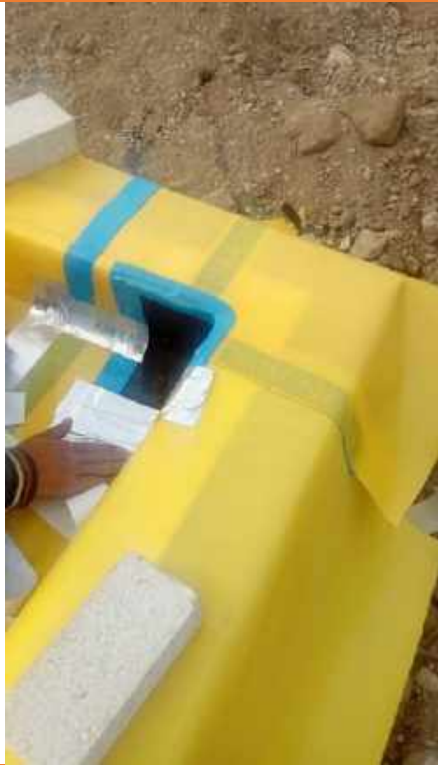
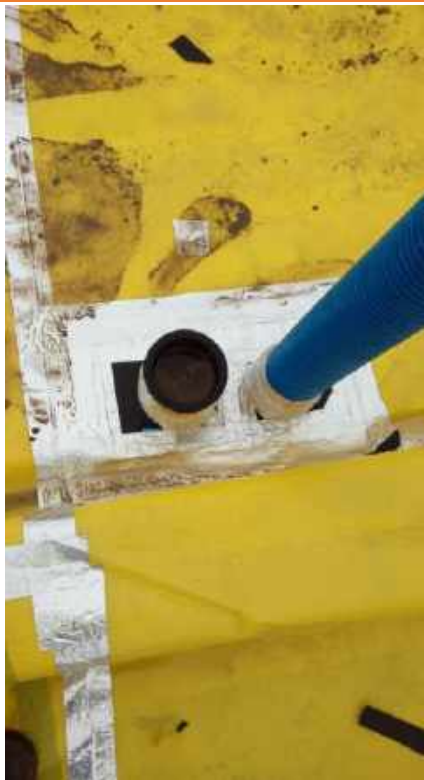
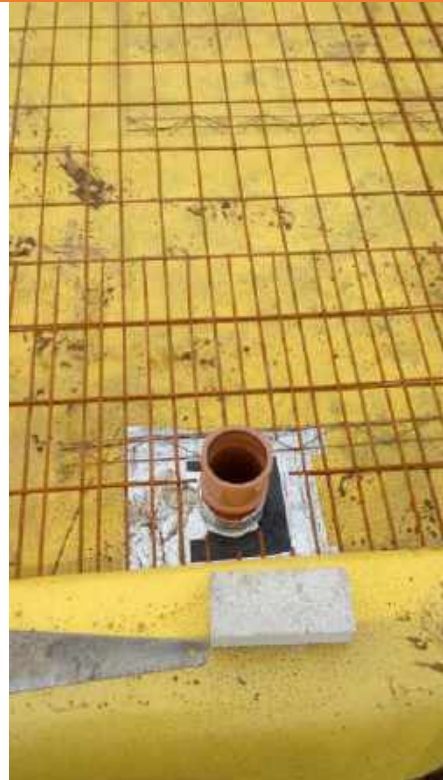
**Plot – 69**

**General Condition of Membrane-Good Condition**

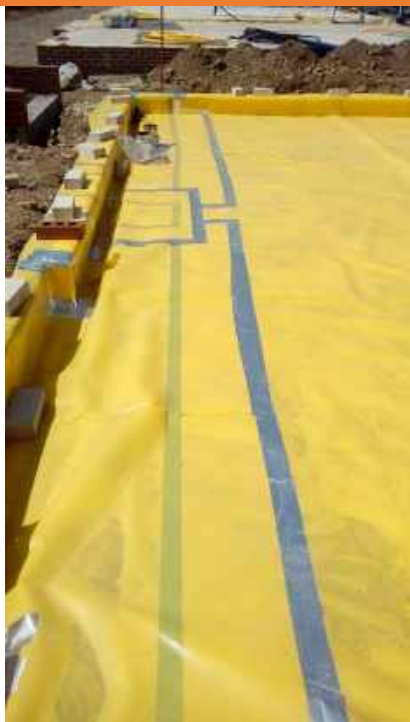
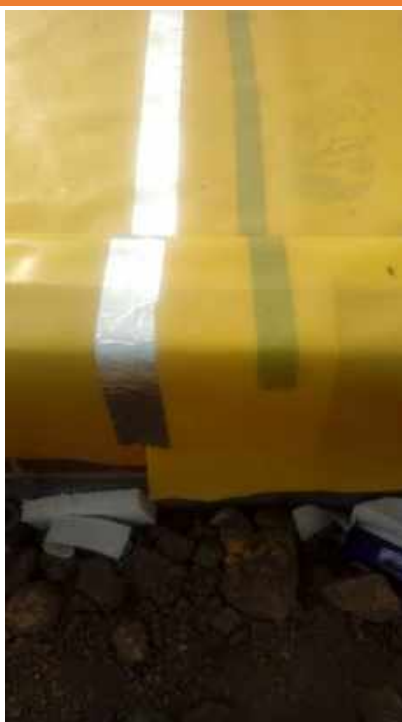
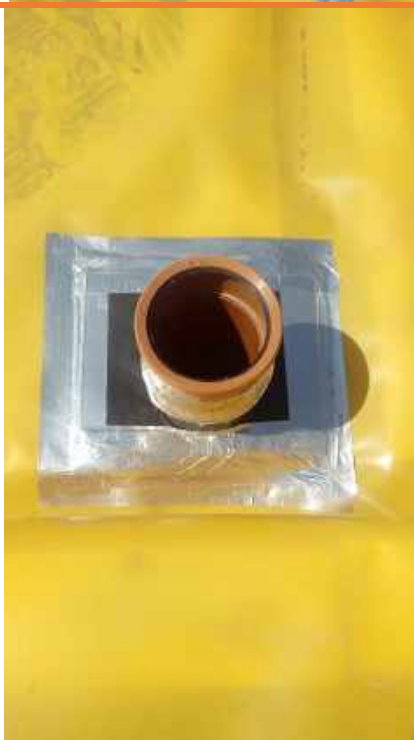
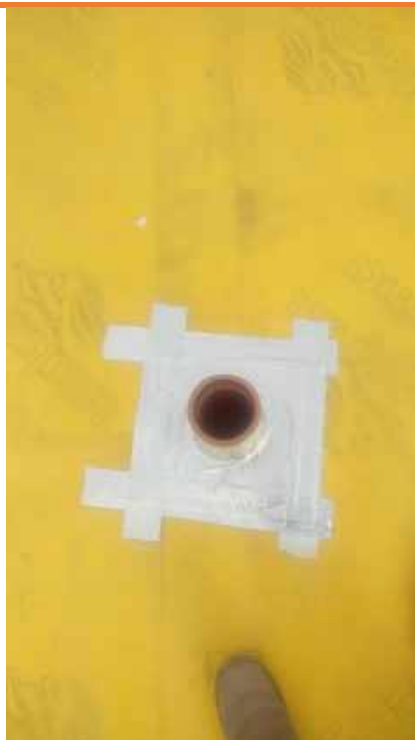
**Plot – 70**

**General Condition of Membrane-Good Condition**

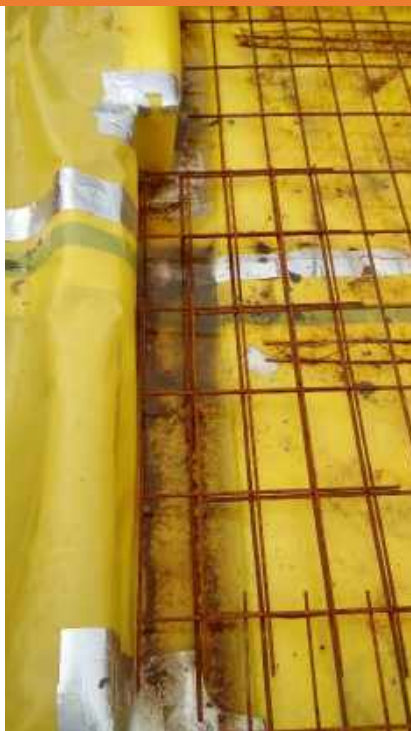
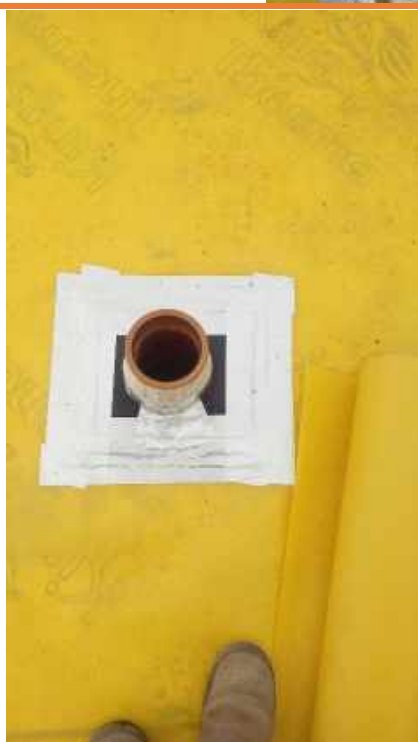
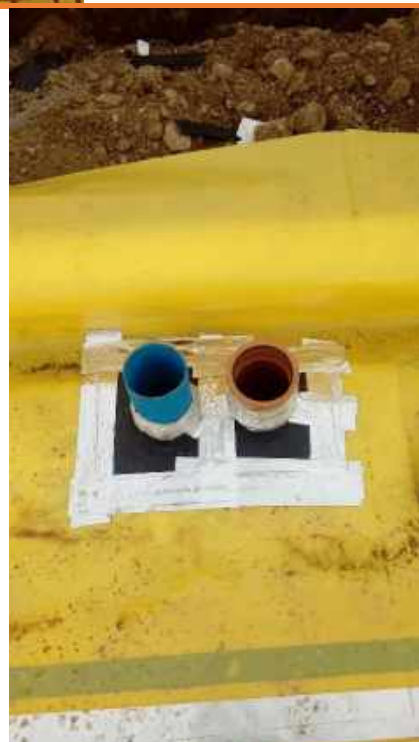
Plot – 71/72

General Condition of Membrane-Good Condition

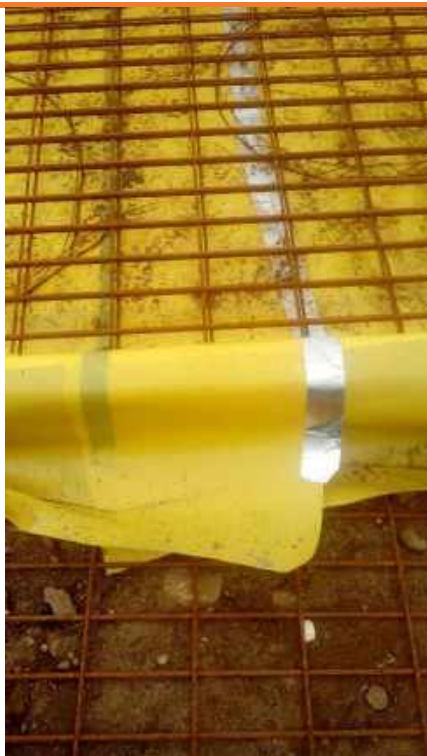
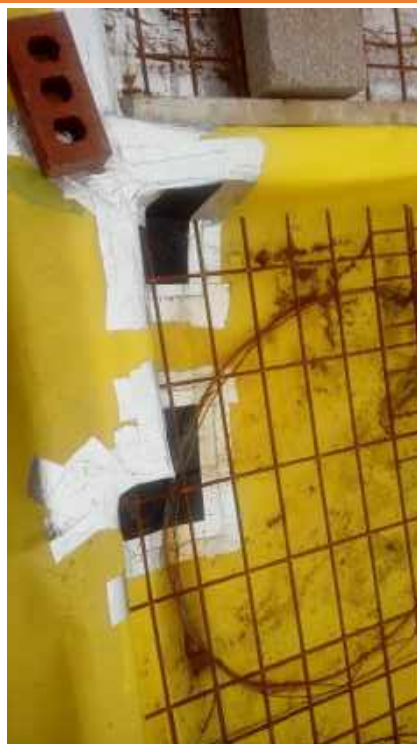
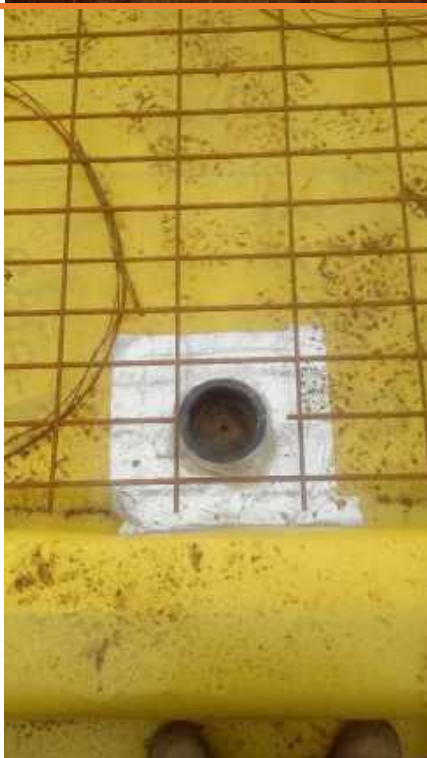
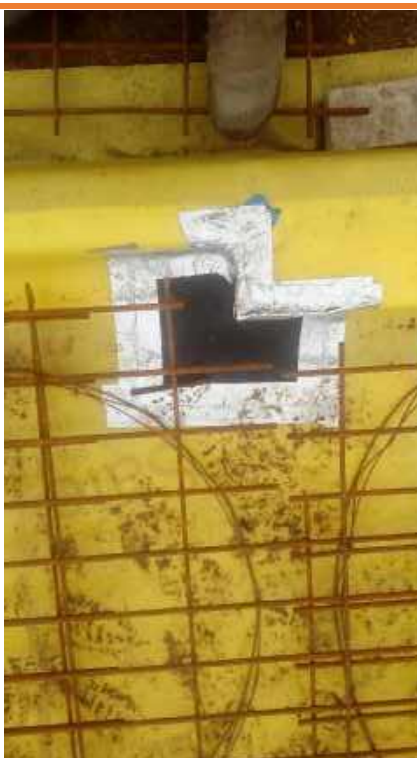
Plot – 73/74

**General Condition of Membrane-Good Condition**
