## Schedule of Condition

Slade Lane Neighbourhood Centre

for Myriad Foundation

Slade Lane M13 0QJ

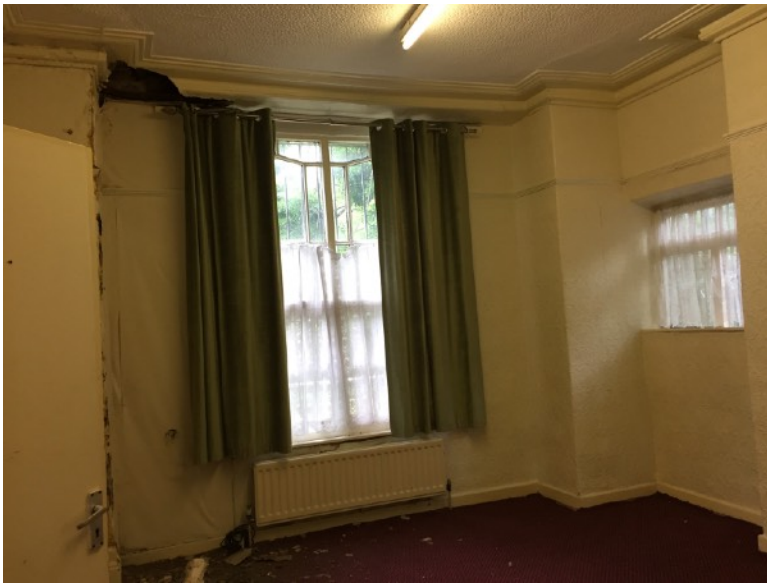
Room 1 looking towards front elevation

**Walls** - Wall paper covering with picture rail in poor condition with mdf skirting to front & side walls; water damage, mould and damp to left hand side of external wall

**Floors** - Carpet floor covering throughout in poor condition, existing timber floor not inspected

**Ceiling** - Lath & plaster in poor condition; cornice around left side above window is broken due to historic water damage; surface mounted strip lighting

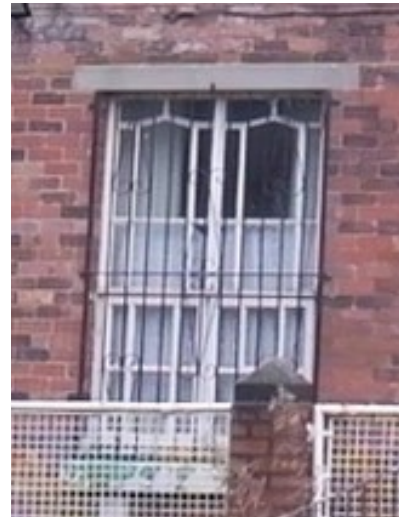
Existing window at front elevation

**Front window** - Timber casement window with fixed upper panel & side hung lower panel all in single glazing painted shut; black painted metal security grille fixed to external brick walls; external concrete lintel; external painted stone cill; internal painted timber cill in poor condition

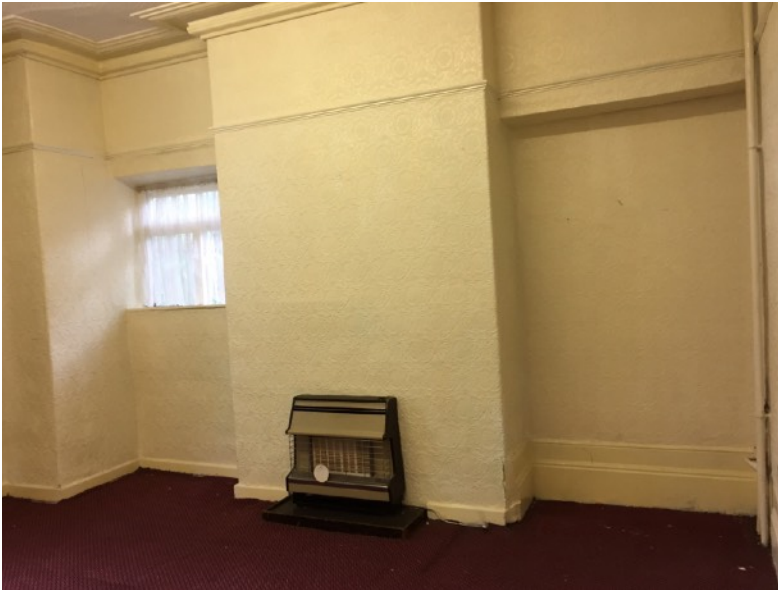
Existing chimney breast with electric heater

**Walls** - Wall paper covering in poor condition with 250mm high timber profile skirting to internal walls; surface mounted electric cables including fire safety fixings

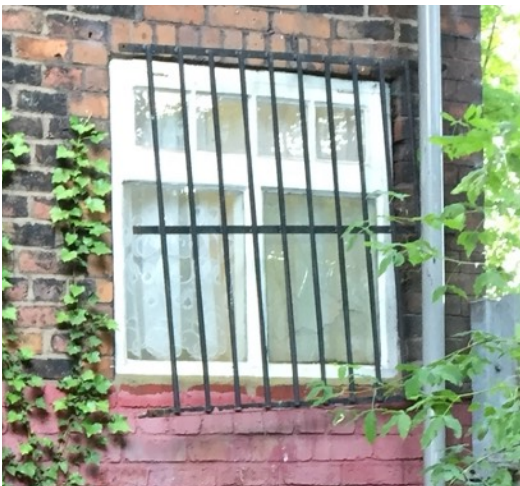
Existing window at side elevation

**Side Window** - Timber top hung casement window in single glazing painted shut; black painted metal security grille half fixed to external brick walls; external brick lintel; internal painted timber cill

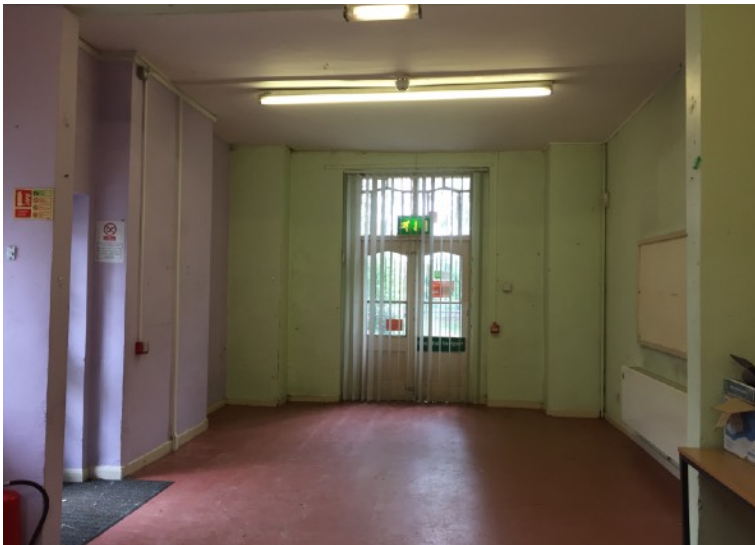
View towards front access doors

**Floors** - Vinyl floor covering throughout in poor condition, existing timber floor not inspected

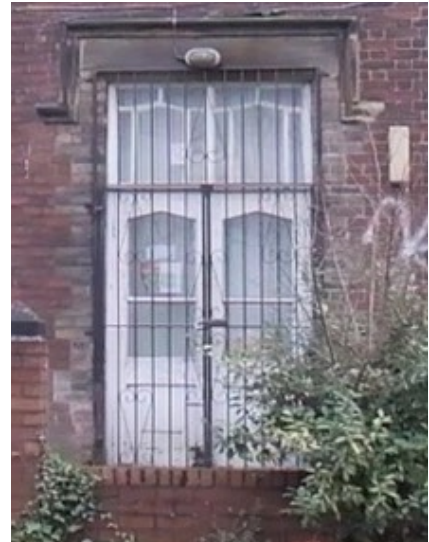
Access doors at front elevation

**Front doors** - Painted timber double doors with glazed fixed over panel all in single glazing; black painted metal security grille fixed to external brick walls; aluminium press bar ironmongery on internal side; external stone lintel;

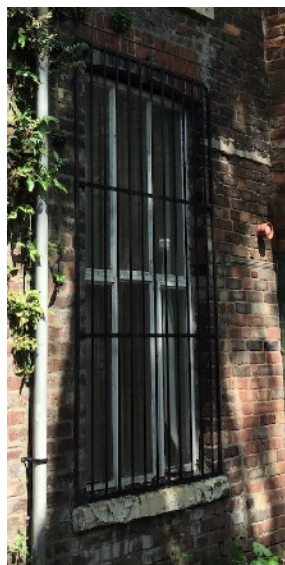
Rear window

**Rear window** - Timber panelled with side hung panel all in single glazing painted shut; black painted metal security grille fixed to external brick walls; painted external stone lintel spalling; internal painted timber cill in poor condition

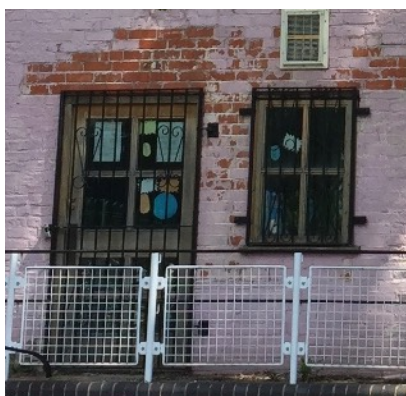
Side entrance & window

**Side entrance door & window** - Timber single glazed panelled door & window inoperable with black painted metal security grille fixed to external wall in reasonable condition.

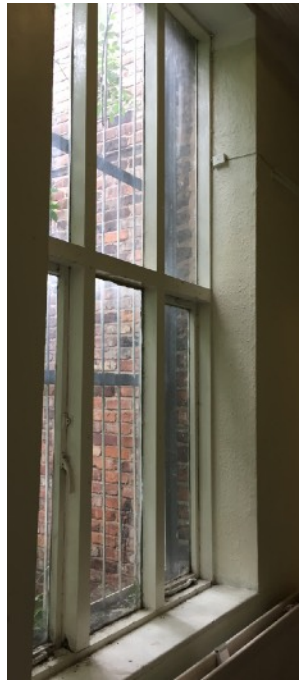
Rear window

**Rear window** - Painted timber panelled window with side and top hung panels all in single glazing painted shut; white painted metal security grille fixed to external brick walls

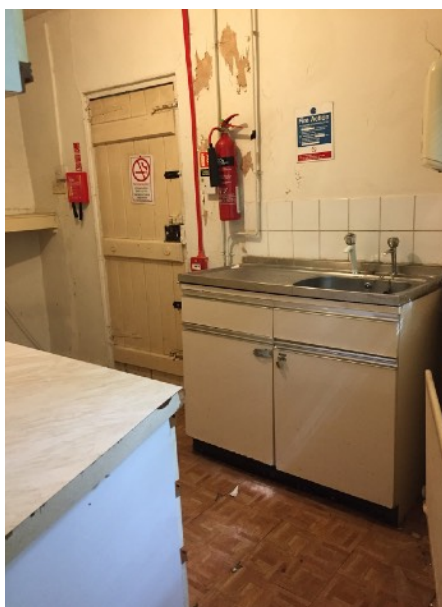
Kitchen facing exit door

**Door** - Painted imber panelled door inoperable with black painted metal security grille fixed to external wall in reasonable condition.

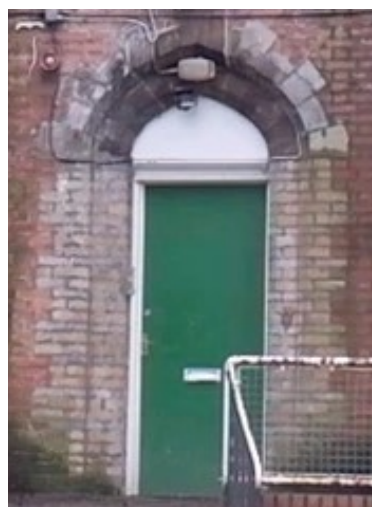
Main entrance at front elevation

**Door** - External painted timber door with solid over panel and aluminium ironmongery in poor condition; internal fire glazed fire door with aluminium ironmongery and glazed over panel in reasonable condition.

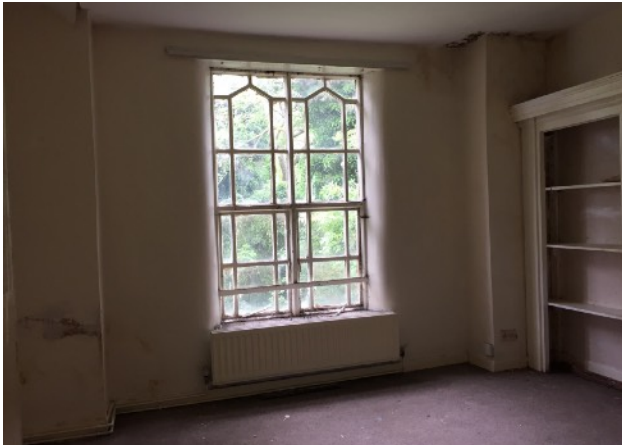
Room 5 looking towards front elevation

**Walls** - Plaster & painted with low skirting throughout in poor condition and water damage patches facing external walls; surface mounted electric cables

**Ceiling** - Plaster & painted in poor condition with water damage and damp along external walls; surface mounted lighting

**Window** - Painted timber panelled fixed upper panels and side hung lower panels painted shut all in single glazing; external stone lintel; internal painted timber cill in poor condition

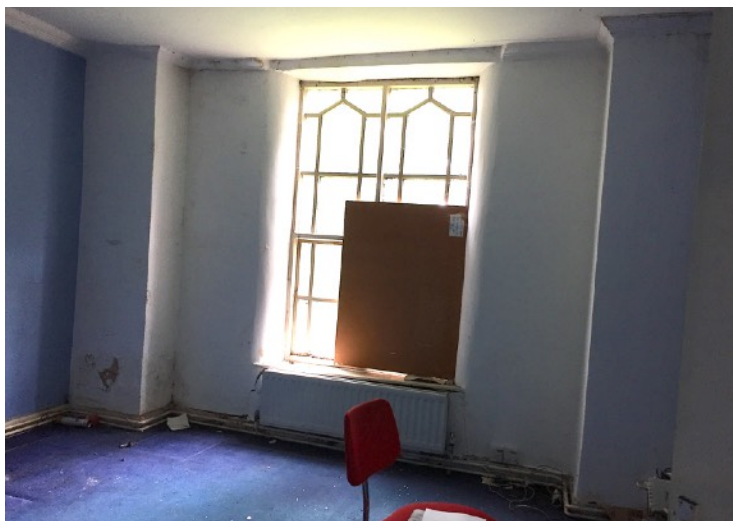
Window facing front elevation

**Window** - Painted timber panelled fixed upper panels and side hung lower panel painted shut all in single glazing; one side hung panel missing; external stone lintel; internal painted timber cill in poor condition

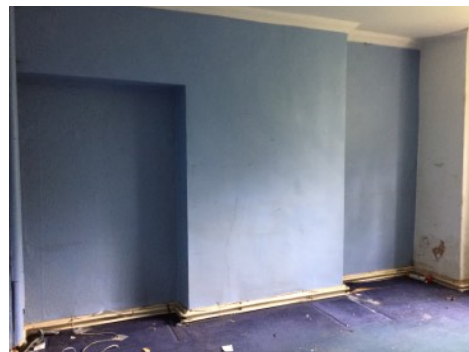
Side external wall

**Walls** - Plaster & painted with low skirting throughout in poor condition; water damage and damp patches on external wall facing front; cornice to internal and side external walls; surface mounted electric cables including heating pipes

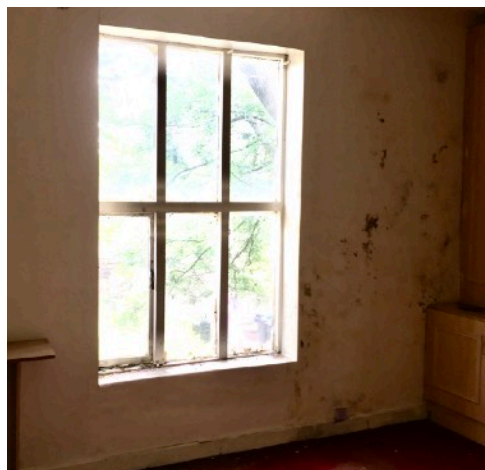
Window facing rear

**Window** - Painted timber panelled fixed upper panels and side hung lower panel painted shut all in single glazing; external brick lintel; internal painted timber cill

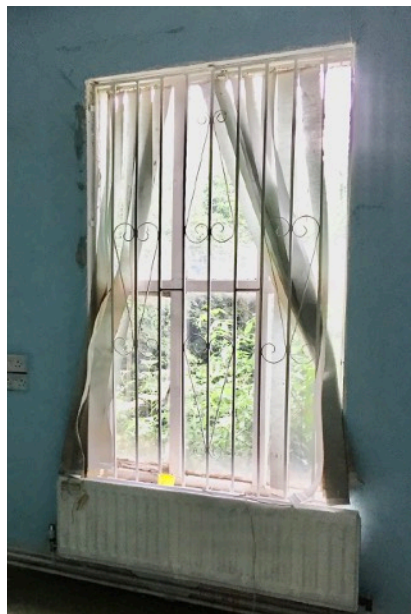
Window facing rear

**Window** - Painted timber panelled fixed upper panels and side hung lower panel painted shut all in single glazing; black painted internal security grille fixed within opening reveal; external brick lintel; internal painted timber cill in poor condition

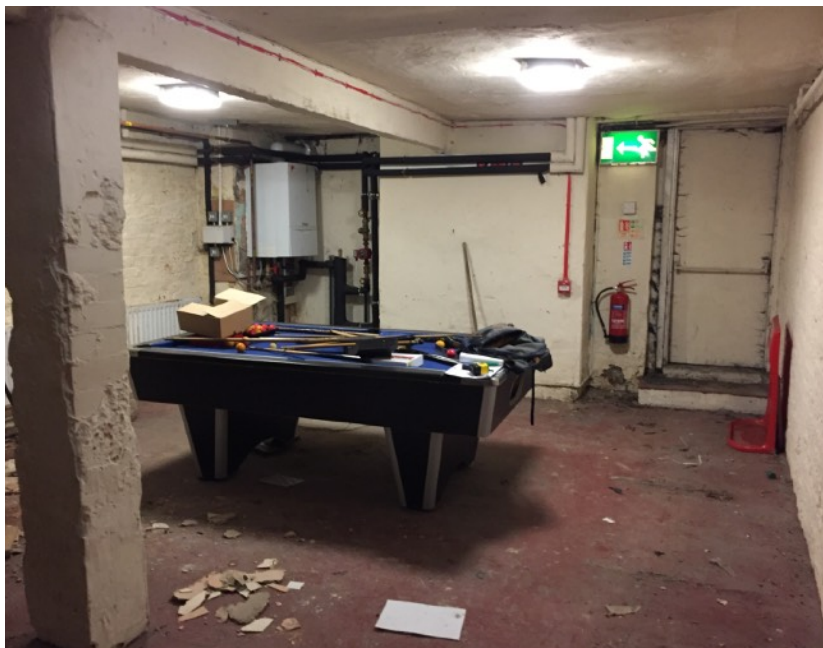
Main chamber

**Walls** - Brick painted throughout; damp & water damage has calcified paint finish on front external side

**Floors** - Painted screed in poor condition; some breakout patches along front external wall

**Ceiling** - Lath & plaster in poor condition; hole in one location; surface mounted lighting and fire safety equipment

**Structure** - Timber beam and brick pier requires structural review
