# DAYTIME BAT AND NESTING BIRD SURVEY OF POWER HALL AT THE SCIENCE AND INDUSTRY MUSEUM, LIVERPOOL ROAD, MANCHESTER

**AUGUST 2019**

**RACHEL HACKING ECOLOGY**

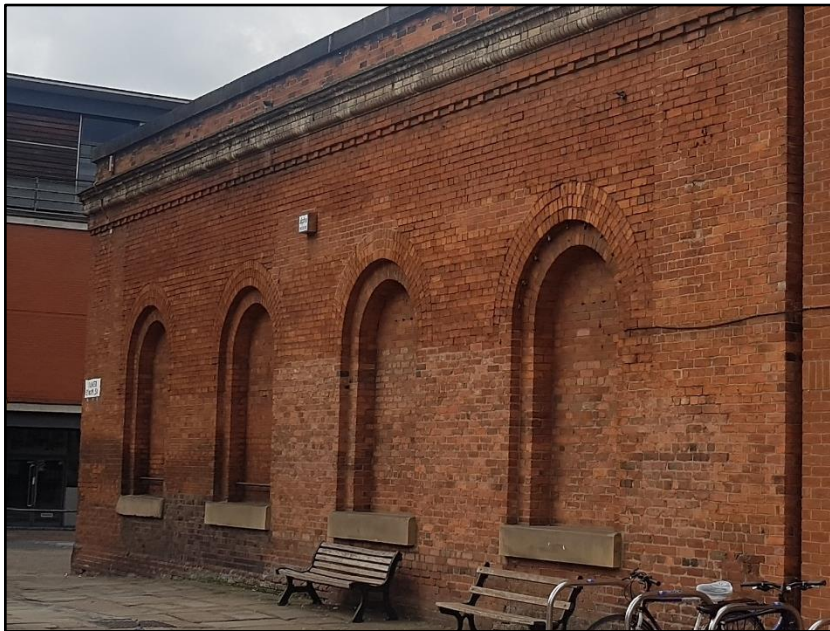
- 3.1 The Power Hall is a large, linear, double-height building. It is constructed from brick with many floor to ceiling windows and double-height metal shutter doors, due to its previous use as a railway yard.
- 3.2 The external brickwork is in reasonable condition (see Photograph 1 and front cover of this report). Small amounts of damage are present across the buildings masonry; however, no potential bat entry points were identified as a result. The mortar is largely present and intact. However, small areas of mortar have receded. These areas are shallow and do not provide potential access to suitable bat roosting cavities.

**Photograph 1 showing the exterior of Power Hall**

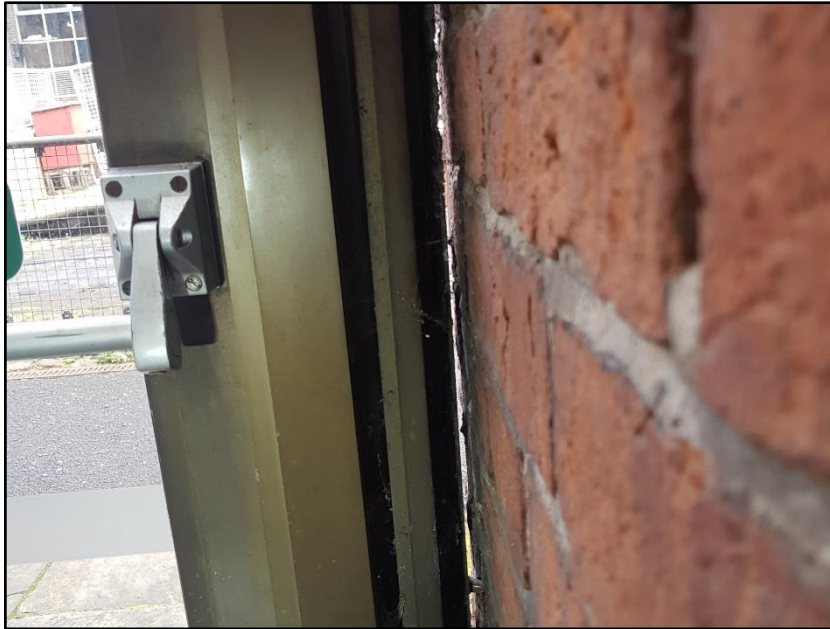
- 3.3 The coping stones along the peripheries of the roof are in good condition and well-sealed with mortar. The metal window frames are in reasonable condition and well-sealed to the surrounding masonry, except in one area, which is on the ground floor (see Photograph 2). The folding metal cargo doors are mostly well-sealed, except for the top of the doors (see Photograph 3).

**Photograph 2 showing the gap in one of the floor to ceiling windows**

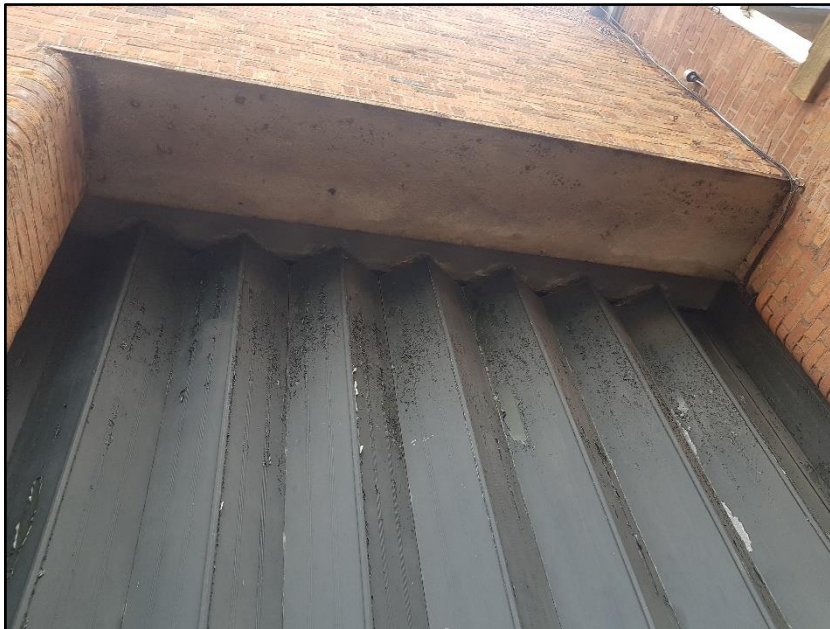
**Photograph 3 showing the gaps above the folding metal cargo doors**

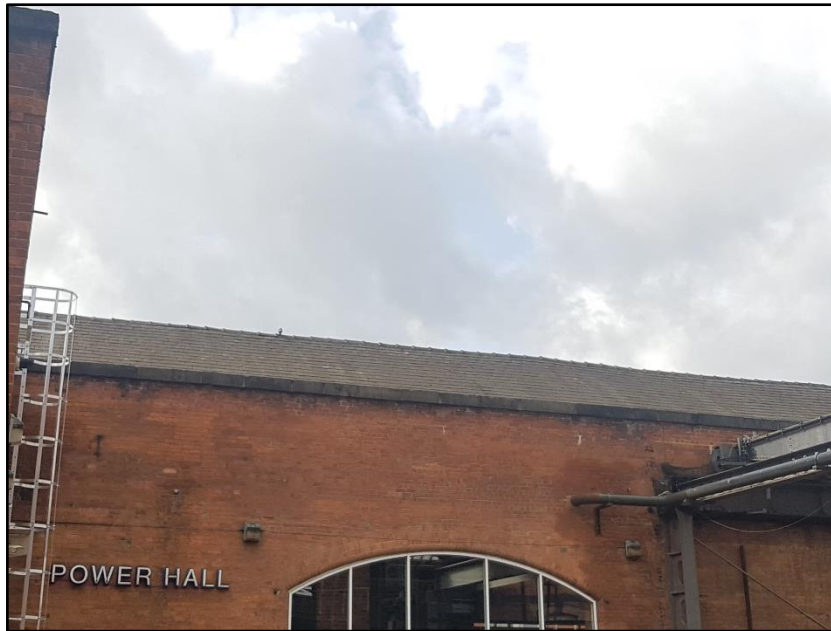
- 3.4 The roof of the Power Hall is double-ridged and tiled, with skylights throughout (see Photograph 4). The tiles and ridge tiles are all intact and in place, leaving no potential access points for bats or cavities. Lead flashing is present on the western elevation of the building, where the Power Hall is attached to a two-storey building. The flashing is not flush in this area (see Photograph 5). No bargeboards or soffits are present on the building.

**Photograph 4 showing the roof of the property**

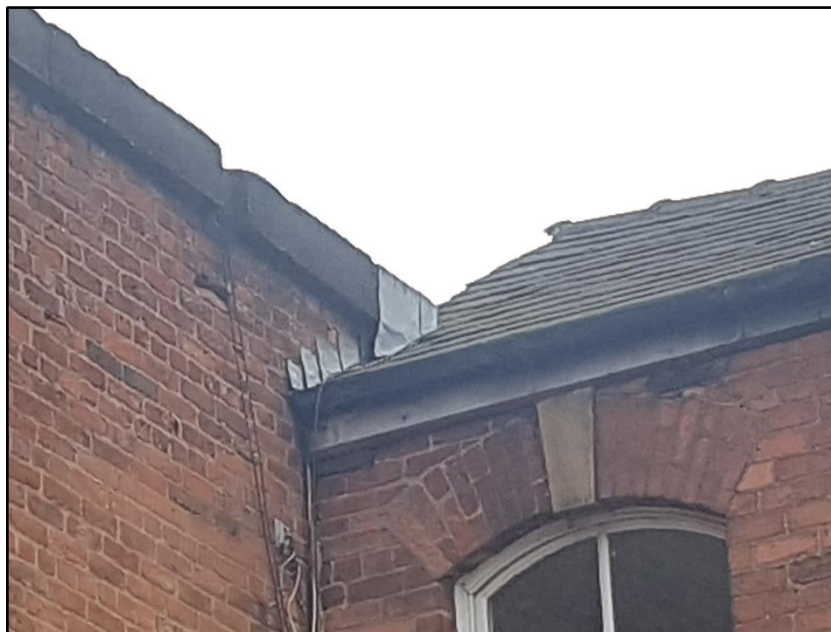
**Photograph 5 showing the loose flashing at the western elevation**

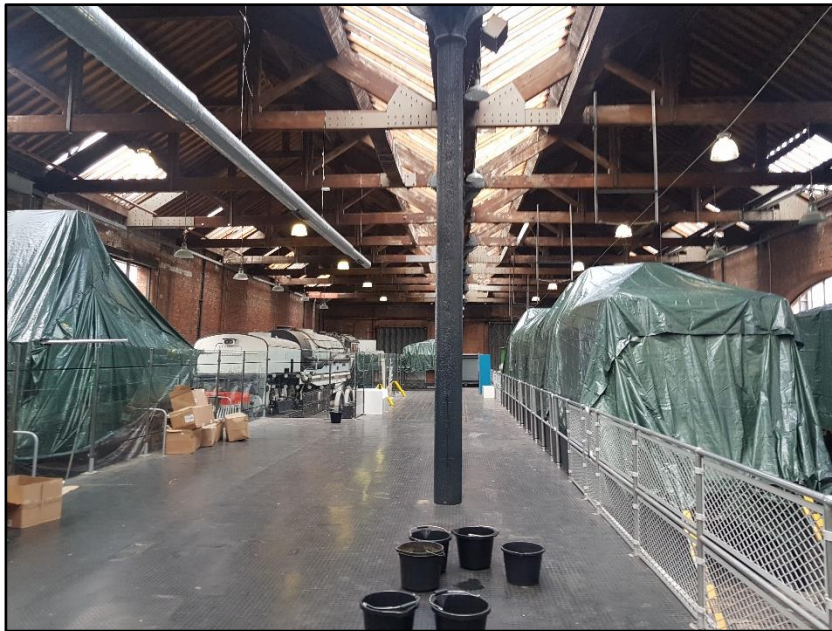
- 3.5 Internally, the building is open to the roof (see Photograph 6). The space is well-lit by the windows and skylights throughout. The internal brickwork is mostly in good condition with some areas of worn mortar that provide shallow gaps (see Photograph 7). These gaps are considered to be too shallow to support roosting bats and no evidence of bat use was found associated with them.

**Photograph 6 showing the internal space open to the roof**

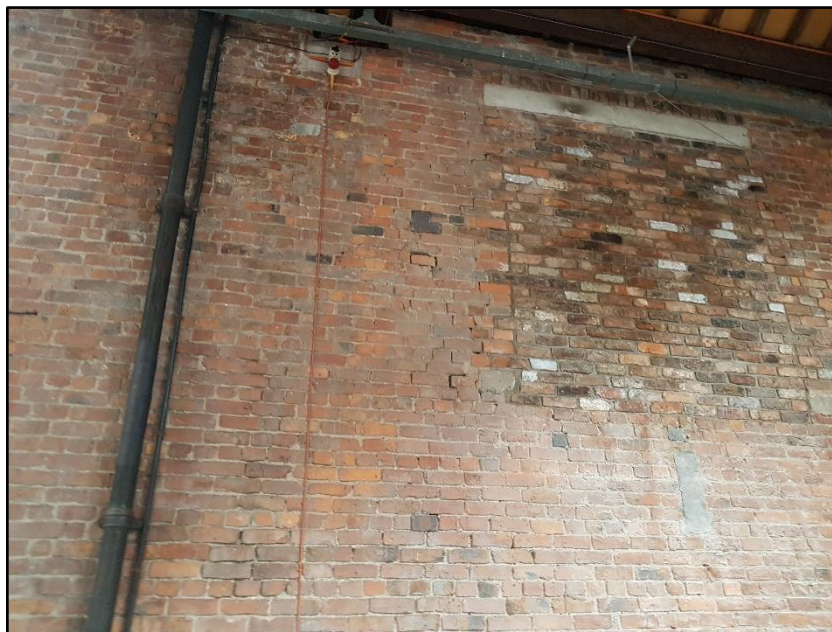
**Photograph 7 showing the internal brick work with some worn mortar**

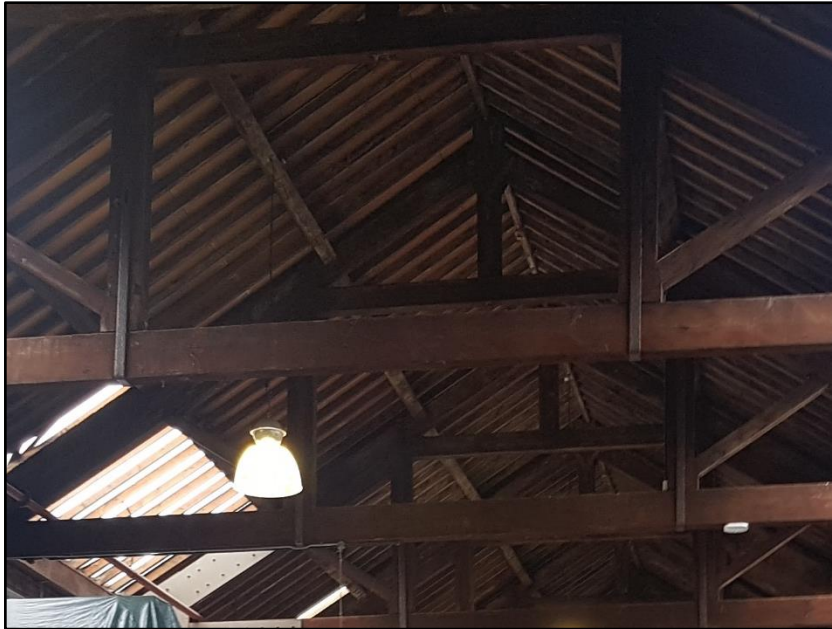
- 3.6 The metal support pillars are in good condition. The large wooden roof beams feature some crevices (see Photograph 8). These do not provide potential habitat for roosting bats as the crevices are only shallow and too small for bats to enter. The roof is lined with wooden boards, which show some evidence of water damage. No bats or evidence of bat activity was found throughout the building.

**Photograph 8 showing the underside of the Power Hall roof**
