## GAS MEMBRANE VALIDATION

| <b>Site: Bowes Street</b> | |
| Date: 23-09-2020 | Project Number: 11-813 |
| Ground Gas Risk Assessment: <b>Characteristic Situation 2 / Amber 1</b> | |

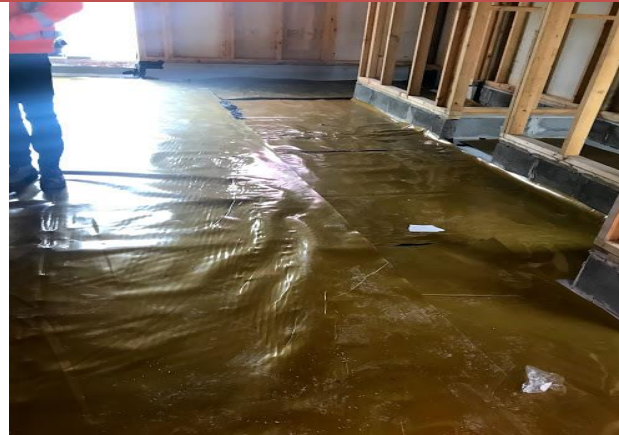
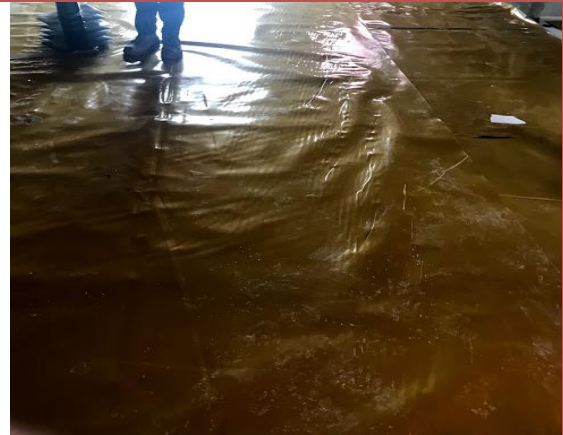
**Plot – 1**

**General Condition of Membrane-Good Condition**

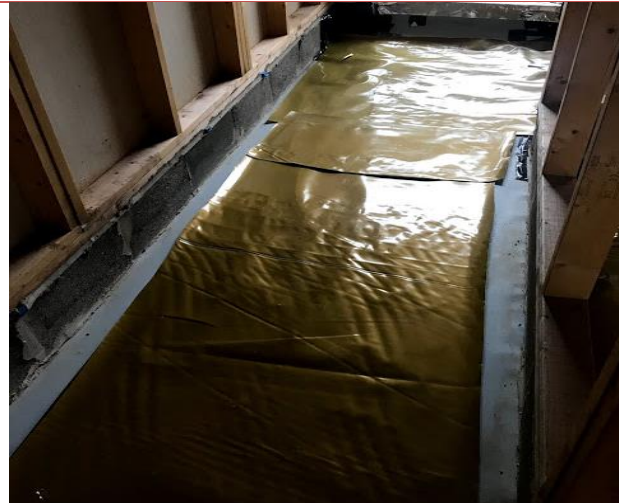
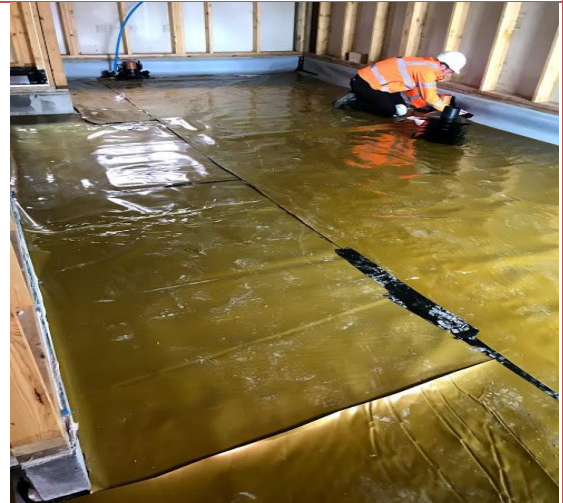
**Verification of Joints and Seals-Good Condition**

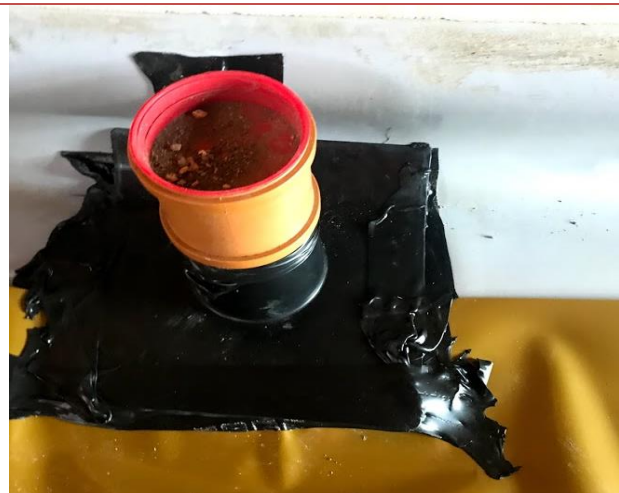
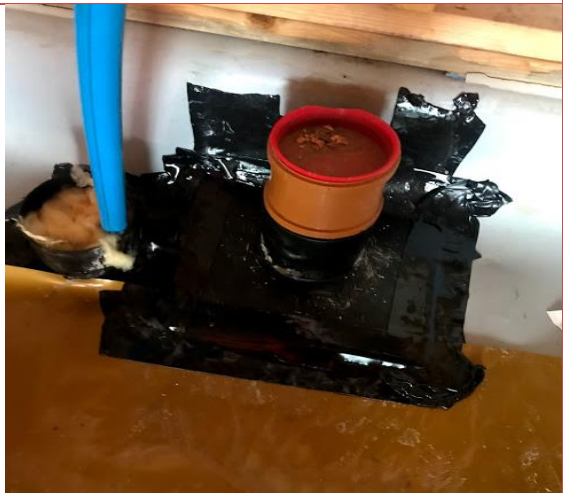
**Verification of Service Penetrations-Good Condition**

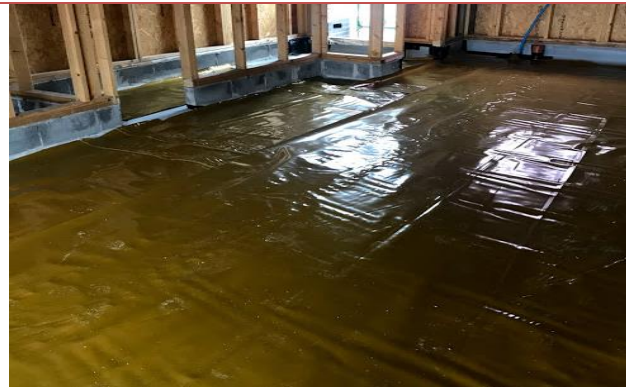
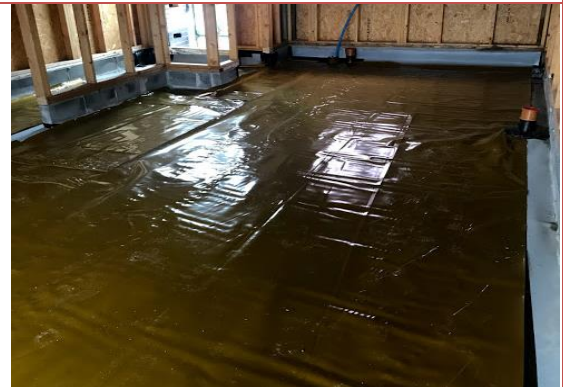
**Plot - 2**

**General Condition of Membrane-Good Condition**

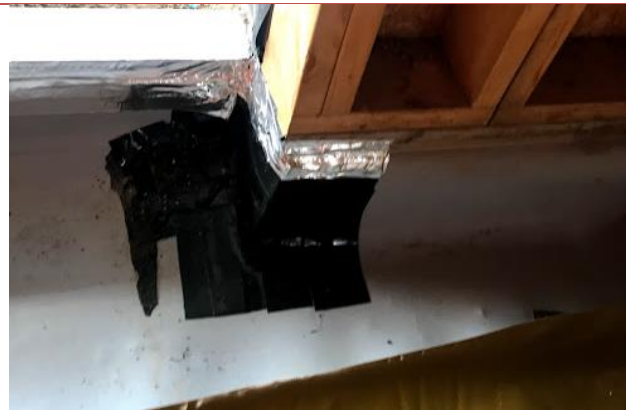
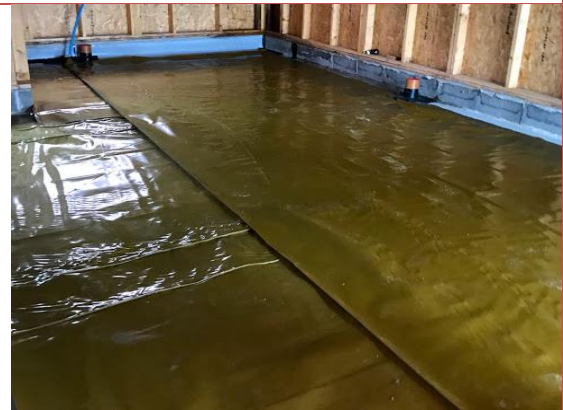
**Verification of Joints and Seals-Good Condition**

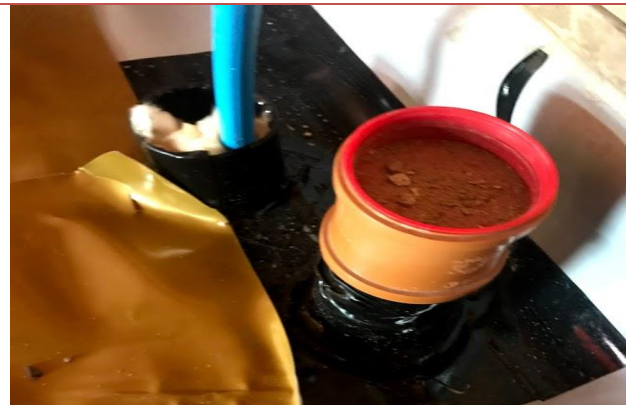
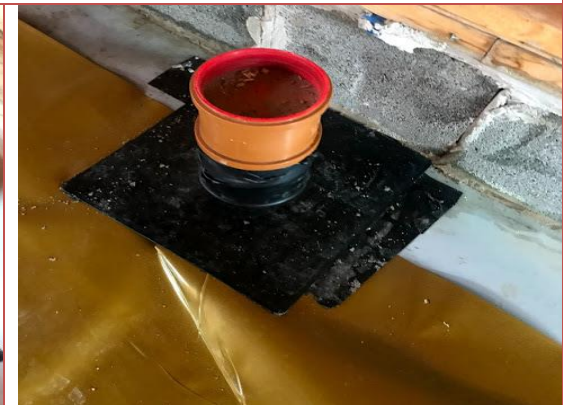
**Verification of Service Penetrations-Good Condition**

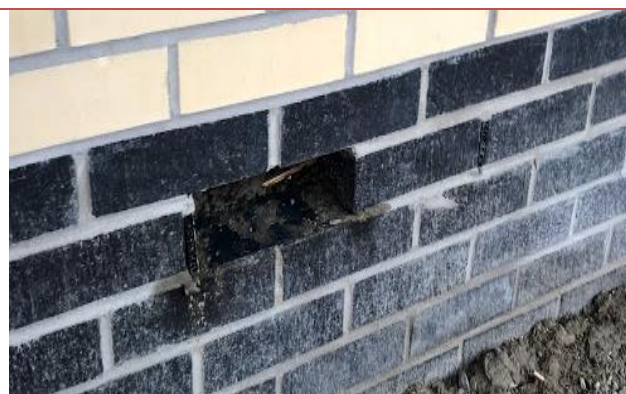
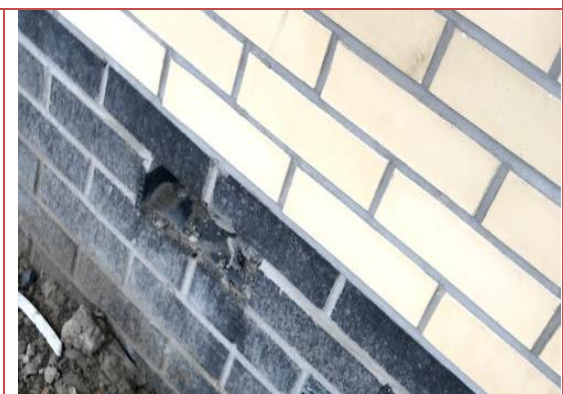
**Verification of ventilation-Good Condition**

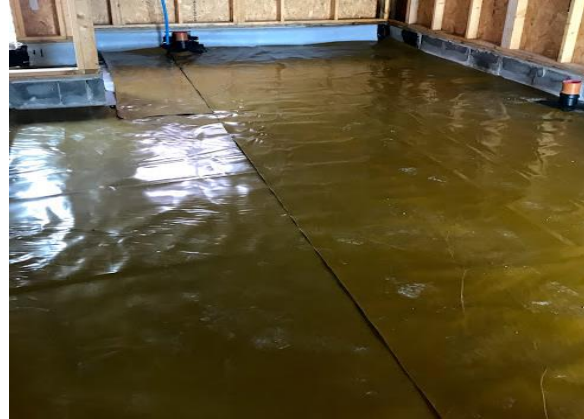
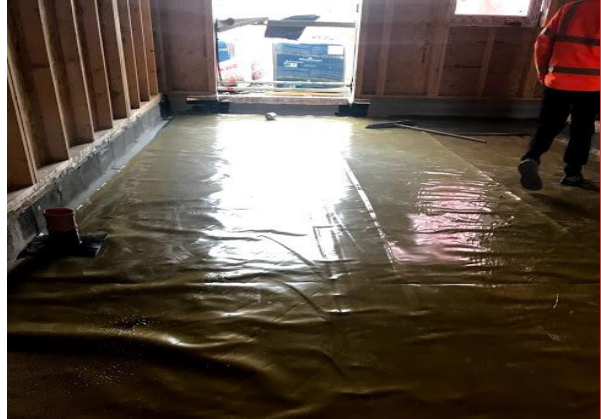
**Plot - 3**

**General Condition of Membrane-Good Condition**

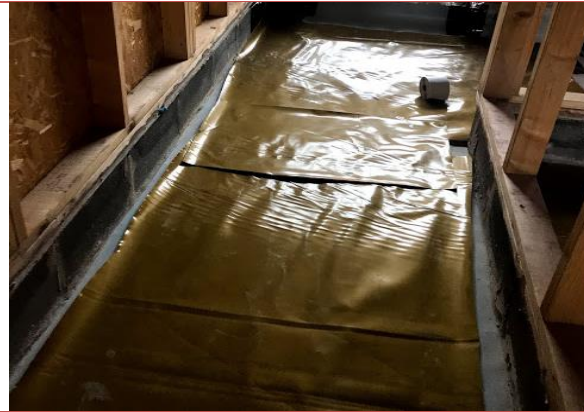
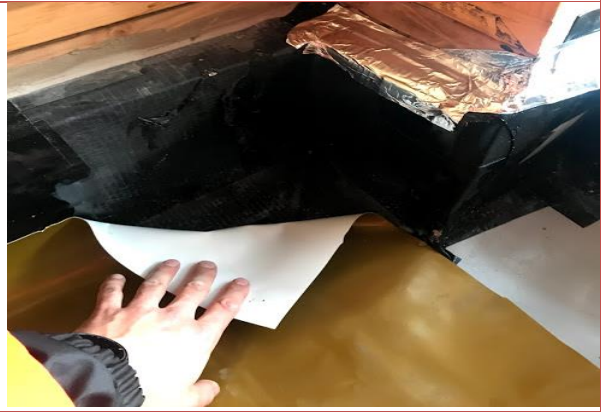
**Verification of Joints and Seals-Good Condition**

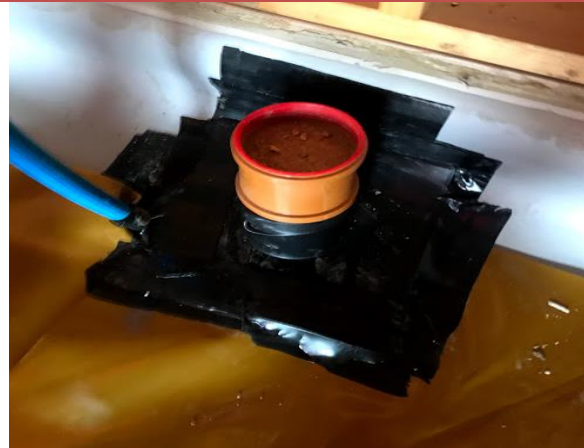
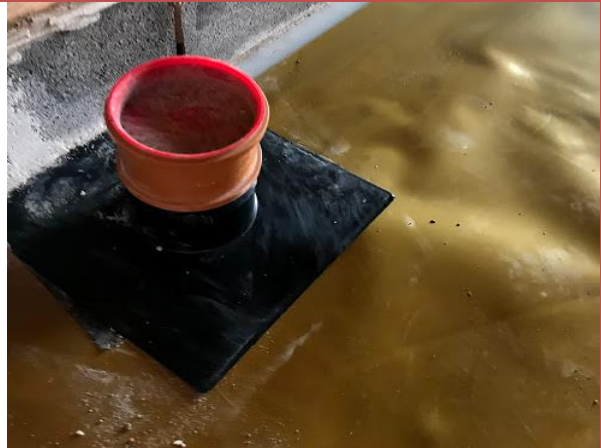
**Verification of Service Penetrations-Good Condition**

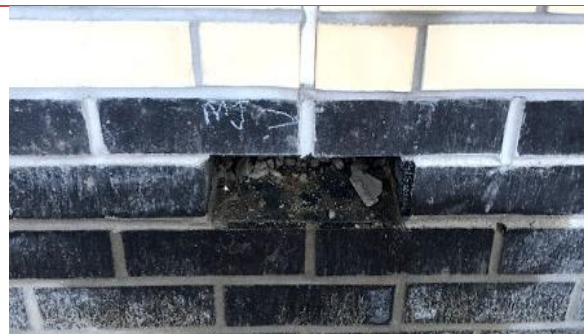
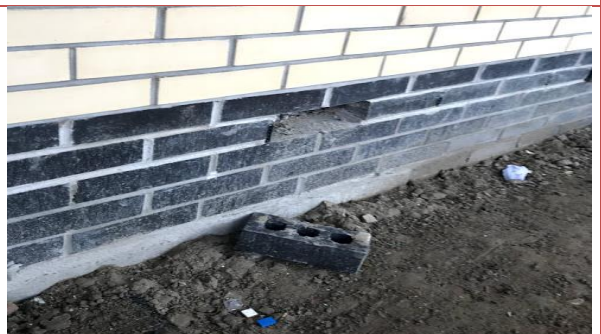
**Verification of ventilation-Good Condition**

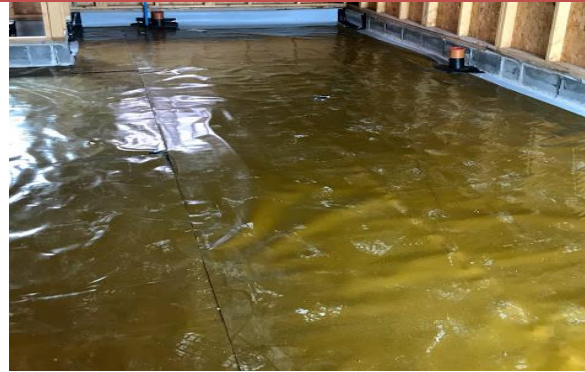
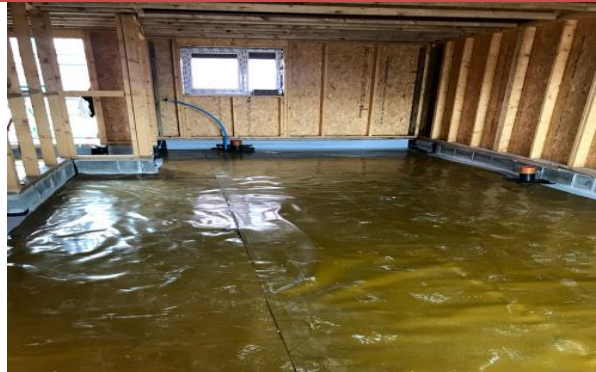
**Plot - 4**

**General Condition of Membrane-Good Condition**

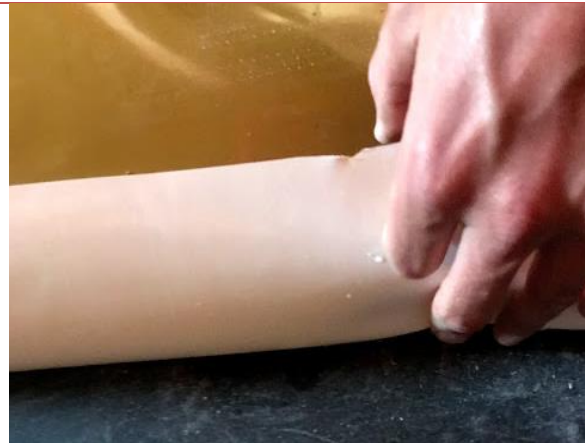
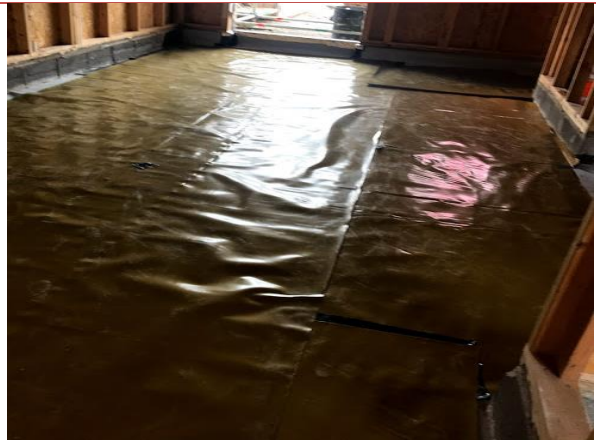
**Verification of Joints and Seals-Good Condition**

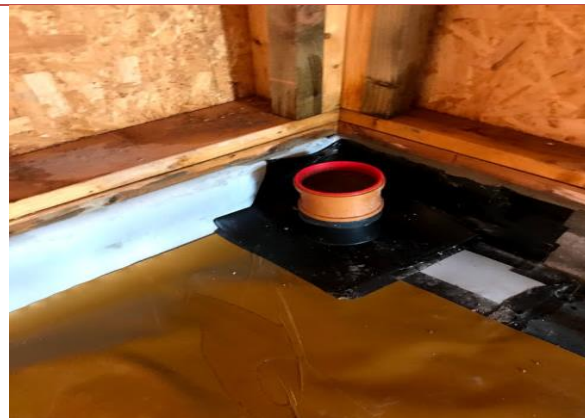
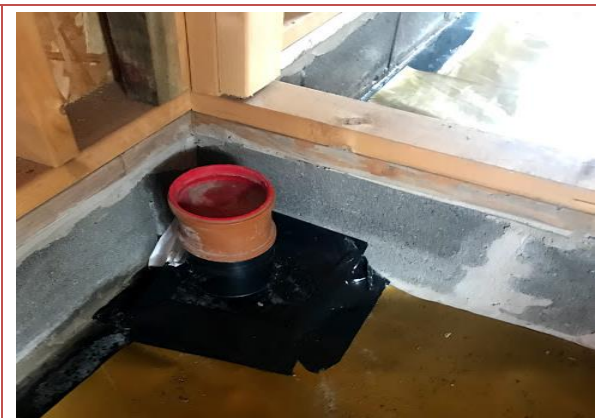
**Verification of Service Penetrations-Good Condition**

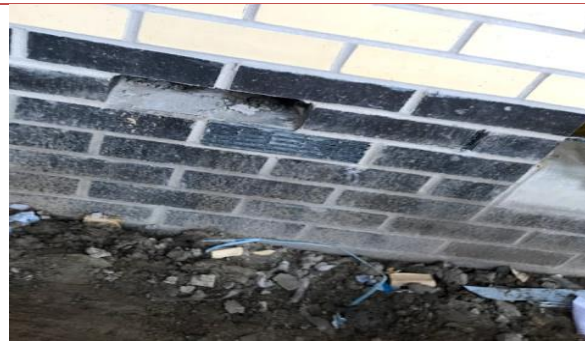
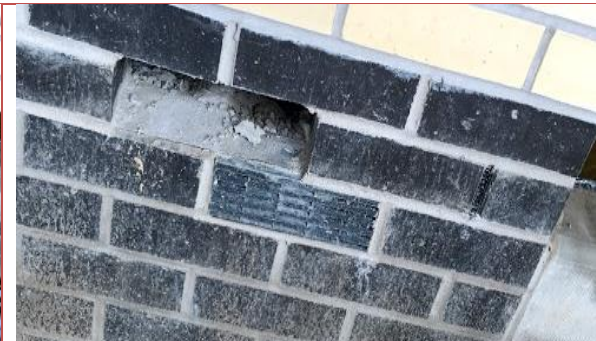
**Verification of ventilation-Good Condition**

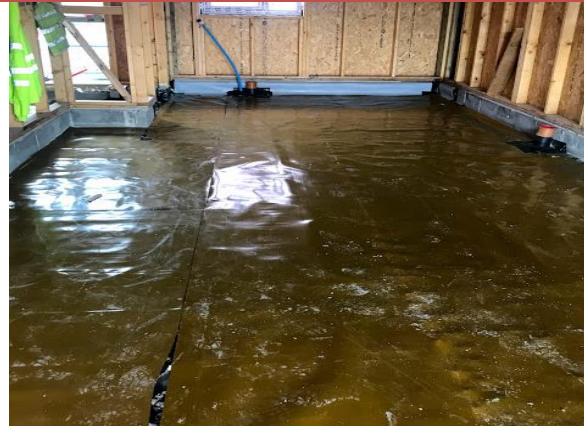
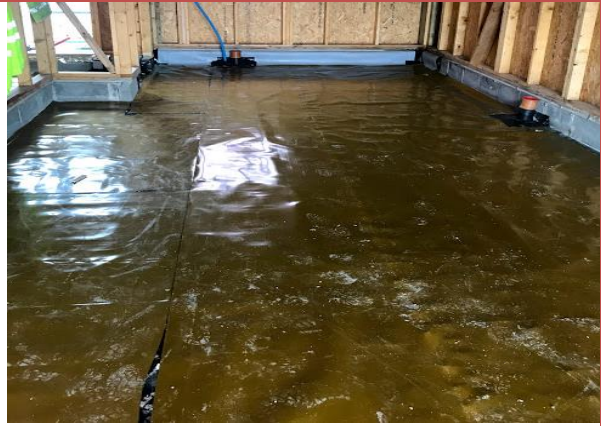
**Plot - 5**

**General Condition of Membrane-Good Condition**

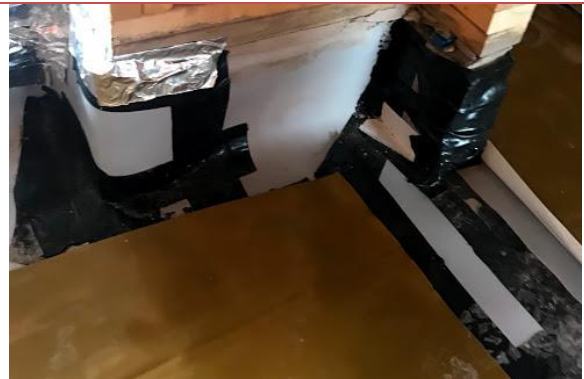
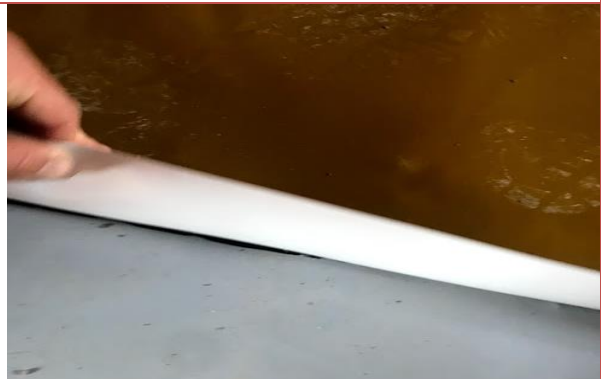
**Verification of Joints and Seals-Good Condition**

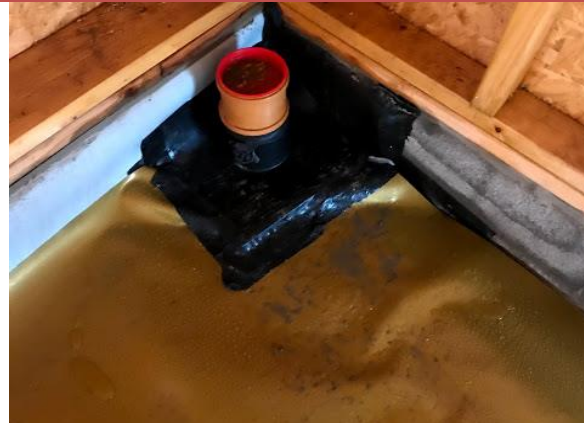
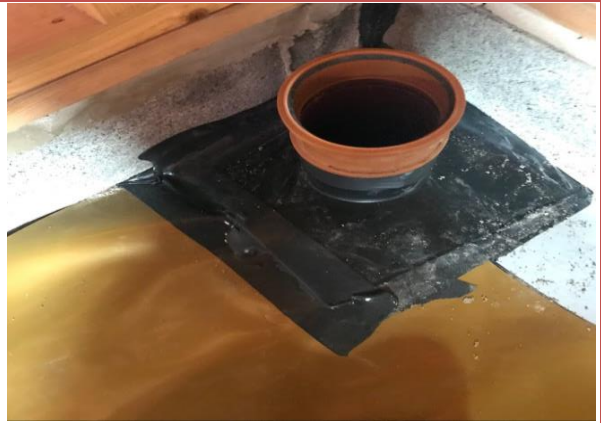
**Verification of Service Penetrations-Good Condition**

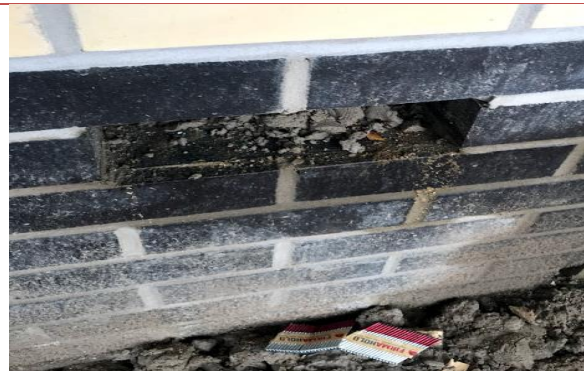
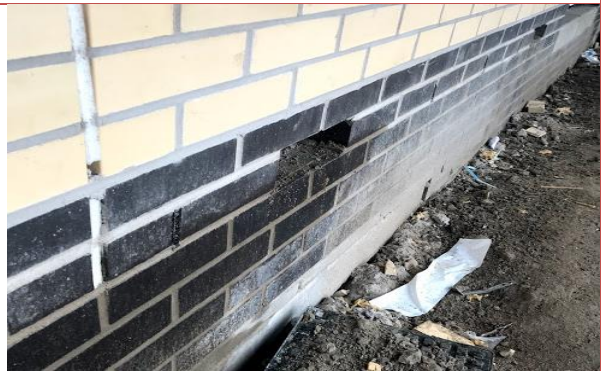
**Verification of ventilation-Good Condition**

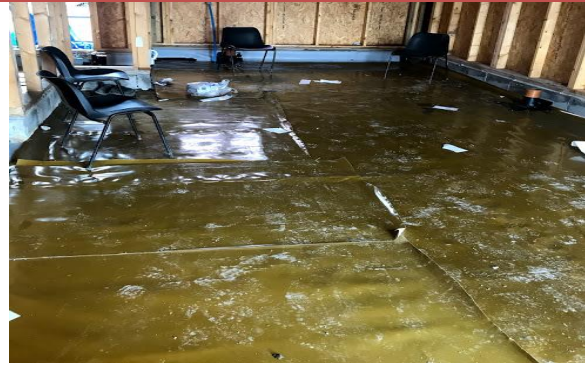
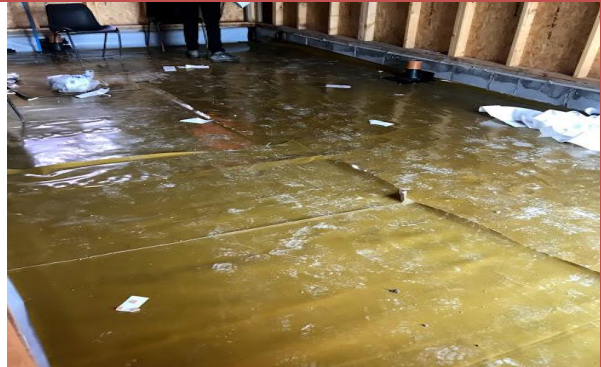
**Plot - 6**

**General Condition of Membrane-Good Condition**

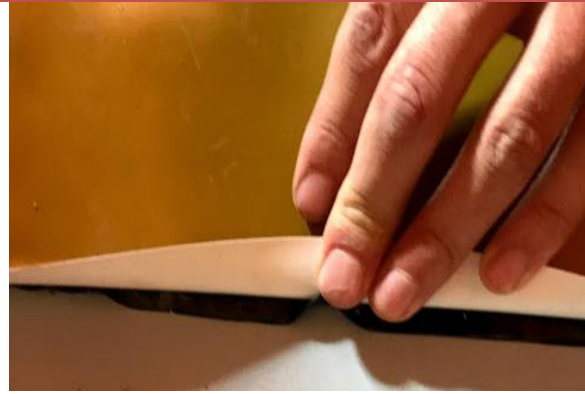
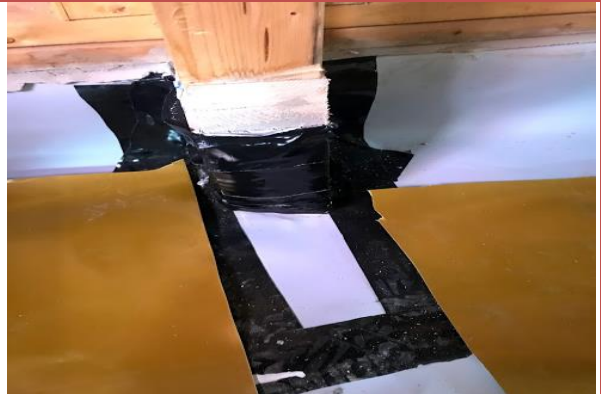
**Verification of Joints and Seals-Good Condition**

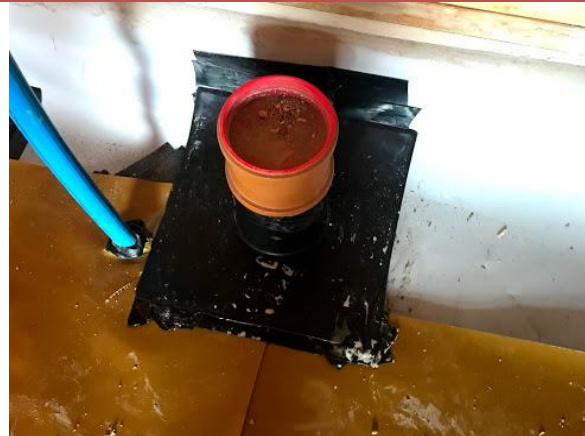
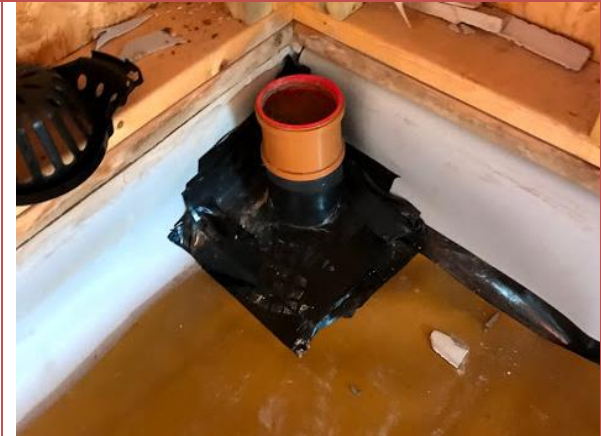
**Verification of Service Penetrations-Good Condition**

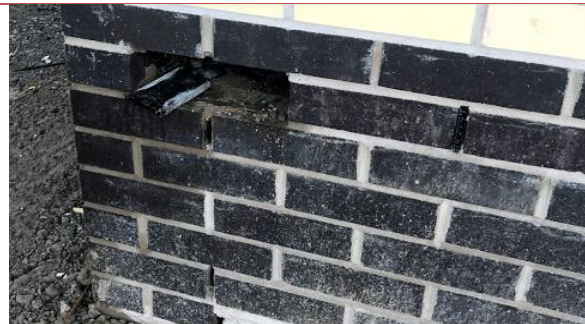
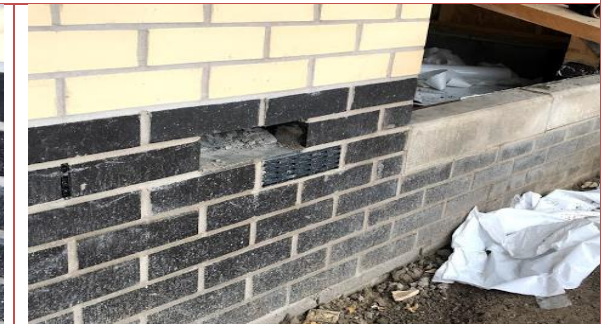
**Verification of Ventilation-Good Condition**
