# Drainage Report

Prepared For  
**First Choice Groundworks**

Site  
**Portway  
Wythenshaw**

## First Choice Groundworks Portway Wythenshaw - CCTV Survey Report : 28/01/21

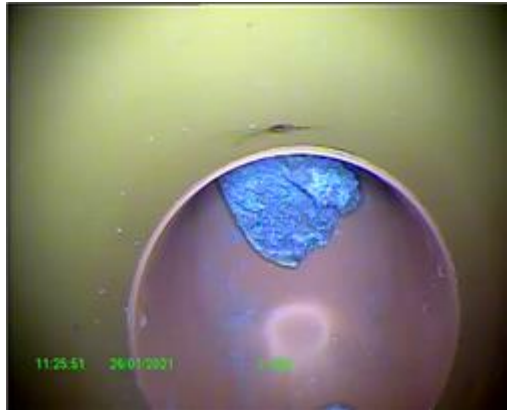
| Position | Code | Description | CD | Pic | Video Ref | |
|---|---|---|---|---|---|--|
| 07.80m | OB | Other obstacles 80% | | 1_3 | 0:01:07 | |

| Pos | Video Ref | Code | Description | Image |
|---|---|---|---|---|
| 07.80m | 0:01:07 | OB | Other obstacles: 80% Cross<br>sectional area loss - Severity 3<br>Object stuck within SVP. | Image Provided - Ref: 1_3<br> |

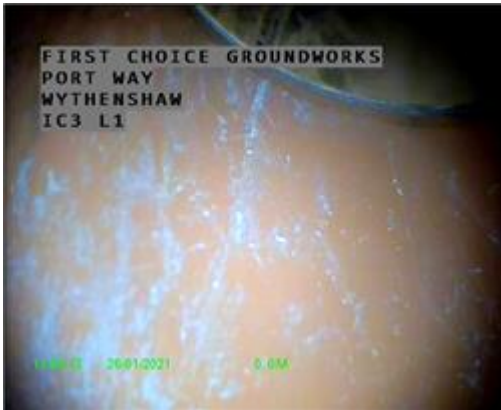
| Pos | Video Ref | Code | Description | Image |
|---|---|---|---|---|
| 00.80m | | SA | Survey abandoned<br>Unable to pass 90 degree<br>bend. | |
