Structural Assessment  
of  
Parapet Walls and Copings  
at  
Victoria Mill  
10 Lower Vickers Street  
Manchester  
M40 7EL

Client Name: Medlock Construction

Our ref: LM31184

## STRUCTURAL ASSESSMENT REPORT

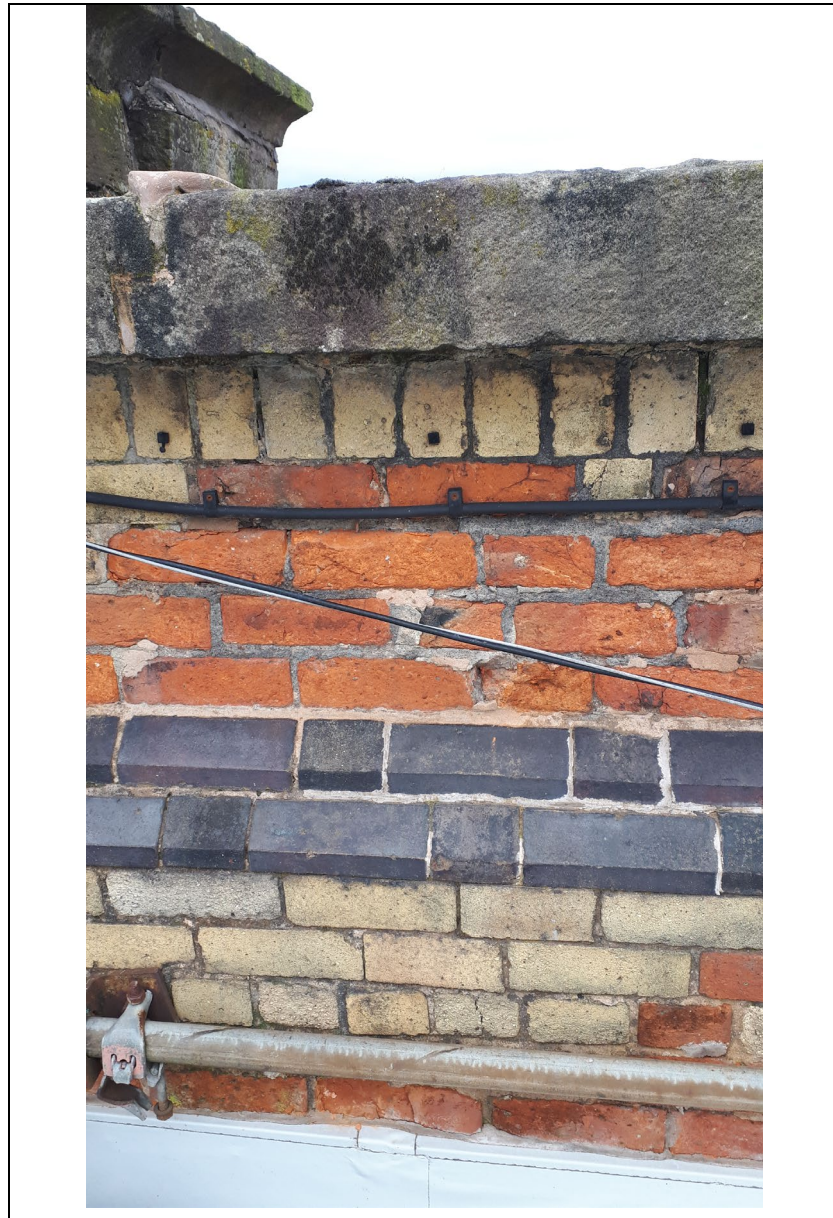
**Photograph No. 1 – Showing general view of front parapet wall and stop coping scarf joint**

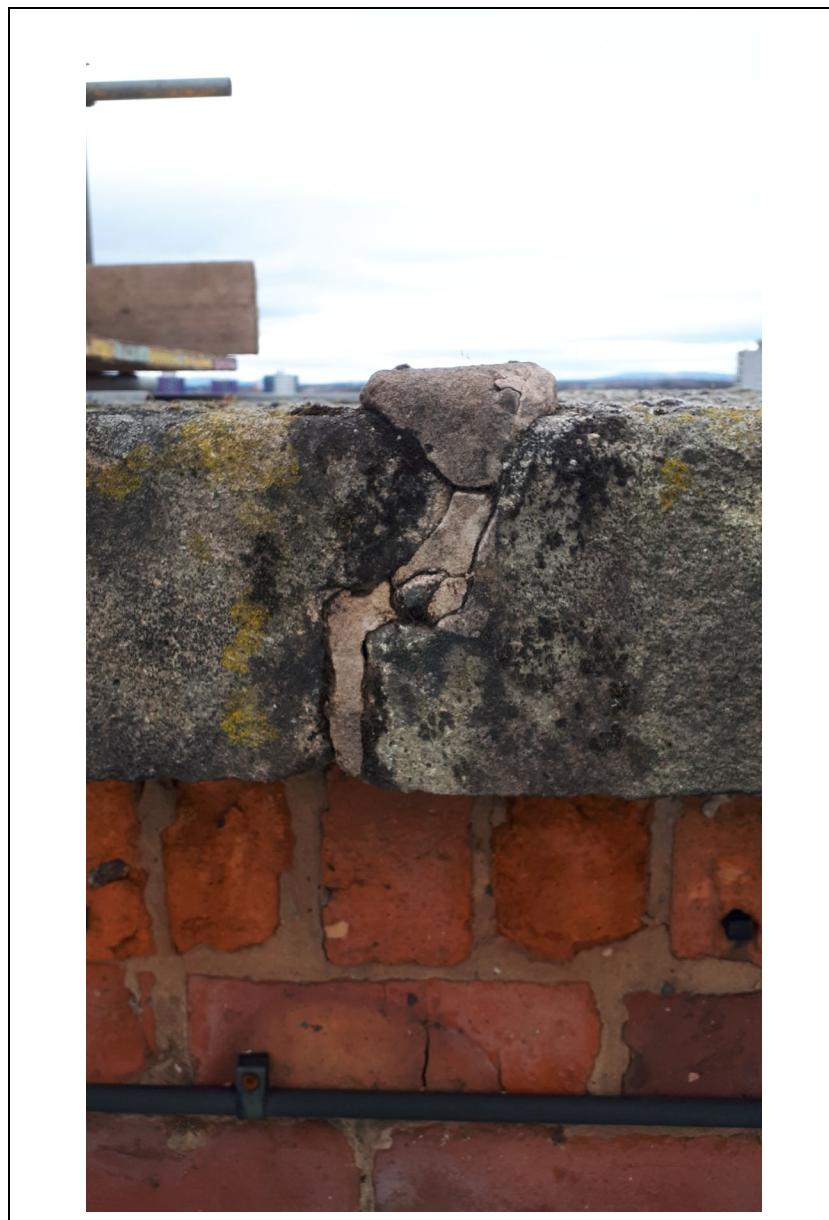
- 4.2.2 Past works have been carried out at this level to point the internal face of the scarf joint between stones and form an approximate 100mm wide x 10mm deep fillet joint between stones upon the surface using sand / cement, we assume carried out at the same time as the parapet wall repointing. Approximate 16mm diameter steel dowel bars were noted through the head of the stone copings located towards the left hand projecting corner we assume fixing the stones into the head of the parapet brickwork.

**Photograph No. 2 – Showing joint between coping and 100mm wide x 10mm deep mortar fillet between stones across elevations**

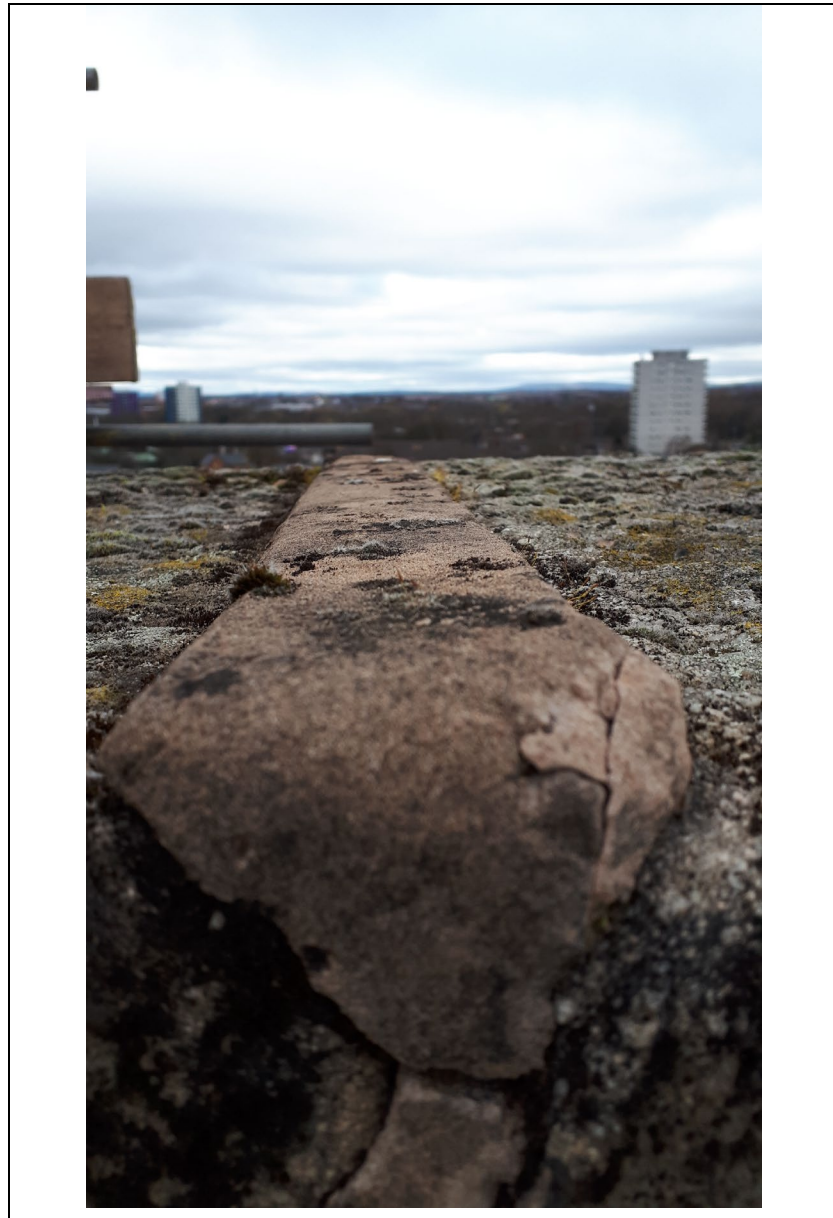
**Photograph No. 3 – Showing approx. 100mm wide x 10mm deep sand/cement fillet between stone copings**

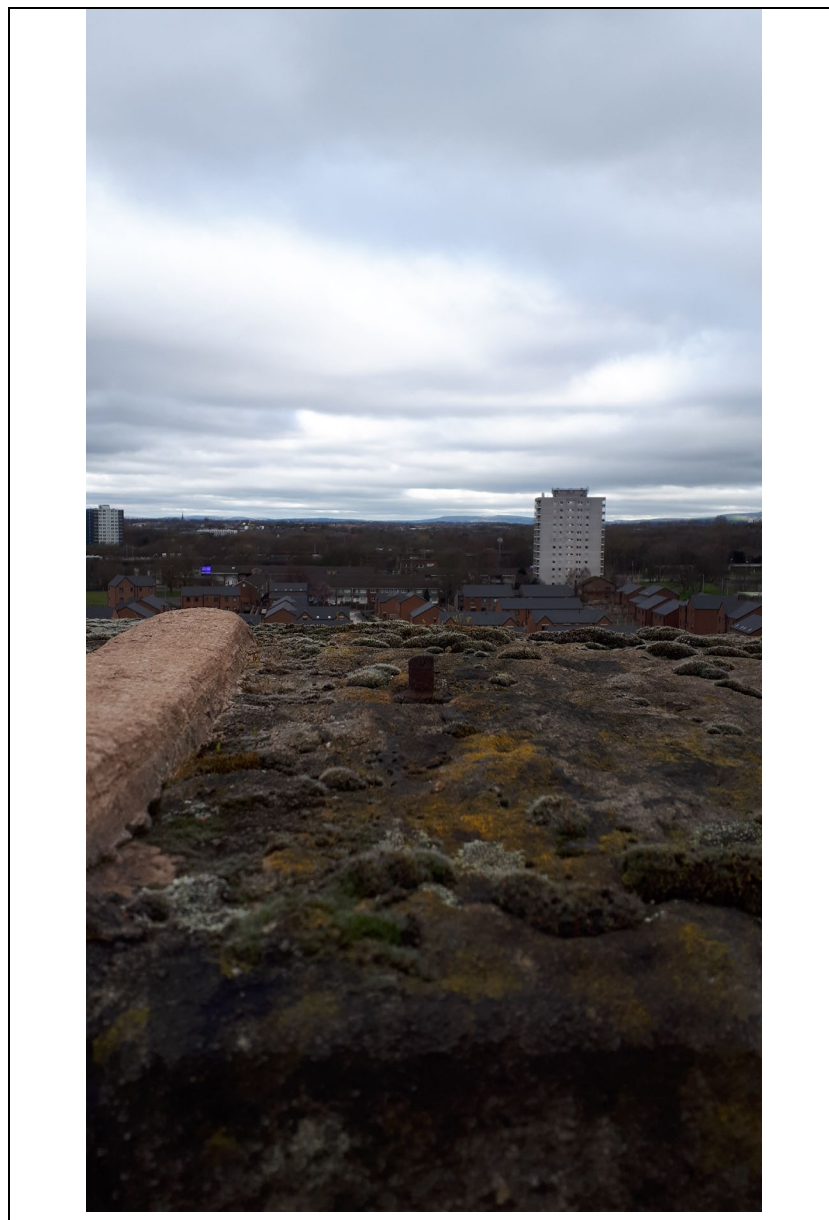
**Photograph No. 4 – Showing steel dowel bar through stone coping to front parapet wall**

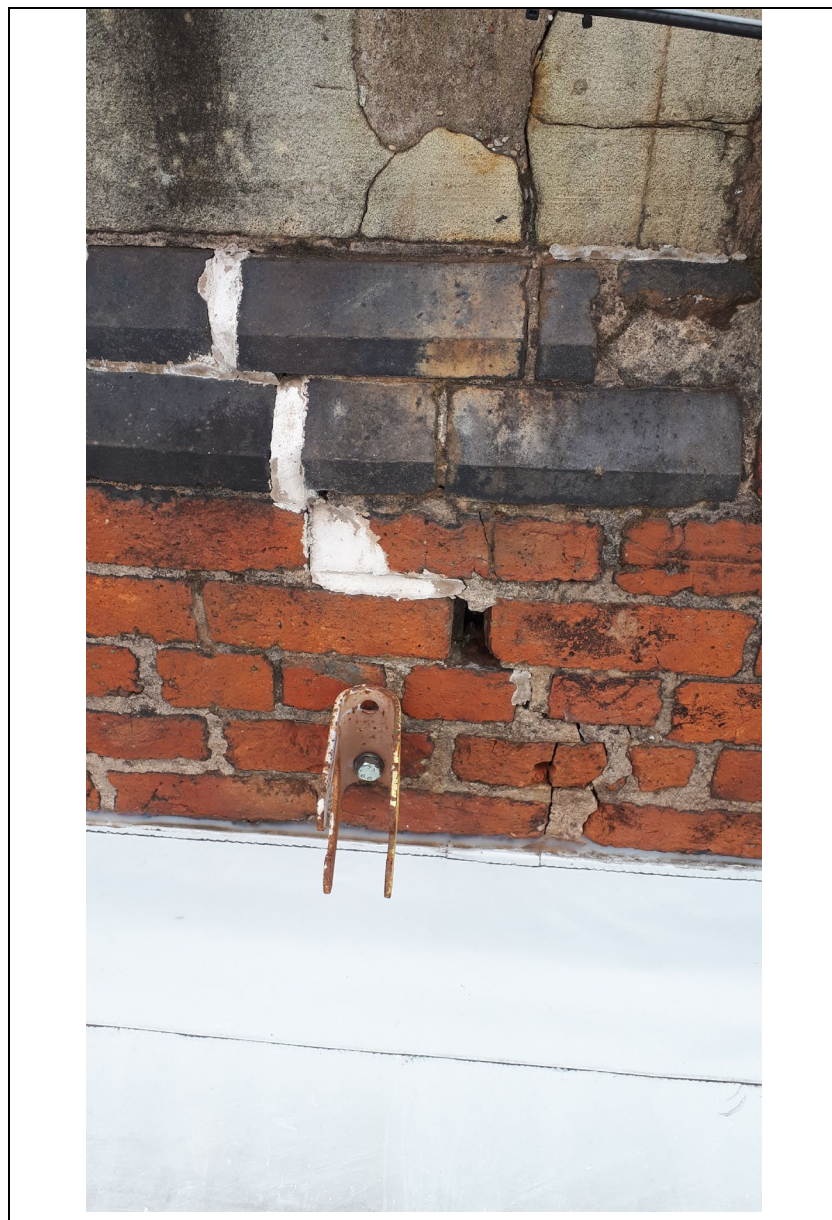
- 4.1.2 The internal face of the parapet walls has in the past, been raked out and pointed using sand / cement mortar as opposed to the original black mortar, which appears to be black ash. Areas of this light sand / cement pointing are cracked and falling out through the effects of long term deterioration and weathering where the depth of the pointing noted to be quite shallow e.g 10mm.

- 4.1.3 The deterioration of the sand / cement mortar is most prevalent to the internal face of the front parapet wall and high level parapet walling at the front / left hand corner of the building leaving open mortar bed and perpend joints to both the common brickwork and white facing brickwork. Remedial action is required in this regard.

**Photograph No. 5 – Showing deterioration  
past painting to front wall requiring  
repointing**

- b. Rake out and remove any cracked, spalled or loose mortar to a minimum depth of twice the height of the joints and thoroughly clean out joints of all plant, seed growth, dust and debris etc. Thoroughly dampen brickwork and repoint areas of brickwork using good quality mortar

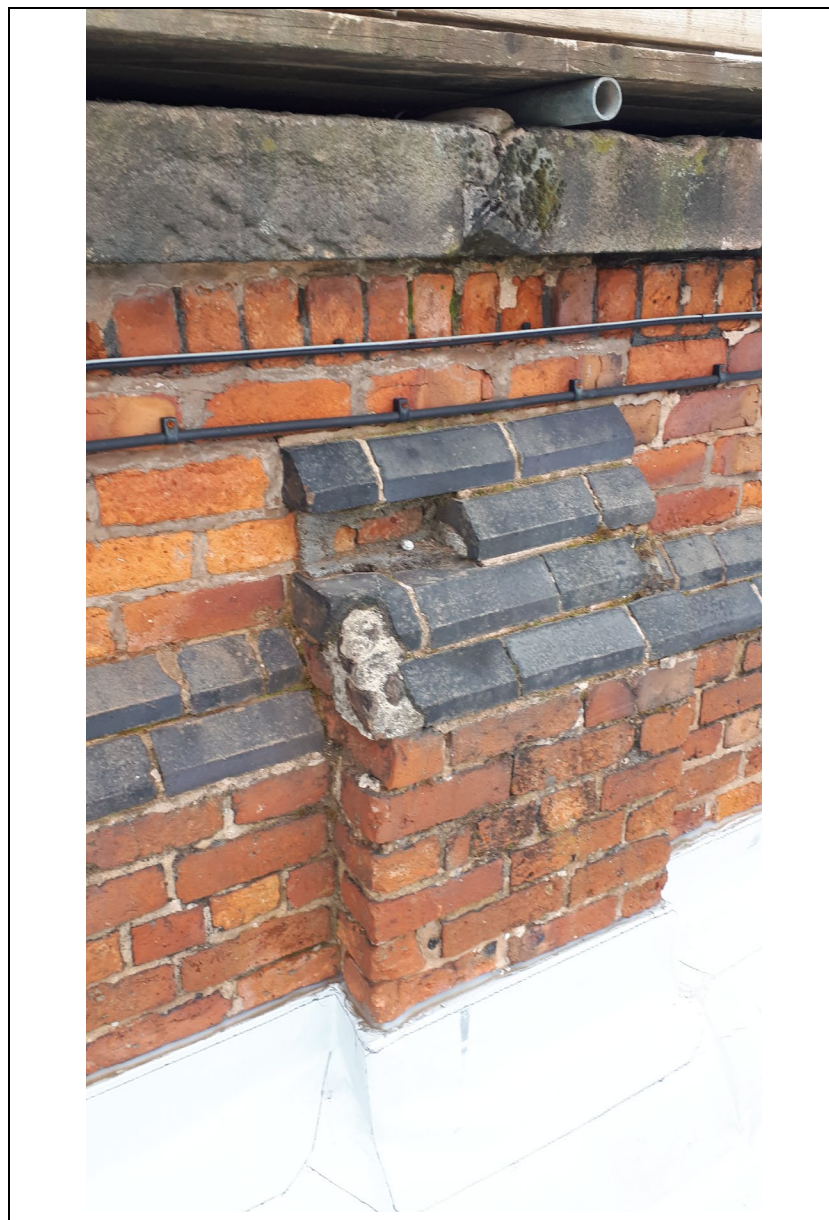
- 4.1.4 There is early stage plant growth within mortar bed joints in isolated locations across the front parapet wall which requires fully removing i.e ensuring the root is removed, followed by localised repointing of the affected areas. Further there is a blue cant brick missing at the head of the buttressing pier towards the left corner of the front parapet wall which requires reinstatement to match the existing.

**Photograph No. 6 – Showing missing cant  
brick to front parapet wall pier requiring  
reinstatement**

- d. Reinstate missing outer leaf brickwork to the high level parapet at the rear / left hand corner of the building
  - e. Reinstate all missing cant bricks and parapet wall inner leaf bricks using good quality bricks and mortar to match the existing

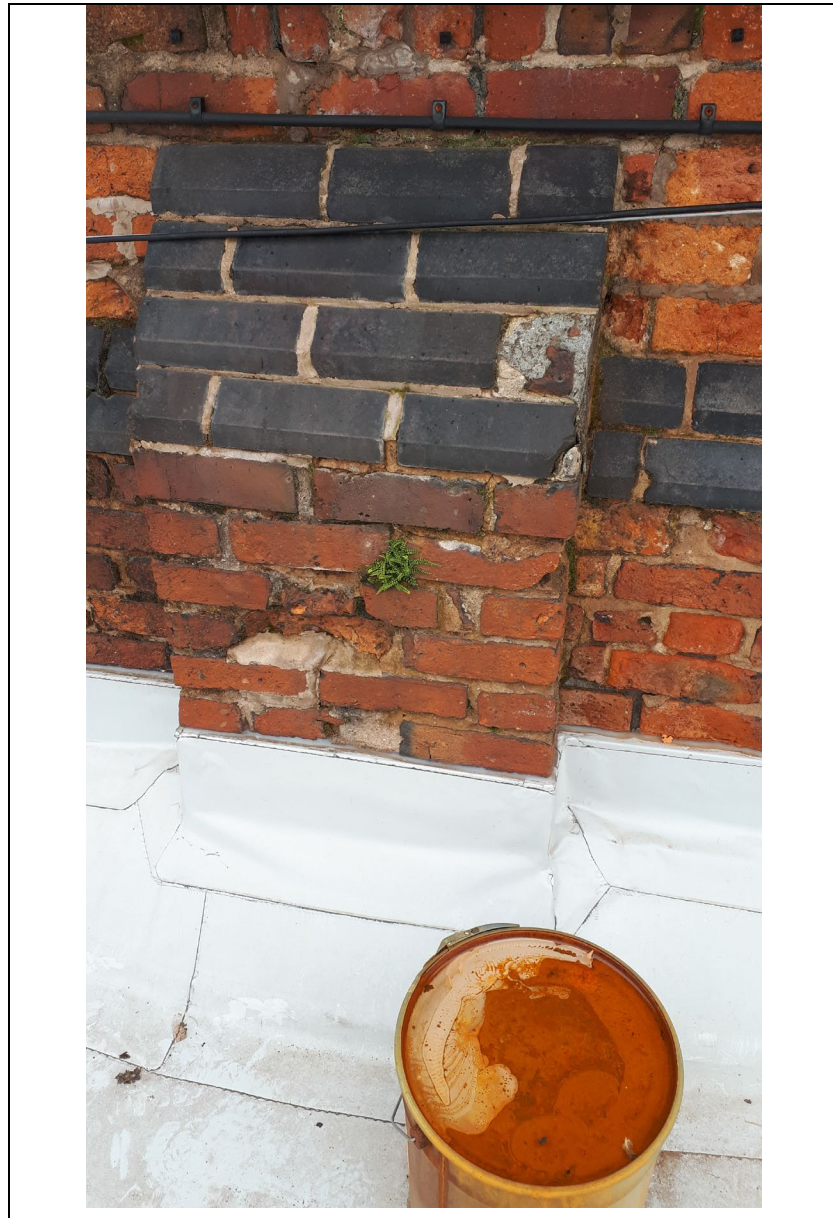
**Photograph No. 7 – Showing spalling to front parapet wall brickwork and early stage plant growth**

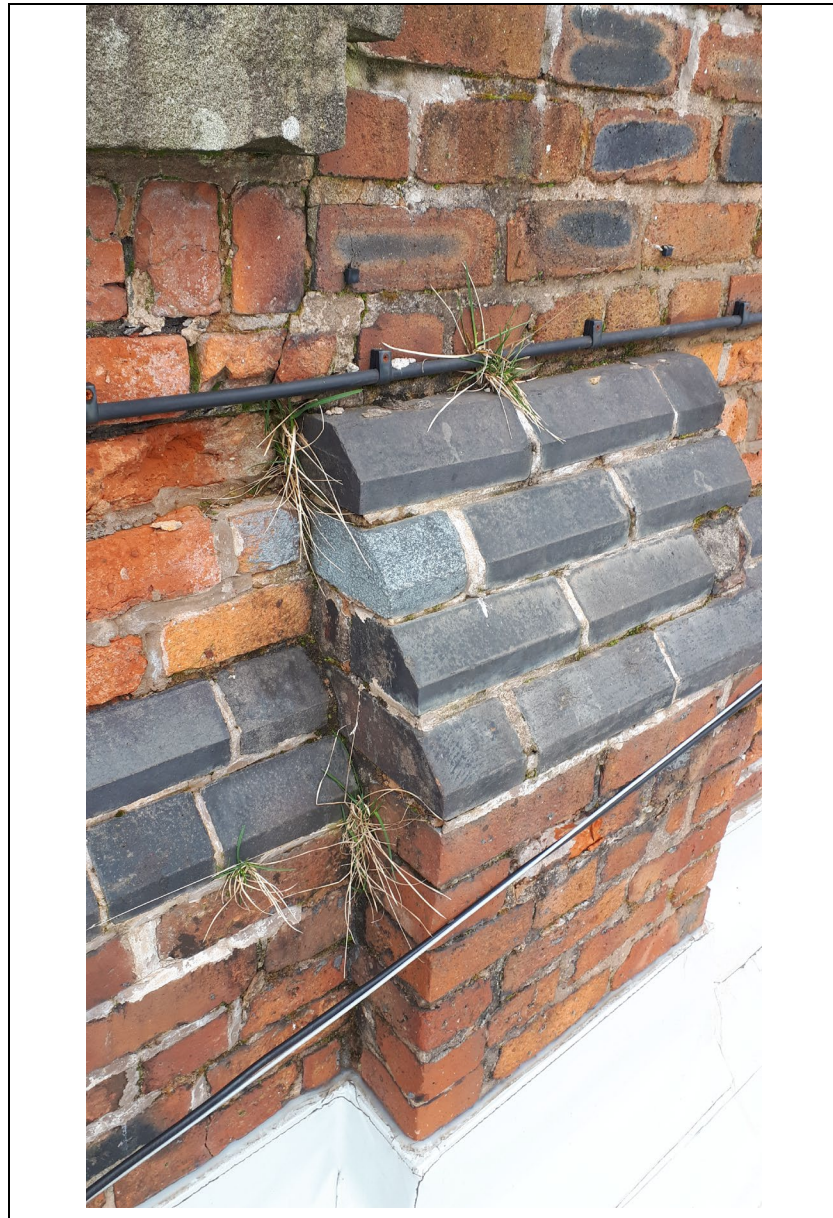
**Photograph No. 8 – Showing early stage plant growth within joints to front parapet wall**

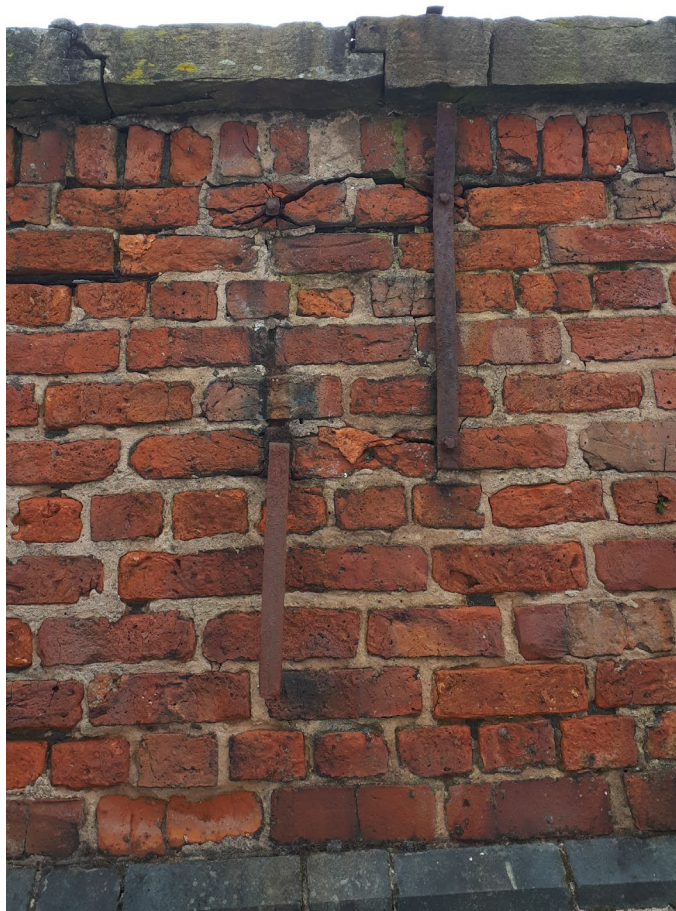
- 4.1.5 There are redundant steel straps bolted to the head of the high level parapet wall at the front / left hand corner of the building. Corrosion on the bolts through exposure to the elements has led to expansion of the steel, with these expansive forces transferred into the bricks causing them to split. In addition there are areas of open jointed brickwork where the sand / cement pointing is deteriorating and falling out the joints.

- 5.5 Corrosion of embedded steel bolts to redundant steel restraint straps has caused damage to brickwork to the high level parapet walling at the front / left hand corner of the building whilst a small section of outer leaf brickwork is missing to the high level rear / left hand parapet. Localised cutting out of cracked / damaged bricks and reconstruction of the affected area are considered necessary at these locations in addition to reinstatement of any current missing brickwork.

**Photograph No. 9 – Showing steel restraint straps and cracking to brickwork at North East corner requiring removal/repainting**

- c. Cut out split / cracked bricks to the high level parapet walls at the front / left hand corner of the building and bed new good quality bricks and mortar to match the existing

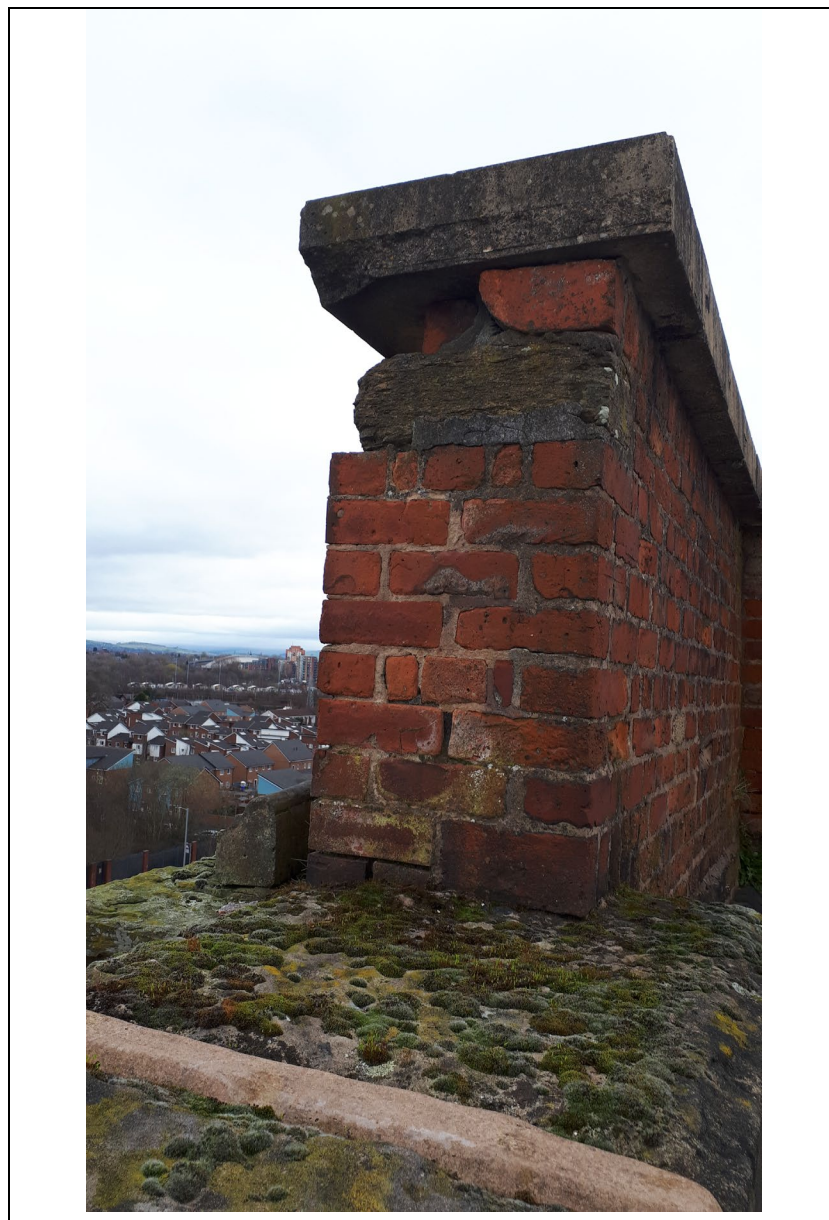
- 4.1.7 A small section of outer leaf brickwork is missing at the corner of the high level parapet walling at the rear / left hand corner of the building which requires reinstatement using new bricks matching the appearance of the existing. A small piece of stone or concrete is located on the external stone plinth at this location which requires immediate removal where it present a safety risk of falling from above.

- 5.6 Immediate works are required to remove the stone which is located on the external plinth at the rear / left hand corner where this presents a risk of falling onto persons below.

**Photograph No. 10 – Showing missing brickwork to outer leaf at South East corner and stone piece on projecting plinth**

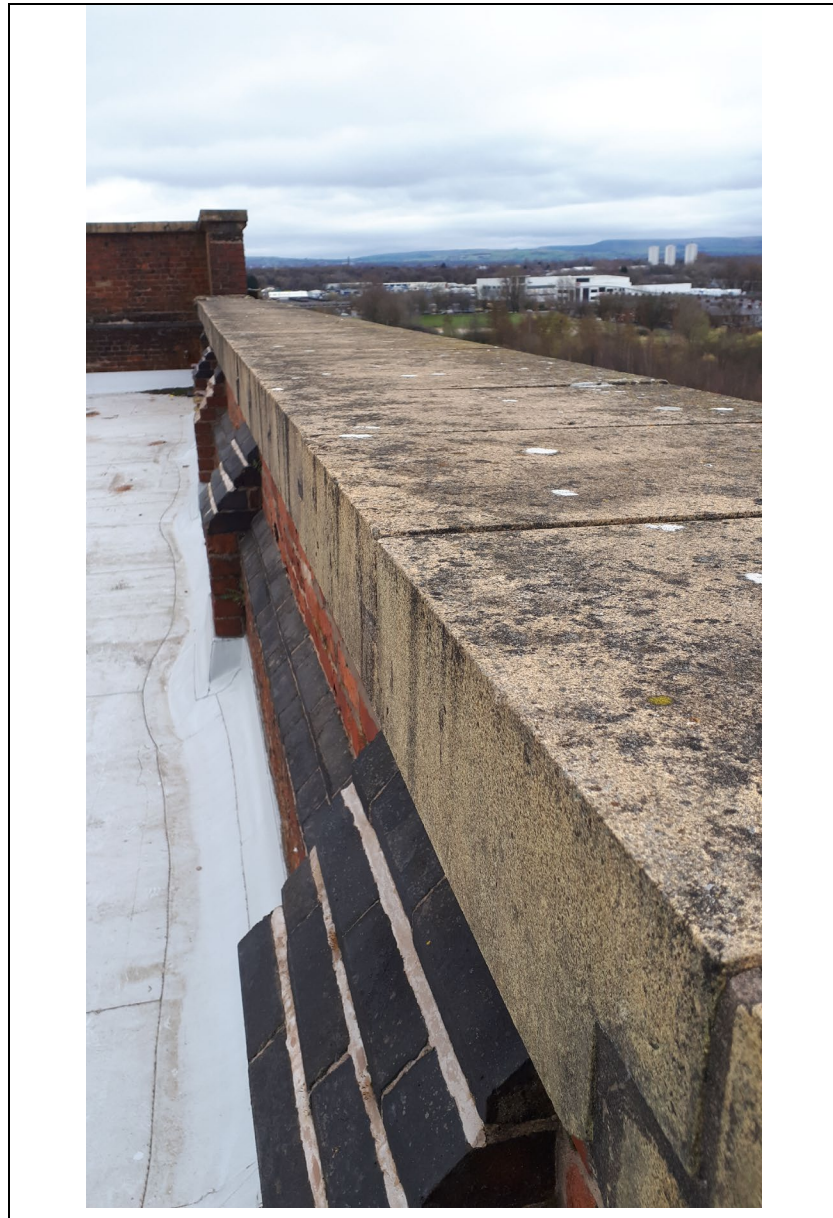
- 4.2.6 Original stones have been replaced with approximate 500mm long x 770mm wide x 150mm deep pre-cast concrete copings above the rear parapet walling, replicating the scarf joint detail of the original stones. This is with the exception of 2 No remaining stones at the abutment of the high level parapet walling at the left / rear corner and initial 4 No pre-cast concrete copings which are 640mm wide. There are 20mm diameter steel dowel bars visible through the head of each coping we assume fixing it to the head of the parapet brickwork. We noted 61 No pre-cast concrete copings across the rear elevation parapet walling.

- 4.2.7 The pre-cast concrete copings were noted to be of reasonable alignment and free from noticeable movement when tested by hand or upon inspection of the mortar between copings. In addition there is no significant moss growth to the surface of these copings where the surface is relatively smooth with falls towards the outer edge.

**Photograph No. 11 – Showing recent concrete copings to South elevation (rear) parapet walling**

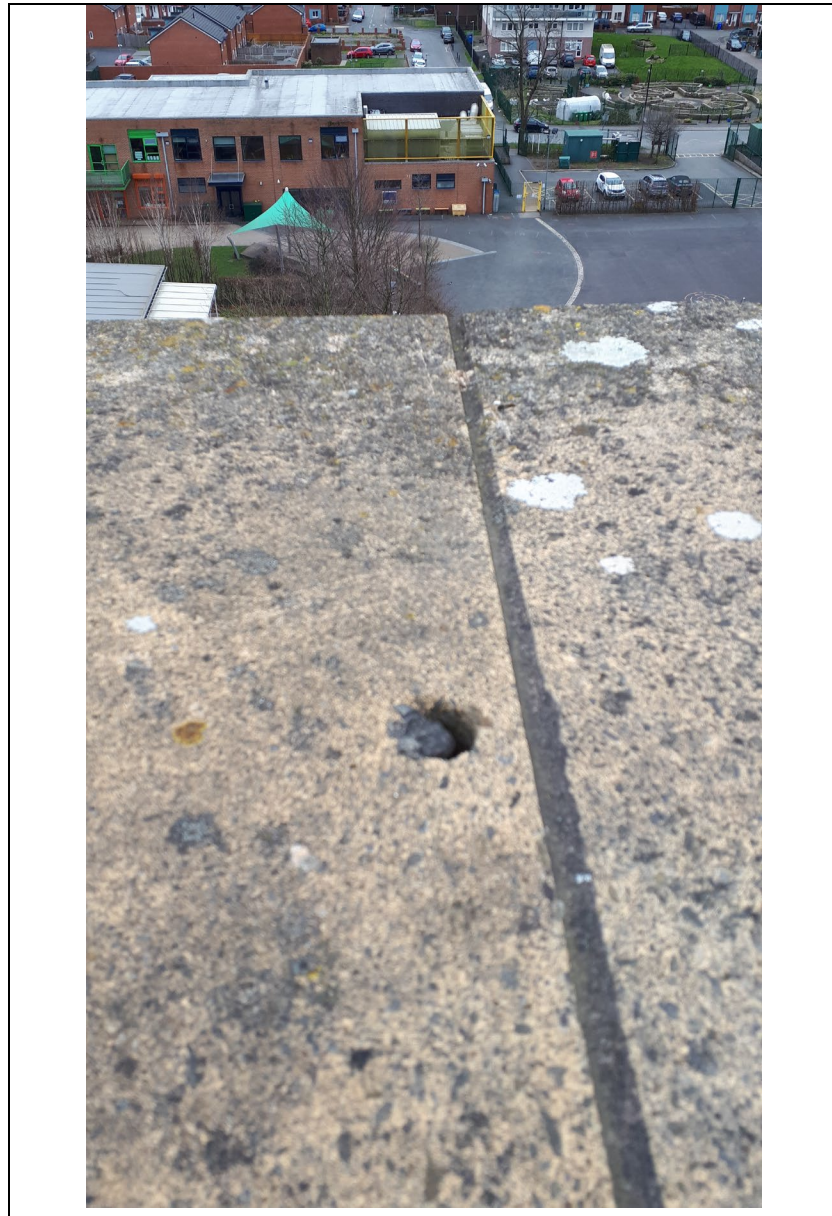
**Photograph No. 12 – Showing steel dowel bolt through concrete coping**

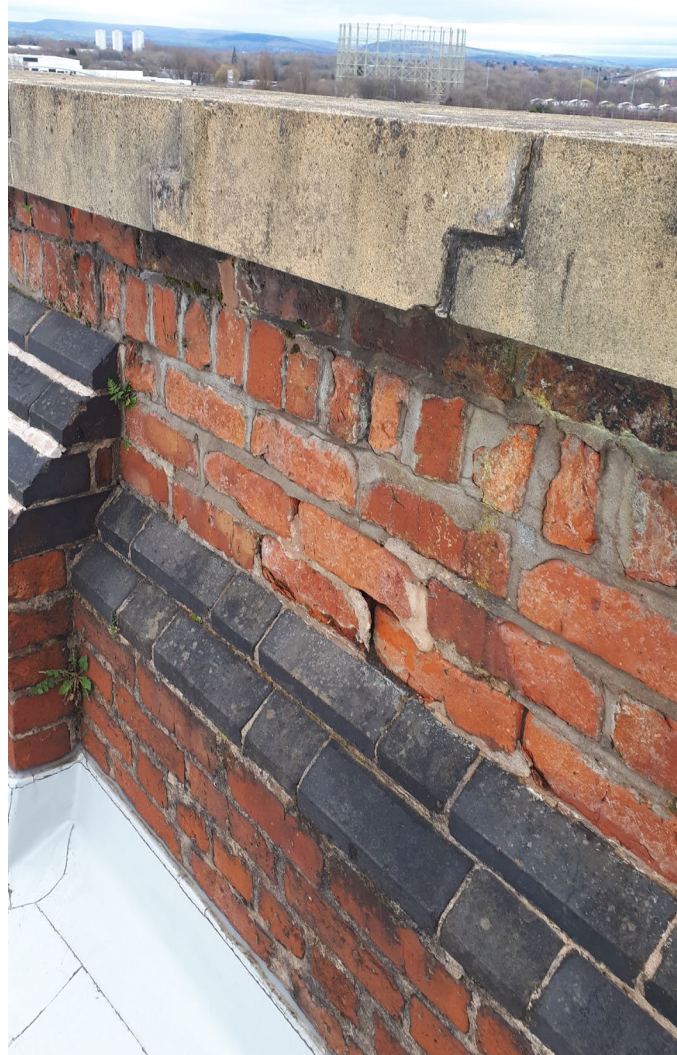
- 4.1.8 Pointing to the rear parapet walling was generally noted to be in a reasonable condition with only isolated areas of deterioration of the shallow sand / cement mortar and isolated early stage plant growth. Localised works are considered necessary to this elevation to remove the plant growth and repoint any areas of loose / missing mortar.

**Photograph No. 13 – Showing weathered brickwork to South (rear elevation) parapet wall**

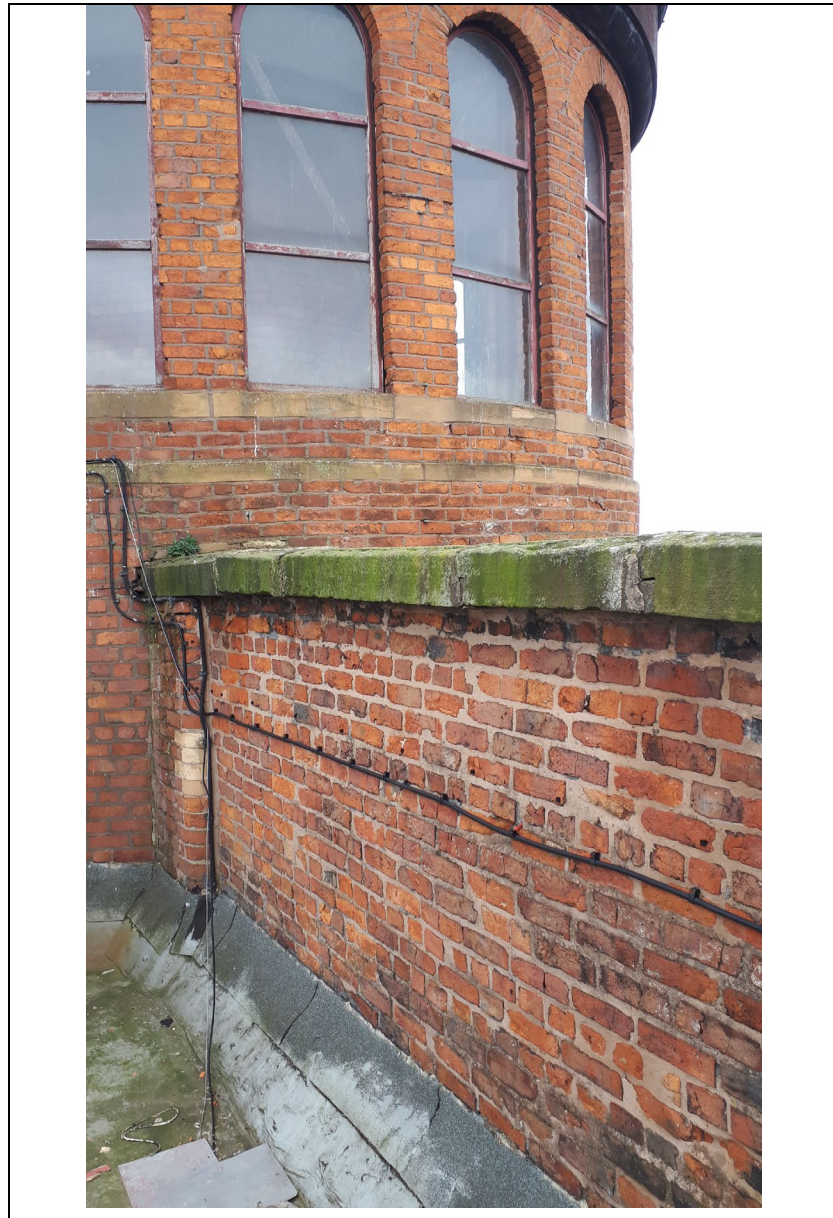
- 4.2.3 Slight undulations were noted between stone copings consistent with a building of this age most noticeable to the short section of the front parapet walling adjacent to the tower. In addition there are cracks and spalling to the internal edge of the stone copings most common at the joint positions with past repairs / repointing of longstanding origin.

**Photograph No. 14 – Showing uneven stone copings to front elevation adjacent to tower**
