| MEDLOCK<br>VICTORIA MILL<br>MILES PLATTING | | | |
| SOUTH EAST ELEVATION<br>RECORD PHOTOGRAPHS AND REPAIRS REQUIRED | | | |
| MED02 | AP202 | A | |

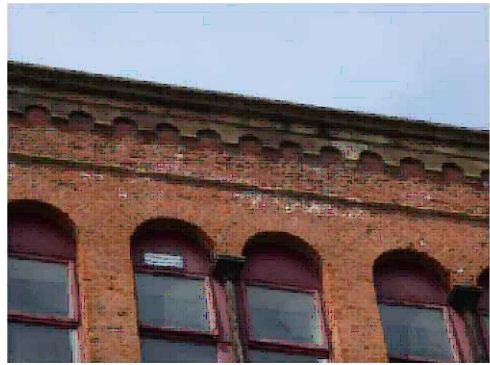
1. Water ingress causing salt to appear on face of brick. Water ingress to be resolved, brickwork to be cleaned.

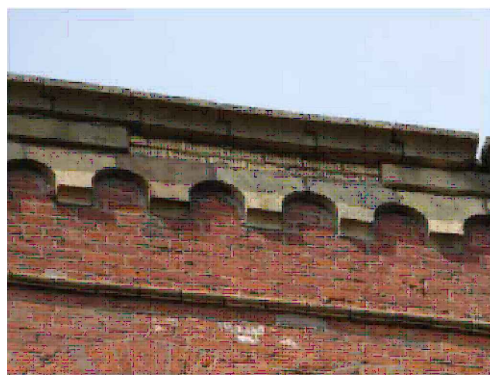
2. Cornice repair. Modern yellow brickwork to be replaced with stonework.

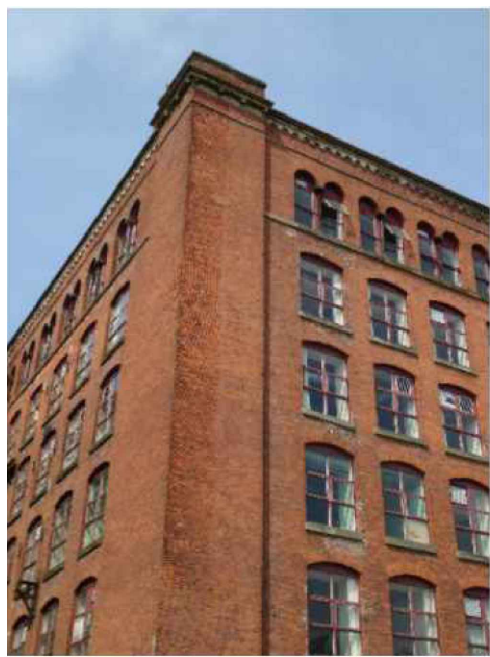
3. Check condition of existing mortar on southern corner, full height of building. Repoint where necessary with mortar to match existing.

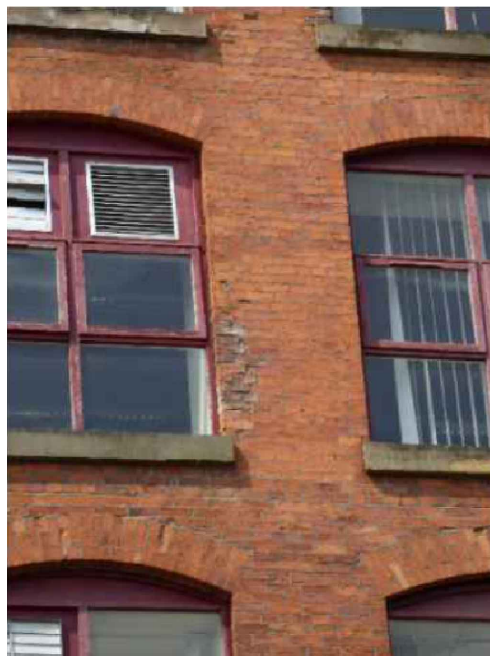
4. Poor pointing to brickwork. Rake out and repoint with mortar to match existing.

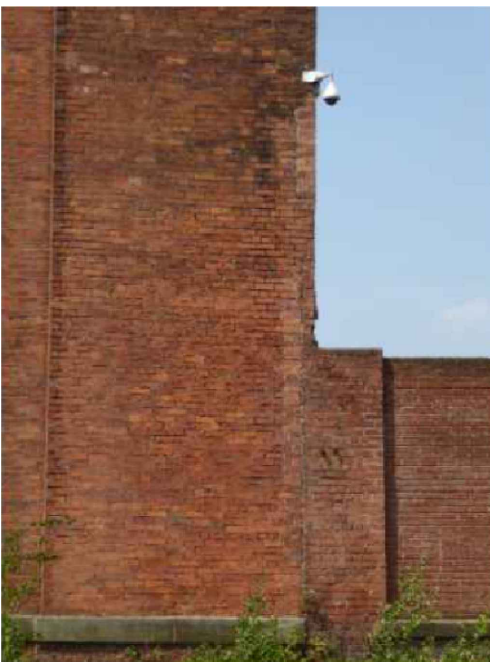
5. Poor pointing of brickwork. Rake out existing mortar and repoint with mortar to match existing.

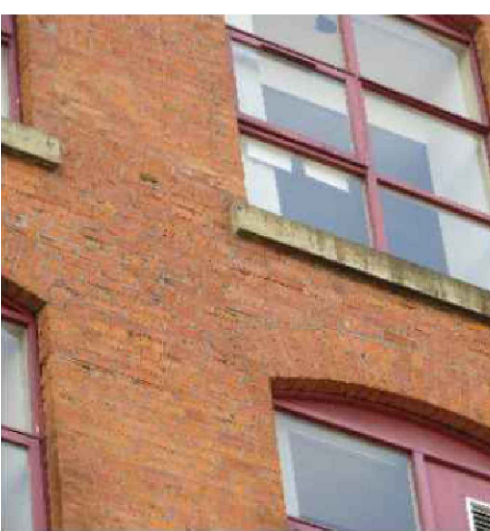
6. Condition of existing stone cill. Record photo.
