| PROJECT<br>MEDLOCK<br>VICTORIA MILL<br>MILES PLATTING | | | <div><br/>ALLISON PIKE<br/><div>ARCHITECTS &amp; DESIGNERS</div></div> | | |
| TITLE<br>NORTH EAST ELEVATION<br>RECORD PHOTOGRAPHS AND REPAIRS REQUIRED | | | | | |
| JOB No<br>MED02 | DRAWING No<br>AP201 | REV<br>B | 7 Buxton Road West, Disley,<br>Stockport, Cheshire, SK12 2AE.<br>Website: www.allisonpike.com | | |

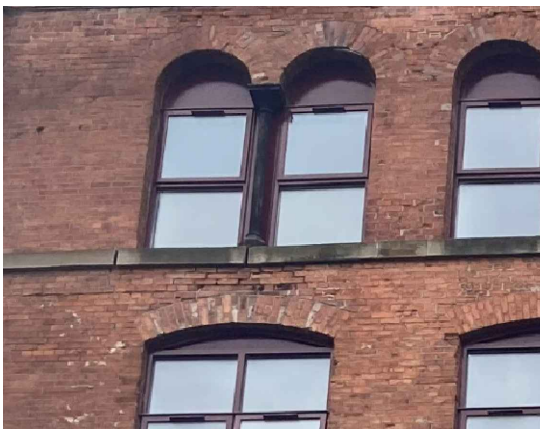
2. Damaged pointing above window head and widow cill to window above. Repointing required with mortar to match existing.
