## **PHASE 1 CONTAMINATED LAND RISK ASSESSMENT REPORT**

**Project No. 1701-6450**

**Dappa Homes Limited**

**White House Club**

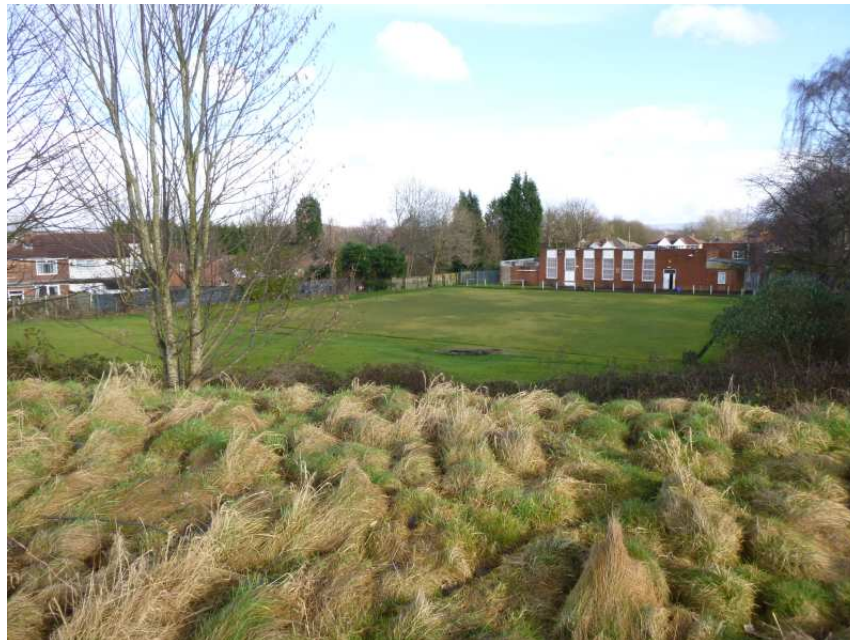
View of the rear of the club and the bowling green. The bowling green was waterlogged at the time of the inspection

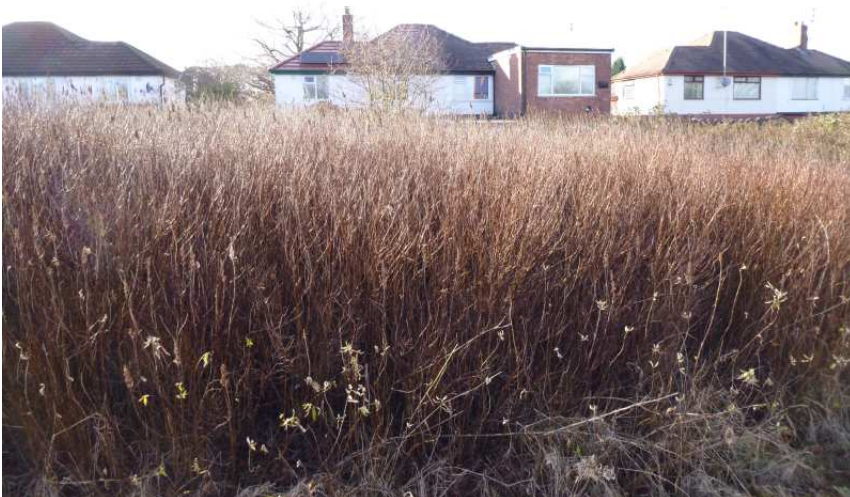
View of annual growth of vegetation on the western boundary.  
The picture shows the slight elevation of the pitch area and the houses to the rear.

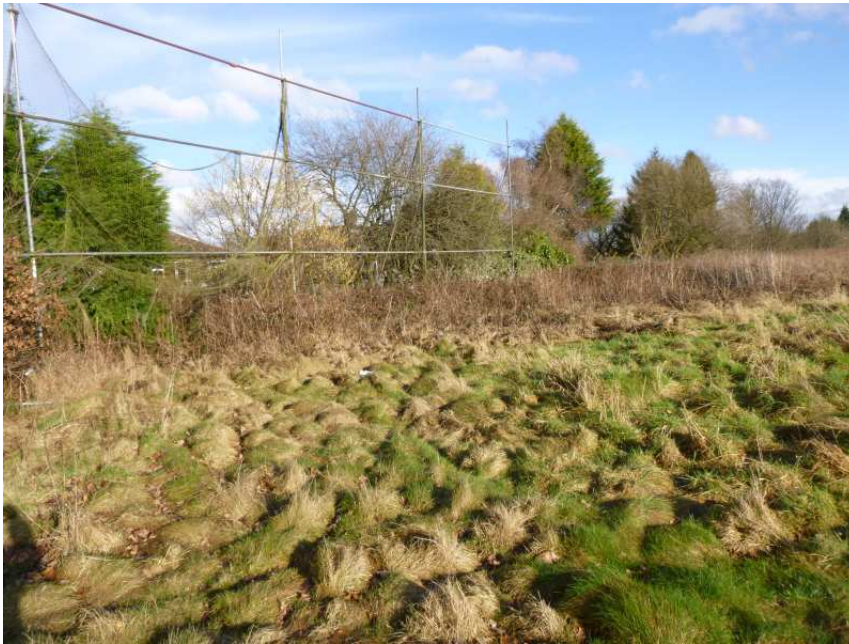
View of the established annual vegetation on the northern boundary of the pitch area.

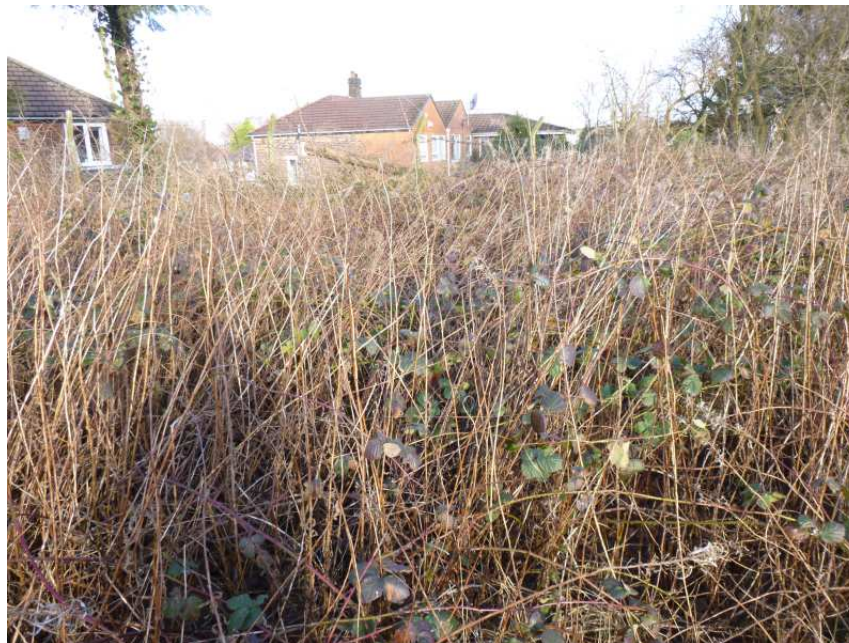
Detailed view of scrub vegetation

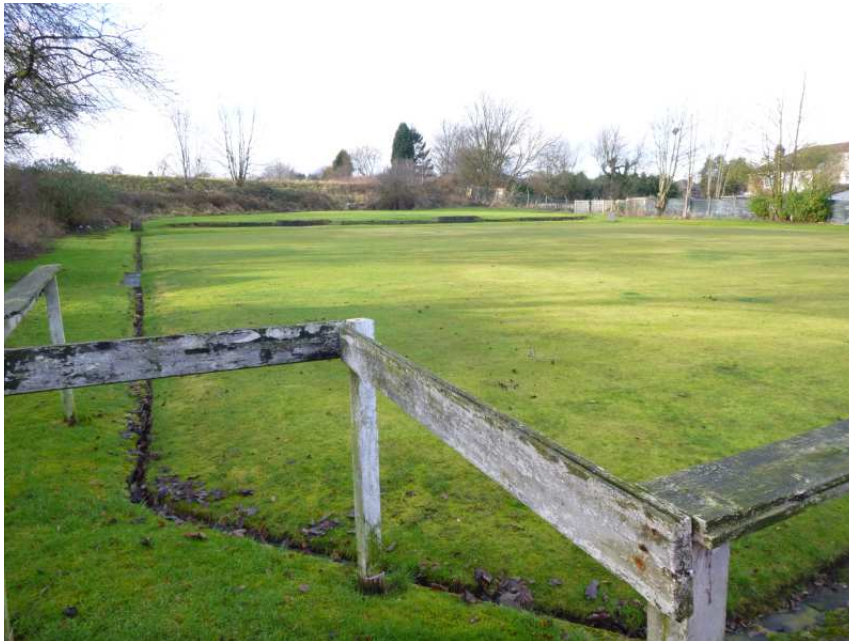
View to the north showing the bowling green and the raised platform of the pitch area in the background.

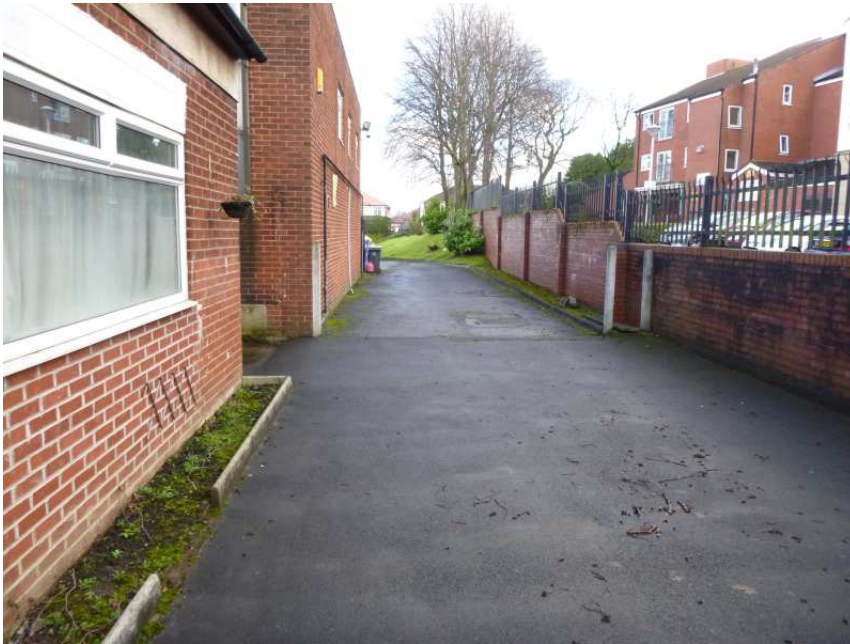
View along southern boundary showing slight elevation of the houses to the right of the picture.

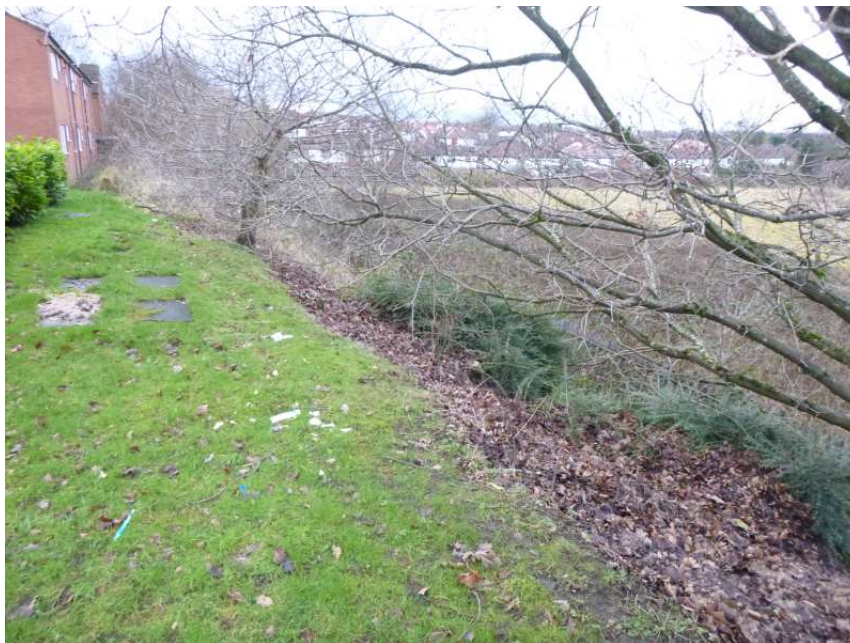
View from the houses on the southern boundary showing the elevated position of the houses relevant to the pitches area
