**GAS MEMBRANE VALIDATION**

| <b>Site: Bowes Street</b> | |
| Date: 11-01-2021 | Project Number: 11-813 |

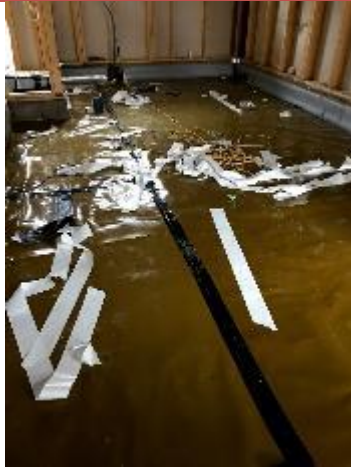
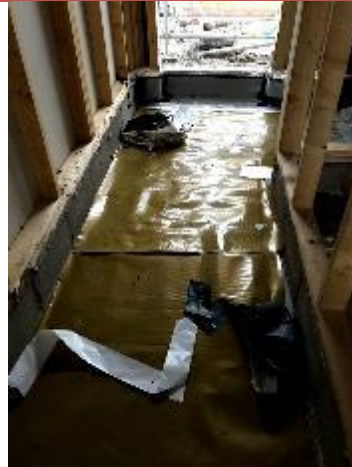
**Plot – 13**

**General Condition of Membrane-Good Condition**

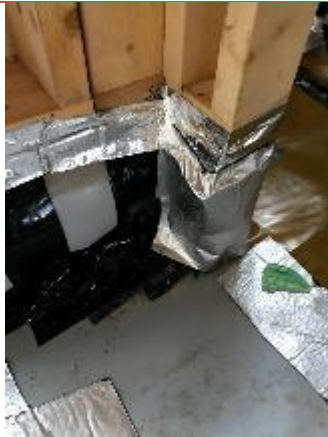
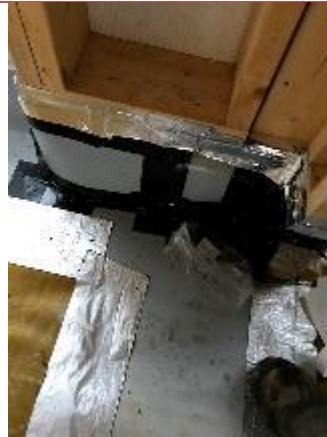
**Verification of Joints and Seals-Good Condition**

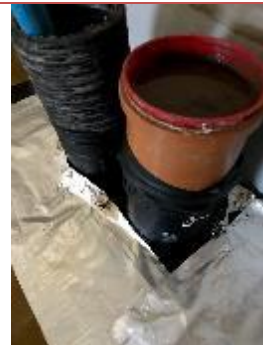
**Verification of Service Penetrations-Good Condition**

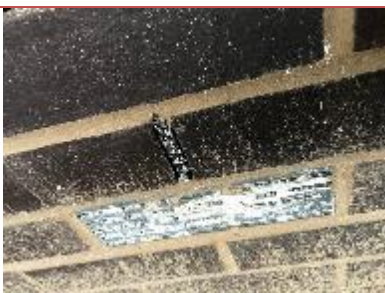
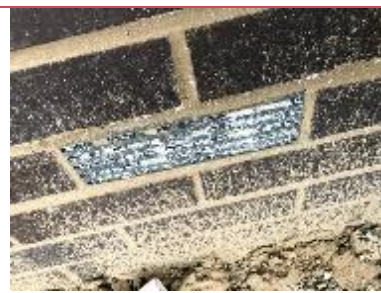
**Verification of Ventilation- Good Condition**

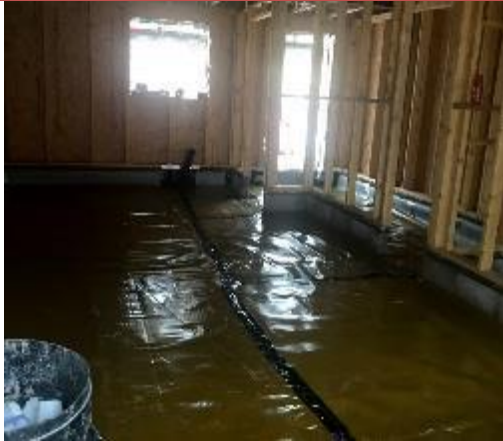
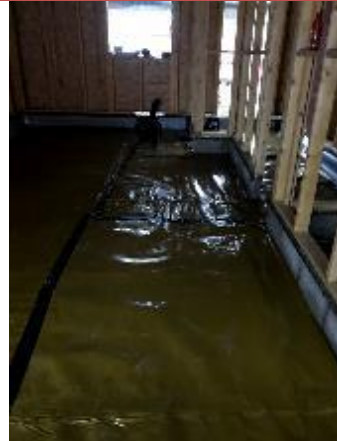
**Plot – 18**

**General Condition of Membrane-Good Condition**

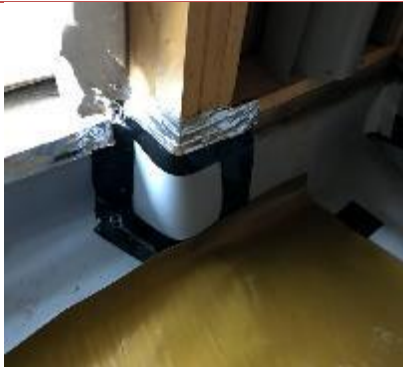
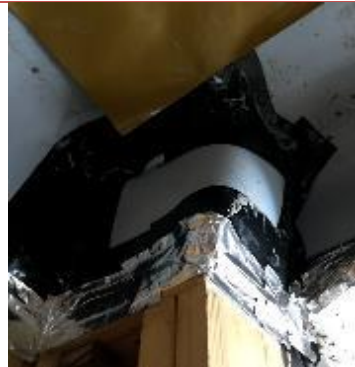
**Verification of Joints and Seals-Good Condition**

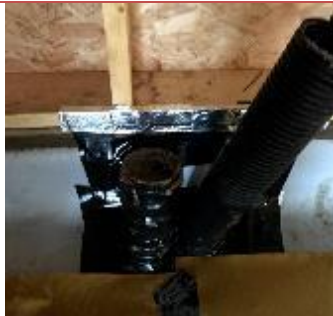
**Verification of Service Penetrations-Good Condition**

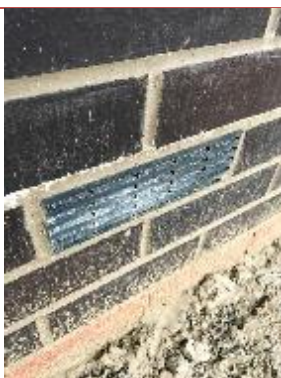
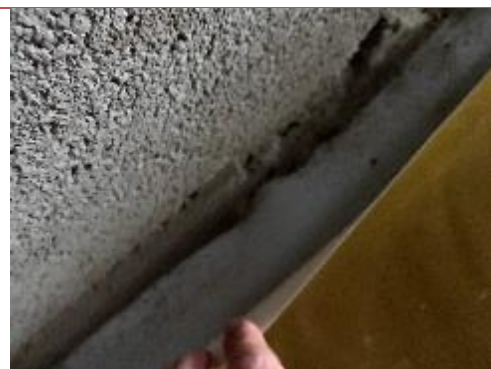
**Verification of Ventilation- Good Condition**
