WHP/MKR/20.018

## Listed Building Consent Application

**The Arthouse, 43 George Street,  
Manchester, M1 4AB**

### Roof Condition Report

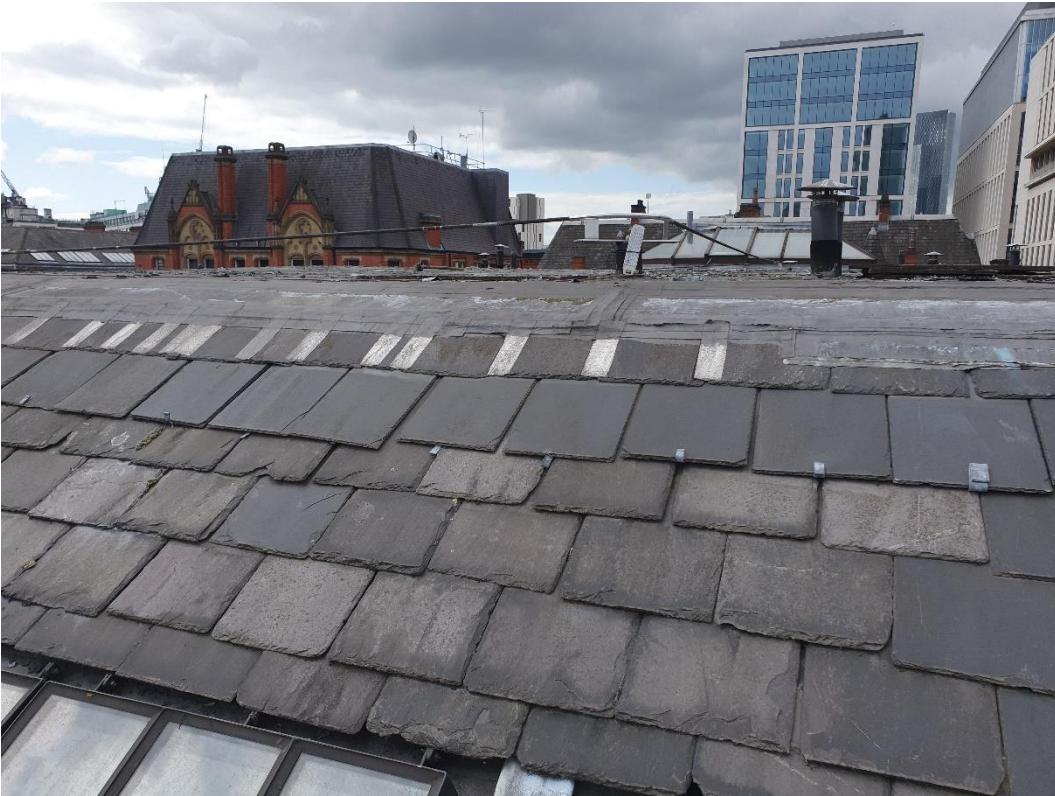
The slate covered mono-pitched mansard roofs are in a poor condition numerous displaced slates, historic slate repairs with tingles that are now failing, flashband repairs to rooflight flashings, flashband and liquid repairs at the junction of the flat roof with the pitched roofs and displaced sections of lead flashing.

1. Typical condition of slated roofs, note tingle repairs, uneven slates and patch repairs at the junction with the flat roof.

- Strip and re-cover the slate covered mono-pitched roofs, re-using the existing slates where suitable and matching slates where replacements are required.
- Strip the existing lead lined gutters, lay new gutter linings to their full length, in accordance with the Lead Association details and methods of workmanship.
- Rake out and re-point all parapet wall stone coping joints.
- Inspect and repair/decorate framed glazing to the lightwell.
- Decorate timber boarding to exterior of stair lightwell.
- Inspect and repair/decorate timber brise-soleil vanes.
- Ensure edge protection railings are secure.

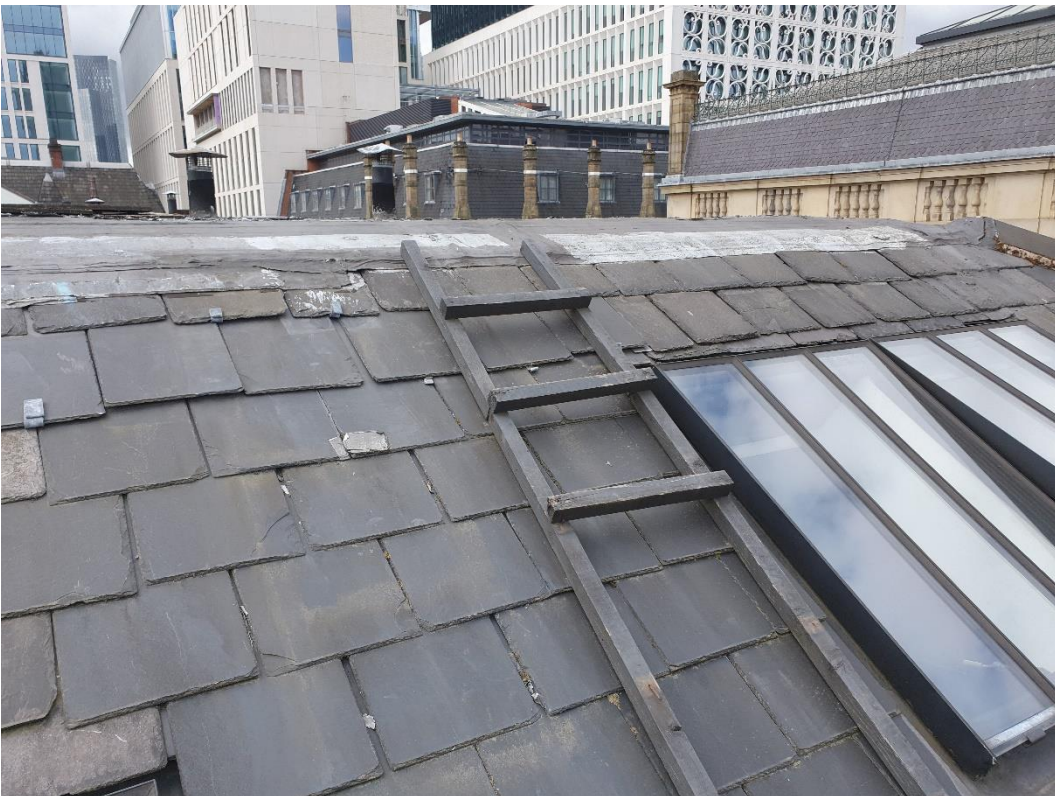
There are timber access ladders providing access across the roof areas, which are damaged and not fit for ongoing use. The works scope includes provision for a permanent roof access ladder solution.

2. Damaged timber roof access ladder. Similar slate defects to above

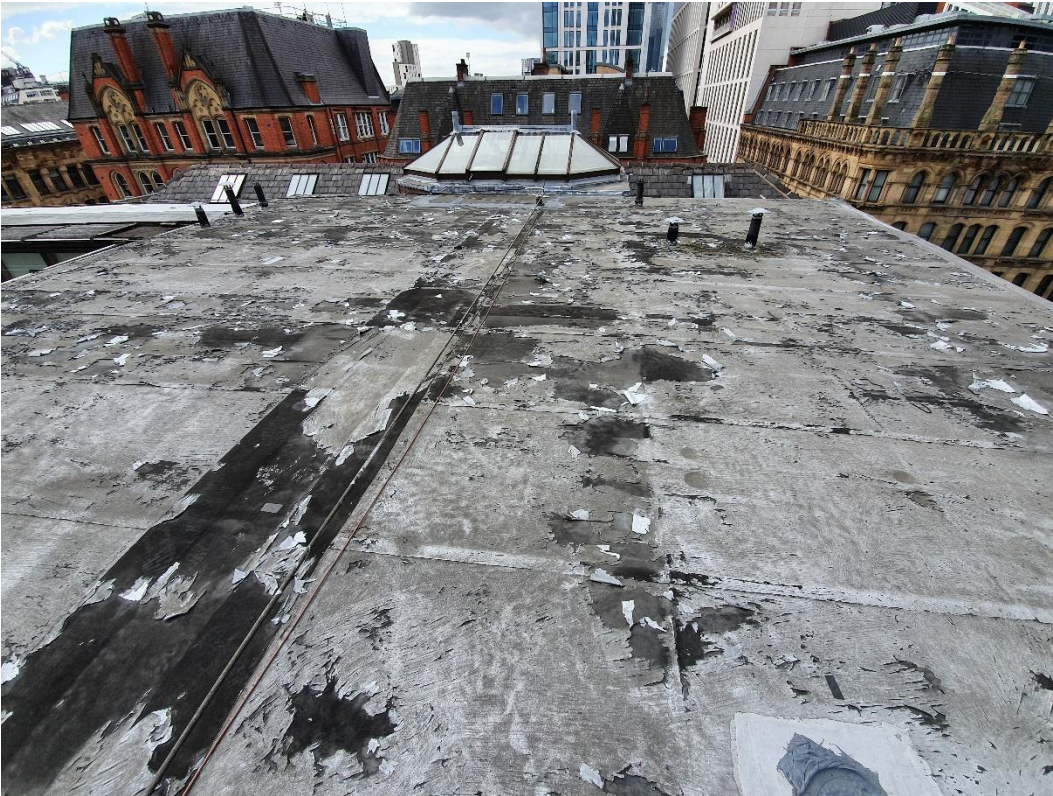
3. General condition of the flat roof covering, peeling and evidence of localised patch repairs.

- Clean, prepare and prime the flat roof areas and details
- Supply and install new EPDM waterproofing to the roof area
- All details to be installed to manufacturers recommendations and guidelines
- Replace timber roof access ladders with a safe, permanent solution – to be discussed.
- Investigate the balcony waterproofing and address damp ingress where water discharges from pitched roof gullies.

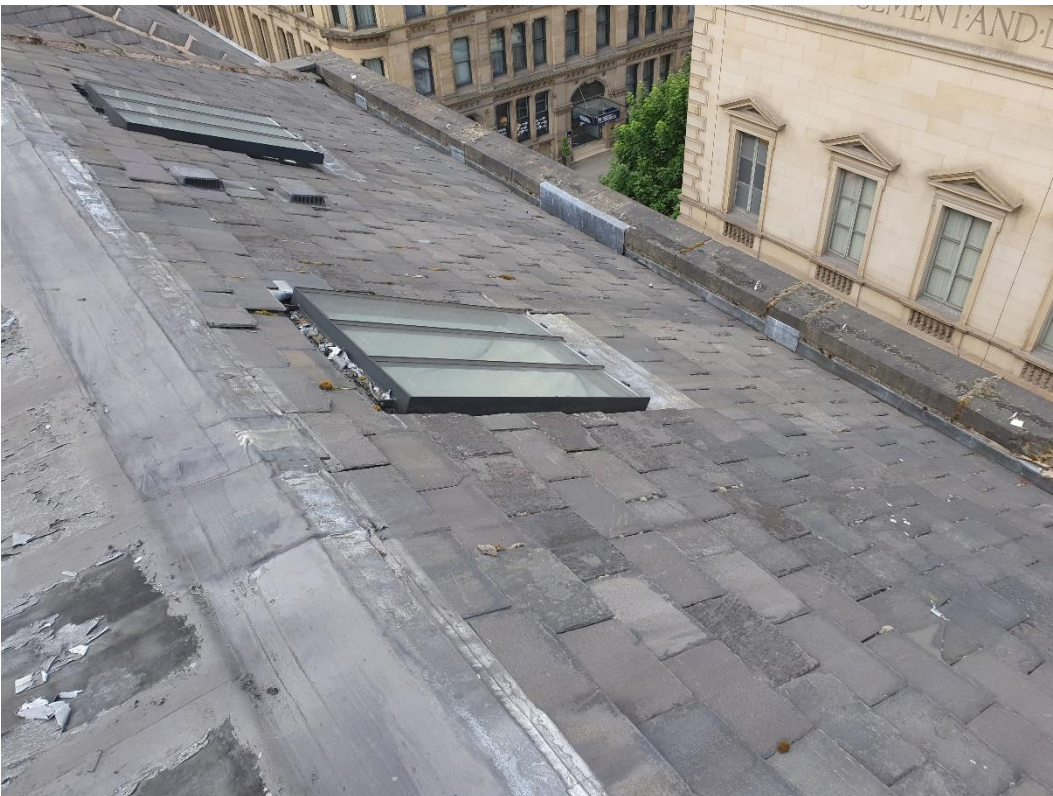
The detailing between the slate roof slopes and the flat roof covering is particularly poor, where numerous patch repairs are evident. Sections of slates have been replaced with lead flashings and other areas have temporary repairs undertaken with flashband and acrypol (or similar liquid applied patch repair solution). The recovering of the flat roof will include the provision of a suitable detail at the interface of the slate roofs with the flat roof covering, to allow construction of a robust waterproofing detail at this junction.

4. Poor detailing of the junction between the flat roof and the slate covered mansard. Note lead patch repairs to gutter.

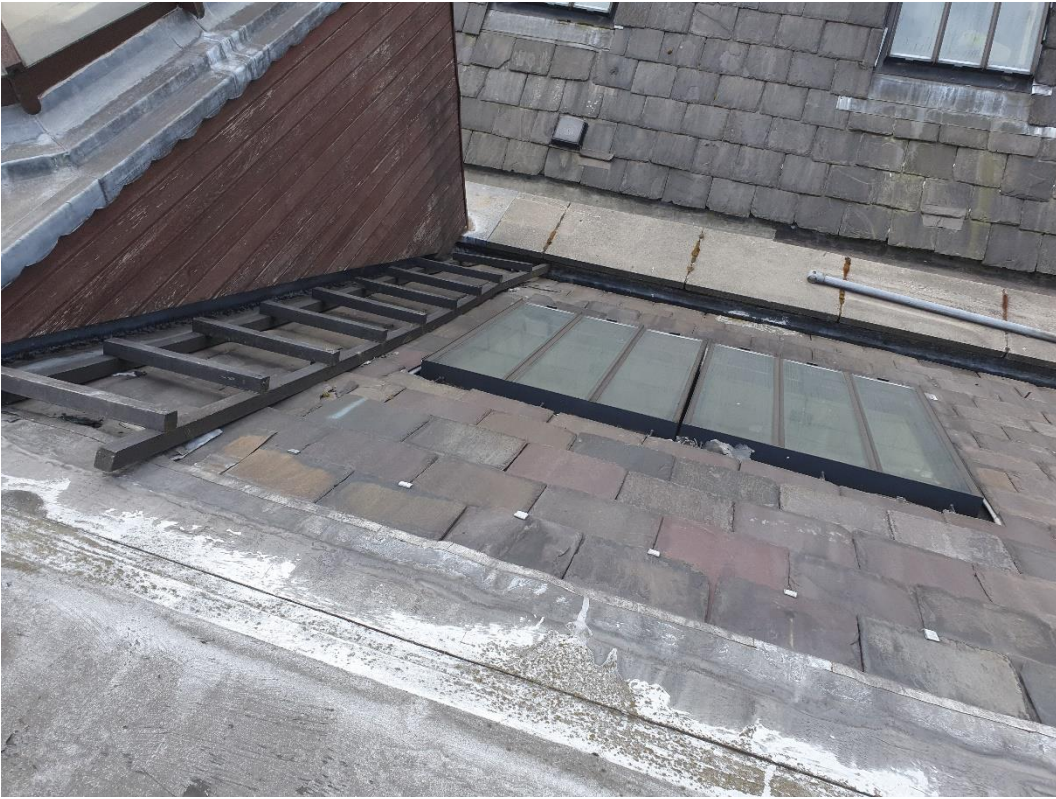
The timber cladding and glazing bars to the stair lightwell are in a deteriorating decorative condition and there is evidence of localised timber decay. Repair works are to include replacement of any decayed sections and re-coating with a waterproof stain.

5. Timber access ladder to valley. Timber cladding to stairwell atrium is heavily aging.

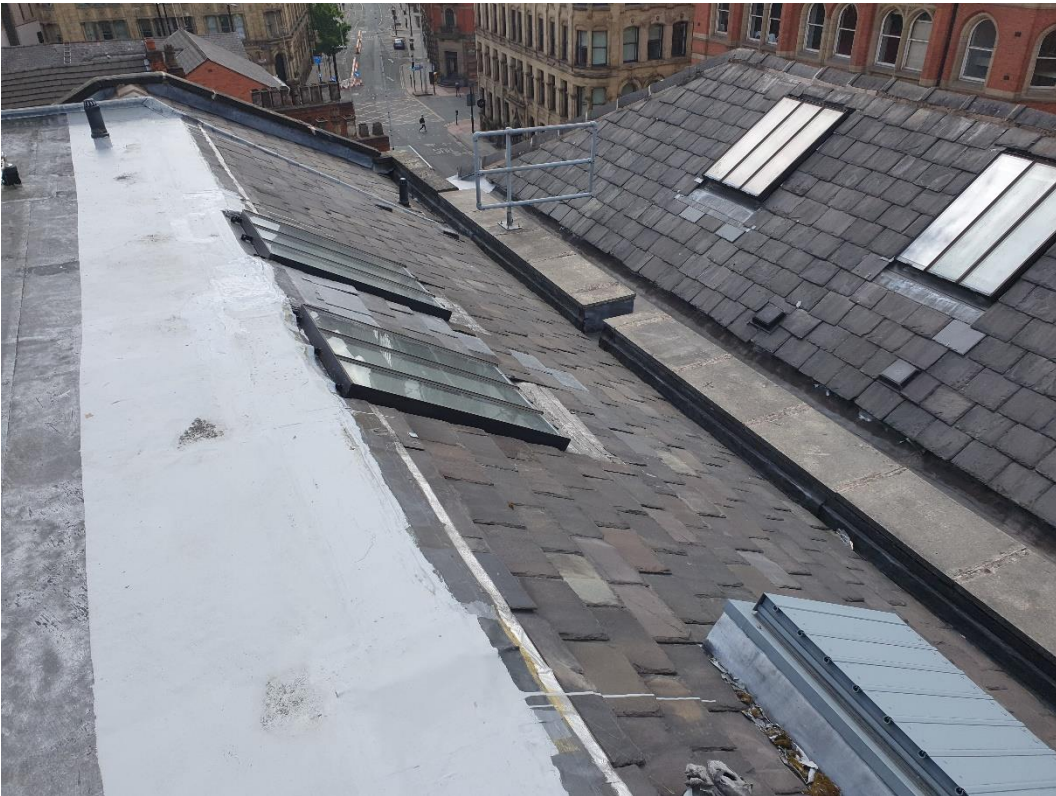
8. Liquid applied patch repair at junction of slate and flat roof.

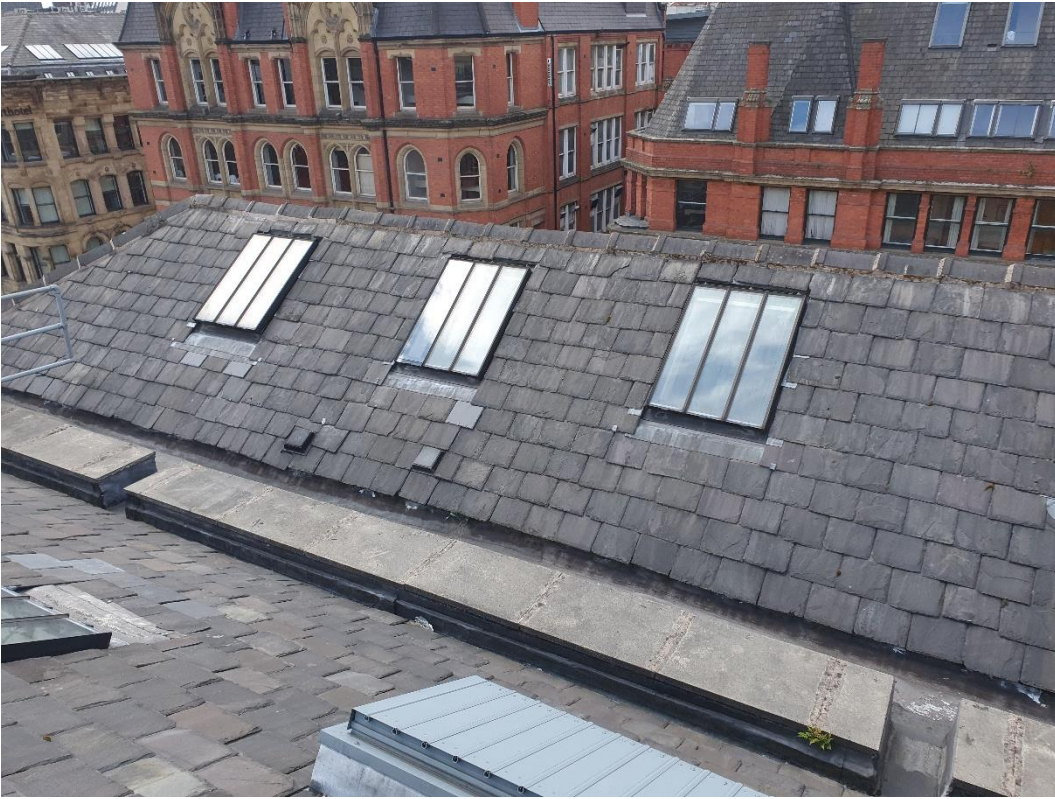
9. Inner slope of hipped roof, note uneven slate courses.

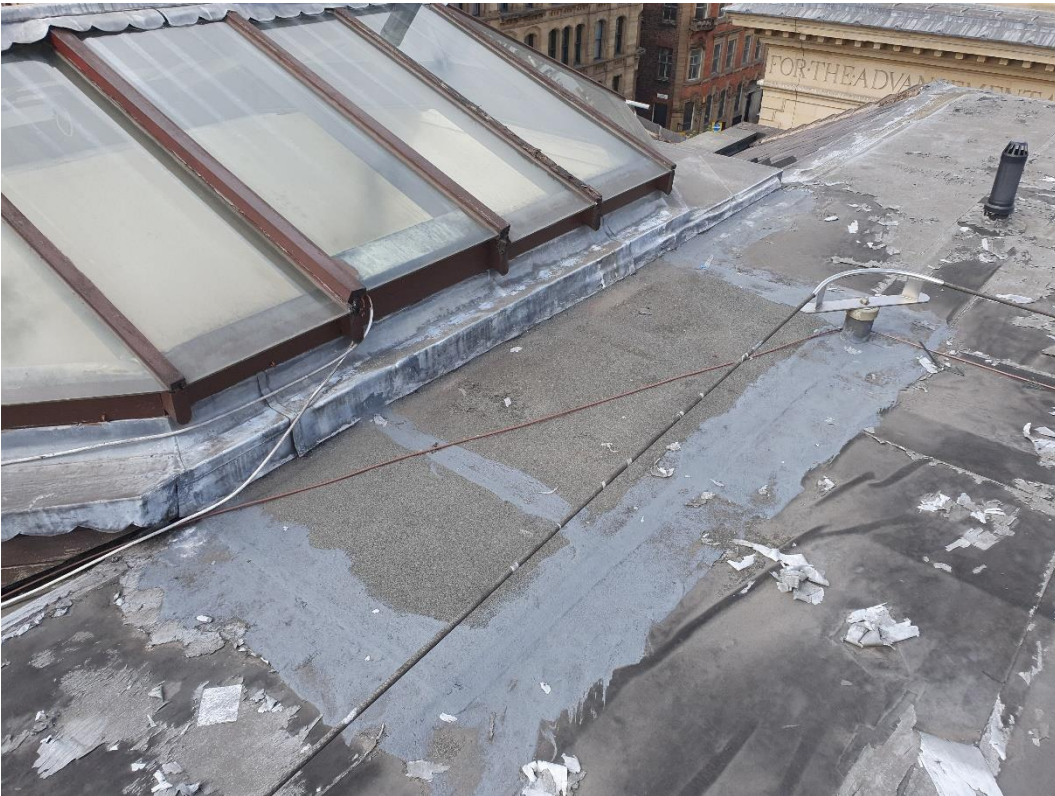
10. Patch repair adjacent to stair atrium.

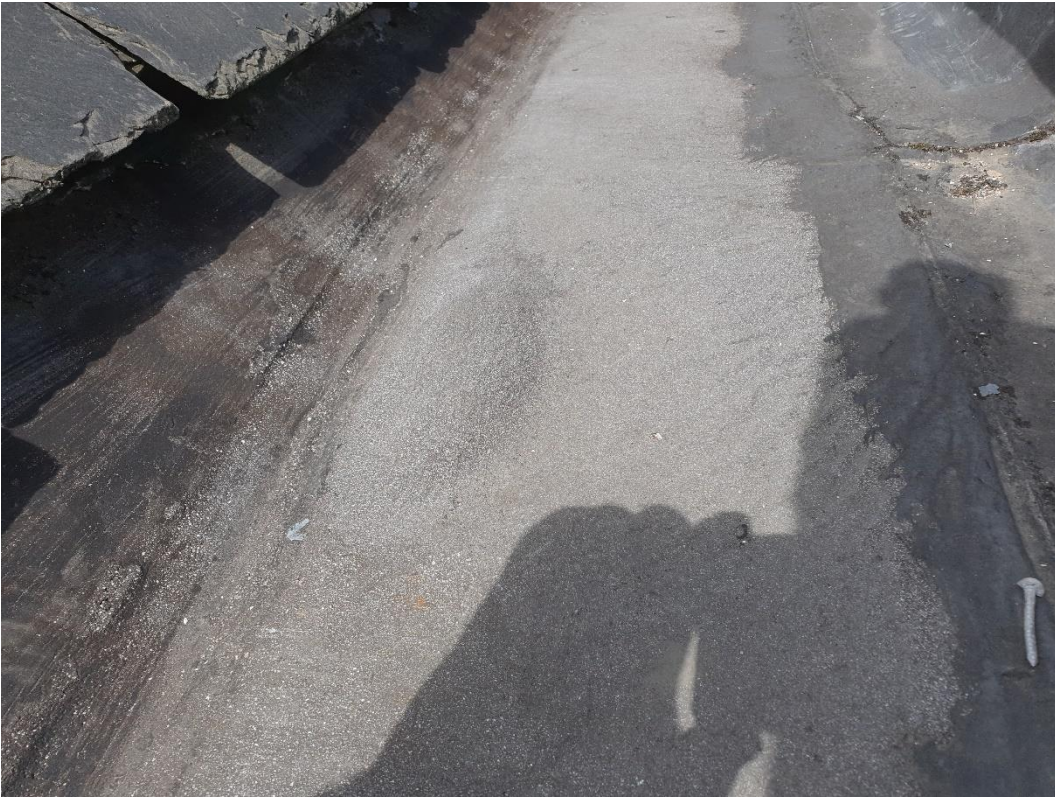
11. Blistering to bitumen coated valley gutter.

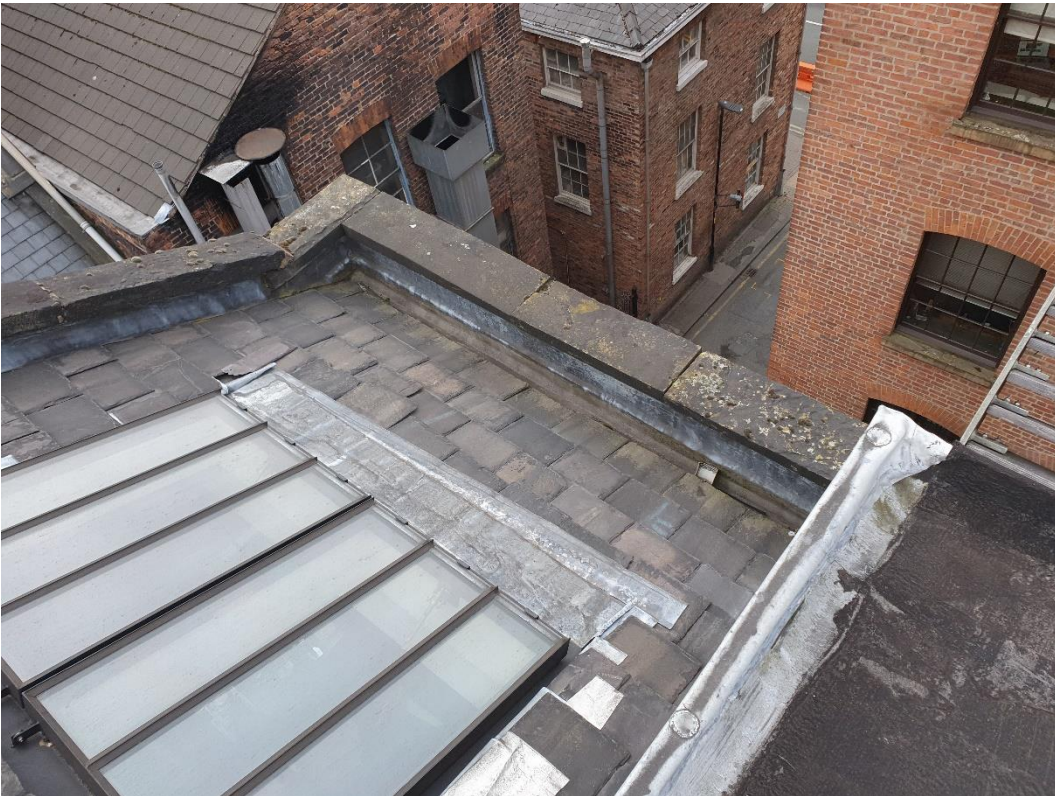
The mortar joints of the parapet walls are failing, allowing a possible route for water ingress into the building. The coping joints will be raked out and re-pointed with lime mortar, to match the existing.

12. Poor condition of mortar joints to stone copings.

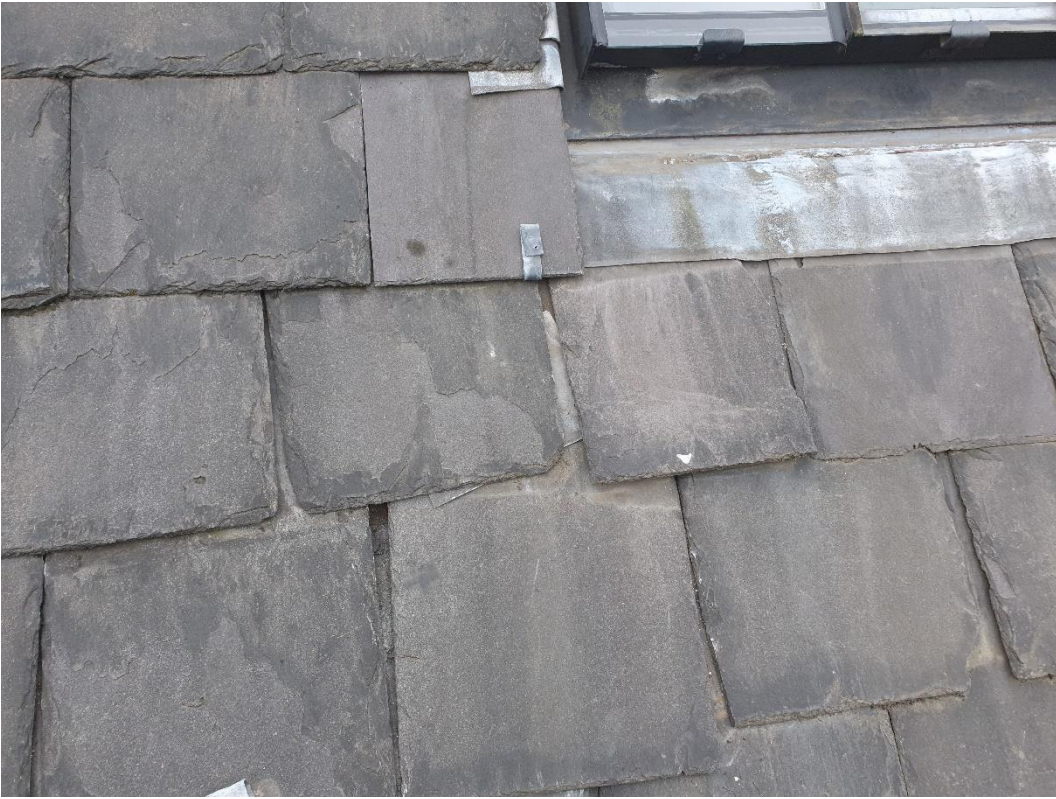
13. Uneven and poorly repaired slates.

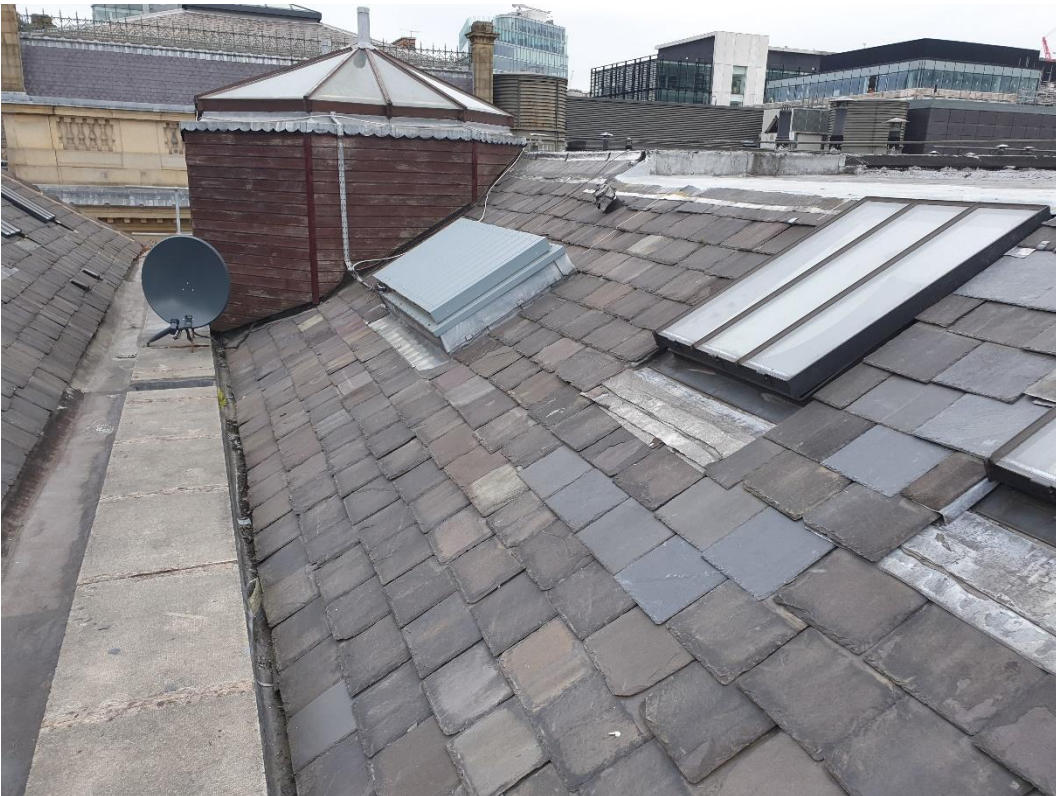
14. Poorly matched and fitted slate repairs.

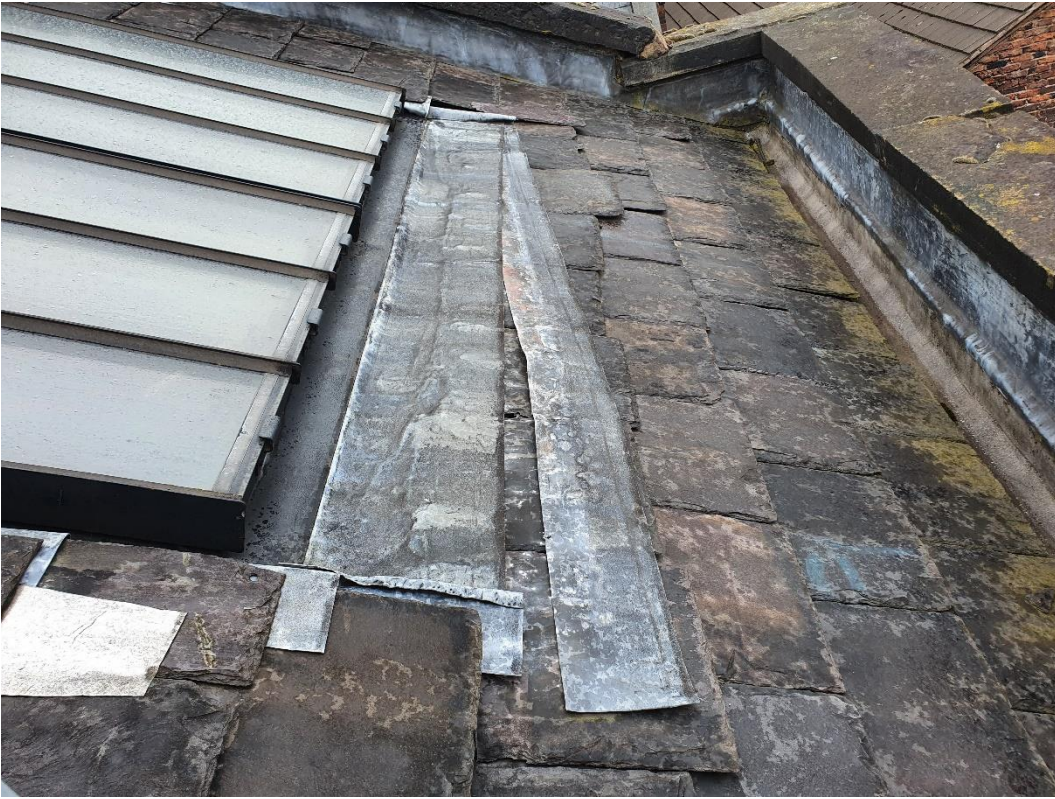
17. Displaced lead flashing beneath rooflight window.

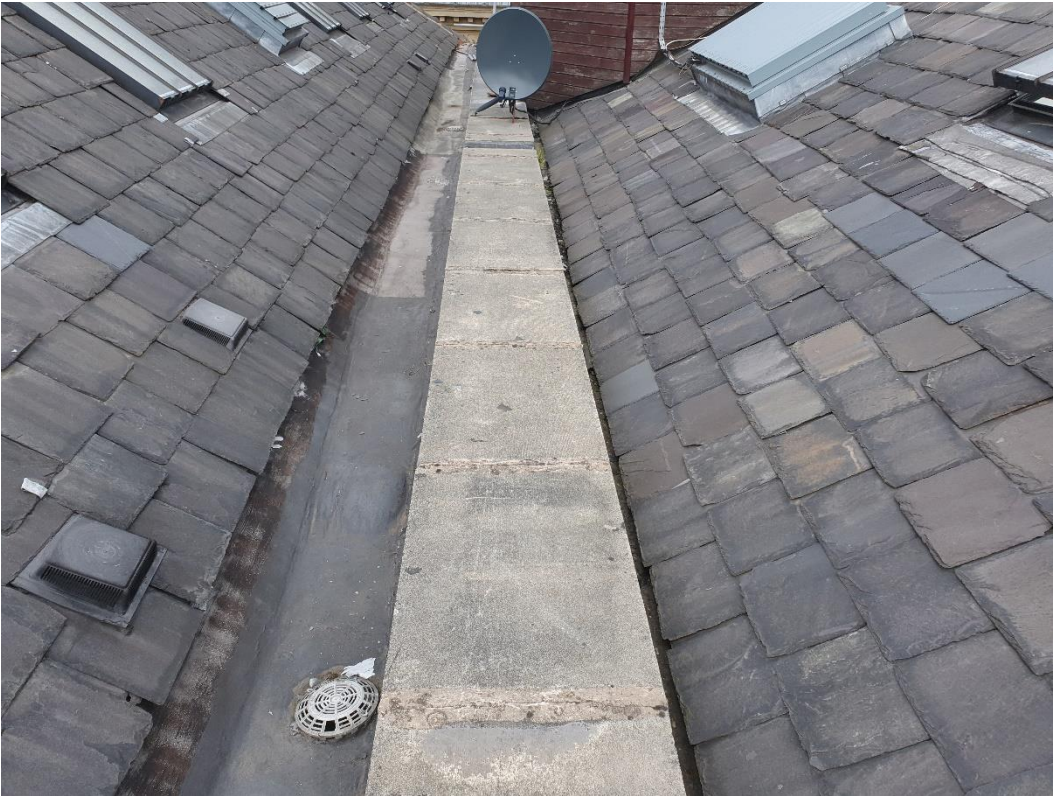
The valley between the pitched front roof and the adjacent mono-pitched roof is formed with an asphalt coating, dressed to either side of the parapet wall that forms the party wall between the two structures. The asphalt finish is cracking and blistered in numerous areas and has received repairs in numerous areas with a liquid applied coating. It is intended to remove any loose and damaged material and prepare the valley to receive a fully bonded EPDM valley lining, to be dressed up beneath the bottom 3 slate rows, to provide a seamless waterproof surface to allow the roof to correctly discharge to the rainwater hoppers.

19. Asphalt lined valley between the front pitched roof and mono-pitch roof to the rear section.

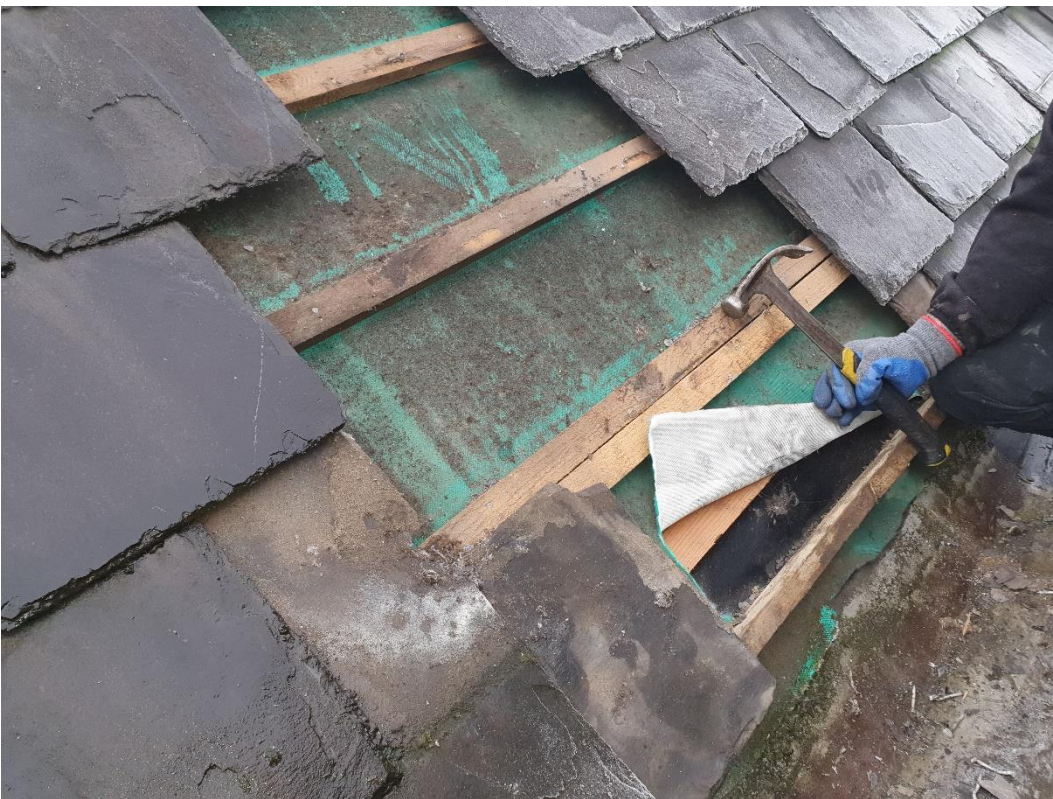
Further intrusive investigation identified that the breathable underfelt has been pulled tight beneath the battens, causing any penetrating water to pond against the battens and promote timber decay. We also noted that the timber battens are untreated softwood and therefore are more susceptible to failure in the medium term.

20. Investigation of pitched roof, showing “tight” roof felt and untreated timber battens.
